12 METER	MILLIME	23	V%AVE	TELE3COPE
MEMO No247

National Radio Astronomy Observatory Tucson, Arizona

July 9, 1991

Subject: 12 m Structural Tilt Measurements

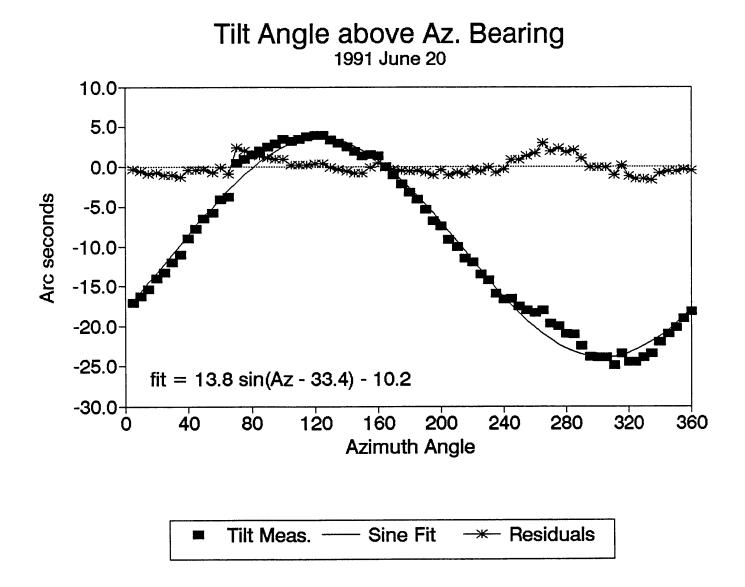
- 1. Tilt angle measured just above the azimuth bearing as a function of azimuth rotation angle of the telescope is dominated by the azimuth bearing tilt. This produces a sinusoidal variation in tilt angle, but with some significant residuals around 270° (Figure 1: June 1991 measurements; Figure 2: July 1978 measurements).

- Figure 1: Tilt angles measured just above the azimuth bearing as the telescope was rotated in azimuth angle. The mounting flange for the tiltmeter was ~6 in above the bearing, directly below the elevation bull gear, on the side in which the dish tips in elevation. The sine curve was fitted by non-linear least-squares.

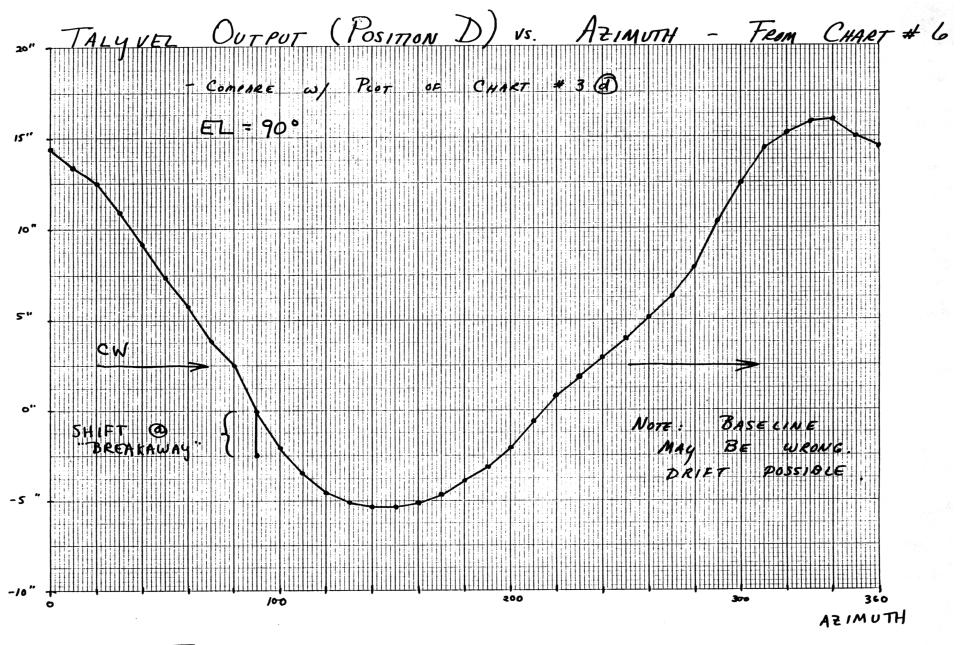
F16. 2

- Figure 2: Tilt data from the same position, taken by MacDowall and Ulich in July 1978. The tiltmeter was oriented 180° different from our measurements, hence the phase difference in the curves.

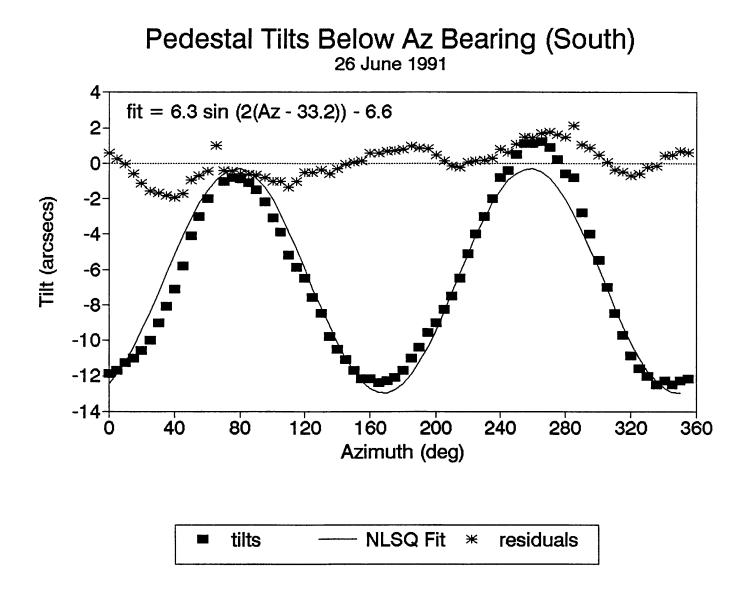
- 2. Measurements below the azimuth bearing on the pedestal are dominated by a  $\sin 2\theta$  curve as the telescope is rotated in azimuth angle. The 1991 data are well-fit with a  $\sin(2\cdot(Az phase))$  term (Figure 3). The data from 1978 seem to have higher order terms, e.g.,  $\sin 4\theta$  (Figure 4).

- Figure 3: Tilts measured on the pedestal below the azimuth bearing, as the telescope is rotated in azimuth angle. The mounting flange is on the slanted part of the pedestal, about 1 ft below the azimuth bearing, at a position facing directly south (180° Azimuth). The curve was fitted by non-linear least-squares.

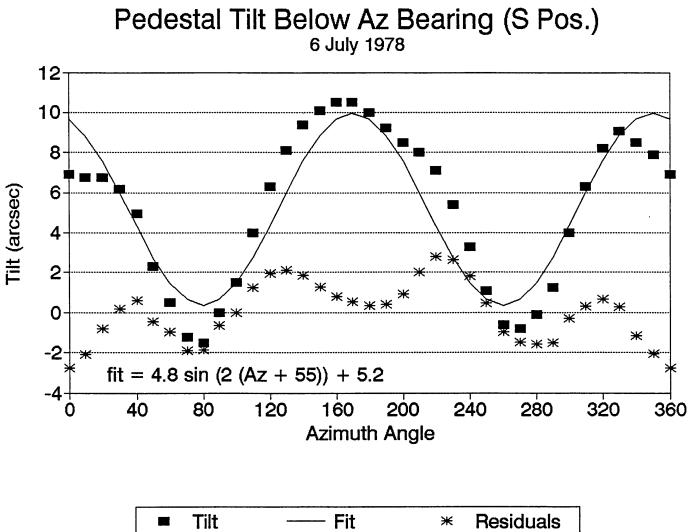
- Figure 4: Tilt data from the same position, taken by MacDowall and Ulich in July 1978. The residuals show more pronounced higher order terms than the more recent data. The fit was by eye.

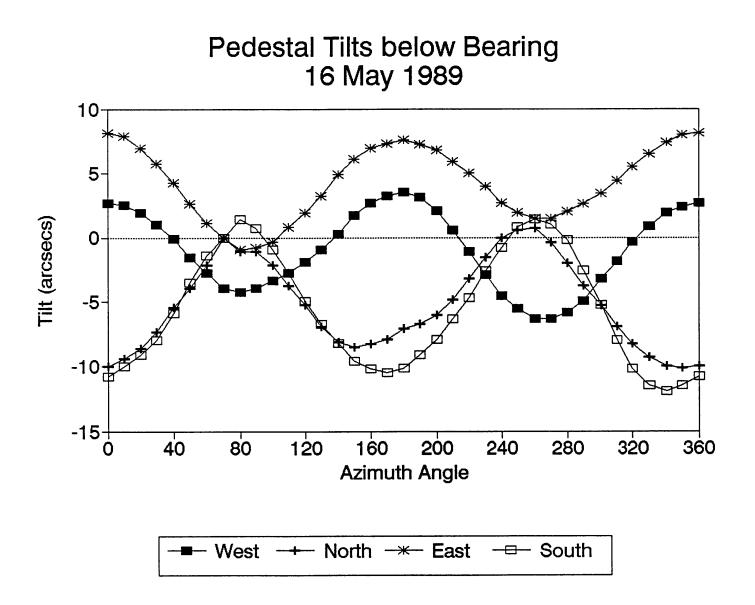
- 3. In May 1989, we made tilt measurements below the azimuth bearing at the four cardinal azimuth positions: 0°, 90°, 180°, and 270° as the telescope was rotated in azimuth (Figure 5).

- Figure 5: Tilts measured on the pedestal, below the azimuth bearing, at the four cardinal points (0°, 90°, 180°, and 270°) as a function of telescope azimuth rotation angle.

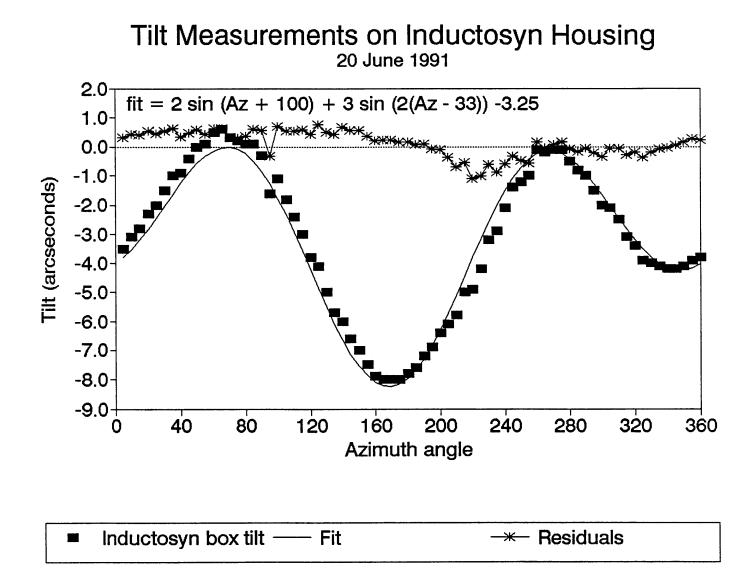
- 4. Tilt measurements on the azimuth inductosyn housing as the telescope is rotated in azimuth show sinθ and sin2θ components (Figure 6). This result may be a significant clue to some of the problems we are having now. There was no comparable measurement in 1978. In January 1990, R. Freund, J. Kingsley, and PRJ made lateral translation measurements of the inductosyn house using the NOAO laser interferometer. The result (Figure 7) shows a double-peaked curve as a function of telescope azimuth rotation angle similar to that shown by the tiltmeter.

The tilt measurements made on the azimuth inductosyn box indicate that the box is under undesirable stresses. If the box is tilting with respect to the telescope pier, the inductosyn is probably not reading the proper azimuth position of the telescope. The stresses could be introduced through the shaft coupling or through the shaft bearing collar and tachometer mount just above the inductosyn shaft. This should be investigated in more detail with mechanical instrumentation.

- Figure 6: Tilts measured with the tiltmeter on top of the azimuth inductosyn house (near right-hand side as you look through the pedestal door), as a function of telescope azimuth rotation angle. The curve shows a combination of  $\sin\theta$  and  $\sin2\theta$  terms.

- 3. Unbolt the shaft collar bearing just above the inductosyn coupling and measure inductosyn box tilts as a function of azimuth rotation angle.
- 4. Consider isolating the azimuth inductosyn from azimuth axle torques through a redesign of the inductosyn mount and the shaft bearing mount.

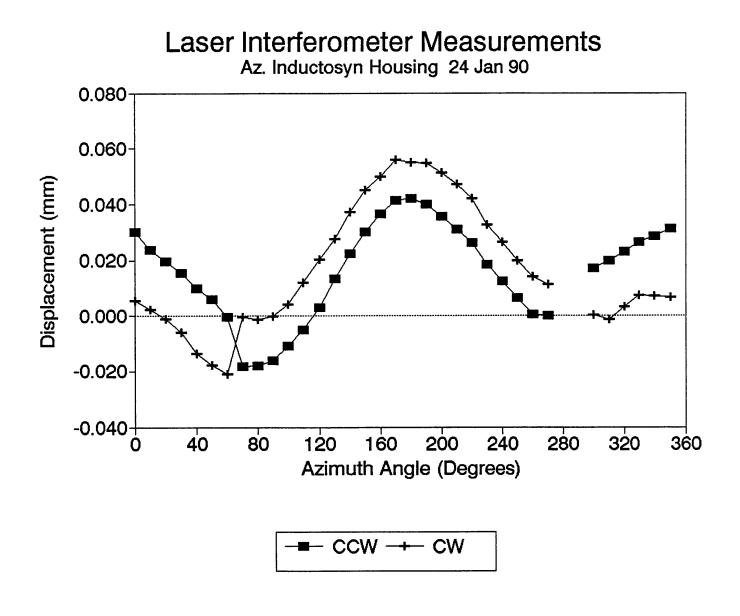
# F16.7

- Figure 7: Linear translations in the azimuth inductosyn house as a function of telescope azimuth rotation, measured with the NOAO laser interferometer in January 1990. The laser was stationed just outside the west end of the control room. The retro-reflector was positioned on the inductosyn house on the near right-hand side as you look through the door (same place as the tiltmeter described in Fig. 6). The break at 70° azimuth results from the cable wrap limit; the break at ~280° azimuth occurred when the service platform ladder interrupted the laser beam.

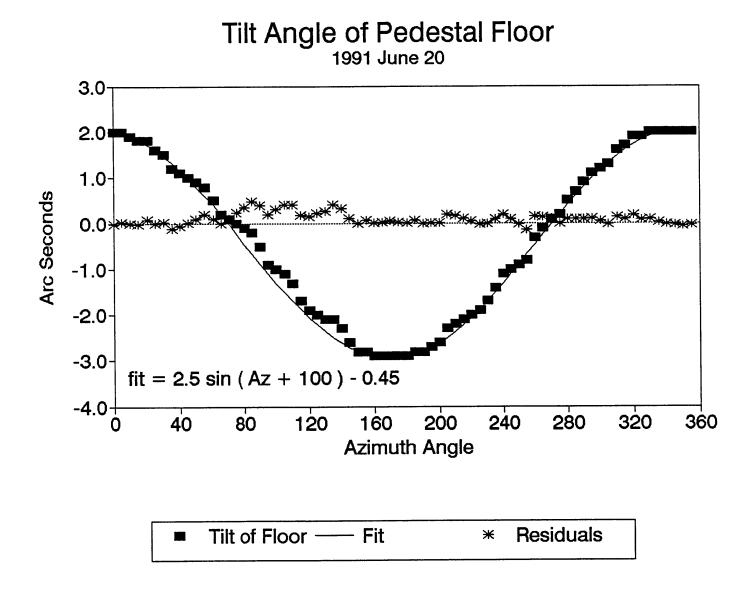
- 5. Measurements on the concrete floor, inside the pedestal, about halfway between the inductosyn stand and the door, show a simple sine-wave (Figure 8). There was no comparable measurement in 1978.

- Figure 8: Tilts measured on the floor of the pedestal as a function of azimuth rotation angle. The tiltmeter was placed about half-way between the door and the inductosyn mounting stand. The fitted sine curve was done by eye.

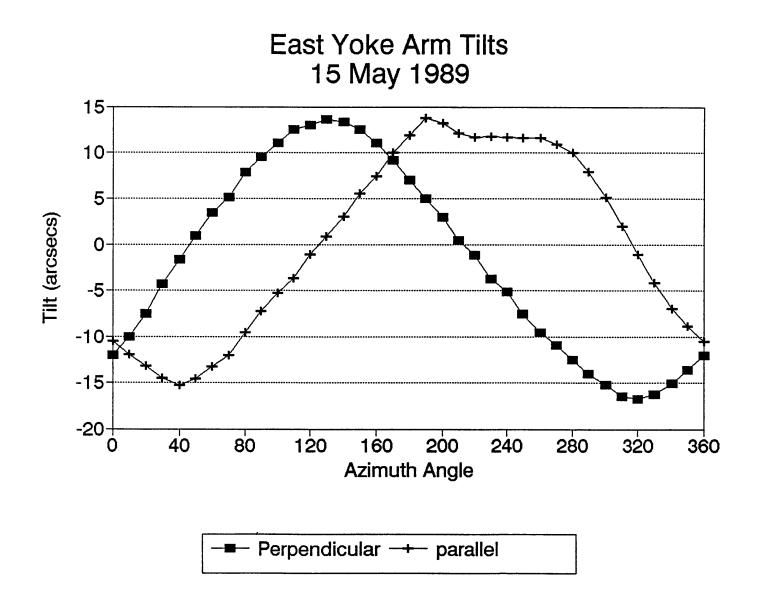
- 6. Measurements on top of the east elevation yoke arm are different depending on whether the tiltmeter is oriented parallel or perpendicular to the elevation axis. Perpendicular to the axis, the tilt is largely sinusoidal as the telescope is rotated. Parallel to the axis, some significant residuals appear, particularly near ~250° azimuth. Results from May 1989 (Figure 9) agree well with those from 1978 (Figures 10 and 11).

- Figure 9: Tilts measured just atop the east elevation yoke arm as a function of azimuth rotation angle, in May 1989. The solid squares show the measurements with the tiltmeter aligned perpendicular to the elevation axis, and the pluses show the measurements with the

tiltmeter parallel to the elevation axis.

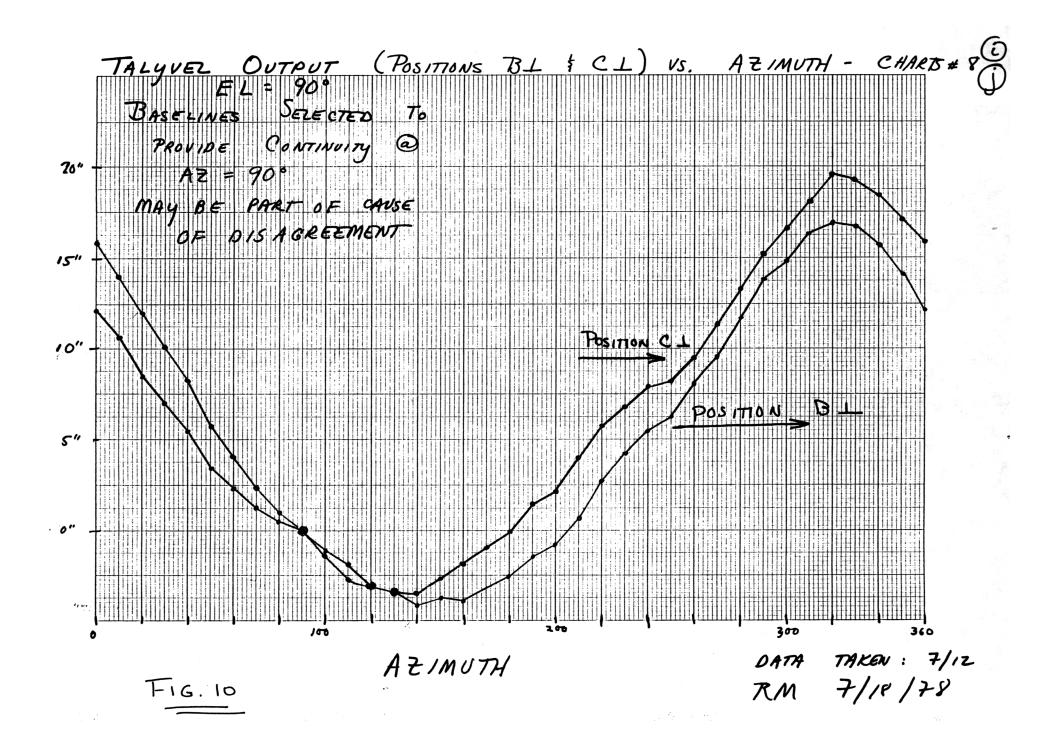
- Figure 10: Same as Figure 9, but measured by MacDowall and Ulich in July 1978. The tiltmeter was oriented perpendicular to the elevation axis. Position "B" was 14 in below the elevation encoder (the old Baldwin), east end of the elevation axis, and corresponded to tipping south. Position "C" was below and to the north of the elevation axis, about 5" from the old air conditioner unit and corresponds to tipping south.

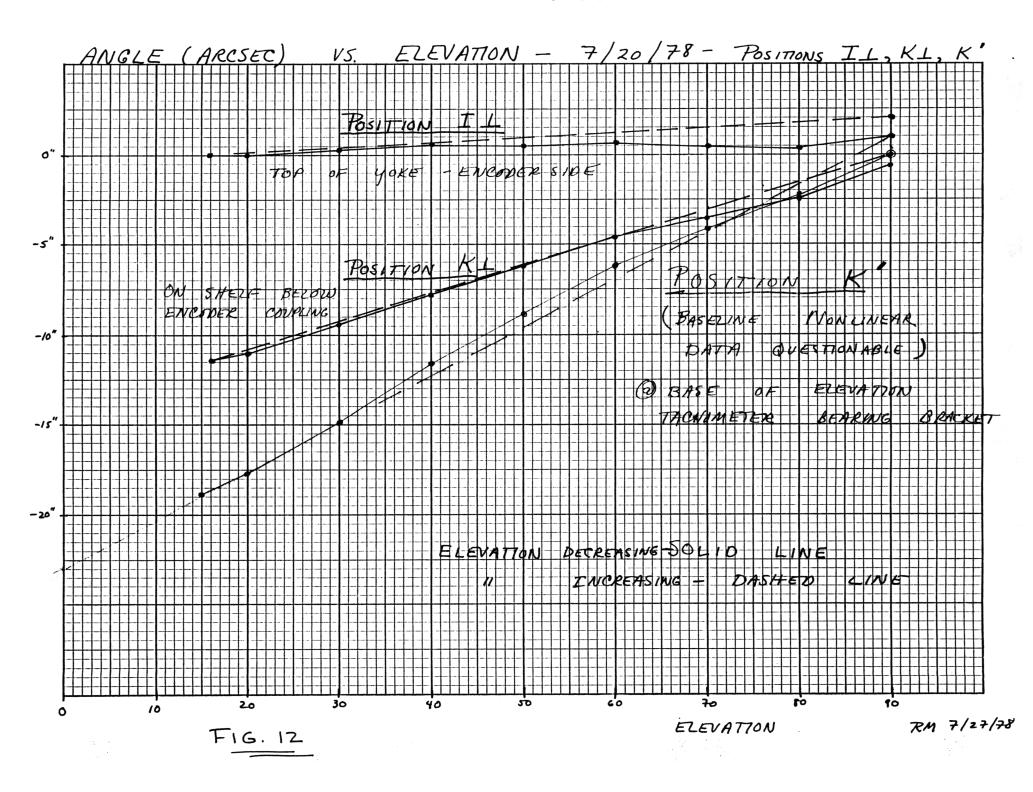
- 7. MacDowall and Ulich also measured tilts in the structure as the telescope is tipped over in elevation, particularly at the mounting points of the old elevation Baldwin encoder. They found that the mounting flange tilted significantly with elevation tipping angle (Figure 12). The Baldwin encoder, which is still on the telescope, is mounted on a bracket that extends about 40 in from the east yoke arm. The encoder is turned by a spindle extending about 12 in from the east elevation torque motor. The elevation inductosyn, which is the angle resolver currently in use, is mounted flush to the west elevation torque motor.

- Figure 11: Same as Figure 10, but with the tiltmeter oriented parallel to the elevation axis.
- Figure 12: Tilts in the elevation structure as a function of telescope elevation angle as measured by MacDowall and Ulich in July 1978. Position "I" was at the top of the yoke, on the (Baldwin) encoder side. Position "K" was on the shelf directly below the elevation coupling. Positive deflections correspond to tipping south.

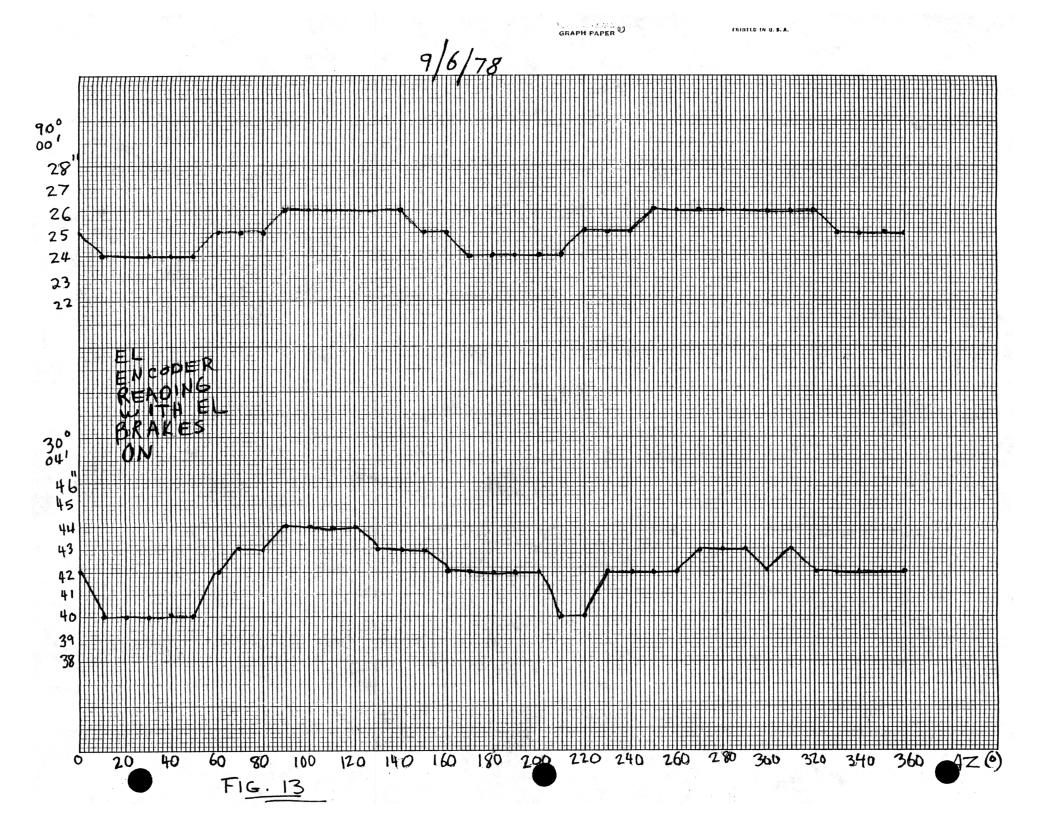
8. MacDowall and Ulich also noted that the elevation encoder readout varied as the telescope was rotated in azimuth angle, perhaps because structural deformations were transmitted to the elevation encoder mounting bracket (Figure 13). We repeated these measurements with the elevation stow pin inserted (telescope at 90° elevation). A peak-to-peak deviation of 1.6" was observed (Figure 14). The terms compensating for this effect and the one discussed in Item 7 (the old ROTEL and ROTAZ terms) are no longer in the telescope pointing model. We should do some more investigation into the term involving azimuth angle.

- Figure 13: Changes in the elevation encoder reading, with the elevation brakes on, as the telescope is rotated in azimuth, as measured by Ulich in September 1978. The top curve was as at an elevation angle of 90°, the bottom at 30°.

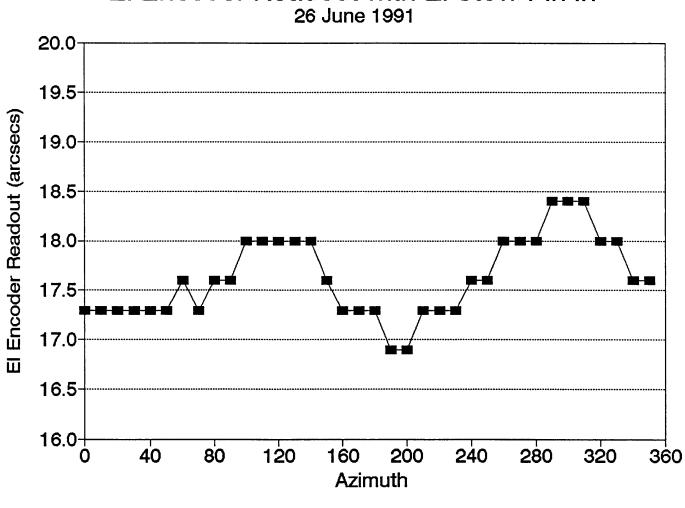
FIG. 14

- Figure 14: Similar measurement to Figure 13, but done in June 1991. The measurement was done with the elevation stow-pin inserted.
- Figure 15: Display of hysteresis in the azimuth pointing offsets as a function of azimuth position. The observations were done with the optical pointing system. All stars were within an elevation band between 25° and 35°. The observations were made starting at 70° azimuth and rotating first clockwise (increasing azimuth), then counter-clockwise, back clockwise, and back again counter-clockwise.

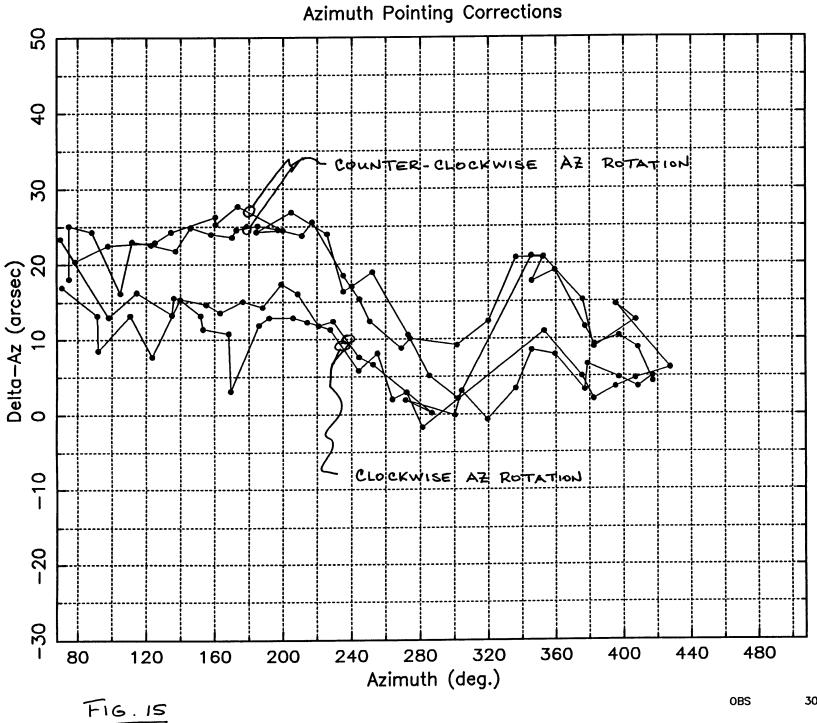
- 9. Figures 15 and 16 show the hysteresis effect in azimuth pointing offsets. These measurements were made with the optical pointing and data acquisition system, programmed by Tom Folkers. With Tom's help, we restricted the sources to be between 25° and 35° elevation. We then drove the telescope counter-clockwise (CCW) to the azimuth limit position, then took data CW, then CCW, CW again, and once more CCW. The curves taken in the same azimuth drive direction agree well, but are separated from the curves taken in the opposite direction by more than 10" (Figure 15). In case the hysteresis results from some binding in the cable wrap at the azimuth limit positions, we did a second run staying ~60° away from the wrap position. The results are shown in Figure 16 and are similar to those with 360° azimuth rotation.

guesses. The hysteresis loop indicates that the azimuth encoder is not accurately measuring the true azimuth movement of the telescope. The are two likely candidates for this problem: (1) the flexible coupling between the azimuth shaft and the inductosyn, which was replaced about 2 years ago; or, (2) the connection between the azimuth shaft and the elevation yoke structure, which conceivably could have loosened over the years. The hysteresis loop seems to open up to its maximum separation nearly immediately upon reversal of drive direction; however, the normal servo overshoot is apparently not enough to unwind the hysteresis. This suggests that the azimuth drive must reach slew rate for the hysteresis effect to be seen.

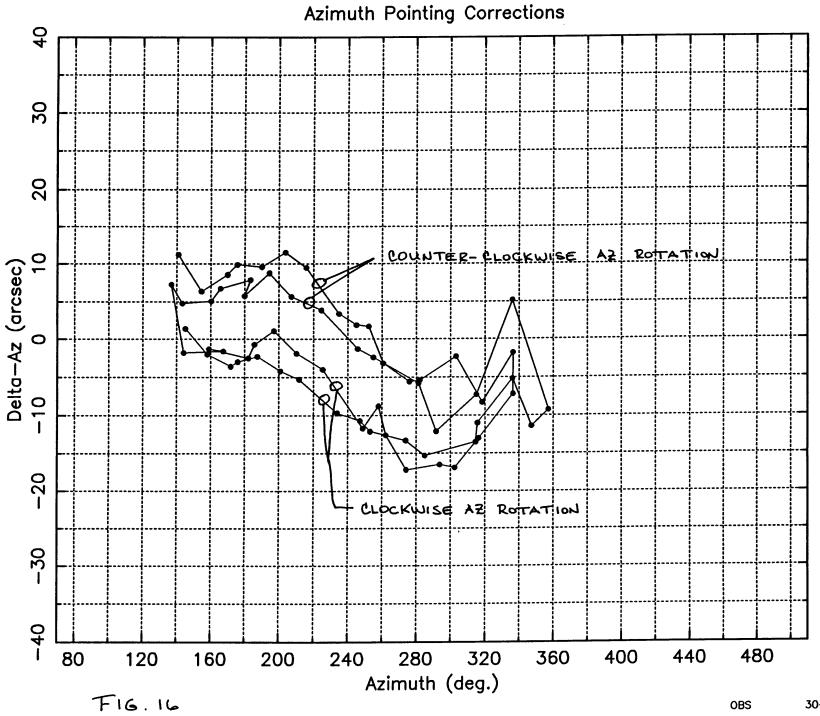
- Figure 16: Same as Figure 15, but in a restricted azimuth range, to investigate the possibility that the hysteresis is introduced in the azimuth cable wrap region.
