REPORT  
OF THE  
TECHNICAL ASSESSMENT PANEL

COLLAPSE OF THE 300 foot RADIO TELESCOPE

**REPORT of the TECHNICAL ASSESSMENT PANEL  
for the  
300 foot RADIO TELESCOPE at GREEN BANK, WV**

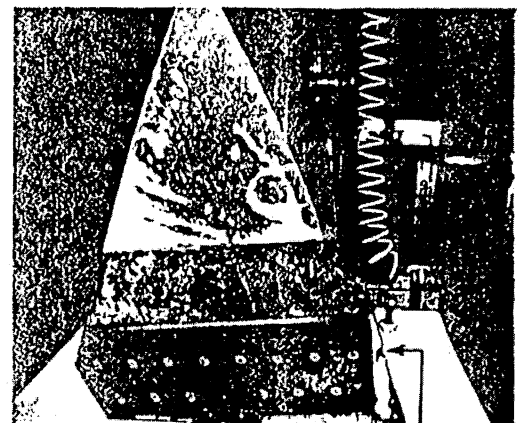
FIGURE 1-16 : RUPTURED GUSSET PLATE DETAILS

2) Visual inspection and laboratory tests of the ruptured gusset removed from the telescope wreckage indicated progressive cracking and eventual rupturing of this plate. The analysis showed that the plate stresses were high enough to cause cracking and crack growth under the cyclic loads from the antenna movements. Rupture of the plate would have resulted in the collapse of the telescope. It should be noted that the telescope had a history of several gusset plate replacements throughout its operational life.

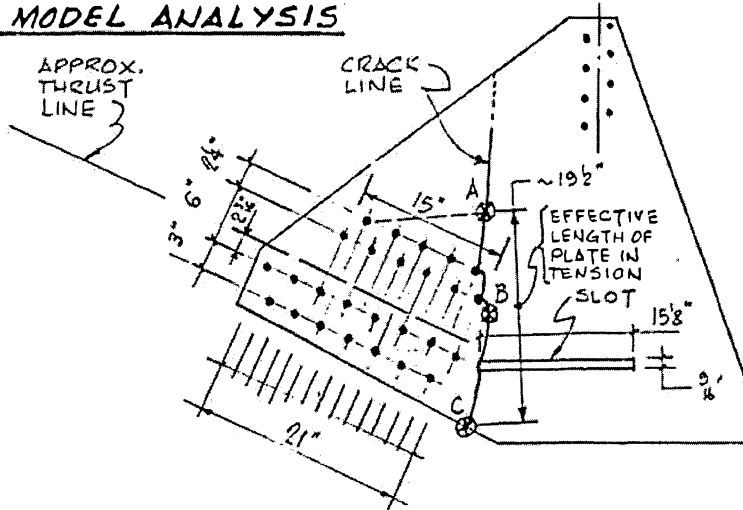
RUPTURED GUSSET PLATE ELEVATION

AVG. BENDING STRESS FLUCTUATION =  $[(117 - 28.1) + (160 - 28.1)]/2 = 110 \text{ ksi}$  ABOVE 28.1 ksi (N&S)  
 (Therefore, since only the yield stress can be developed, the p will yield)

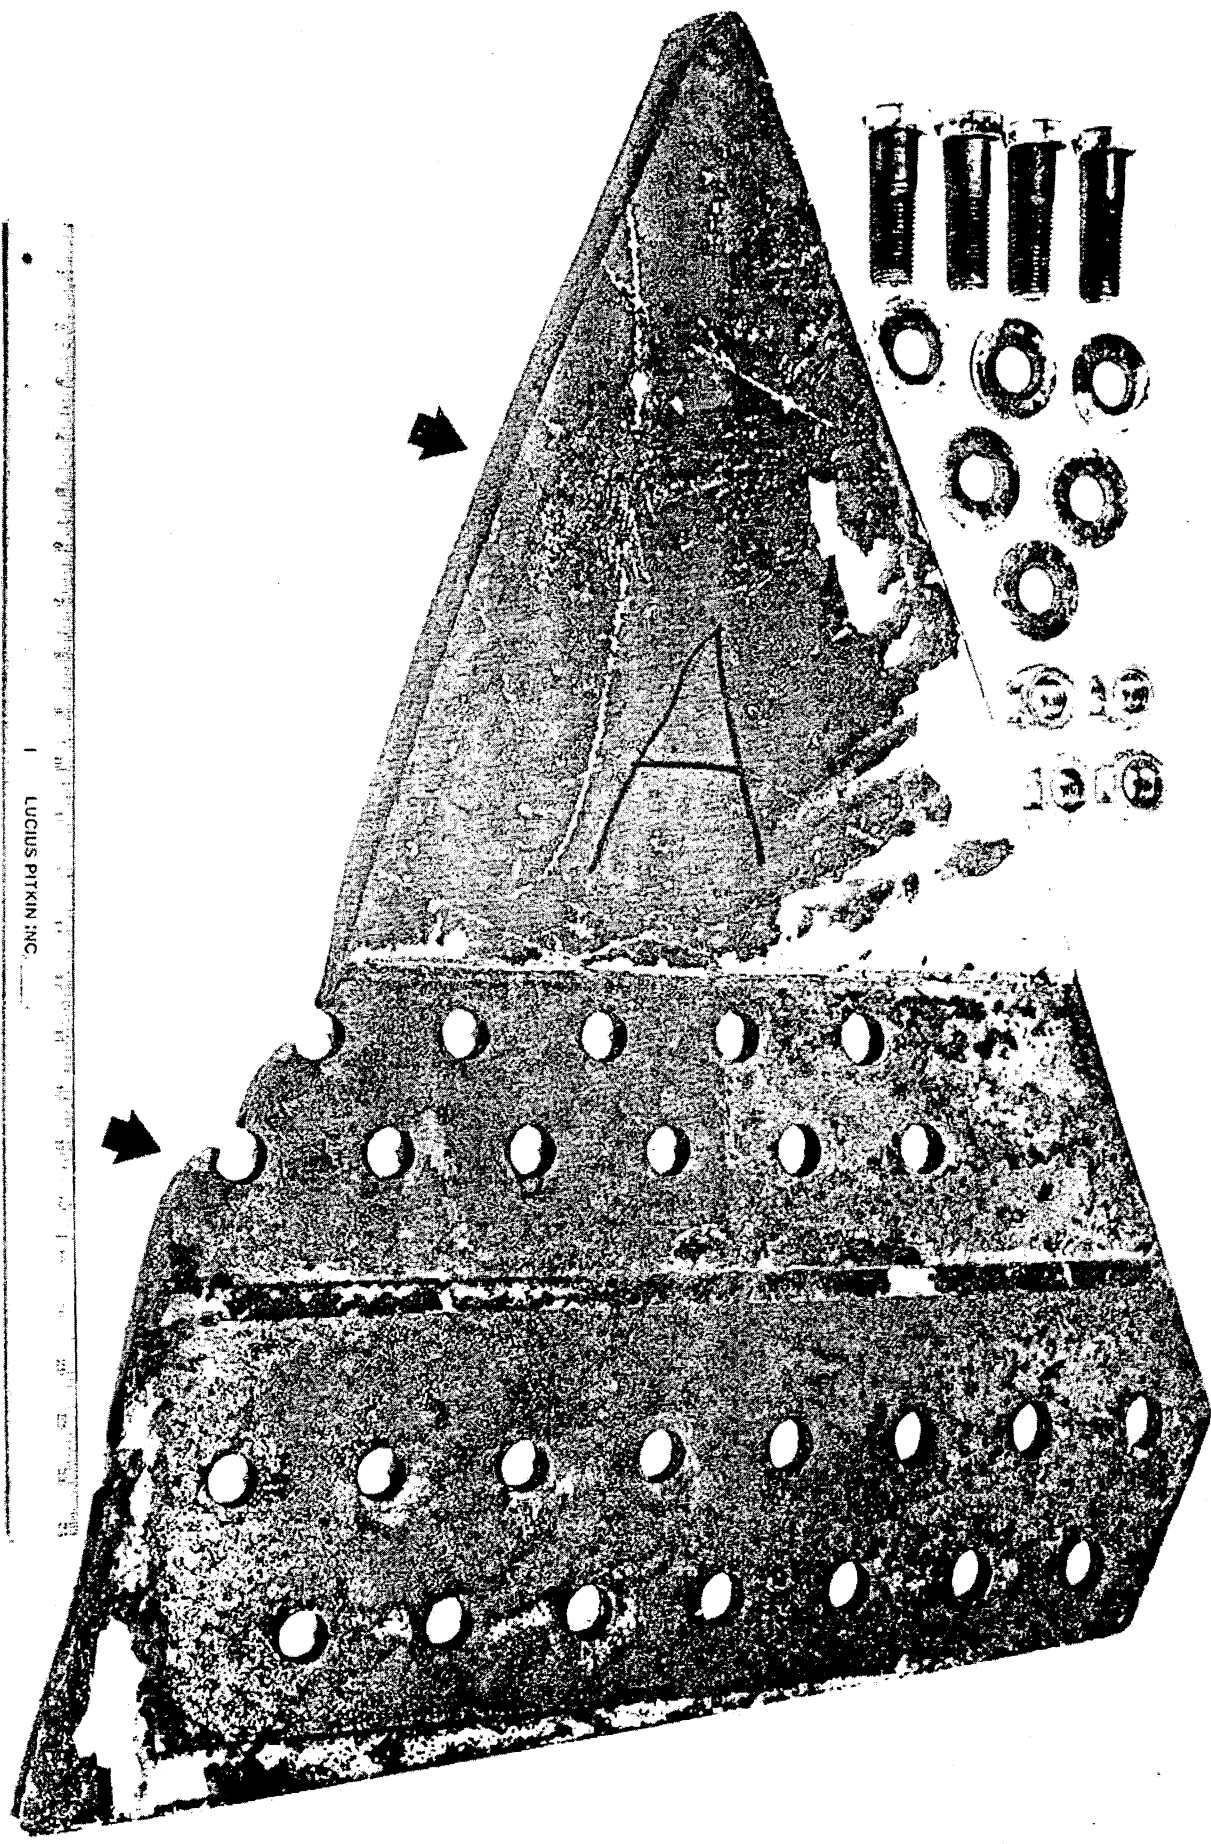
FAILED MAIN BOX GIRDER PLATE,  
AS-RECEIVED

Photograph showing the submitted 1/2-in. thick main box girder plate from the 300 ft. radio telescope at Greenbank, West Virginia, in the as-received condition. The plate fracture was approximately 37 in. long (arrows) and intersected two bolt holes.

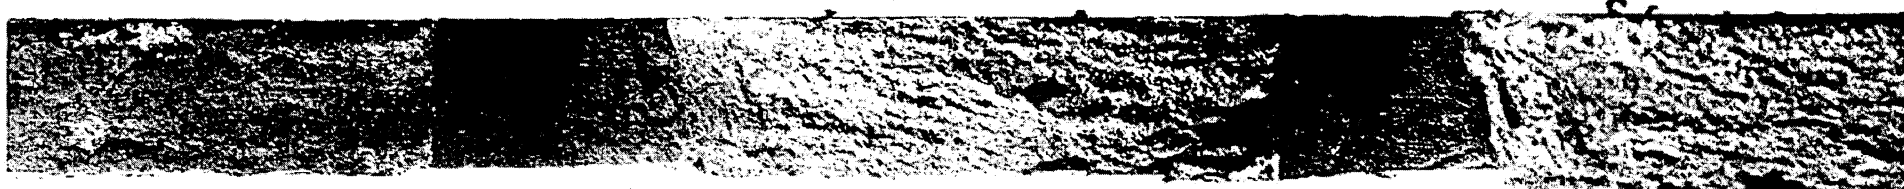
**PLATE FRACTURE SURFACE**

Photograph showing the flat and heavily oxidized appearance of the plate fracture surfaces adjacent to the bolt holes. This flat and heavily oxidized fracture appearance is characteristic of long-term progressive or fatigue cracking. The convergence of chevron-like marks indicates the bolt holes to be the fracture origins.

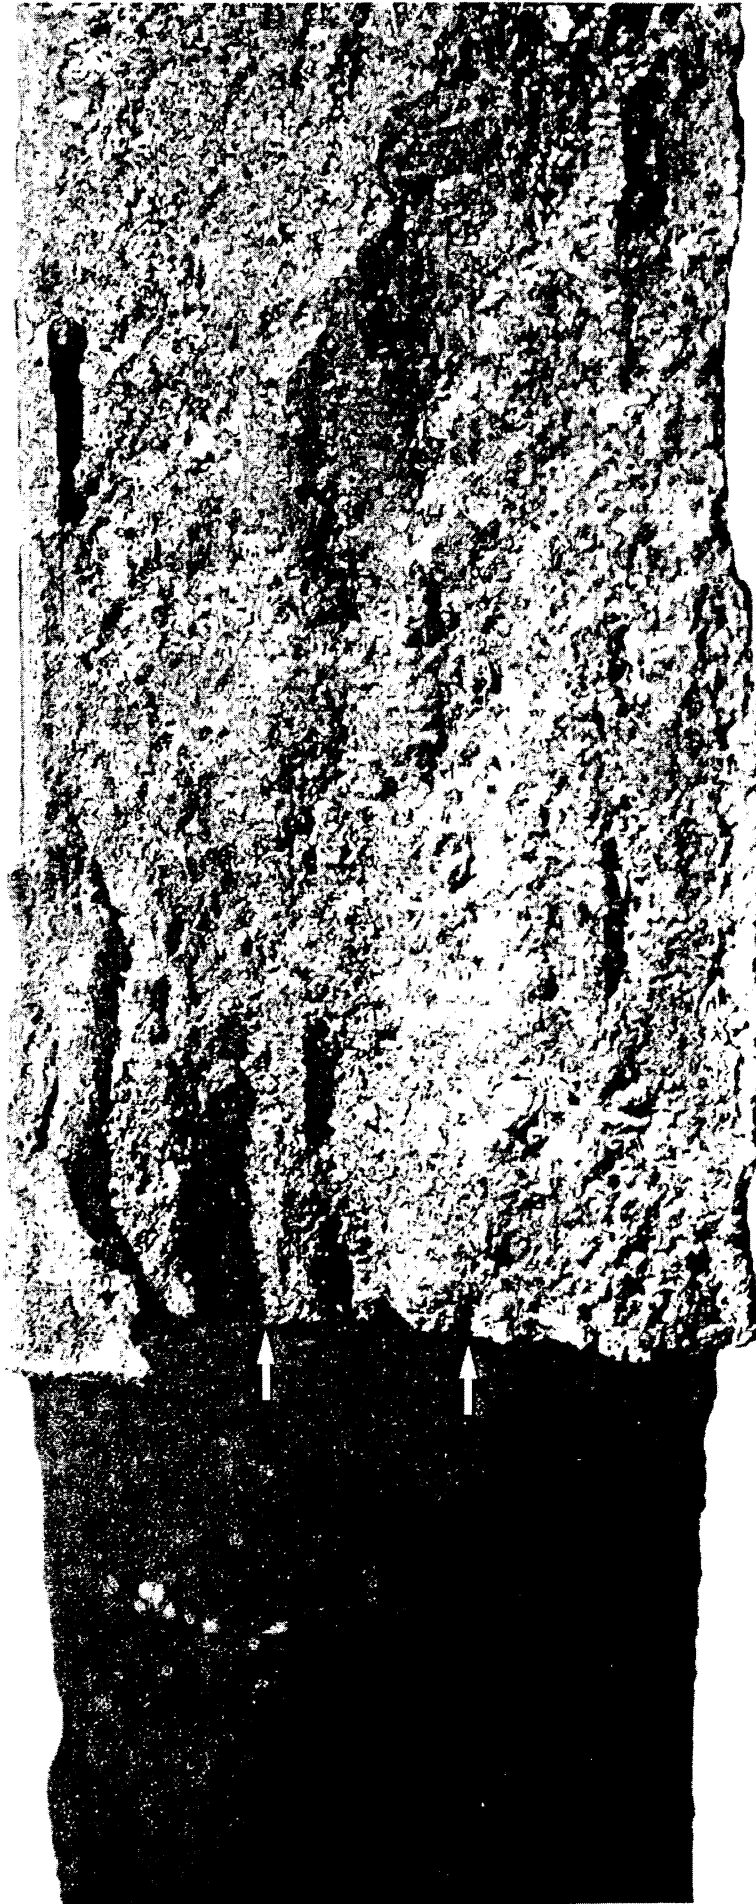
**FRACTURE ORIGIN**

Close-up photograph showing the presence of fracture surface ratchet marks (arrows) at the bolt hole surfaces, as is characteristic of progressive crack initiation in the nature of fatigue.

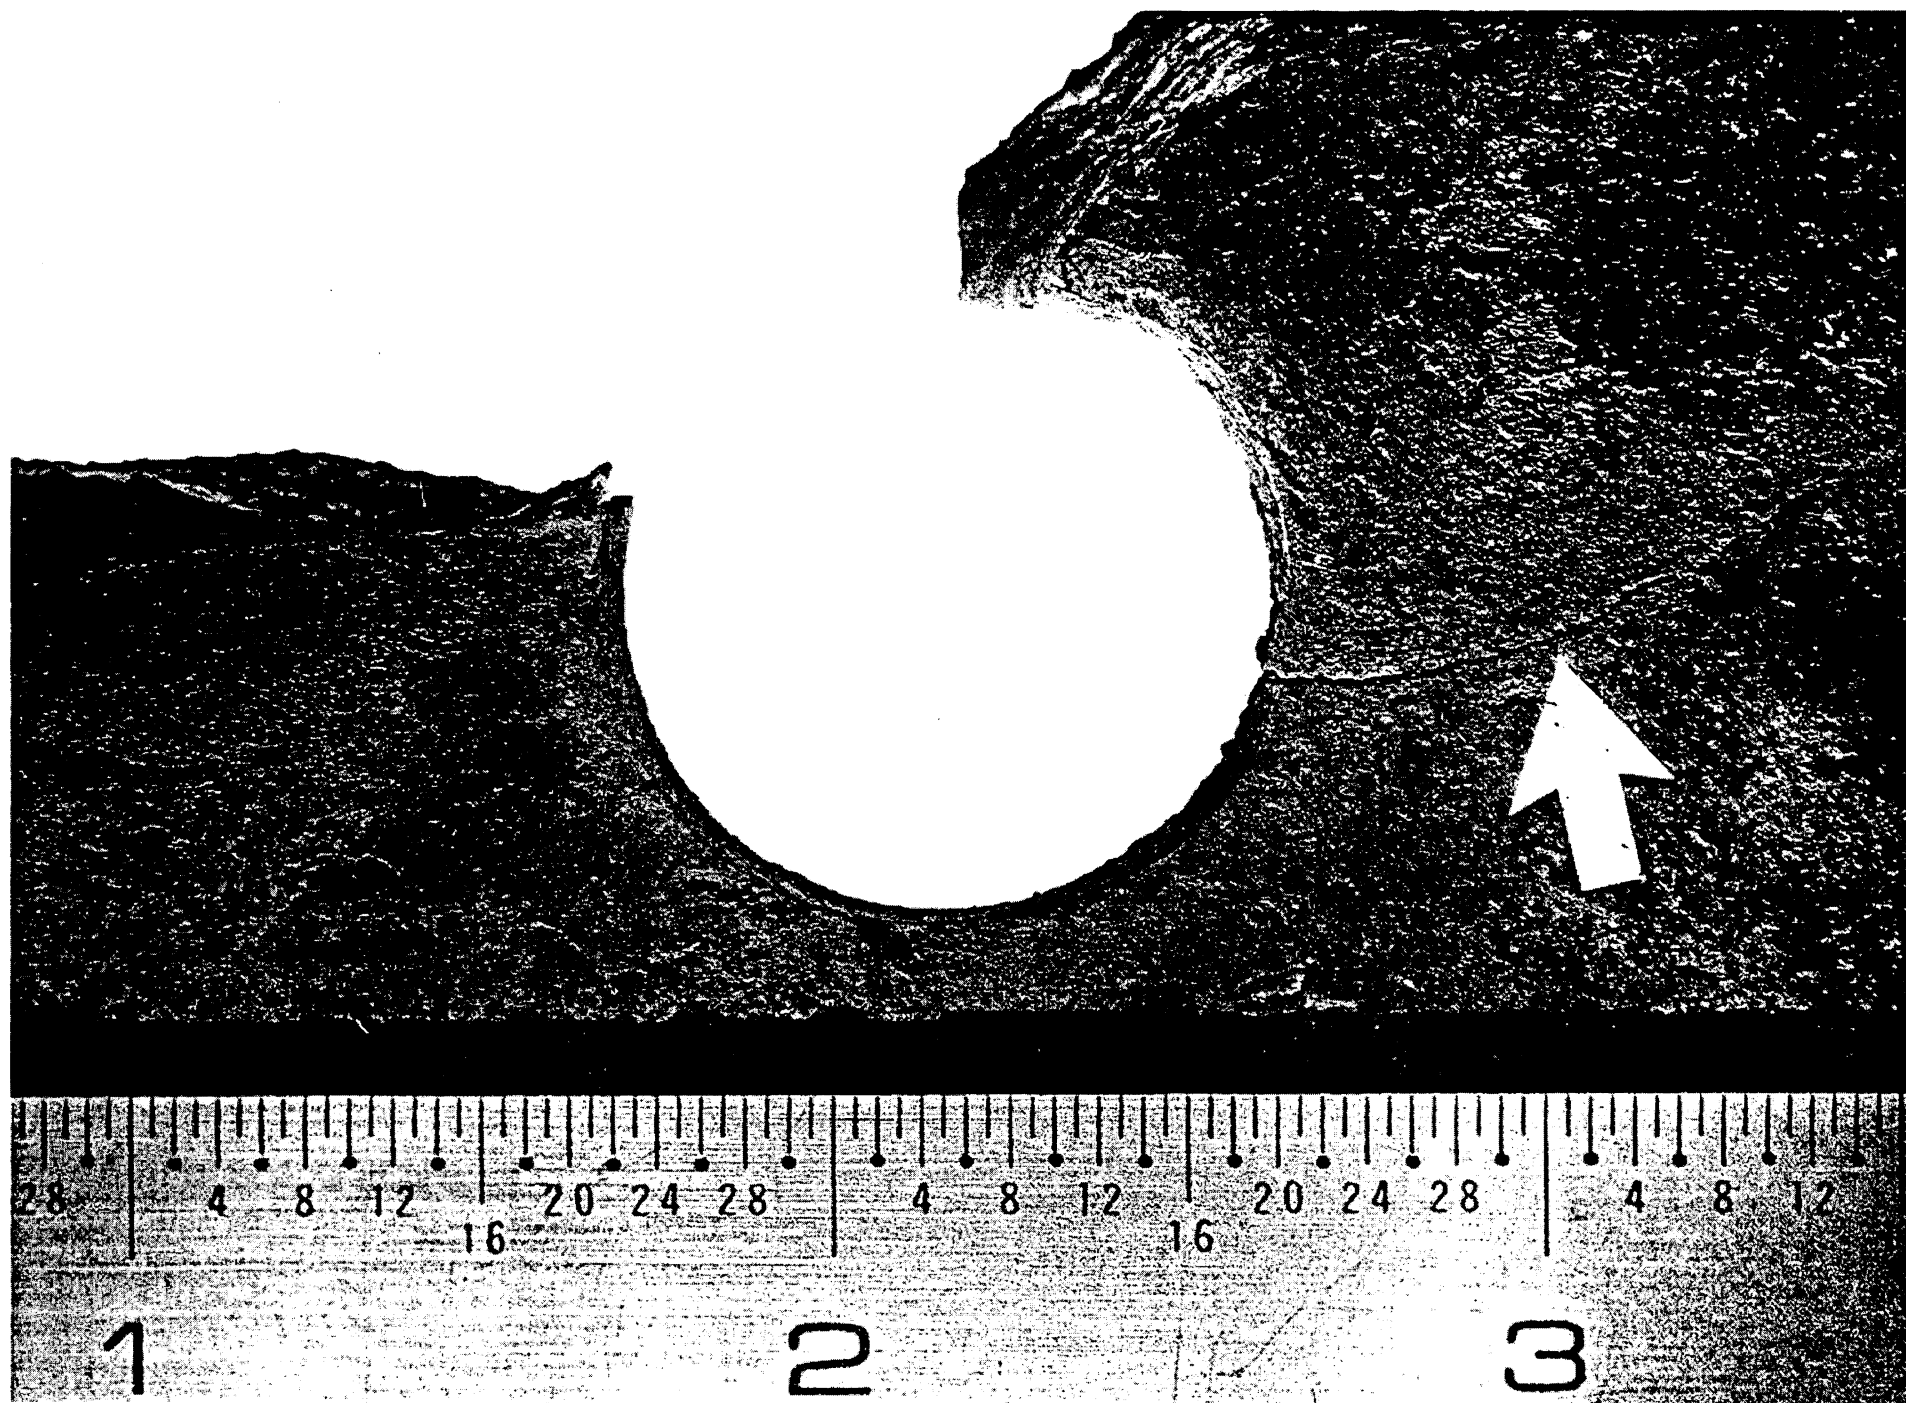
SECONDARY FATIGUE CRACK

The results of the fractographic examination revealed secondary fatigue cracks also had originated at the bolt hole surfaces. The presence of secondary fatigue cracks at the bolt holes indicates the presence of intermediate to high cyclic stresses.

Close-up photograph showing a secondary fatigue crack (arrow) parallel and adjacent to the primary fracture, as is characteristic of fatigue cracking under intermediate to high cyclic stresses.

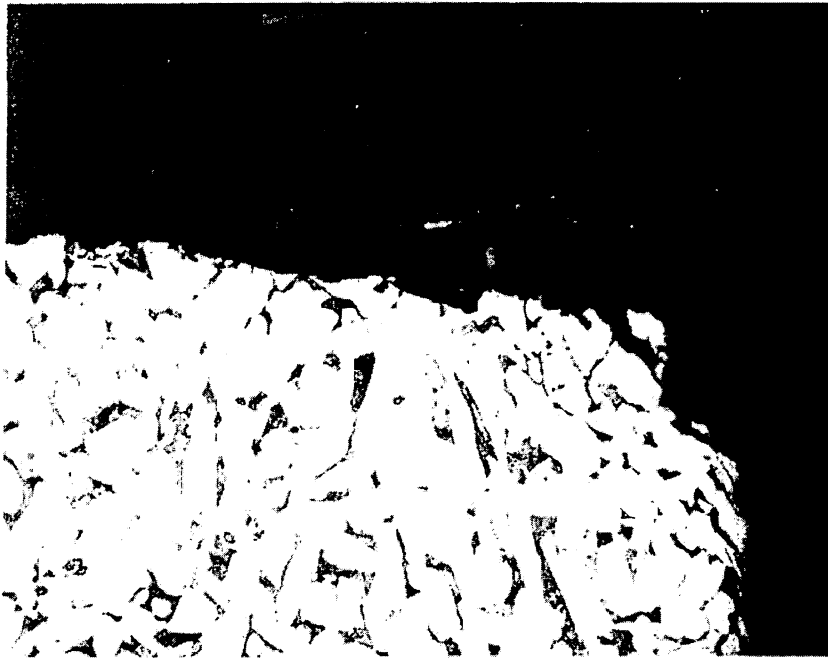
Fig. 9

FRACTURE PROFILE AT ORIGIN

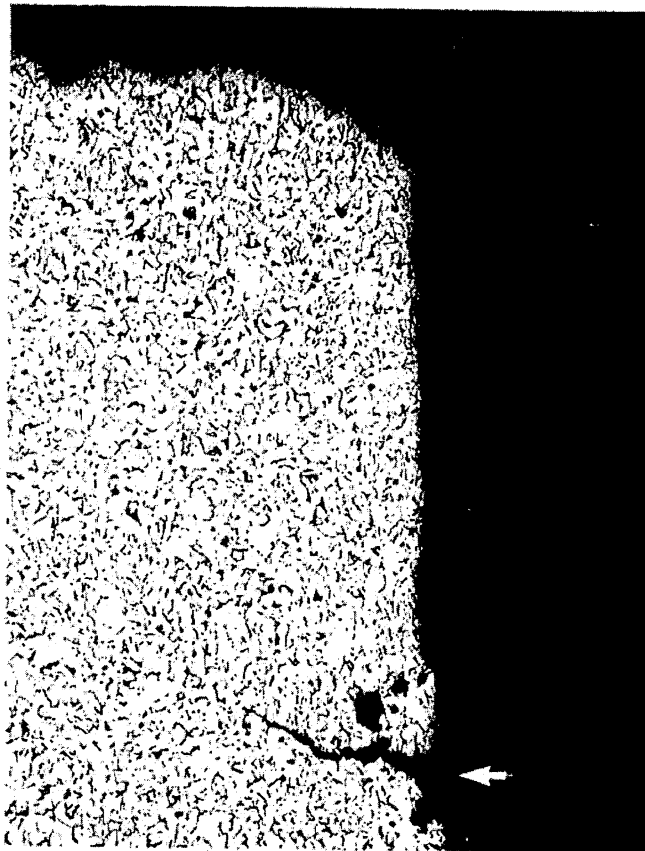
Fig. 10

SECONDARY FATIGUE CRACK
