National Radio Astronomy Observatory
Antenna Barn Inspection Memo Series – No. 1
Steven Tran
INSPECTION REPORT – VLA Site, July 18 – Sept 26, 2023
ENGINEERING INSPECTION

Introduction

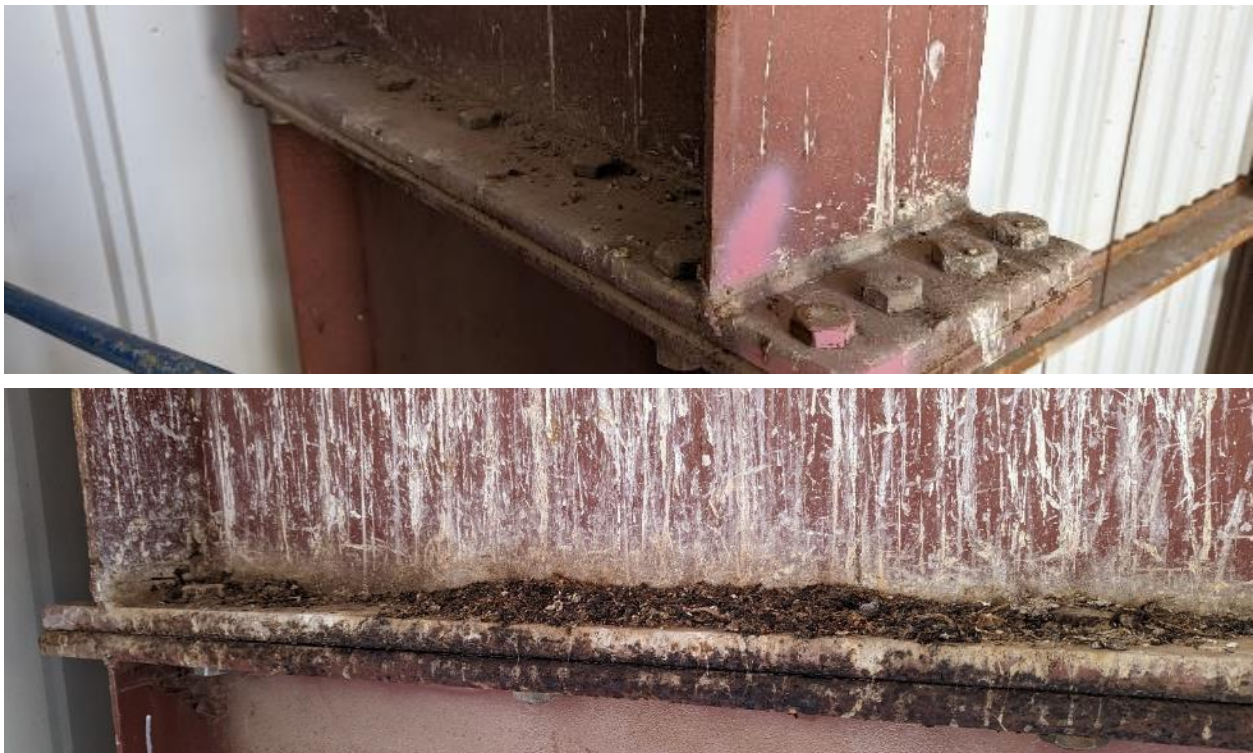
Figure 6: Top – Typical debris found (10b). Bottom – Non-typical debris found (16c).

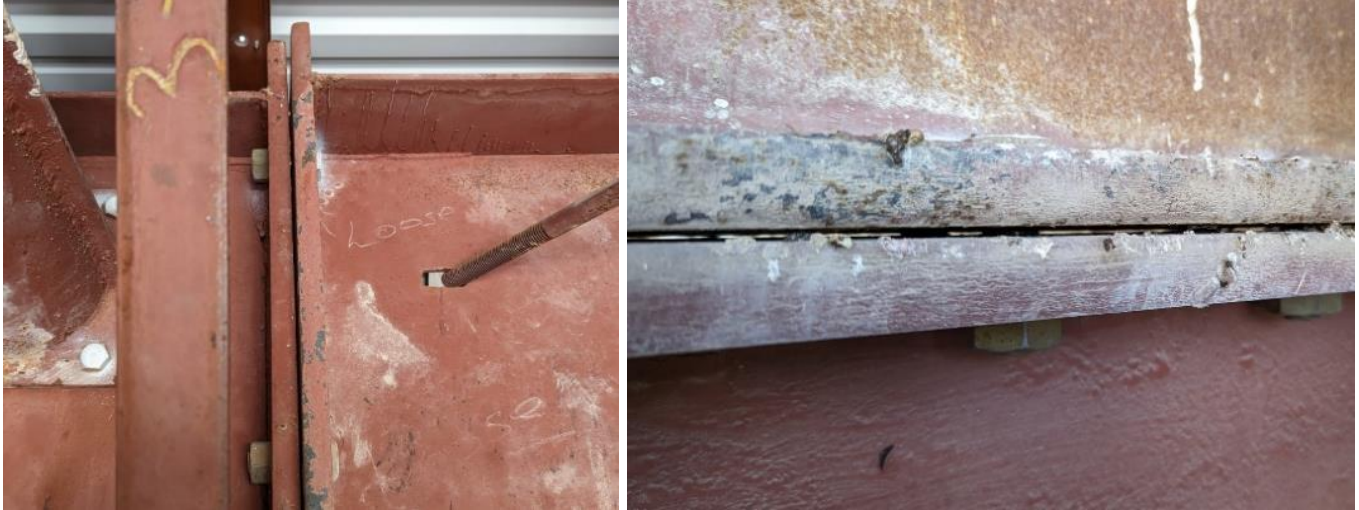
those found in figure 8, had likely formed during construction. The fillet welds binding the I beam column and plate would've slightly pulled the plates apart as the weld shrinks from cooling down.

Figure 7: Left – Threads of bolt 5 are visible in gap (6e). Right – Bolts 1-4 & 24 were tight but had visible gaps. (13b)

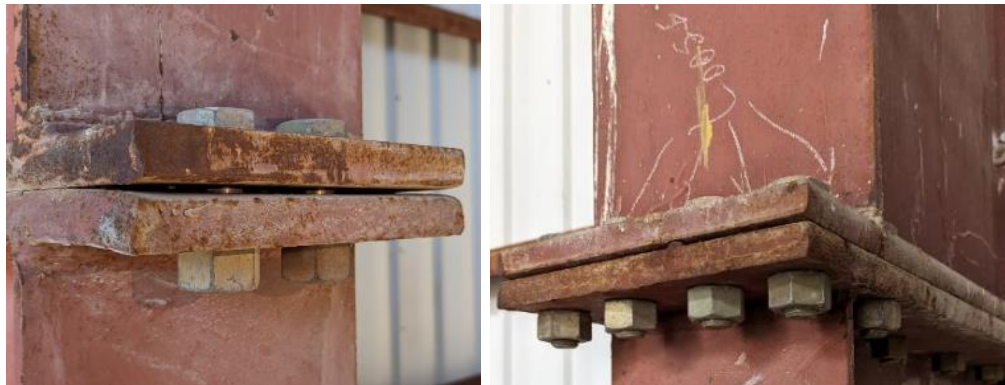
Figure 8: Left – Bolts 6 & 7 rotated about 15 degrees (4c). Right – (7c)

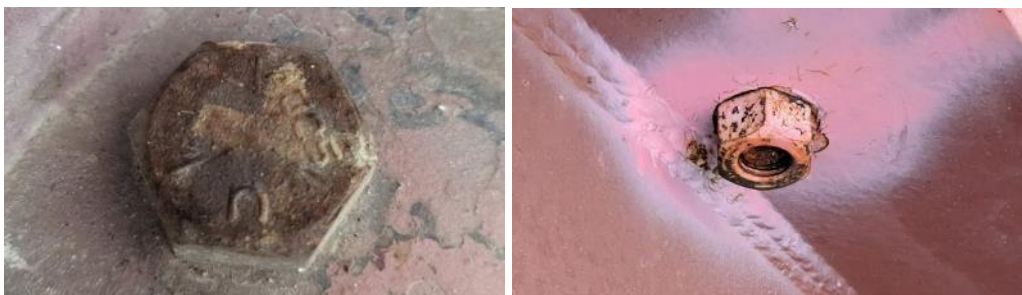
Bolt 18 (1b) and bolt 3 (12b) are compromised bolts that had previously been spray painted with a pink color, and should be replaced once spare A325 hot-dipped galvanized bolts, nuts, and flat washers arrive.

Figure 9: Bolt 18 (1b) found to be heavily corroded and short.

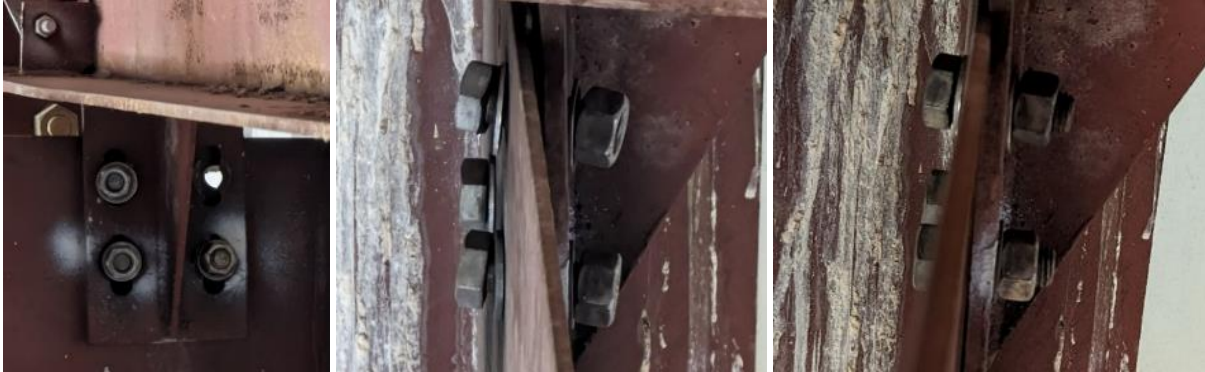
In figure 10 the connection between roof truss 6 and column 10 doesn't align properly, as the plate is misaligned. This is expected when considering the weight of the supported members pushing down, and the movement from high winds hitting the structure. As these bolts get worn their diameter decreases, resulting in the bolt hole to shift and close up. This makes it more difficult to simply insert a new bolt for replacement each time since new ones have a larger diameter than old ones.

Figure 10: Left & Middle - Loose, missing, and misaligned bolts in connection (10d). Right – After initial tightening.

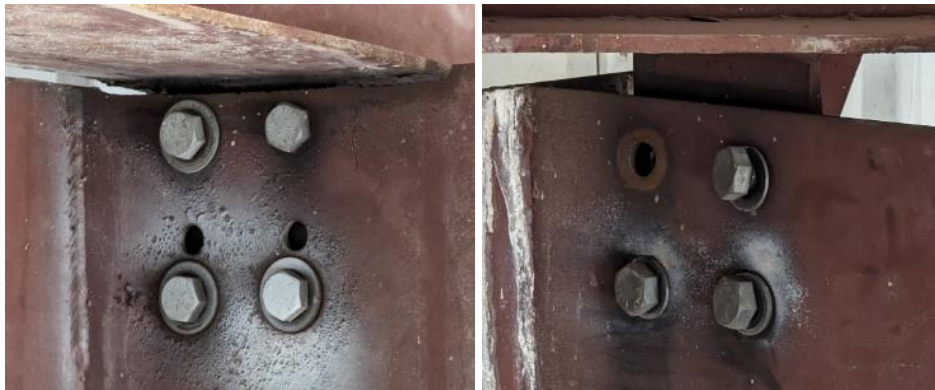
Figure 11: Visual comparison before tightening between 9d and 10d. Left – (9d). Right – (10d).

Further inspection showed bolts 1 and 4 from sections 7d - 10d, as well as bolts 2 from 8d and 9d were hand tightening loose despite looking good. While tightening bolts in section 9d to an initial torque of 150 ft lbs, we deduced bolts 1 and 4 to be compromised as they became hand tightening loose after tightening 3 and 2. Bolts 1 and 4 were replaced with new bolts before tightening the rest to 200 ft lbs, according to table A3. These replaced bolts can be seen in figure 12 along with bolt 1 at 10d, which had completely worn threads resulting in a smooth body between the head and nut interfaces.

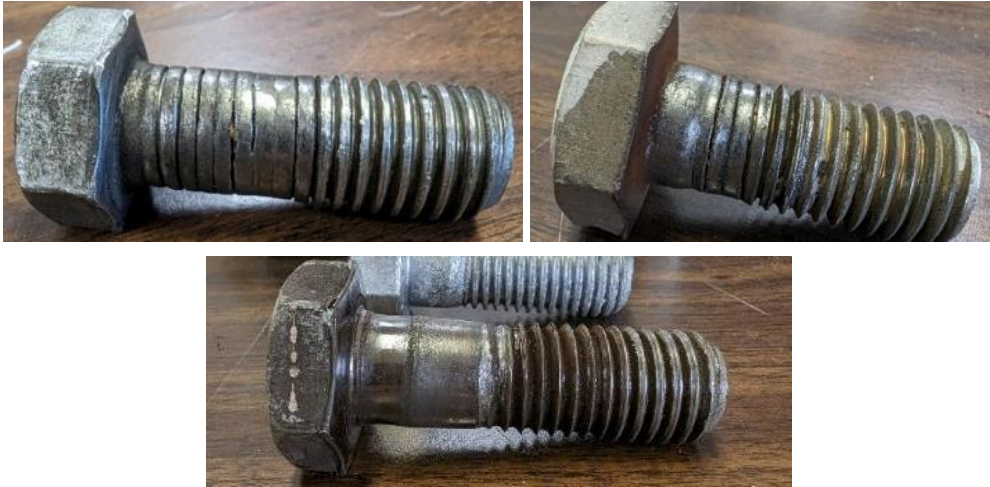
Figure 12: Left – SAE grade 5 bolt 1 (10d). Right – A325 bolt 1 (7d). Bottom – A325 bolt 4 (9d).

A pneumatic die grinder was used to expand the holes for bolts 1 and 2 (10d), and bolt 4 (7d), which allowed the bolts and nuts to sit flat onto the flat washers after installation. This is a quick fix for the next few bolt replacements if needed, but installing a new tee joint will eventually be needed. In total, bolts 1 and 4 from 7d and 9d, and bolts 1 and 2 from 8d and 10d were replaced.

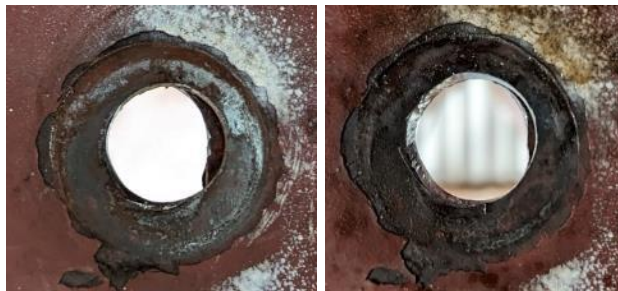
Figure 14: Visual clearance of bolt 4 (7d) Left– Before die grinding. Right – After die grinding.

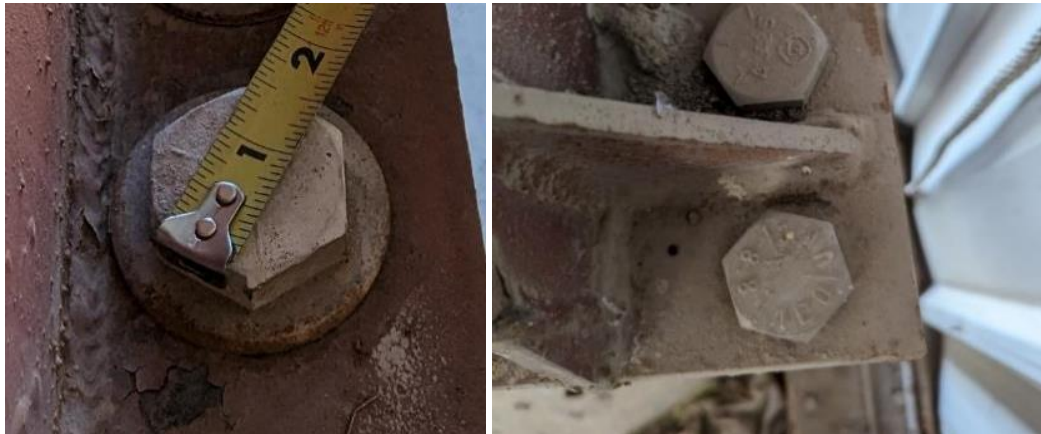
A few bolts across the barn had been replaced with A325 strength equivalent bolts, such as class 8.8 metric bolts, or SAE grade 5 bolts. The difference is that A325 bolts have a heavy head hex, resulting

Figure 15: Left – Bolt 12 (14c) replaced with SAE grade 5 bolt. Right – Class 8.8 metric replacement of bolt 21 (5b). All f level bolting sections appeared to be in good condition, with no signs of looseness or damage.

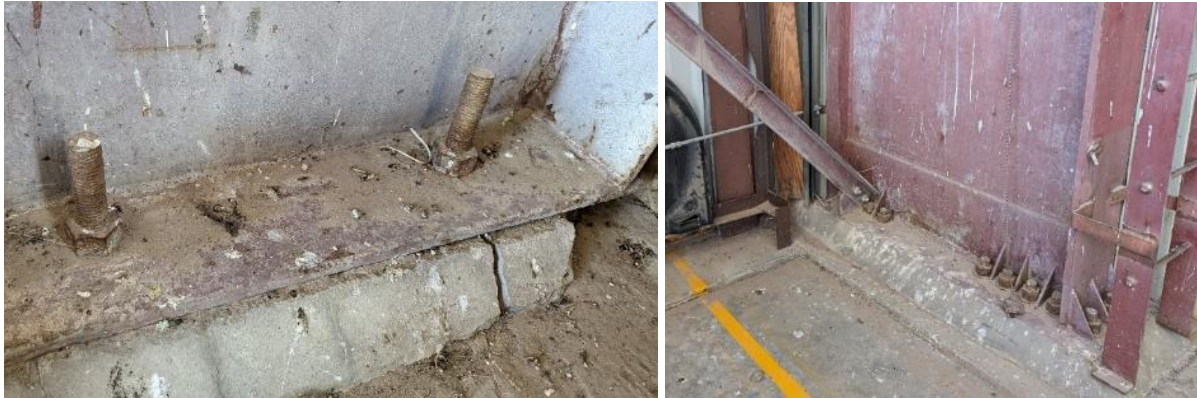
Figure 17: Left – CS2 foundation crack (8a). Right – Exposed section (4a).

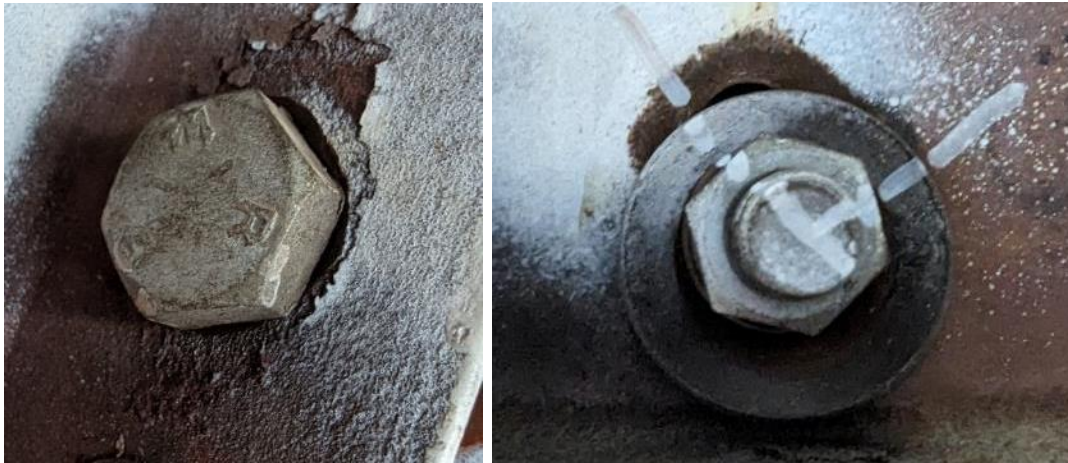
Flange brace 10 shows an example where flat washers would be highly beneficial. The head of the bolt is large enough to still work as intended, but doesn't have an ideal gripping area without a flat washer. This worsens the mechanism of sinking into the members known as embedding, resulting in preload loss in the bolts, and consequently loosening of bolts in shorter times.

Figure 21: Top bolt in flange brace 10. Left – View of head. Right – View of nut double match marked.

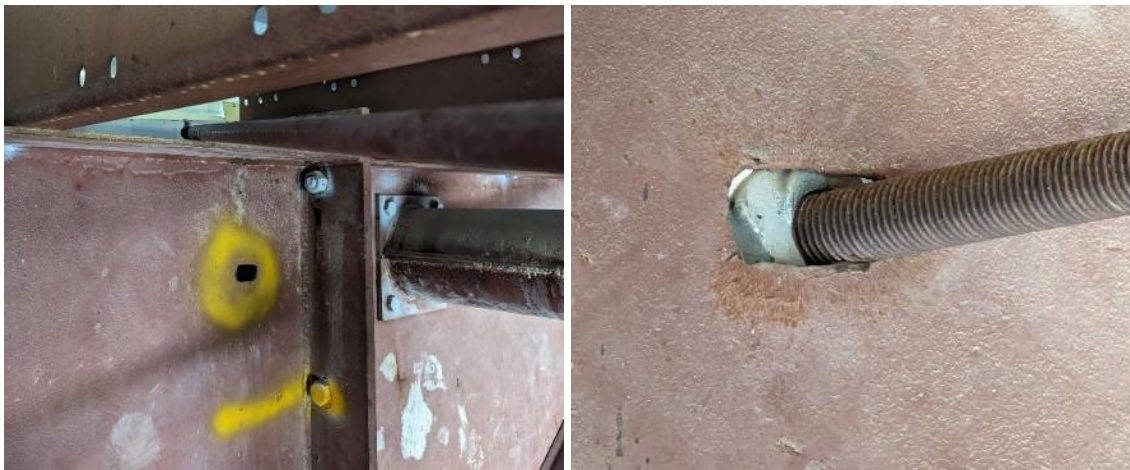
One cross rod found in R-B5 had fallen out. Below shows one of the members still intact, while the other is unattached. Other cross rods across the roof are still intact, but the ones in the R-C5 and R-D5 are all sagging down with no tension. These cross rods should have some tension applied to bear intended loads. At the current state, they are just extra weight with no benefit.

Figure 23: Left – Member fell out (11e). Right – Member still intact (11e to 11f).

Not all compromised flange brace bolts had been replaced due to manlift and time limitations, but future replacements should implement flat washers. Cross rods at R-B5 should be re-installed if possible. The holes in the antenna barn roof should be further inspected and sealed before the next monsoon season starting June 2024, to prevent corrosive damage of the structural members and any items susceptible to water damage in the barn. Cleaning and repainting high corrosion areas such as section 14d, is another low priority item.

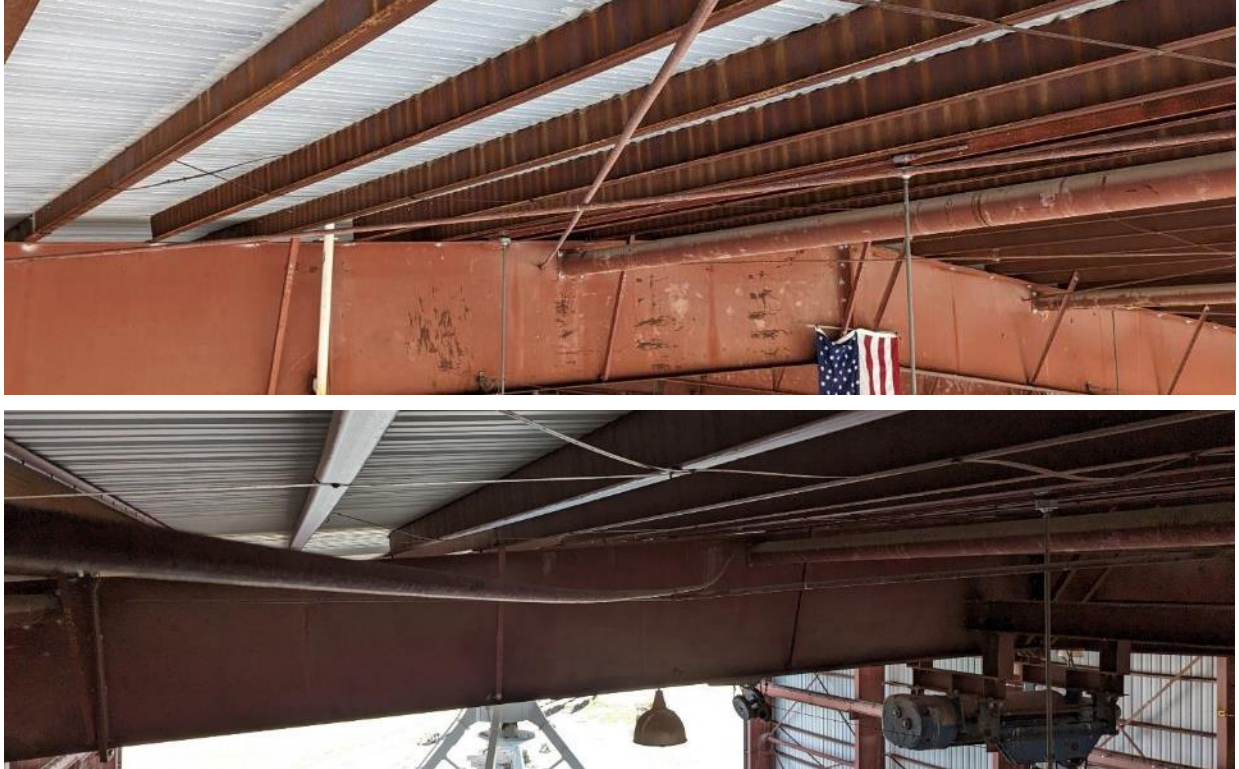
Figure 24: Top – Better tensioned cross rods (R-B1). Bottom – Members loose and fallen (R-B5).

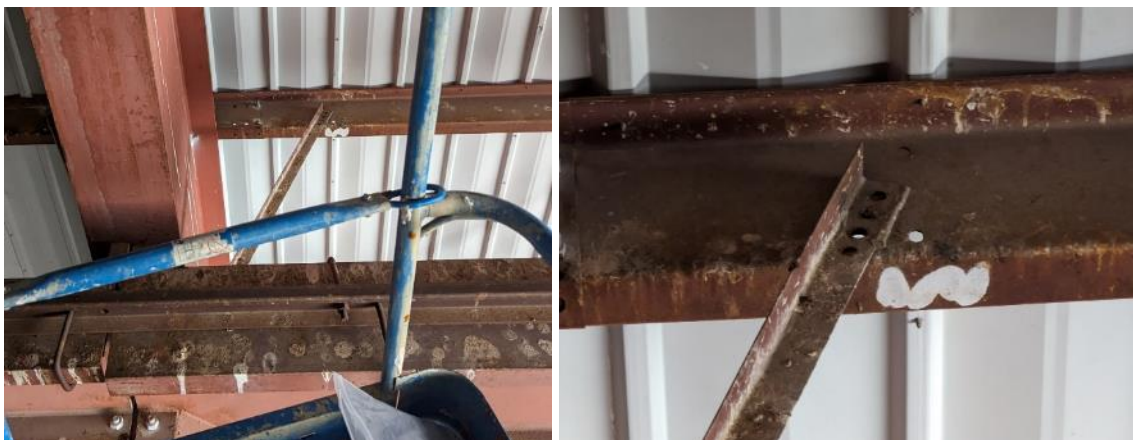
Although not as concerning, a bolt was missing on a horizontal flange brace which classified as a CS3 connection. This was fixed by installing a new bolt with flat washers.

Figure 25: Missing 1/2" bolt for flange brace under 15d.

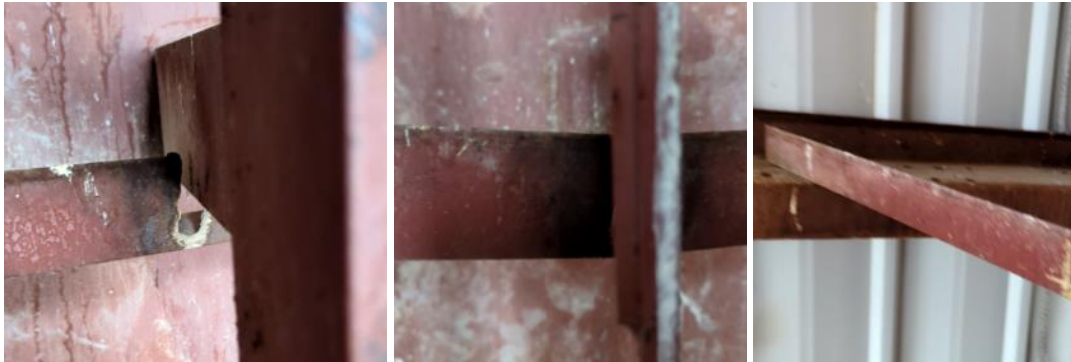
Some members were found to be modified and bent, such as one of the wall girt members intersecting with the fixed ladder. These members also appear to be non-structurally critical,

Figure 26: Slotted and bent member to run through ladder.

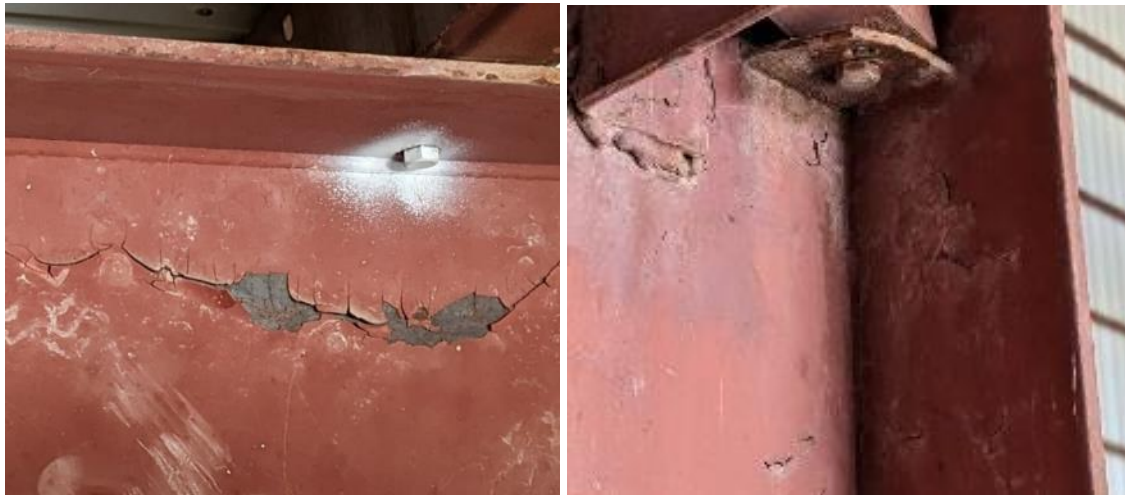
All flaking paint seen has been non-concerning at CS1. This was determined by physically inspecting the paint and revealed steel. Typically, cracking of the paint in situations like these signifies expansion or distortion of the members. However, the revealed steel's surface felt normally smooth to the touch, removing possible concerns relating to cracking paint.

Figure 27: Left – Between 6d and 6e. Right – Near horizontal flange brace under 5c.

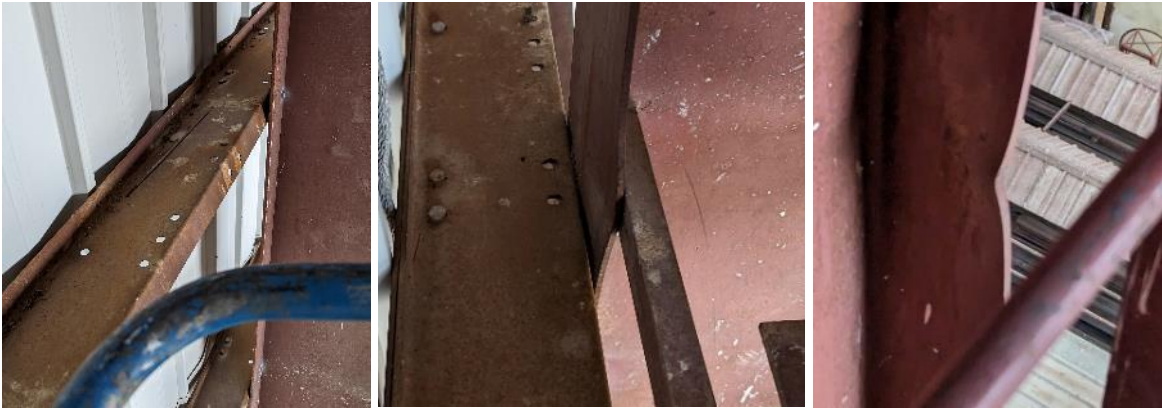
There were some cases of CS2 distortion that can be seen in figure 28. Column 5 had appeared to have some slight buckling interfacing the wall girt, as well as on the column's flange. Whereas column 8 is undistorted, but instead distorting the wall girt in contact. These distortions likely occurred during structural erection to fit everything into its place.

Figure 28: Left – Column is pushing into wall girt near 8c. Middle – Wall girt pushing into column at 2nd ladder landing. Right – Slight buckling of column flange near 2nd ladder landing.

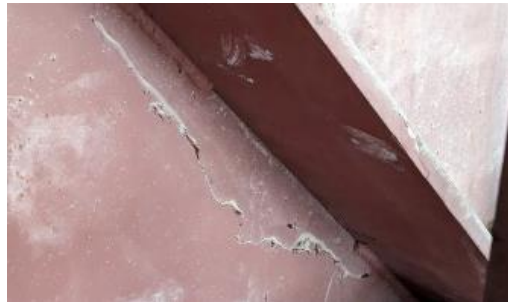
No cracks occurring in structural members were identified, figure 29 shows an example of non-critical surface cracks of paint.

Figure 29: Typical surface cracks of paint (5d).

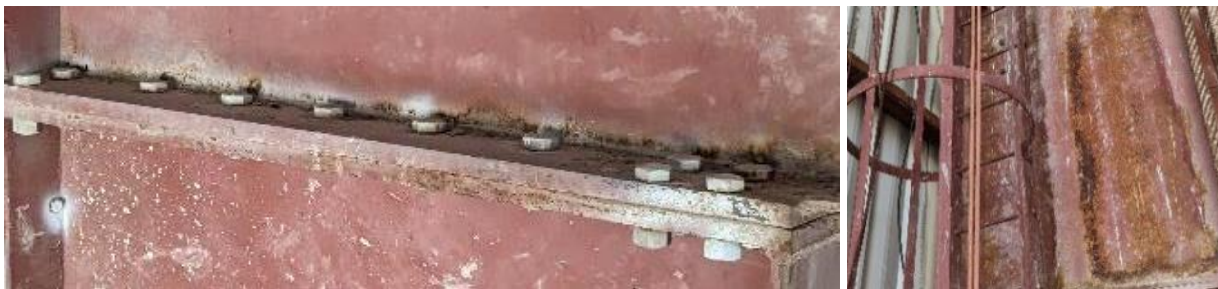
Typical of most corrosion is found on the surface of the paint without penetration into the steel.

Figure 30: Typical corrosion found. Left – 6d. Right – 5b.

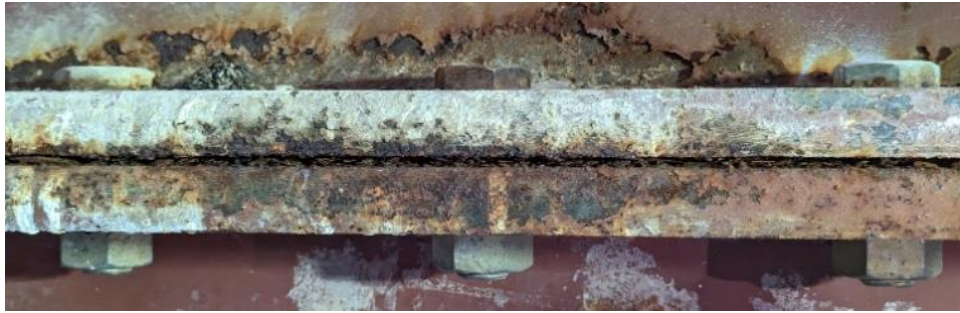
Figures 31 shows areas with the highest corrosion seen at section 14d, classifying as a CS2 case.

Figure 31: Corrosion found at 14d.

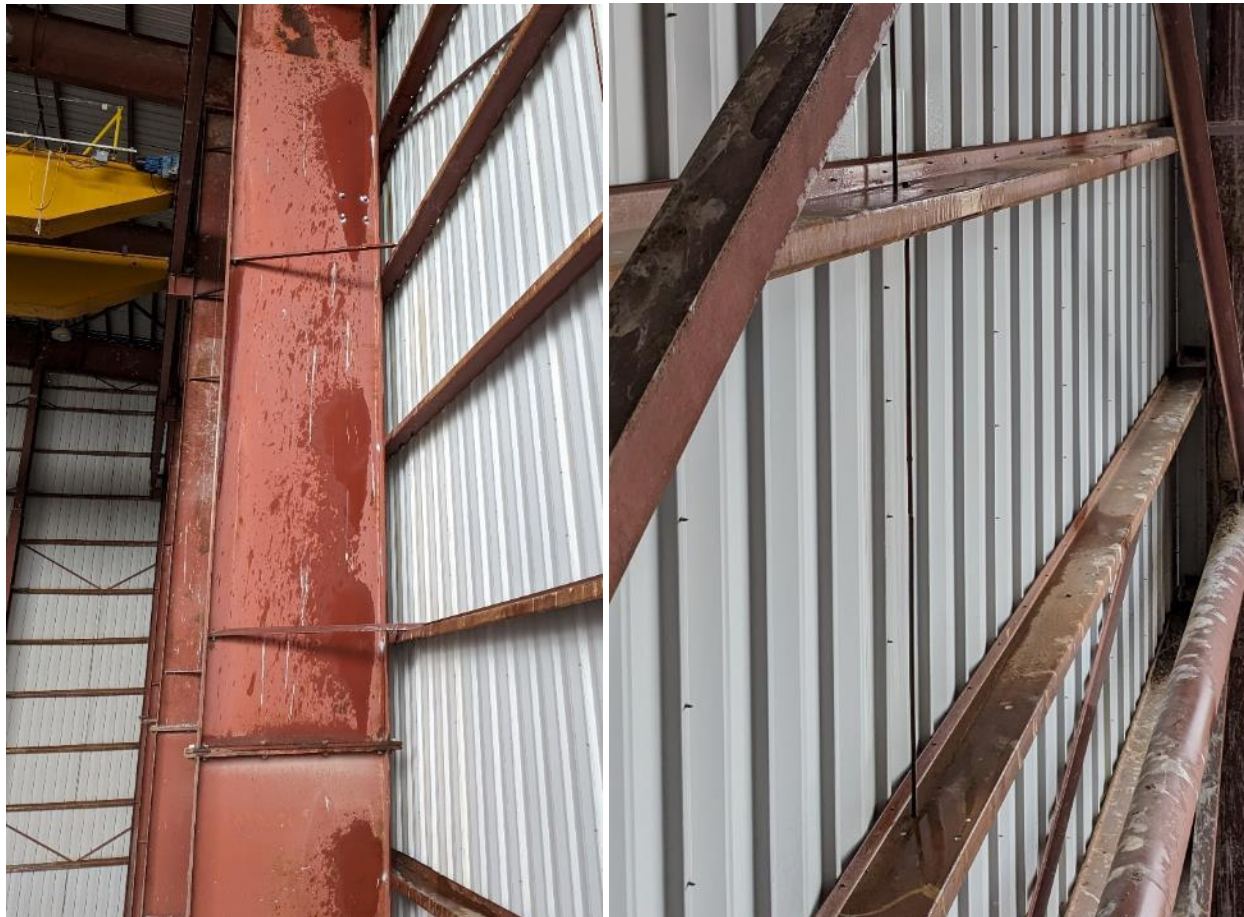
The antenna barn roof contains some defects, allowing for water to leak during downpours. All water leakages result in expedited, but preventable corrosive damage in the affected areas. The sources of leak areas that would be beneficial to patch up can be easily traced after a prolonged heavy downpour. These leaking areas can easily be fixed with caulking, butyl tape, silicone, or other common types of sealants. Example areas can be seen below.

Figure 32: Left – Water dripping around column 14. Right – Slight puddling of water (W-D5).

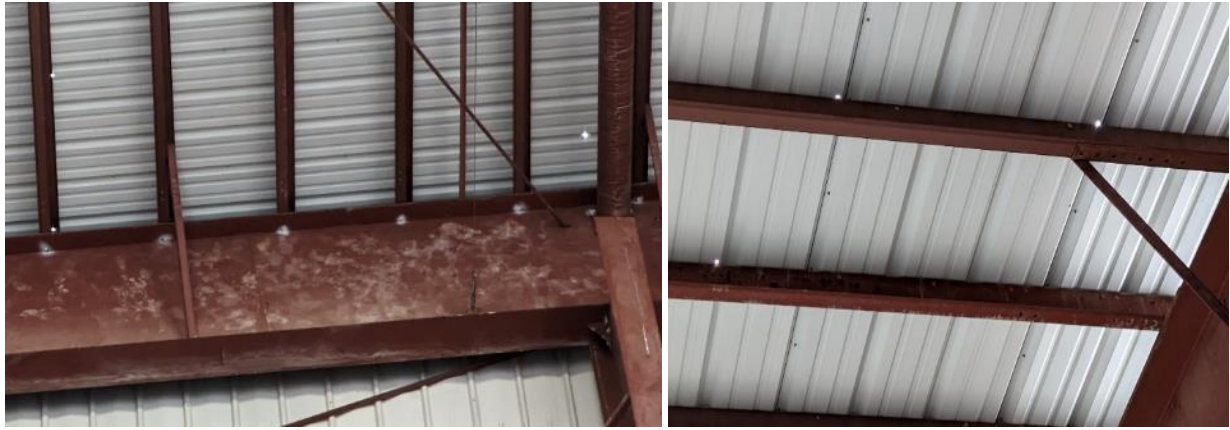
Figure 33: Left – 3 small visible holes (8d bottom right of image). Right – 3 more holes (R-B5, between 5e & 5f).

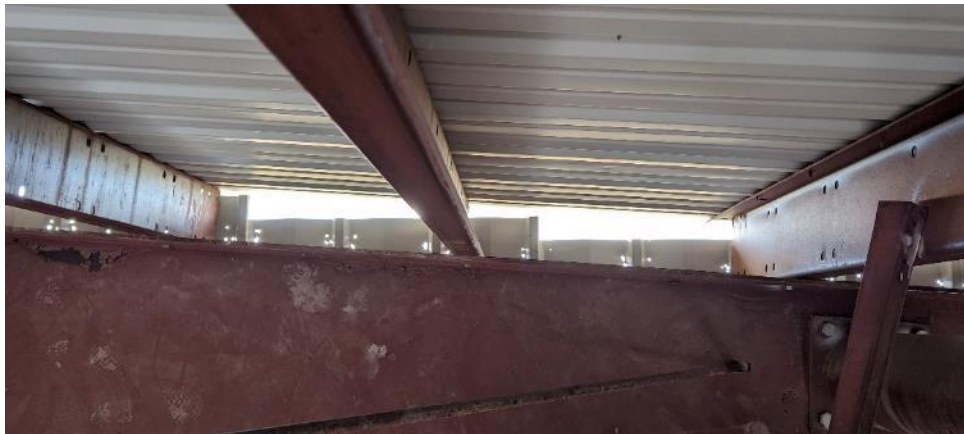
Larger gaps between the roof and south wall may allow unwanted moisture to enter into the back. But at the same time, it may help with ventilation.

Figure 34: Large gap between roof and south wall (R-C5).

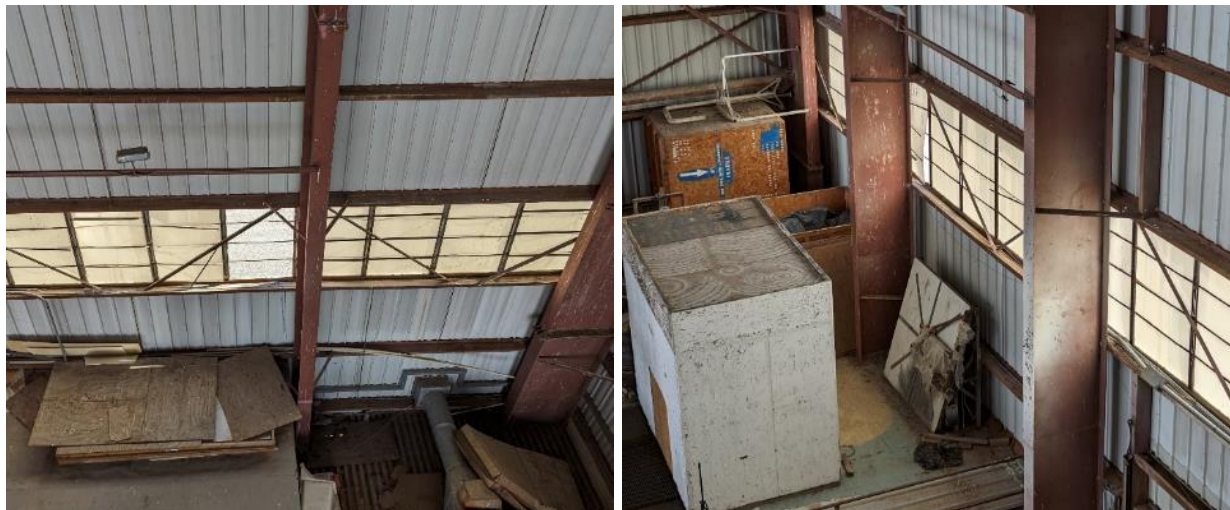
Figure 35: Left – Window panel missing (under 10b). Right – Window panel loose (under 7b).

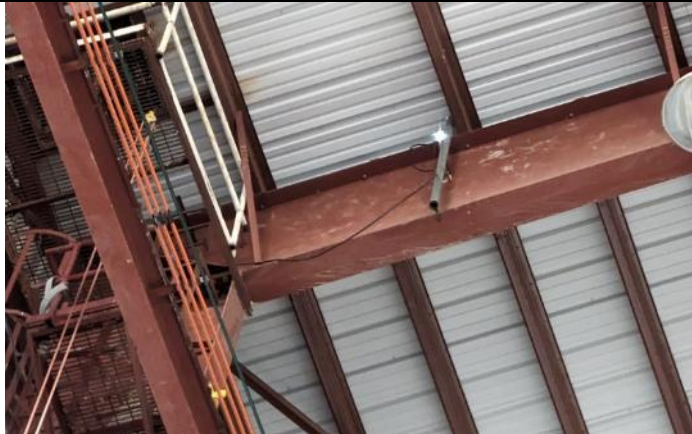
Visible hole near 5d

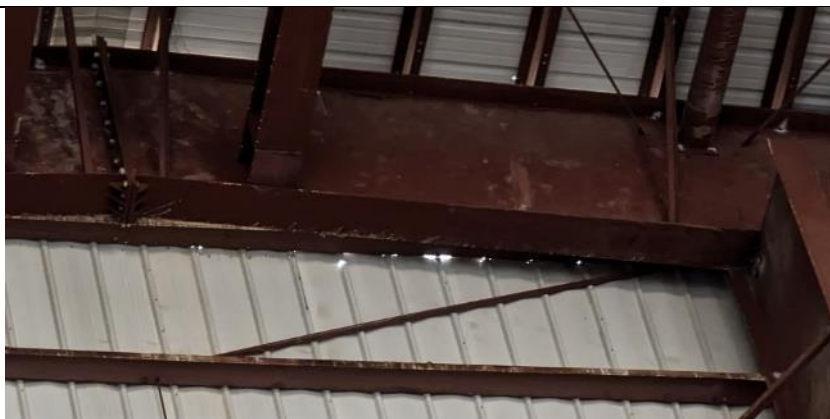
Visible holes near 6f
