Green Bank Observatory  
Electronics Division Technical Note

EDTN 230

# **GBT Receiver Room Turret Gasket**

October 13, 2021

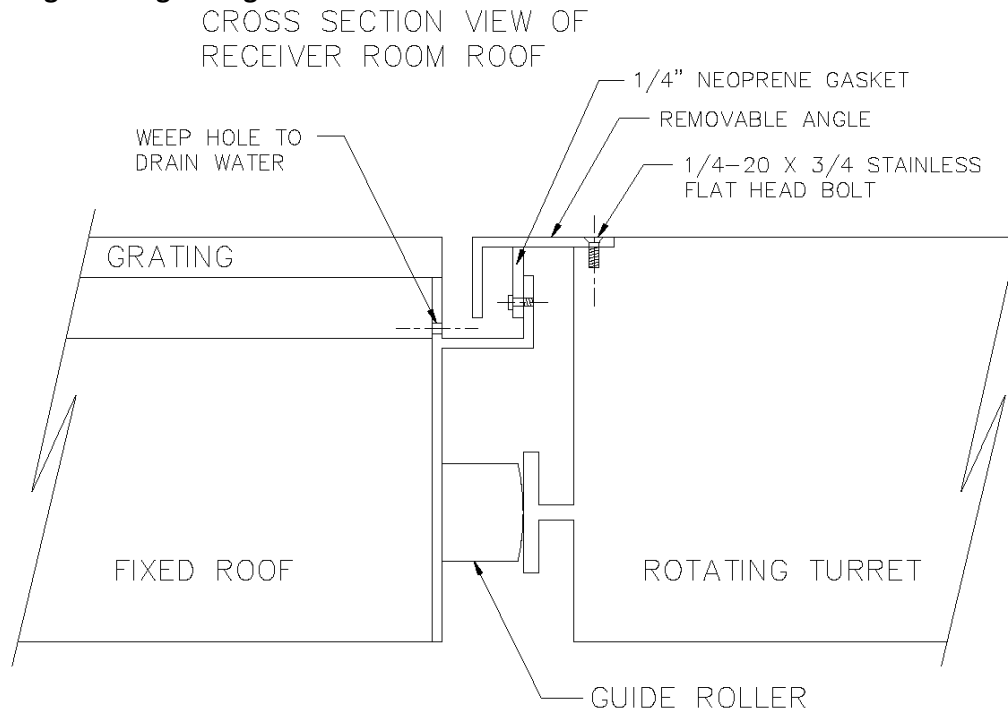
## Original flange and gasket:

In July 1996, Loral purchased a 1/4 inch thick, non-conductive black neoprene seal to prove the concept. We noted lots of problems, mostly related to the flange of the rx room (not the turret) not being even in height around the perimeter. We measured deviations of up to 0.9". To fix this, a track torch was mounted on the turret. It was then rotated, which evened out the flange, fixing the misalignment. A hand grinder was used to smooth out the rough torch cut. This helped, however, the contact between the gasket and the top rail remained uneven.

Further testing showed the thick neoprene material was causing unacceptable drag (high current draw) on the turret motor. The gasket was greased, which helped, but there was still too much drag. The 1/4 material was simply too rigid, so a new design was needed.

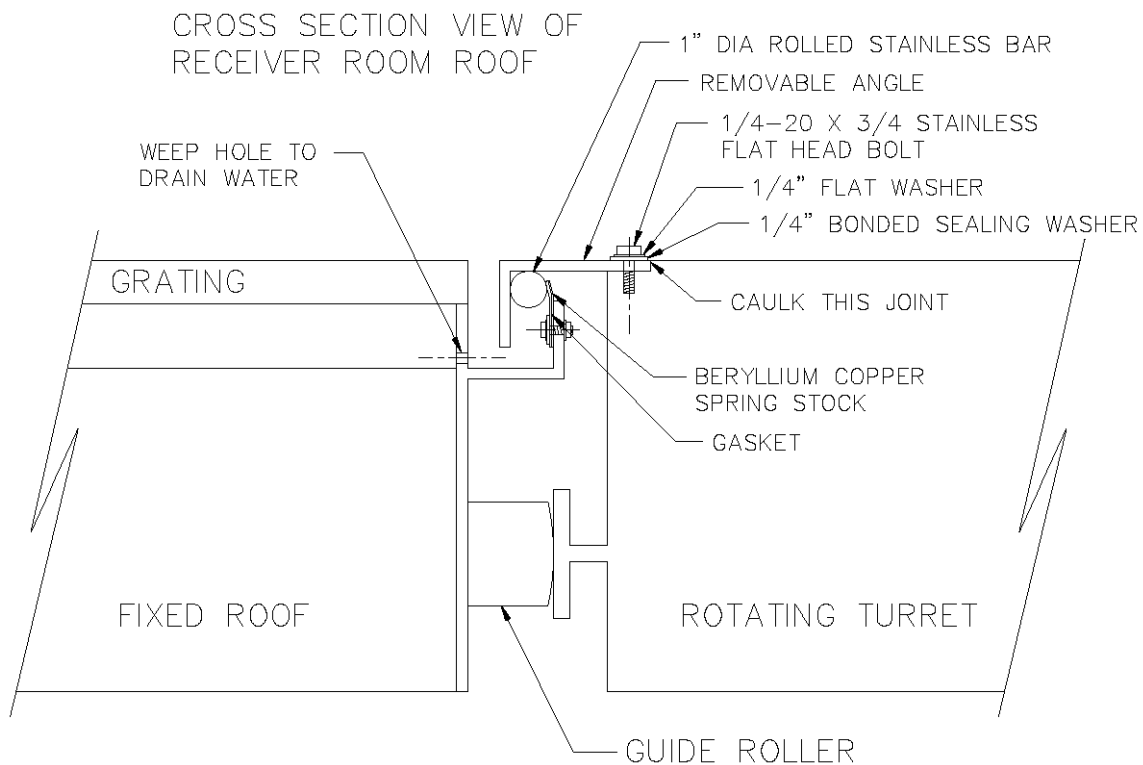
**Modified flange and gasket:**

For the new design, a 1-inch diameter round stainless bar was welded into the angles. This concept allows for small height changes, less drag, and better service life.

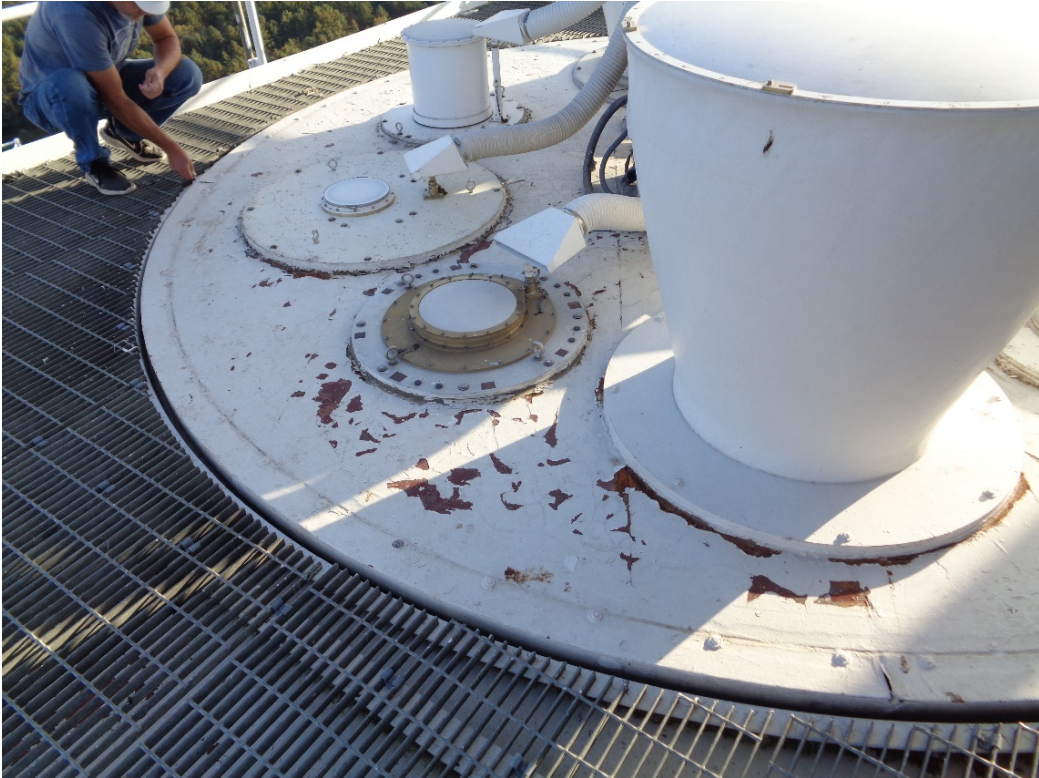
Rail section to be removed:

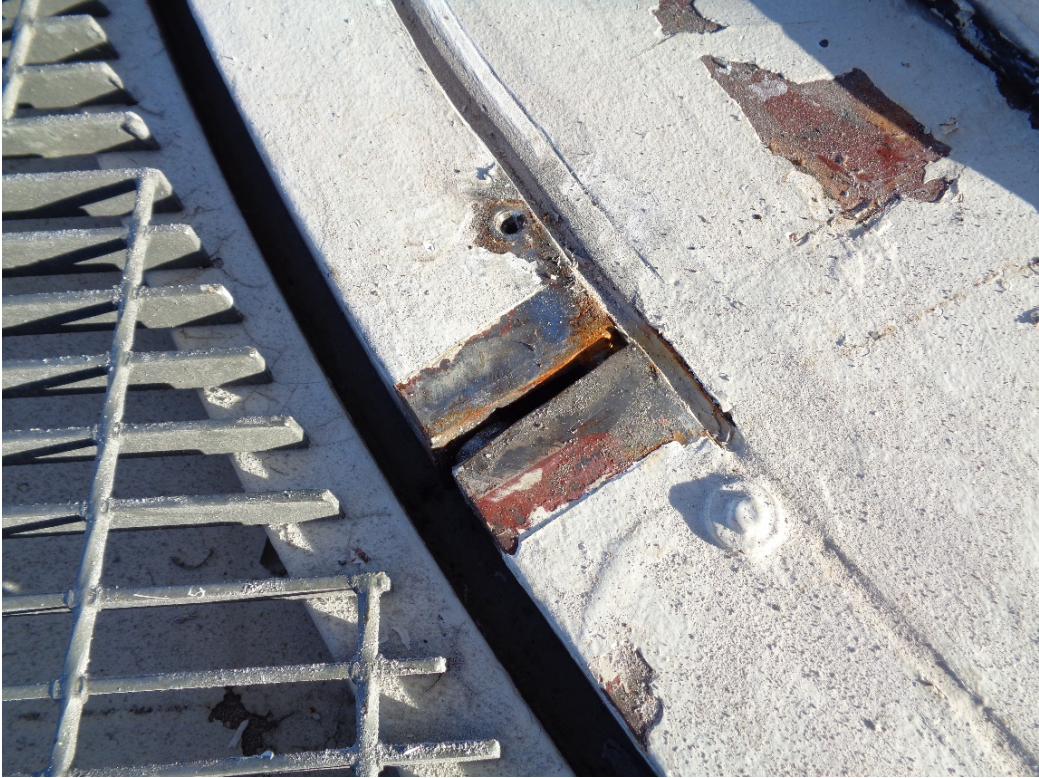
Old caulking, bolts, and copper tape between rail sections removed:

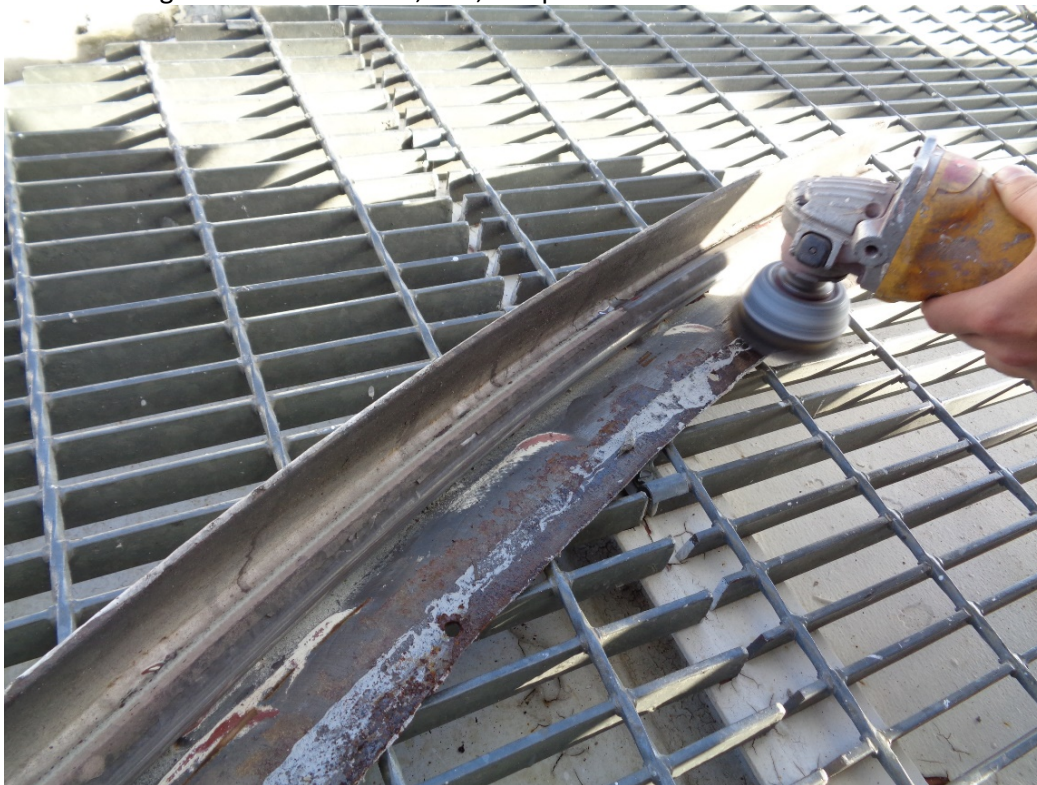
Wire brushing to remove old caulk, rust, and paint:

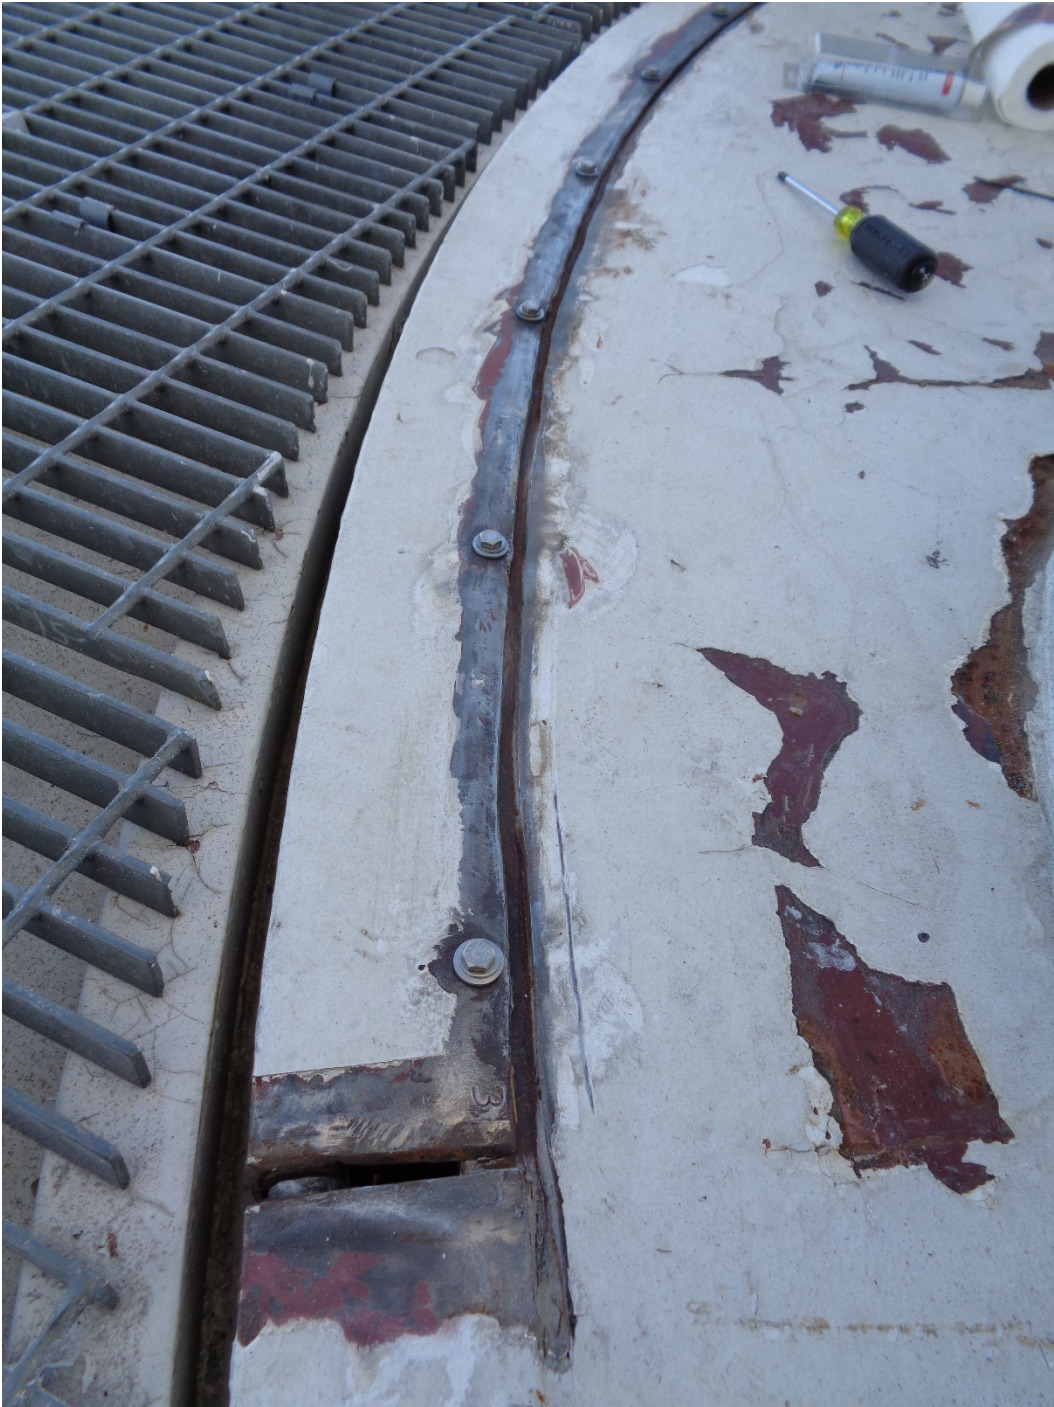
Cleaned rail section reinstalled with new hardware:

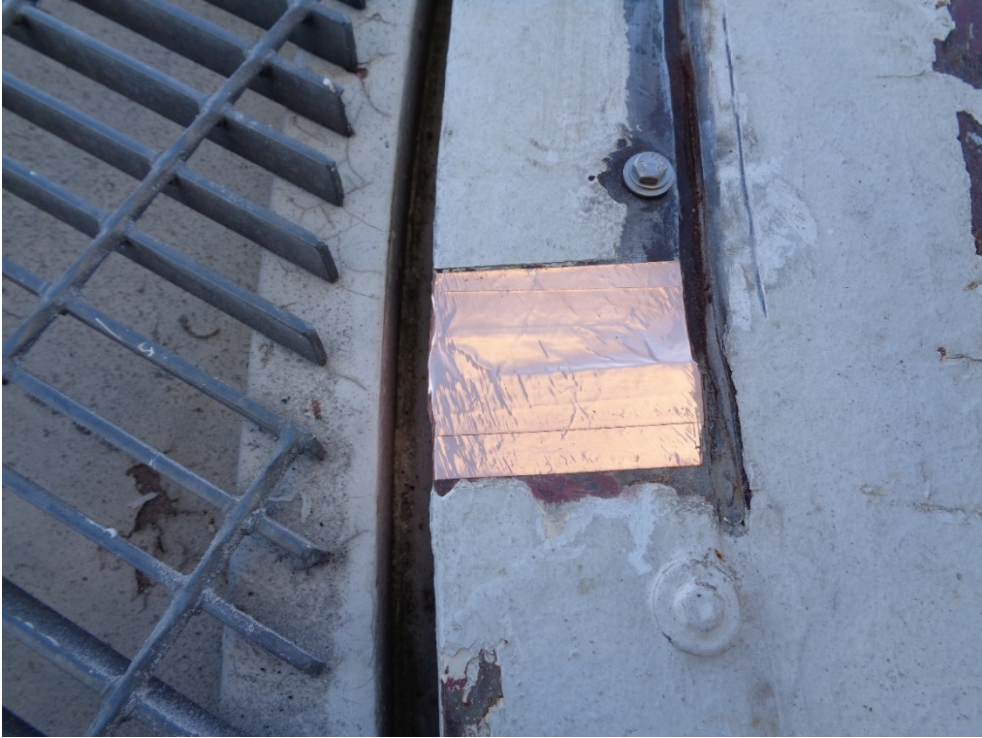
New copper tape over joint section. Ready to apply new caulk and paint:

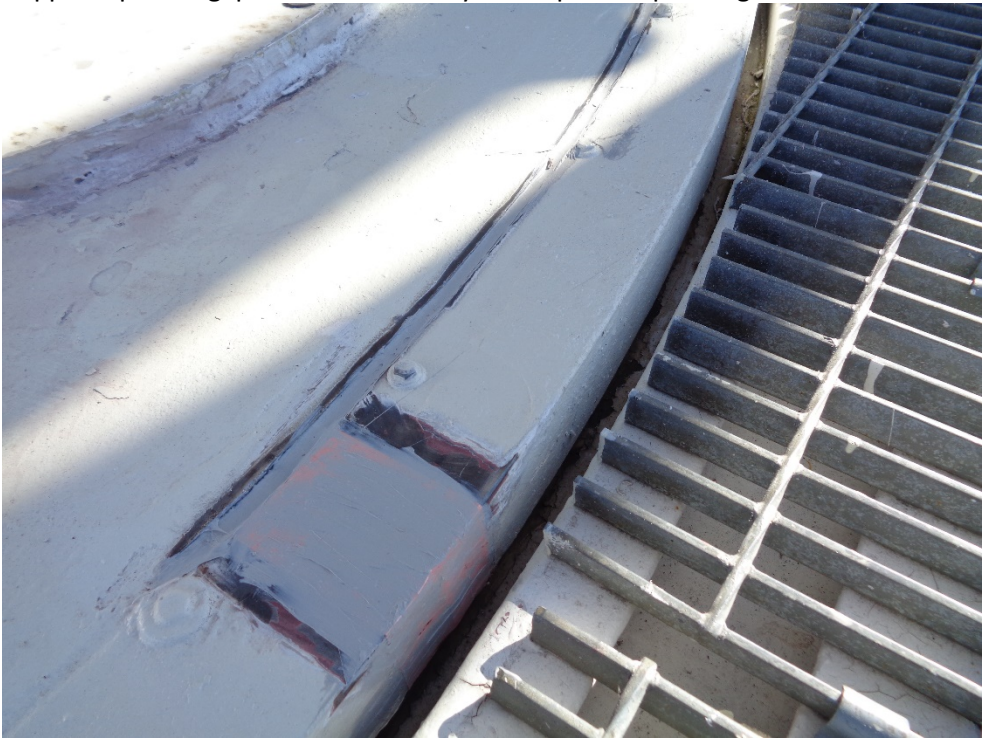
Copper tape and gap covered with Butyl caulk prior to painting:
