NATIONAL RADIO ASTRONOMY OBSERVATORY
Socorro, New Mexico

VLBA Antenna Memo Series No. 5

VLBA Antenna Hard Stops

J. E. Thunborg
April, 1998

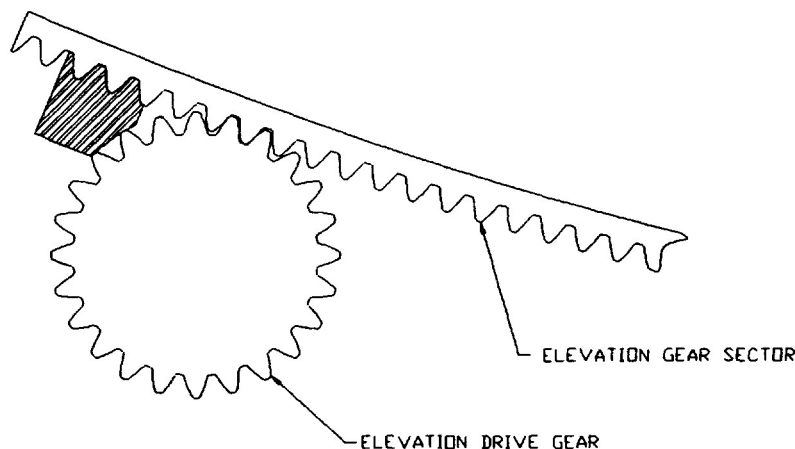
The hard stop that keeps the antenna from being driven off the "up side" of the gear sector is simply a 5" long steel block that is welded to the gear sector. This block contacts the teeth of the elevation drive gear and gear sector as shown below when it is driven past the final limit switch. If the antenna is driven into this block by the servo system, an approximately 75,000 lb. load will develop. This load may damage the gearbox and the drive gear. However, this damage is less severe than the damage that can occur if the reflector is driven off the gear sector.

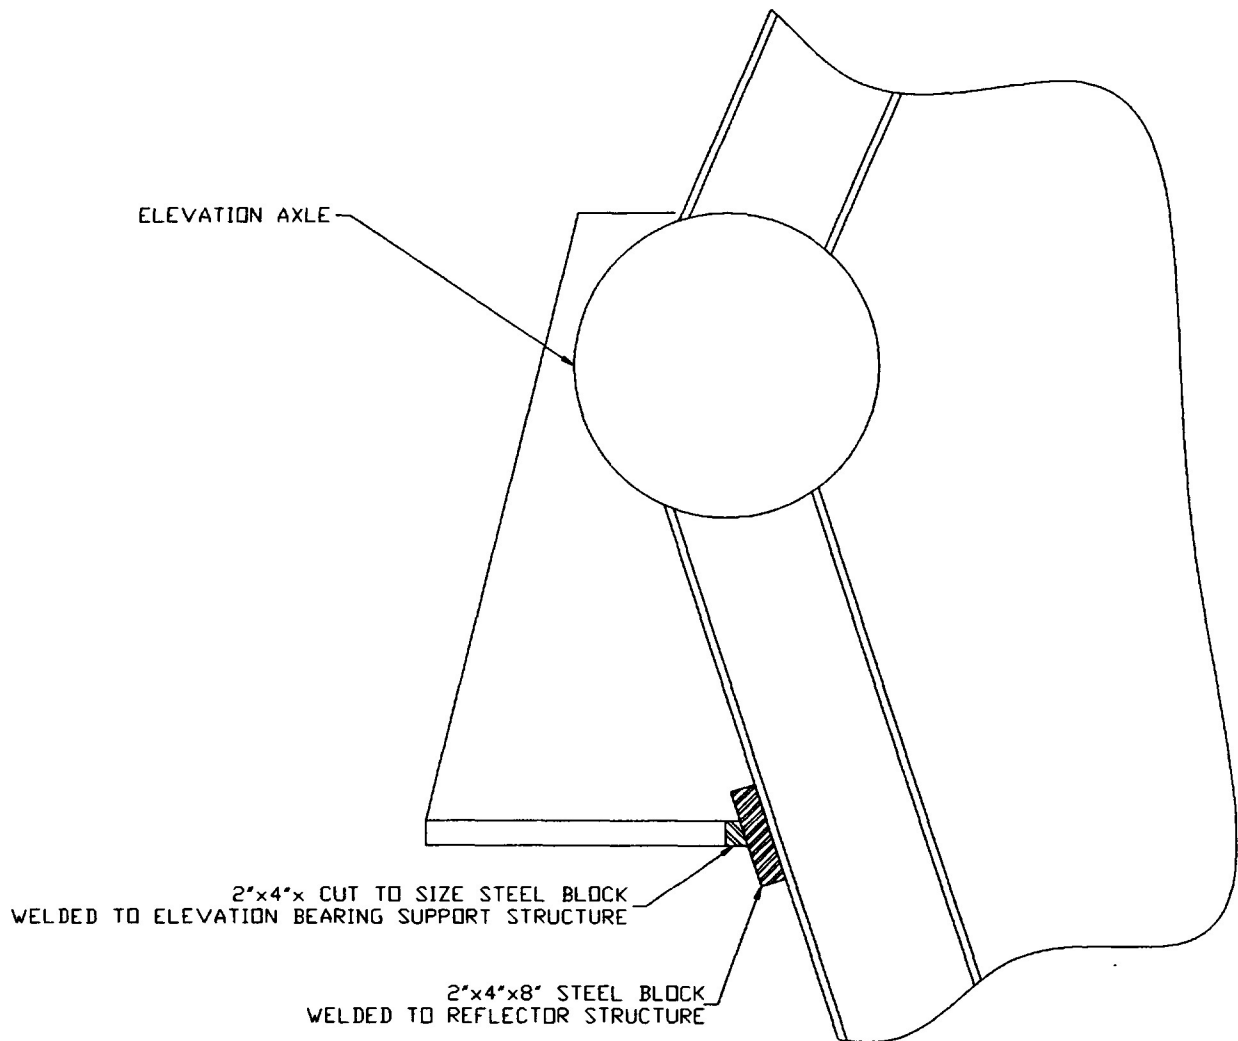
When the reflector is driven past the final limit on the "down side", the reflector contacts the elevation support tubes. These support tubes could be damaged if the reflector is driven into them with excessive force. It is not possible to install a block on the gear sector as was done for the "up limit", because it would interfere with the stow pin. Therefore, Steel plates will be welded to the structure as shown below. These plates will ensure that the reflector structure contacts the elevation bearing support before it contacts the support tubes. The servo system can exert over 200 tons of force on these hard stops if it continues to drive past the limit at full torque. Even with the hard stops it is possible to damage the structure in this kind of failure condition.
