## National radio Astronomy Observatory VLBA Antenna Memo Series – No. 108

Steve Taylor

TRIP REPORT – Hancock, NH Tiger team, September

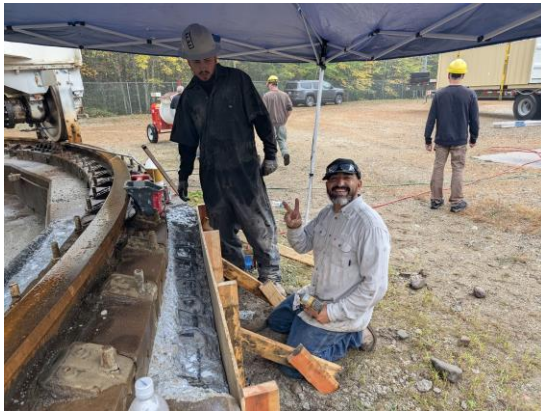
**WO XXXX** It would appear that some of the foundation concrete on the west side of the foundation may have frozen during cure, it was extremely loose and friable, and extended two feet down the wall at the maximum extent. On the inside of the wall the breakdown was only a couple of inches deep. Jackhammers were used to break out this rotted concrete

Rain slowed work. Javier led the concrete repair, fabricating a piece of formwork for the outside foundation and 6 bags of concrete were mixed and poured

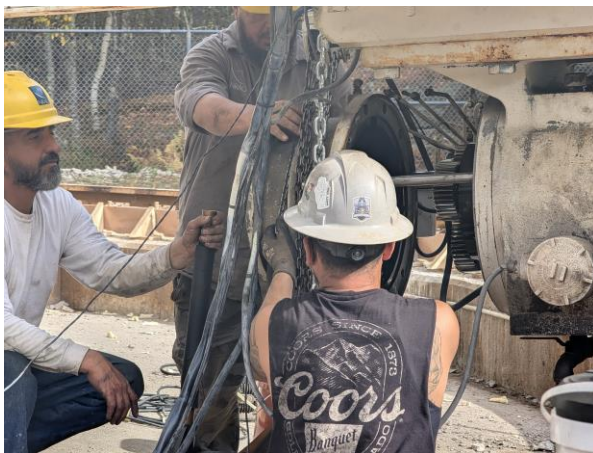
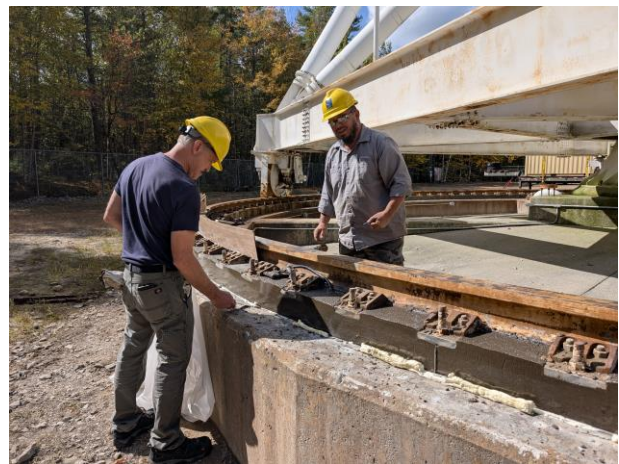
The formwork was stripped off the first two sections of epoxy grout. Note the polished finish!

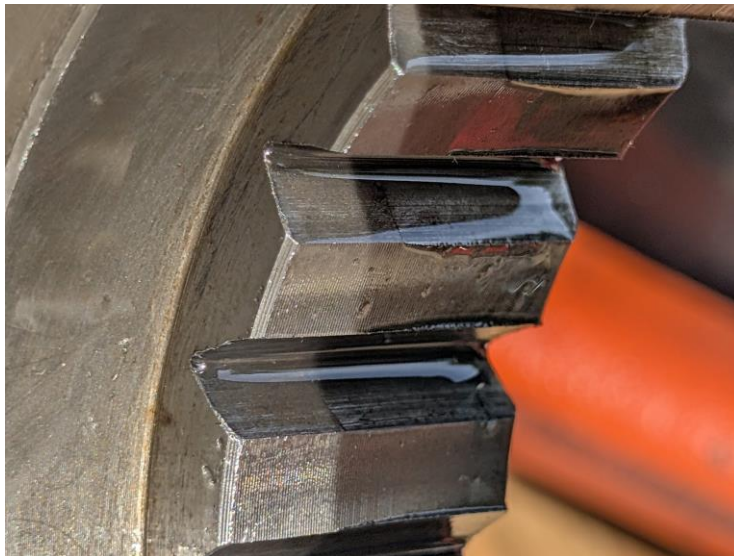
Steve took gearbox stage to press out sun gear at a local machine shop. 3<sup>rd</sup> stage took much more force than expected to separate – see burrs in picture below

Need 35 ton press. 12 tons is not sufficient to dismantle and reassemble the stage plate.
