### VLBA Antenna Memo Series – No. 109

TRIP REPORT – North Liberty, October 20-25, 2025

#### 1. Trip Summary

A group from the VLA traveled to the North Liberty, Iowa VLBA station to rebuild all four gearboxes and replace one of the FRM linear shafts:

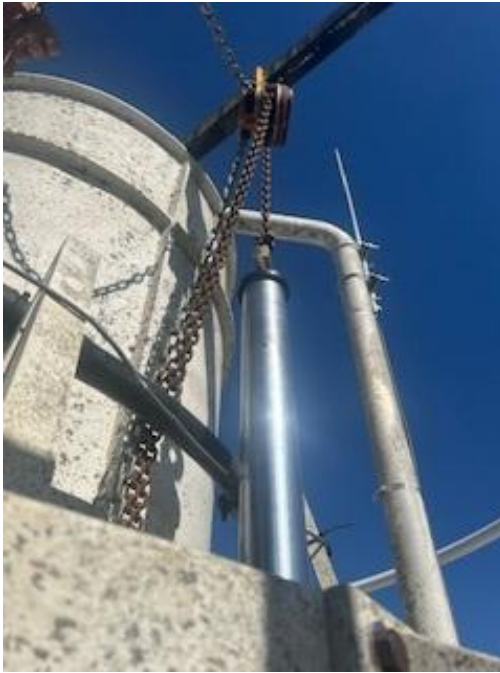
*Figure 2: FRM Linear Shaft*

One of the four FRM linear shafts was reported to have scoring. It was additionally relayed that there was oil leakage coming from the traversing ring where the linear bearings are housed. The shaft site in question was located below the flex shaft closest to the bevel gearbox (non-focus motor side). The replacement of the linear shaft was performed in situ. Prior to the maintenance visit, the sequence of operations was worked out on the VLBA FRM spare in the AAB. This is the first time a linear shaft replacement has been performed in the field.

The 53-inch-long Thomson “lite” shaft spans across the three casted 67.5-inch diameter FRM rings. A lifting device was custom made to raise and lower the shaft, which anchored to the top of the subreflector support tube. This aided in the removal and installation of the 37lb shafts. Each of the three rings contain components supporting the shaft. Once the FRM was driven to the desired position, the apex E-stop was engaged on the FRM J-box and the FRM was locked out. We worked within the apex ring breaking loose all fasteners on the various components along the bottom, middle (traversing ring) and top ring. All components [see drawing no. 6100-04 C], fasteners, O-rings, bellows, seals and packing were replaced.

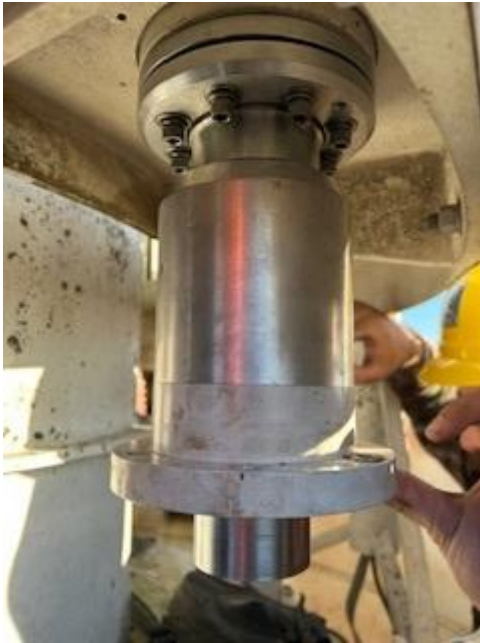
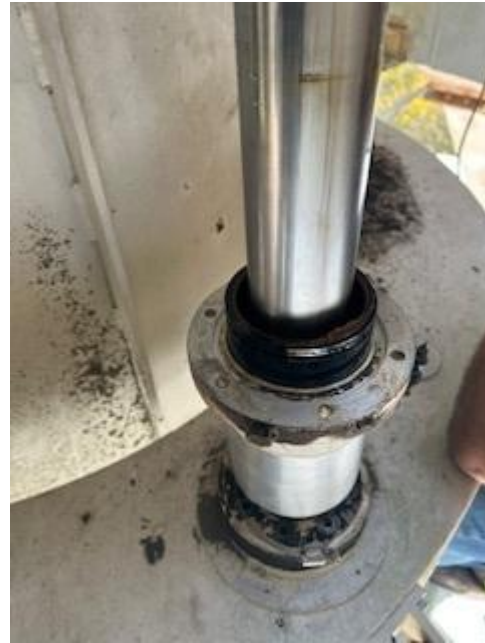
*Figure 4: FRM Bearing Mount (Topside)*

*Figure 5: FRM Bearing Mount (Bottomside)*

The already assembled bearing mounts brought, required replacement of their wiper seals. This seal lip type includes one external scraper and one inner rubber wiper lip. This style scraper seal creates a tight seal on the shaft and prevents debris from entering the linear bearings. It's important to note that these scrapers are outward facing. Since the ends of our shaft do not have a lead chamfer, the running surface needed to be coated (oiled) to reduce friction between the shaft and the scraper edge during installation.

The middle rings topside bearing mount seal can be round formed by temporarily turning the bearing mount upside down and sliding the shaft through. This allows for the shaft to easily fit through the housing bore during final install without damage to the scraper seal.

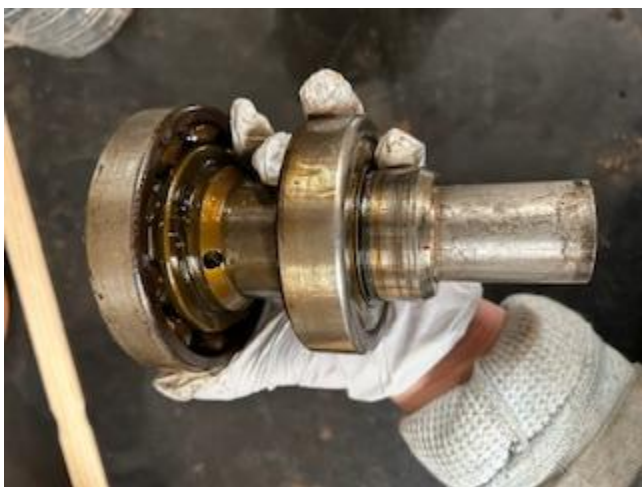
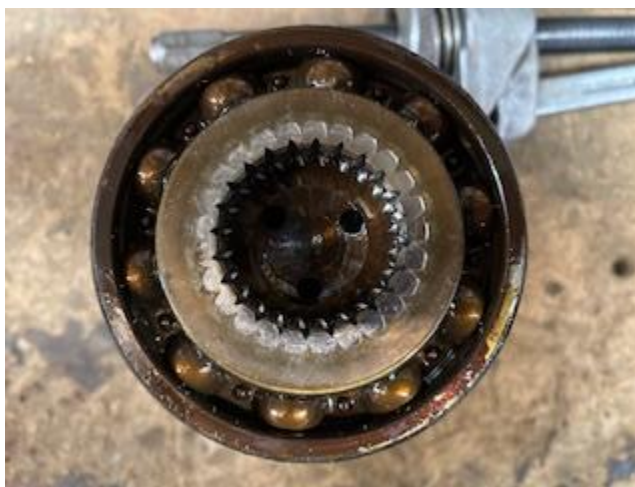
*Figure 9: EL #2 Input Shaft*

*Figure 10: EL #2 Splined Input Shaft Face*

High wear and replacement components are typically all sun gears, thrust bearings and thrust washers (behind 1<sup>st</sup> and 2<sup>nd</sup> stage sun gears) and shims behind the planetary and sun gears (optional) which deform and flatten over time. These components manage the axial forces and are used to maintain alignment. The elevation gearboxes had the typical rebuild with the replacement of the input shaft due to significant wear found on EL #2 shown in Figures 9 and 10. Oil level indicators were also replaced for EL #2.

Based on replacement needs, additional input shafts will need to be assembled for later gearbox rebuilds. Revisiting collar and bearing removal/installation procedures can improve quality of performance and recovered components.

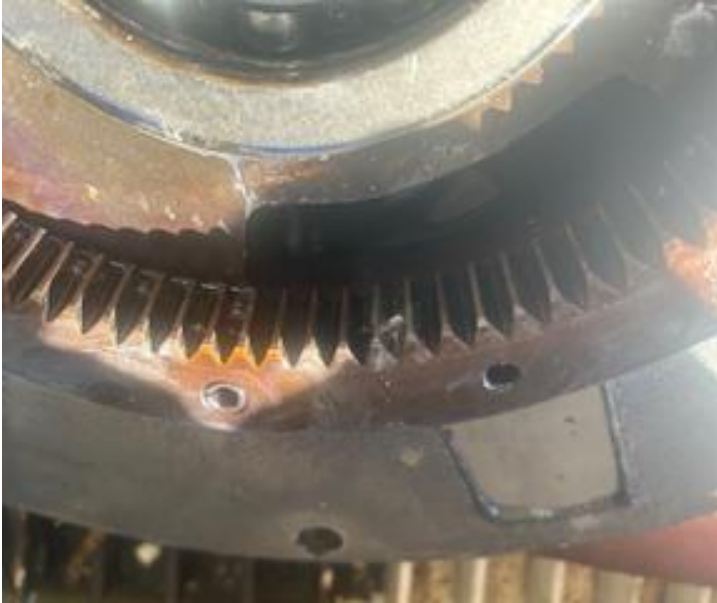
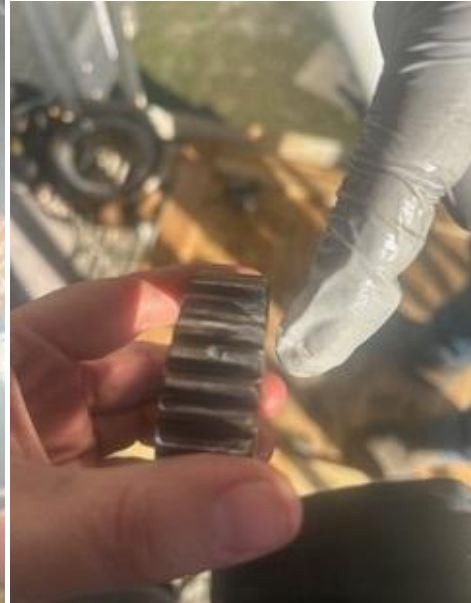
*Figure 11: EL #2 Damaged Ring Gear*

*Figure 12: EL #2 Damaged Planetary Gear*

During checkouts, elevation movement seized. Site techs deduced which of the gearboxes likely failed based on motor current readings taking the guesswork out of which of the two gearboxes to tear into. Draining of the gear box (7.5 gal) along with the removal of its motor, adapter, shaft coupling and two of the seven oil lines had to be repeated to access the first stage gearbox housing. Right away the input shaft resisted rotation by hand indicating problems within the first stage. This was confirmed immediately when a small piece of metal was found stuck between the teeth of the outer ring gear shown in Figure 11. This was enough damage caused by grinding to break the tooth of both the ring and planetary gear shown in Figure 12. This happened due to one of the rollers falling out of the old thrust bearing which was not recovered during rebuild and managed to wedge its way after install. This soon prompted for in-line and bypass filters to be checked and cleaned as well as thoroughly flushing out the first stage housing on the remaining gearboxes that had yet to be opened.

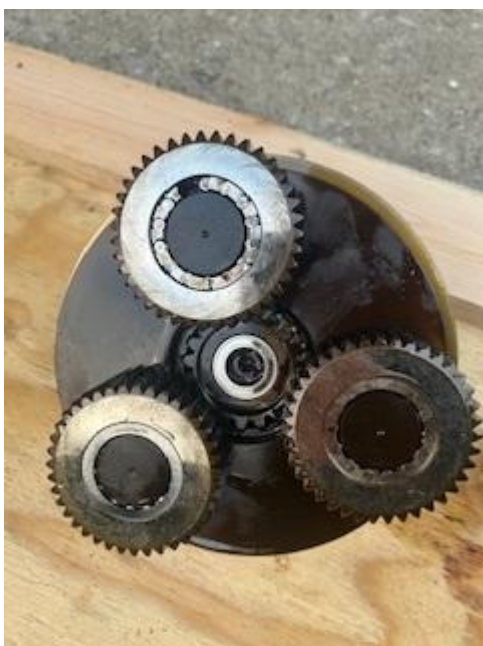
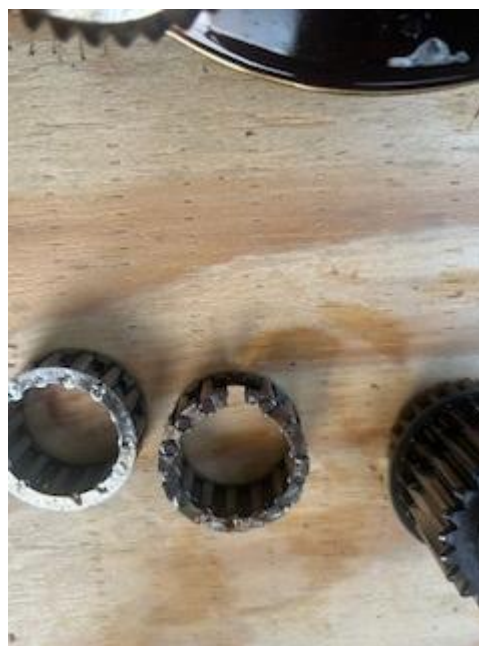
Figure 13: AZ #2 Planetary Gears

Figure 14: AZ #2 Planetary Gear Bearings

Just like the elevation gearboxes, similar parts were replaced for the azimuth gearboxes. Despite the smooth rotation of the input shaft, what was completely unexpected was the condition of the first stage planetary bearings and later fourth stage sun gear. The cages were worn down exposing the roller bearings. One roller had fallen out of the bearing shown in Figure 14 which was found and collected. During draining of the inline filter, a lot of metal particulates were found in the oil.

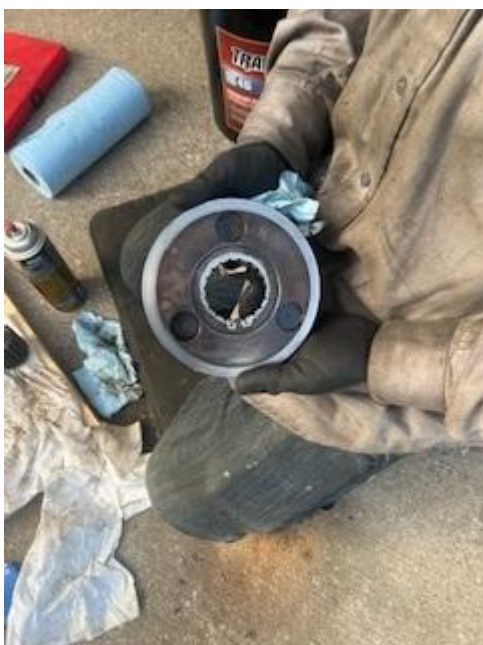
Figure 15: First Stage Carrier (Rear View)

The desire was to replace the first stage carrier due to that fact the rear ring gear of the second stage sun had worn into the carrier surface shown in Figure 15. However, the replacement carrier was poorly machined, and the material felt substantially lighter than the existing one. One of the site tech made the attempt at removing burrs and protrusions of material left on the part. Given the discoloration on the components within the AZ #2 gearbox we decided to use the original carrier.

The heat scorches indicate that the components have been exposed to high temperatures. This implies either a lubrication failure and/or misalignment. Many of which stem from several underlying issues. If the oil can no longer provide a protective film between the moving parts, there will be increased metal-to-metal contact. By the result of the dark color and sludge formation, it seems like the oil has oxidized.

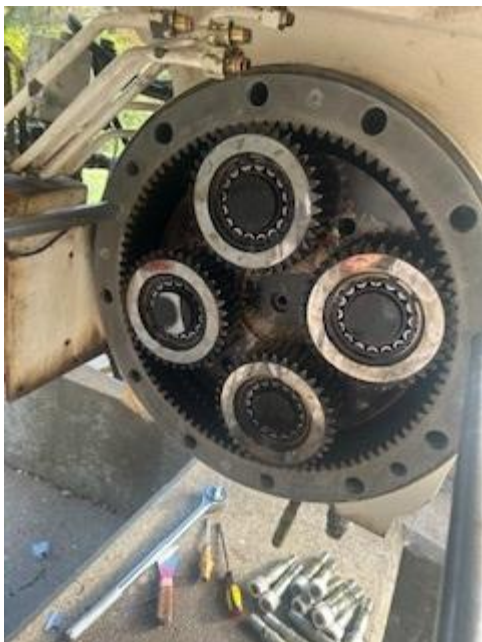
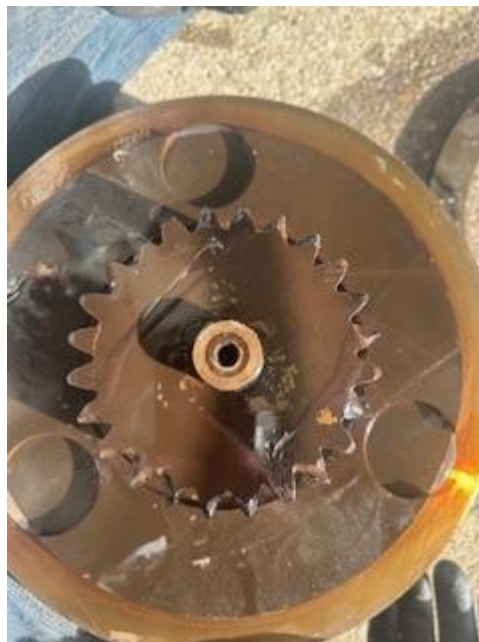
*Figure 17: 4th Stage Carrier*

*Figure 18: 4th Stage Sun (Rear View)*

The most astonishing finding in the AZ #2 gearbox was the 4th stage sun. The rear teeth were chipped as shown from the third stage carrier above in Figures 18-20. Some edges were breaking to the touch. This has not been seen in any of the gearbox rebuilds before.

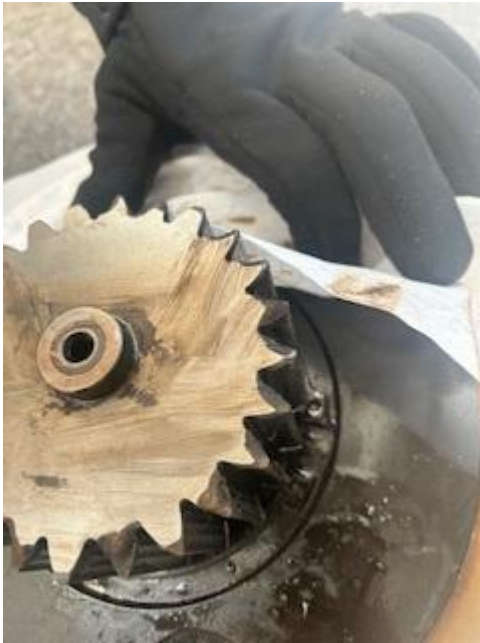
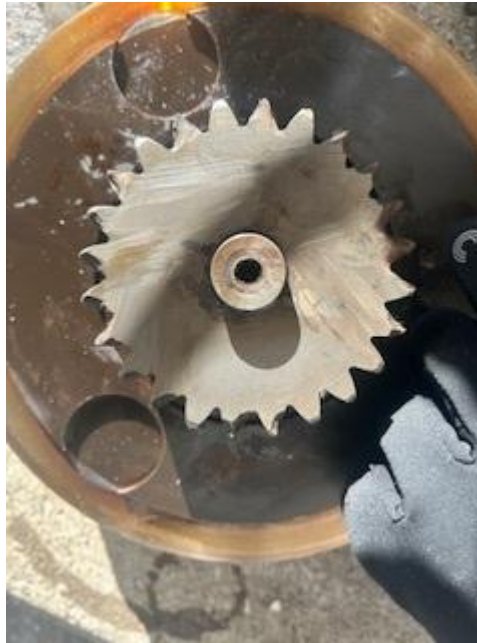
*Figure 19: AZ #2 Sun Gear*

The condition of the sun gear supports idea that these components have been exposed to intense heat. This has further exacerbated the problem likely hardening this component leading to the gear damage shown in Figures 19 and 20. Further evaluation of this damage will be reviewed when parts return to the VLA.

Additional means for pressing out the sun gear need to be secured. We currently don't have the capability (tonnage required) to press the fourth stage sun gear out from the third stage carrier in the field with our hydraulic press. In anticipation, we brought spare carriers, and Mike Burgert found a local auto shop with this capability ahead of the scheduled trip. This was suggested by the Hancock tiger team as they were faced with this challenge during their gearbox rebuilds.

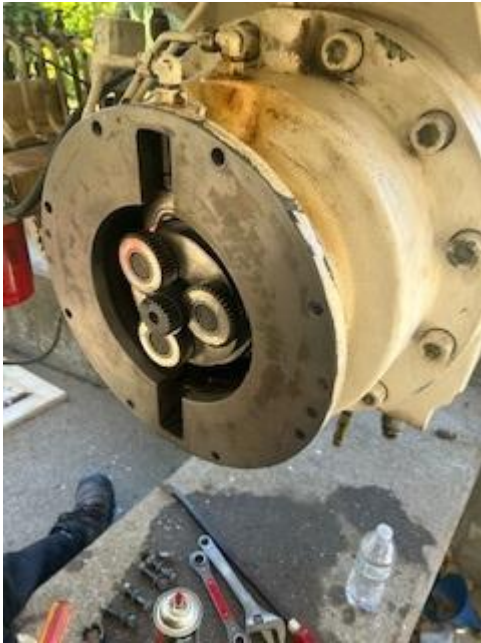
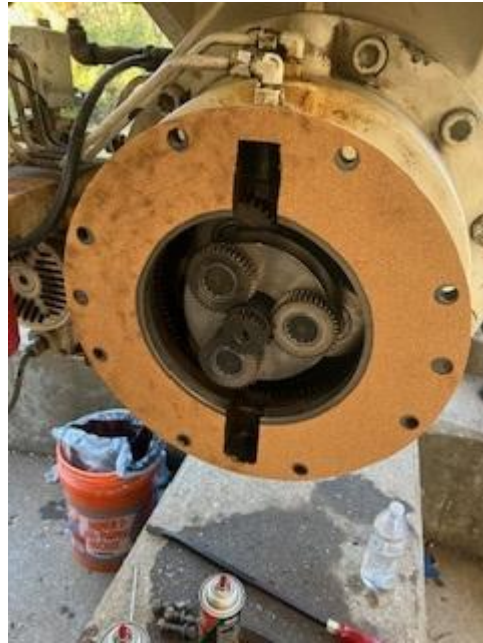
Figure 21: Gearbox housing

Figure 22: Gearbox with gasket

The gearbox axial clearance and adjustment procedure was followed to address the of the AZ #2 gearbox. 1/16" thick cork gasket was added. This acts as a spacer to reduce compressive forces. Surprisingly, the AZ #1 gearbox was nowhere near the condition of AZ #2.

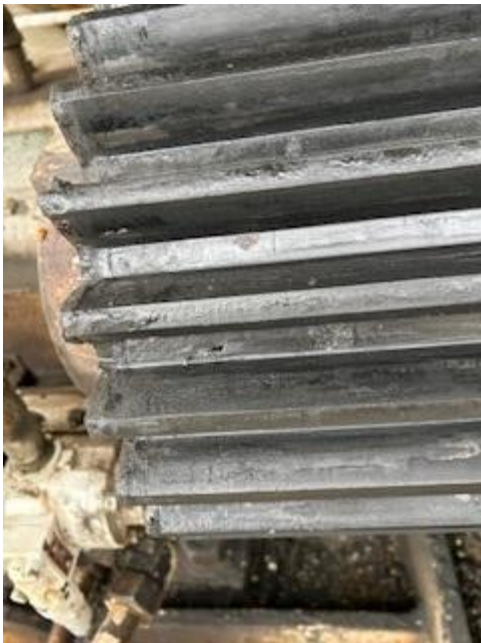
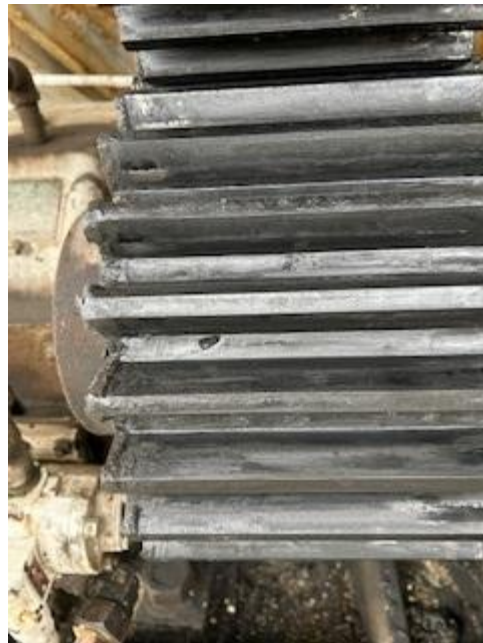
Figure 23: Elevation Pinion Gear

Operation ran smoothly when running elevation however, the pinion gear of EL #2 showed damage on two bottom lands about four teeth apart. This is the surface between two adjacent teeth. As it was noted that the grease dissipates towards the EL2 side of the drive gears, it could be due to misalignment causing concentrated loads on a specific area of the teeth leading to uneven wear and gouging as shown in the figures above. Monitoring these areas will need to continue.

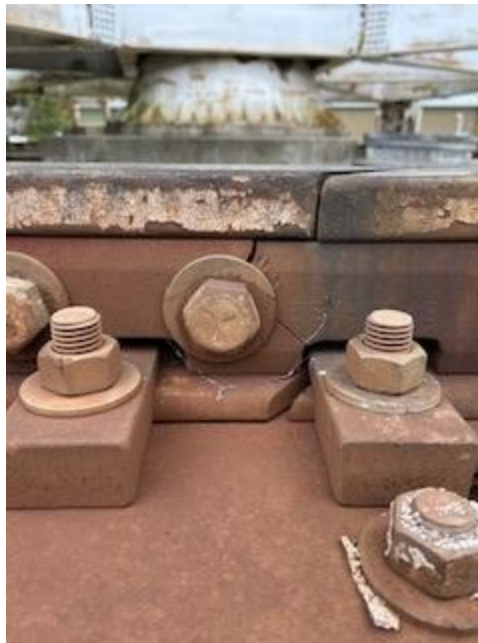
*Figure 25: Splice Bar*

The rail splice bars were an already identified issue from an earlier engineering inspection, reported in September 2025. Lack of material and time didn't allow for this task to be included in the scope of work for this trip. WO-27394 will infer the amount of raw material needing to be ordered for all VLBA splice bar replacements. Again, North Liberty has identified eight out of the twelve splice bars requiring replacement. Hancock, New Hampshire is the only VLBA site to have the most current modified splice bars installed [see VLBA Antenna Memo 108].
