Inspection report 110

VLBA antenna Mauna Kea Dec 2025

Perform a top to bottom inspection of the antenna, preparatory to a potential tiger team visit to replace bearings in the AZ wheels and gearbox rebuilds.

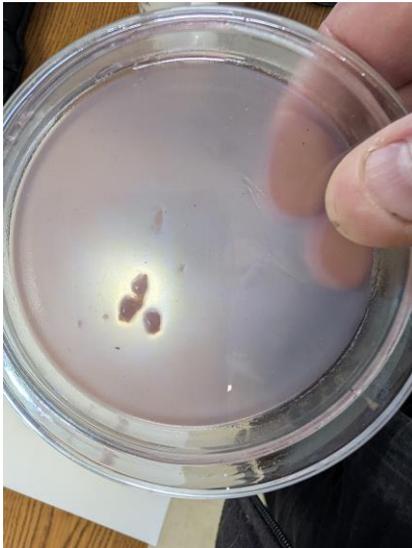
One sample “pink” AZ2 inner was poured into a 4” Petri dish, covered and the solvent allowed to evaporate

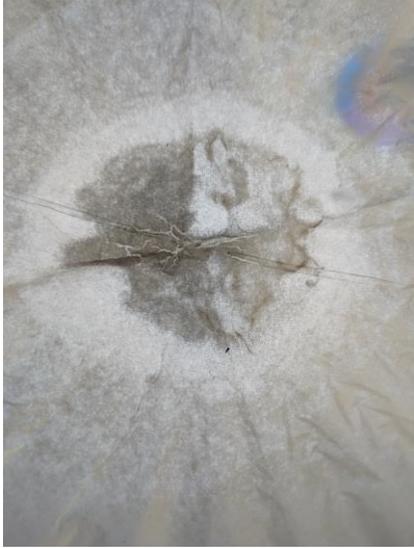
One sample “blue” AZ2 outer was poured through a folded coffee filter into the waste container, and the filter allowed to dry.

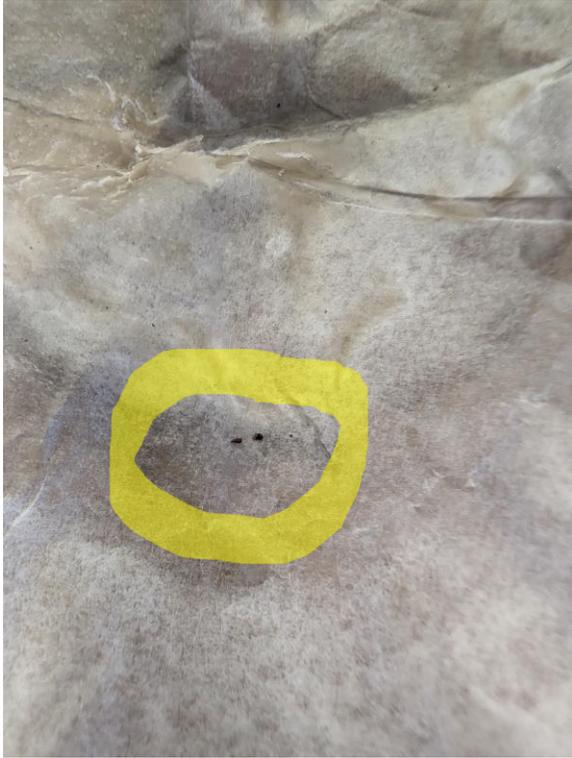
A close examination of both samples with a magnifying glass reveals only one or two large particles.

This particle was originally one, then prodded with a pencil tip, whereupon it broke into two. It was probably sandy grit.

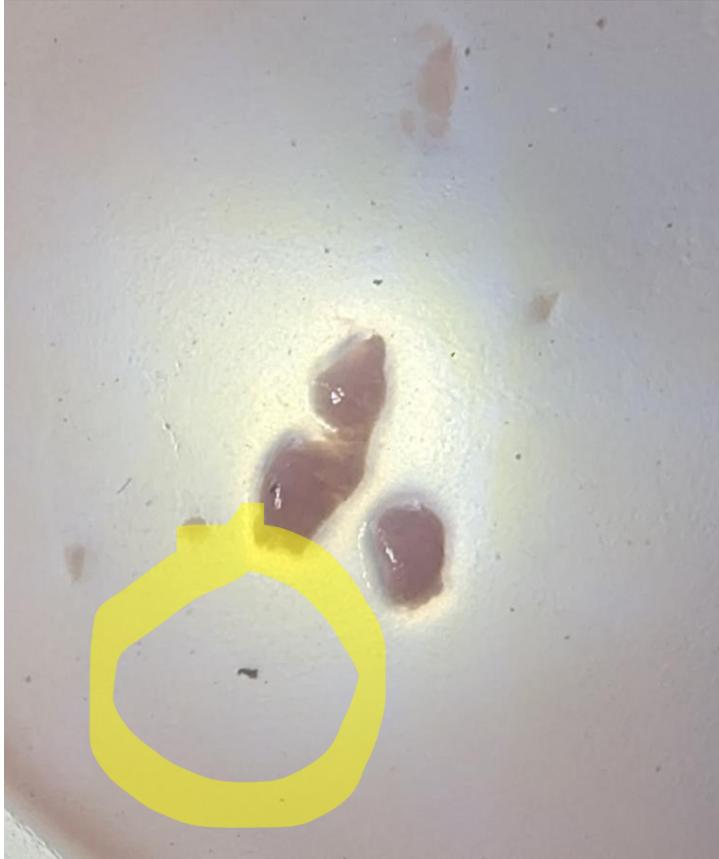
This is the “pink” sample. This large particle was tested with a magnet, but wasn’t attracted to it.
