National Radio Astronomy Observatory

VLBA Antenna Memo Series – No. 111

TRIP REPORT – Fort Davis, March 10-12, 2026

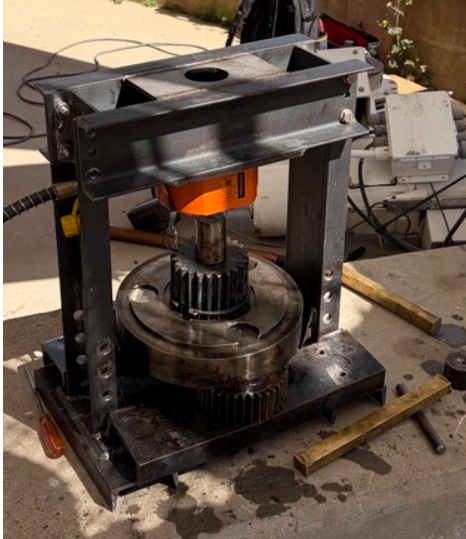
We fabricated a 50 ton press to help assemble and disassemble the 3rd stage sun gear.

Whilst the applicable force was sufficient (but needs a pressure gauge), the press was unfortunately slightly too narrow, and slightly too long. New sideframes will be fabricated and the device retested.

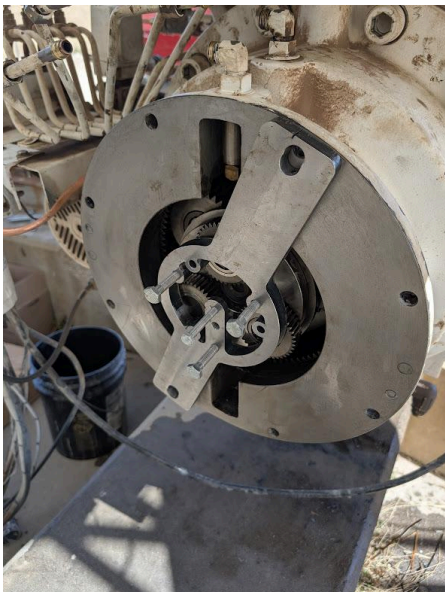
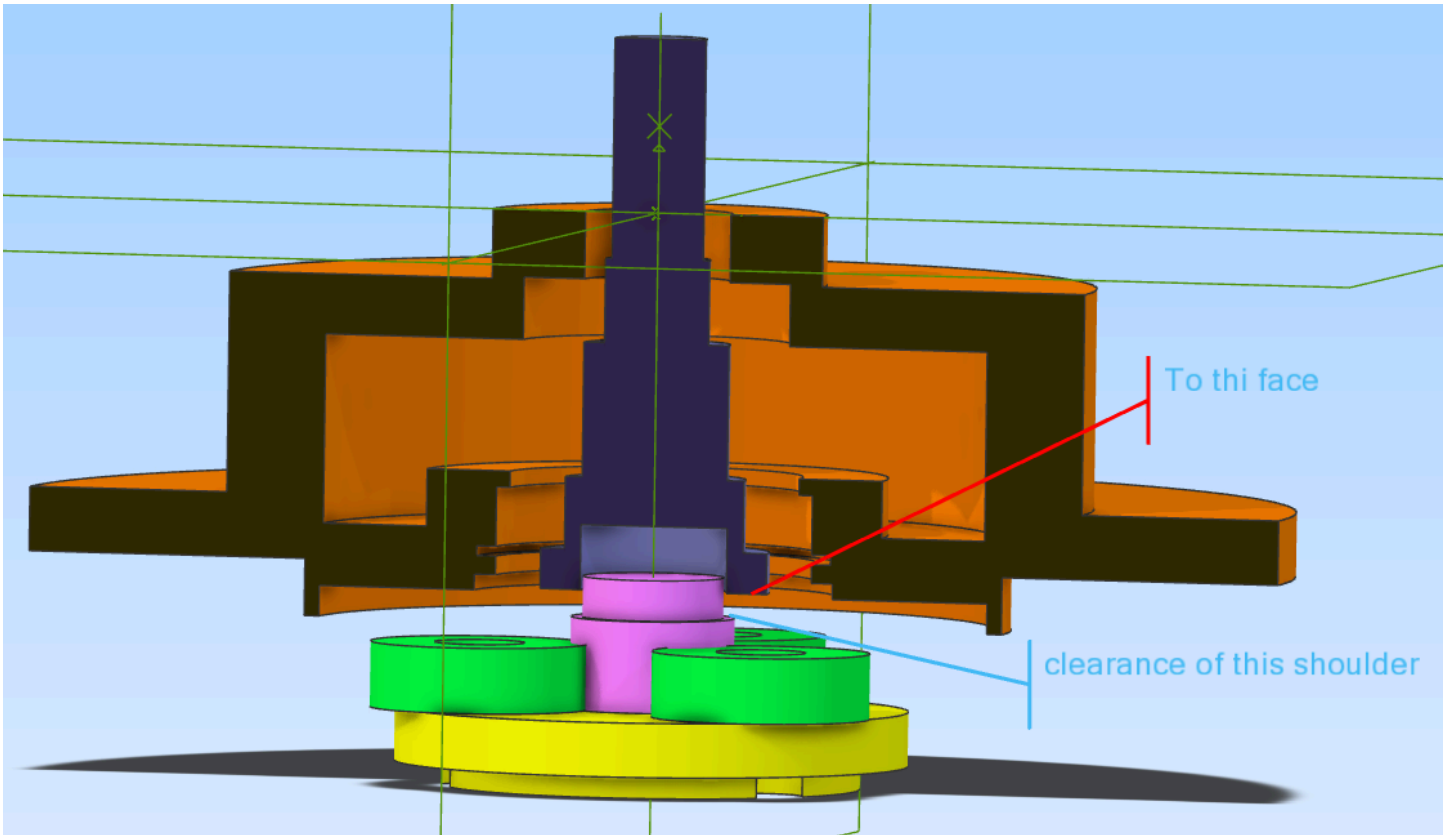
The measurement we are trying to make is illustrated below.

Its is a complex measurement to reach, and requires 5 different measurements to achieve.

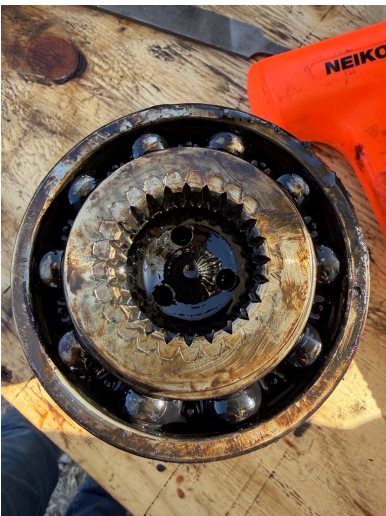
During examination of the components of the input shaft housing this was observed. This nicely demonstrates a gearbox with insufficient interal clearance, as the imprint of the first stage input gear may be clearly seen on this input shaft spline. To counter this, the box was reassembled with a 1mm spacer removed from the thrust washer on the rear of the second stage stage sun gear.
