## 1. Trip Summary

## 2. Executive Summary

**National Radio Astronomy Observatory**  
**VLBA Antenna Memo Series – No. 112**  
Chantel Flores and Fernando Santoro  
**INSPECTION REPORT – Fort Davis, March 10-12, 2026**

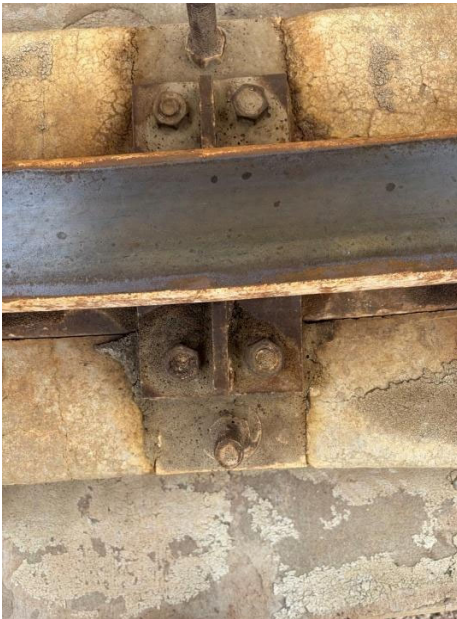
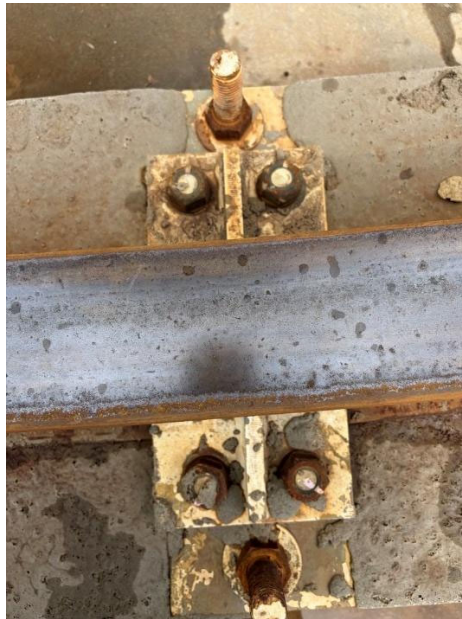
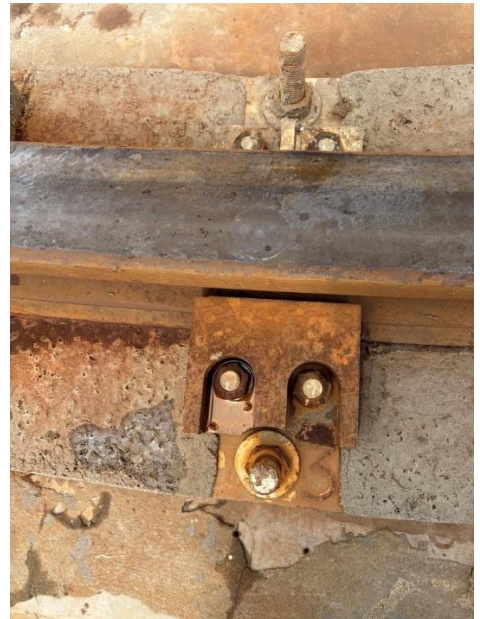
Two different types of rail clips were used on the same track sections. Five of the rail clips that secure the railway along the base plates had different geometry. Having consistent clip types ensures uniform rail behavior and simplifies maintenance. It's possible to replace these clips to the standard size during the upcoming maintenance visit. Both fastening pairs shown opposite of each other can be seen in Figure 4.

Figure 2: Rail Clips (Bolt No. 70)

Figure 3: Rail Clips (Bolt No. 8)

Figure 4: Rail Clips (Bolt No. 3)

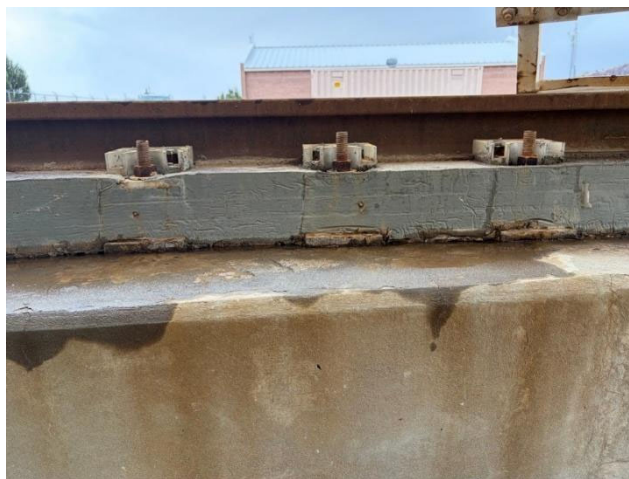
Figure 5: Plates (Bolt No. 3)

It was noted that steel plates were protruding from the grout at bolts 9, 10 and 11. Should the track section require regrouting in the future, extra care should be taken during demolition around this section of rail.

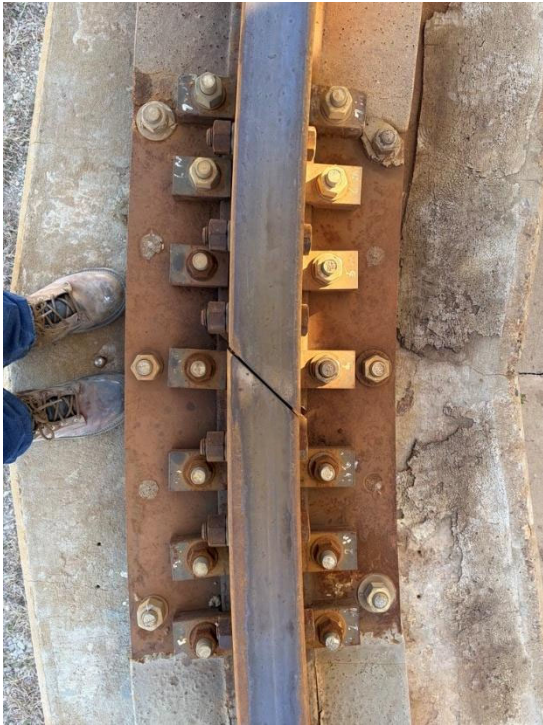
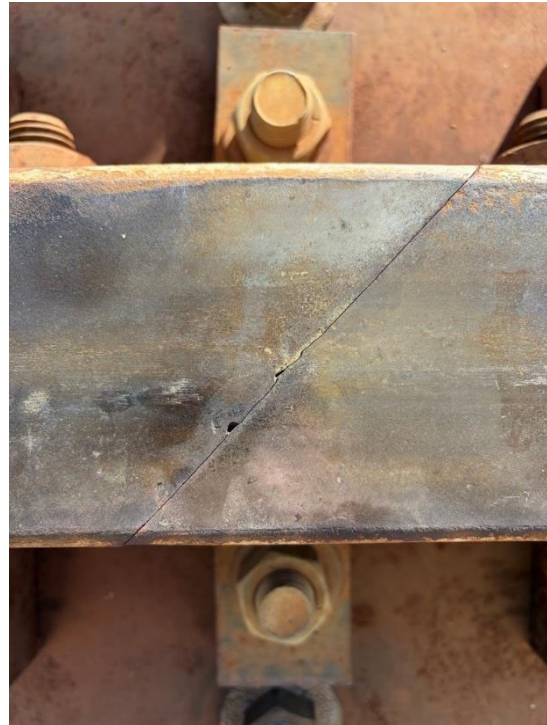
The splice joints were all inspected along the rail track. One of the joints had a visibly larger gap compared to the other five intersections. These gaps are necessary to allow for thermal expansion however, excessive joint gaps can potentially lead to surface damage, rail creep or broken components. The gap was measured to be roughly around 0.117 inches and will need to continue to be tracked. The remaining splice joint gaps were considerably smaller however, movement was recorded at these intersections. The splice joint at Bolt 61 shows localized chips (see Figure 7). Regular monitoring at this joint will allow for tracking of any further crack development and/or propagation.

Figure 6: Splice Joint (Bolt No. 41)

Figure 7: Splice Joint (Bolt No. 61)

Splice bar replacement

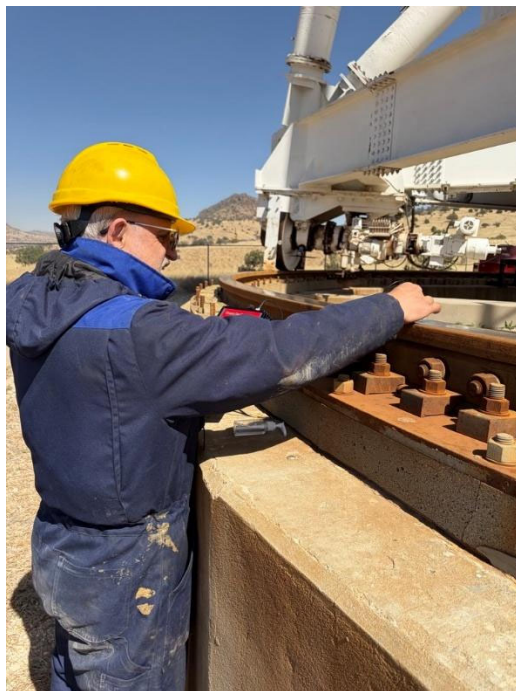
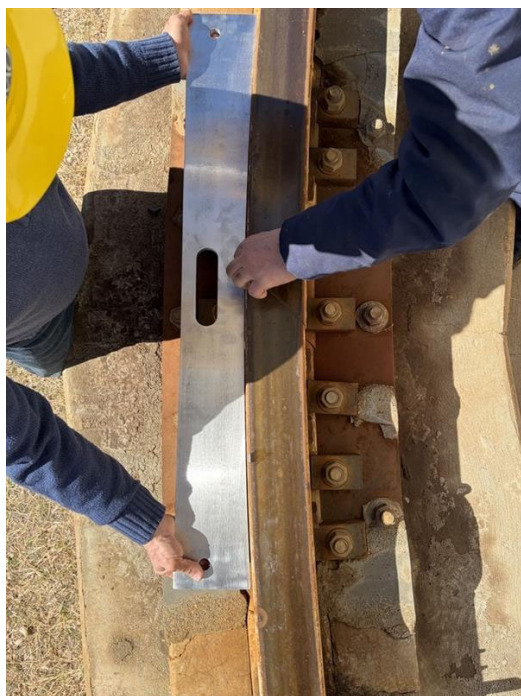
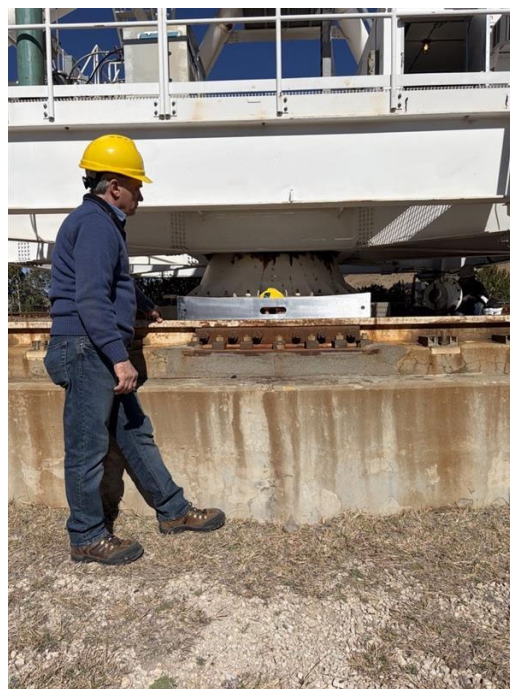
Figure 8: Ultrasonic Testing

Various measuring instruments were used to develop geometric characteristics of the rail track. An ultrasonic tester was used on the rail to detect if internal flaws were present, such as cracks or voids. There was a disruption in the signals path between bolt 60 and 61 possibly revealing a hidden defect at one of the splice joints. Splice joints on rail are more prone to failure largely because they are considered to be weakest points. During the next maintenance visit, all splice bars will be replaced, exposing the webbing at these intersections, allowing for further field observations and evaluation.

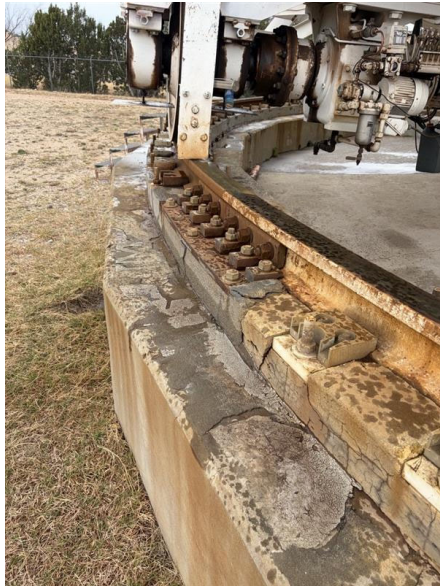
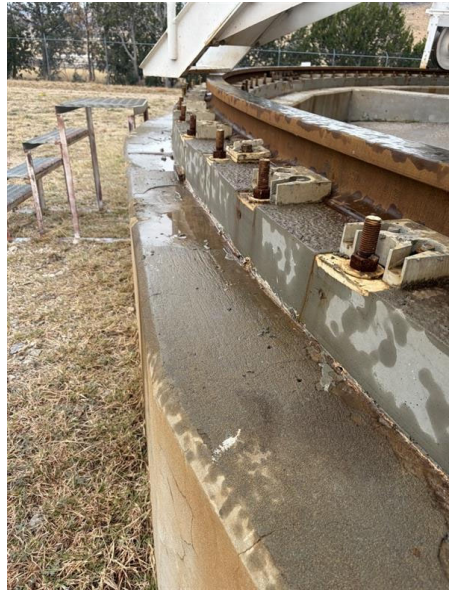
The overall foundation and track of Fort Davis is in acceptable condition. 50% of the grout exhibits high uniformity and integrity (see Figure 11) while the other half of rail across three consecutive 20-foot spans show visual deterioration between edges and around plates (see Figure 12). While functioning well, pushing forward to regrouting sections at a time will ensure longevity and performance of the Fort Davis railway infrastructure.

Figure 11: Older Grout Section of Rail

Figure 12: Newly Poured Grout Section

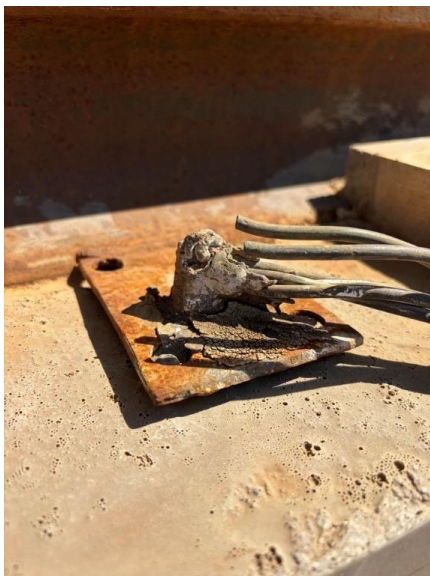
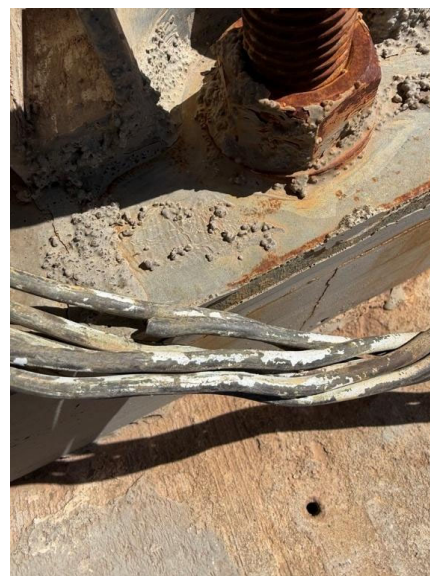
One of the two grounding cables to the rail had loose and reduced wire connections. It's recommended that it be included as an upcoming maintenance activity during the next scheduled visit to avoid unwanted conductive paths. This can be achieved with wire extensions through a split bolt to a wire mold or lug. The location of this grounding cable is between bolts 36 and 37 shown in Figures 13 and 14.

Figure 13: Rail Ground

Figure 14: Grounding Wire

Grounding cable repair

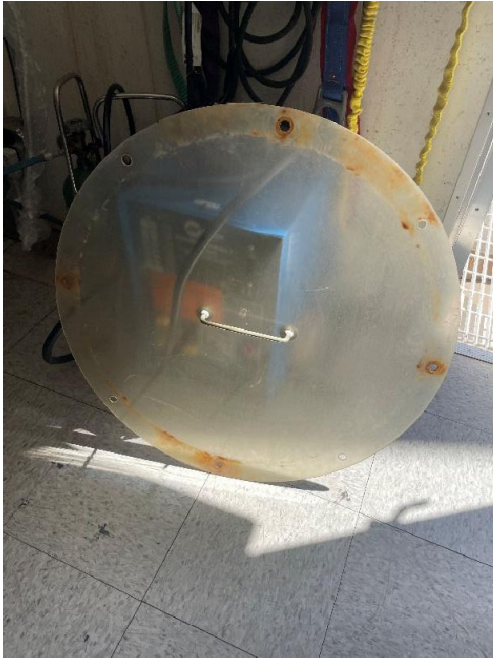
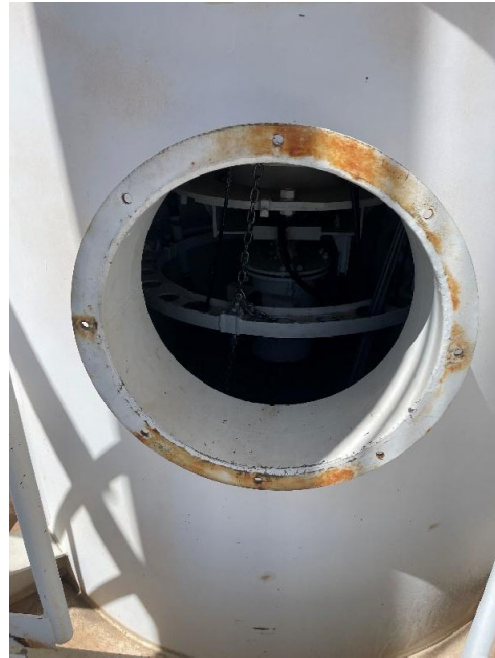
The porthole to the pintle bearing room was inspected and found to be in good condition. The plexiglass cover does not currently have a weather seal, and some superficial rust was observed at the flange interface, indicating that water may be entering (superficially) through this area.

Figure 17: Port Cover

Figure 18: Pintle Bearing Room Port Hole

As part of Safety Corrective Action 3621 (VLBA Pintle Bearing Room Porthole Cover Redesign), a threaded pin will be installed at the upper portion of the mounting flange to support the cover when all fasteners are removed. In addition, a silicone gasket will be applied to the cover to prevent water infiltration. This solution will be initially applied in PT and then to FD during the upcoming Tiger Team.

Exterior sealing

Update porthole cover (Safety Corrective Action 3621)

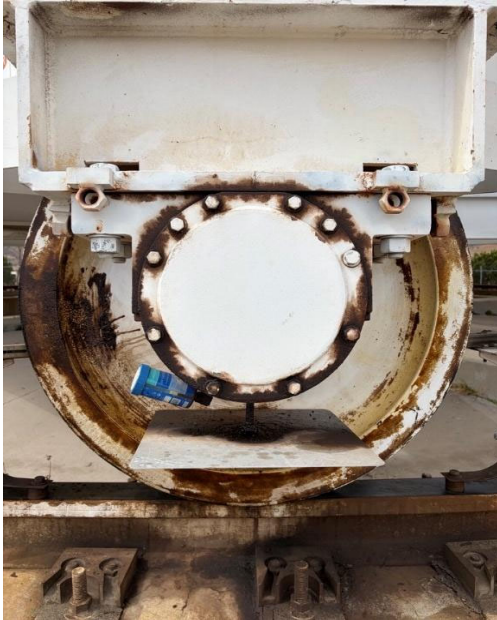
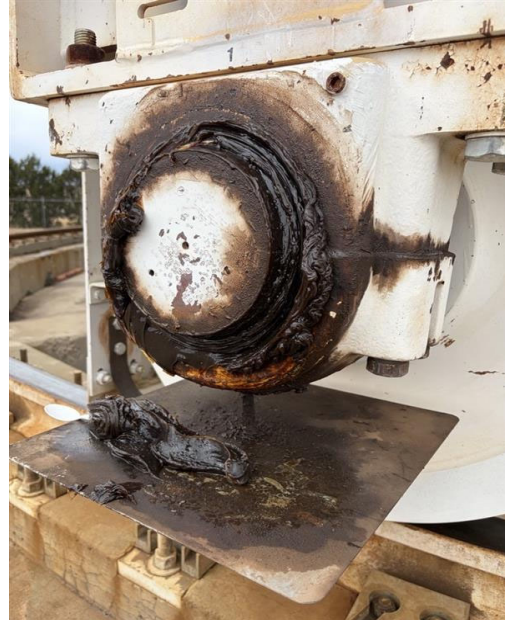
The AZ #1 gearbox was rebuilt in 2023, and the EL #2 gearbox in 2025. The remaining two gearboxes were rebuilt during this trip, refer to VLBA Antenna Memo 111. It was observed that Drive #1 wheel has an inner solid pillow block and split outer pillow block. The Drive #2 wheel has solid pillow blocks. Both Idlers wheels have all split pillow blocks. These pillow blocks bolt to the antenna structure holding the shafts and bearing components in place. Solid pillow blocks are made of one solid piece while split pillow blocks are made of two pieces. These different housing units can be seen in both Figures 19 and 20. The solid pillow blocks can be replaced with splits during scheduled bearing changes for those wheels.

Figure 19: Solid Pillow Block

Figure 20: Split Pillow Block

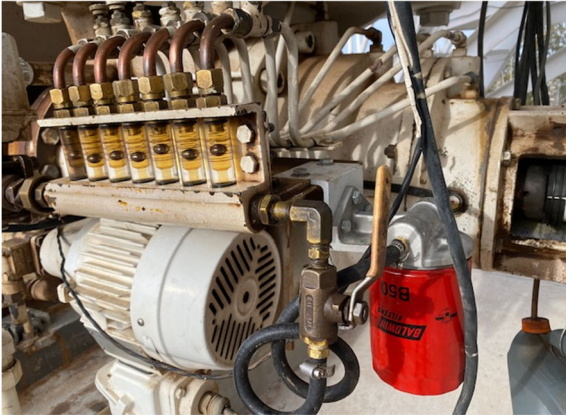
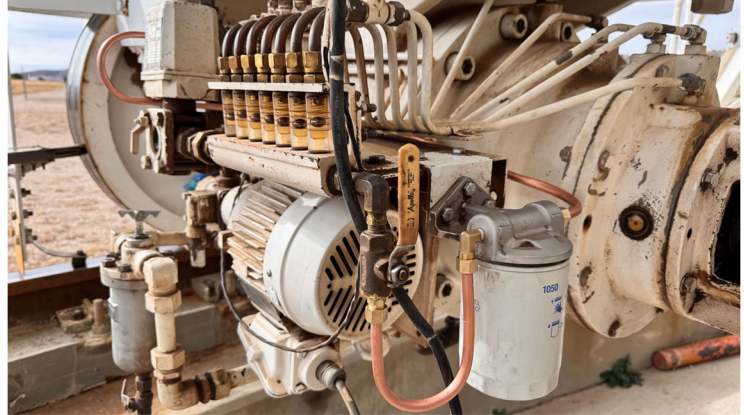
The bypass filtration system for all four gearboxes was installed at the end of 2023. The nitrile/neoprene hose lines were recently replaced with 3/8 copper tubing and reported to have improved performance due to previous hose cracking. This solution can be pursued for sites experiencing frequent hose replacement. One of the sight glasses was reported by the site tech with a loss of flow. Flow monitoring at this sight glass has been requested.

Figure 23: Bypass Filter Nitrile Hose Lines

Figure 24: Bypass Filter Copper Lines

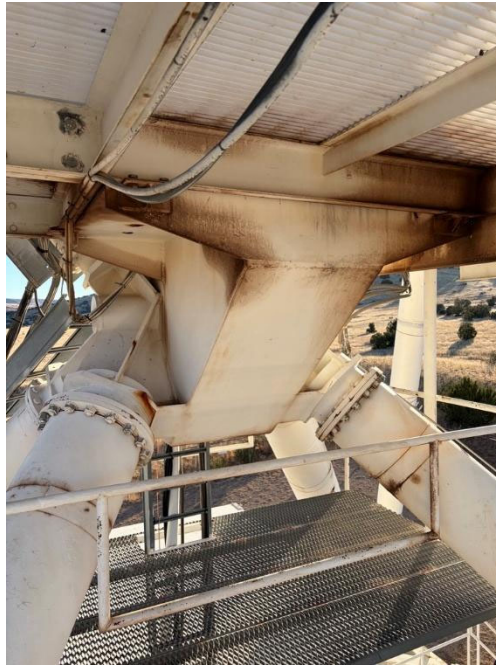
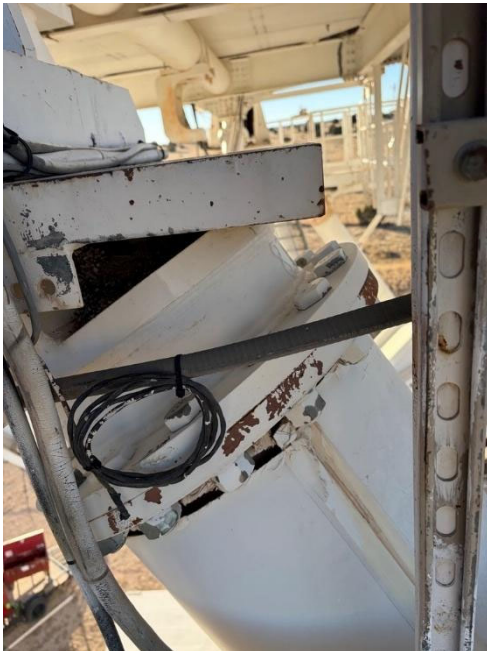
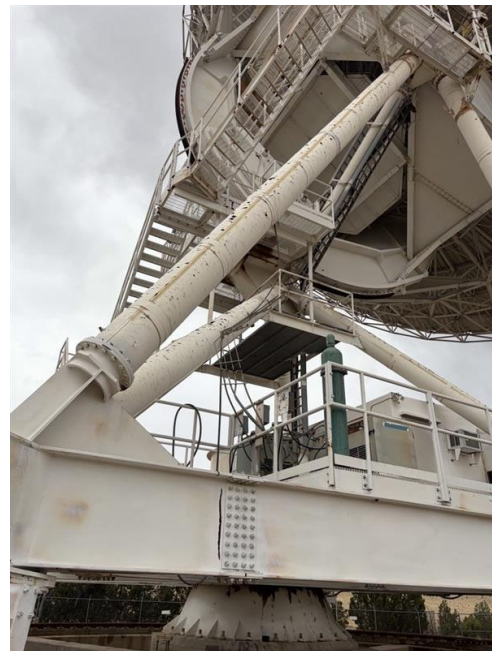
Similarly to the structural inspection in Mauna Kea (VLBA Antenna Memo 106), a half inch hole was drilled in the center of the bottom plate (as seen in Figure 27) as preventative maintenance against structural damage due to moisture buildup. Insulation repair will need to be performed along the two quadrapod configurations on the pedestal assembly shown in Figures 28 and 29.

Figure 27: Knuckle

Figure 28: Quadrapod Support (Synchro)

Figure 29: Quadrapod Support Insulation

Lower level quadrapod insulation repairs

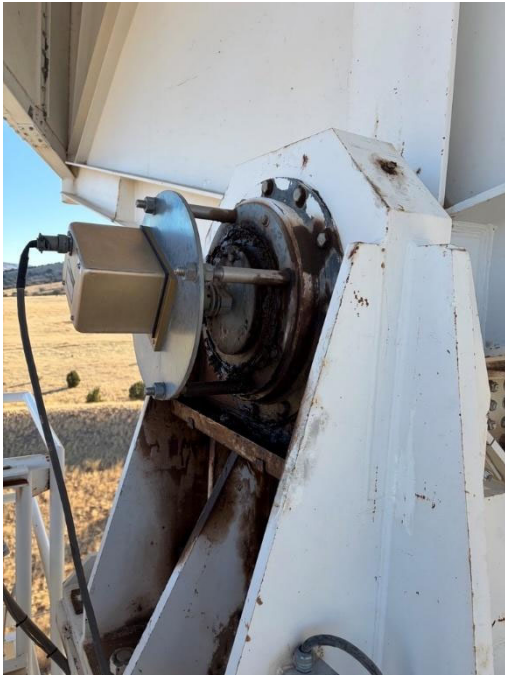
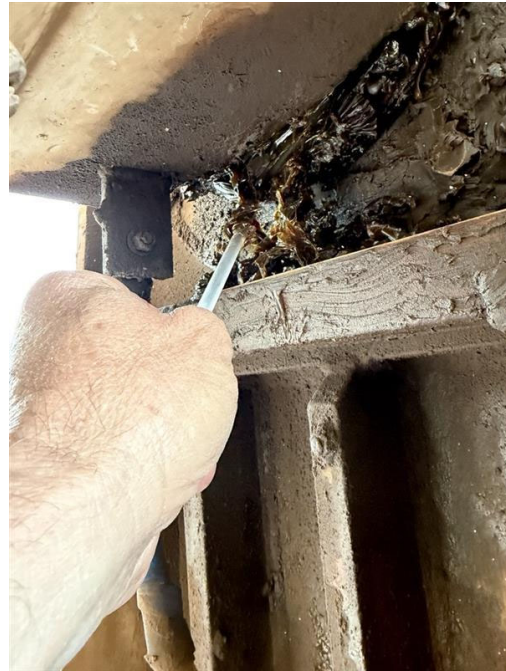
Grease sampling was additionally performed at both elevation bearing locations. Both the synchro plate and encoder cover prevented sampling from active areas within the pillow block. Purged grease closely around the axle and pillow block cover still enabled representative grease samples to be taken without the disassembly of these components.

Figure 30: Synchro Pillow Block

Figure 31: Encoder Pillow Block

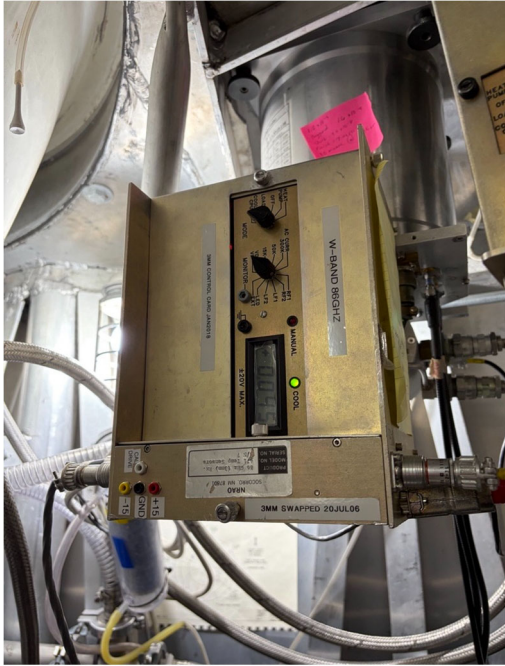
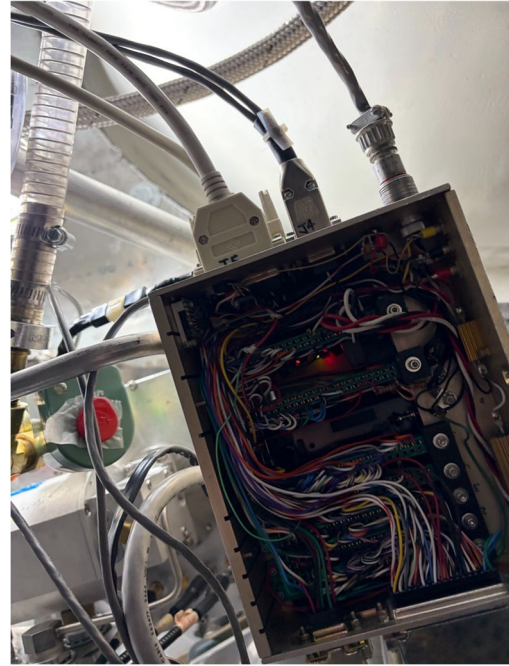
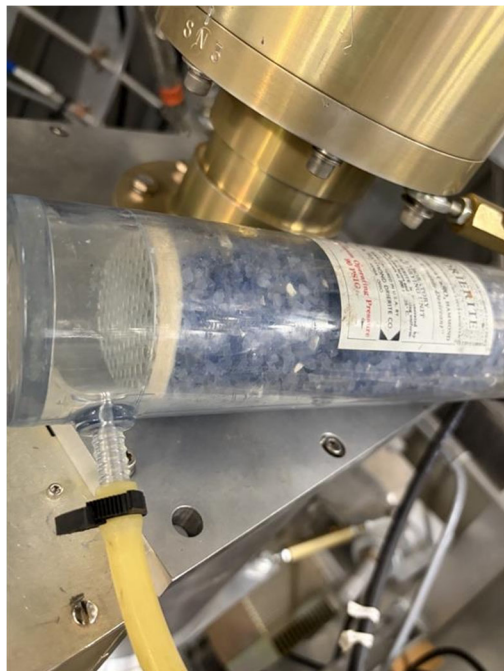
The vertex room has been well-maintained with only minor concerns identified. The 3mm (W-Band) receivers control card enclosure does not include a bottom panel (see Figure 33). The desiccant located on the C-Band receiver needs further securement to the mounting plate seen in Figure 34. It has the potential to shift during EL movement. Air velocities were measured at the inlets and outlets of racks A, B and E. Air flow continues to be evaluated within these racks.

Figure 32: W-Band Receiver

Figure 33: Control Card Enclosure

Figure 34: Desiccant

Desiccant securement (C-Band)

Enclosure cover (W-Band)

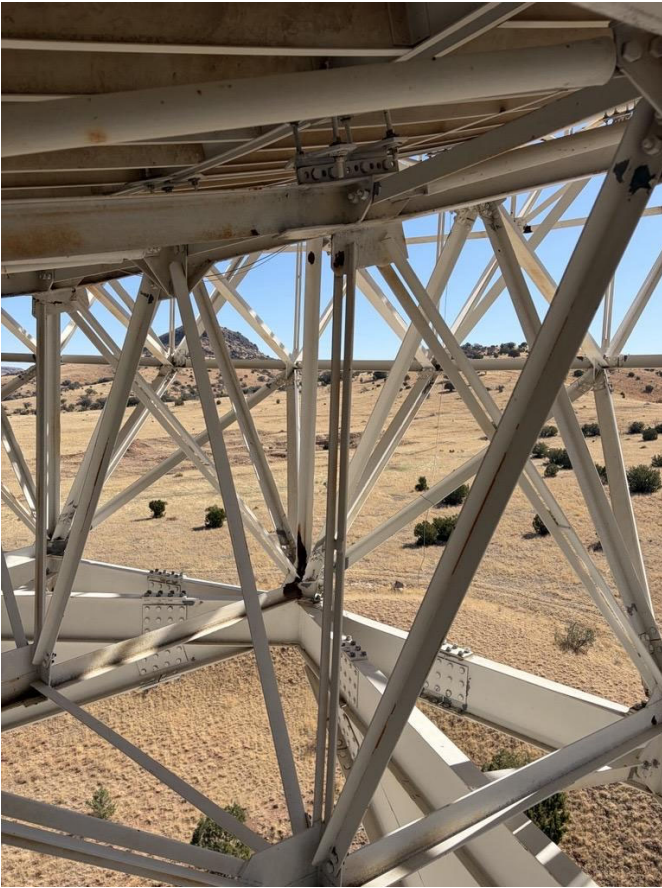
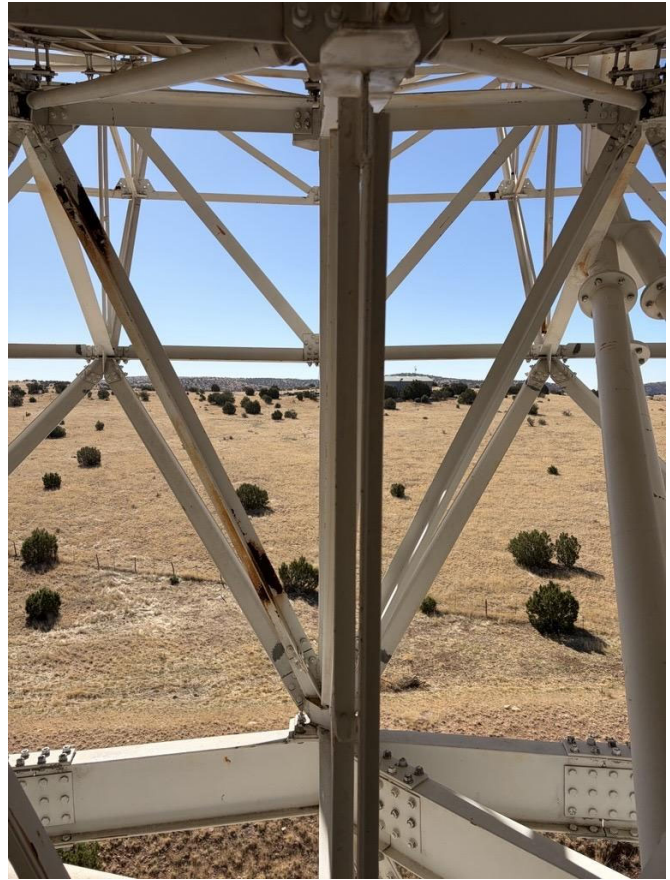
The backup structure is a trussed network supporting the reflector panels, subreflector support structure, elevation bearings and sector gear/counterweight structure. One of the web runners along the circumferential truss revealed surface level rust shown in Figure 37 and at one of the hard joints in Figure 36. It is recommended that during the upcoming repainting of the subreflector that protective paint layers be applied to these areas. This will prevent these support members from worsening if left unprotective.

Figure 36: Truss Joint

Figure 37: Truss members

Prime/Paint web runner (truss)

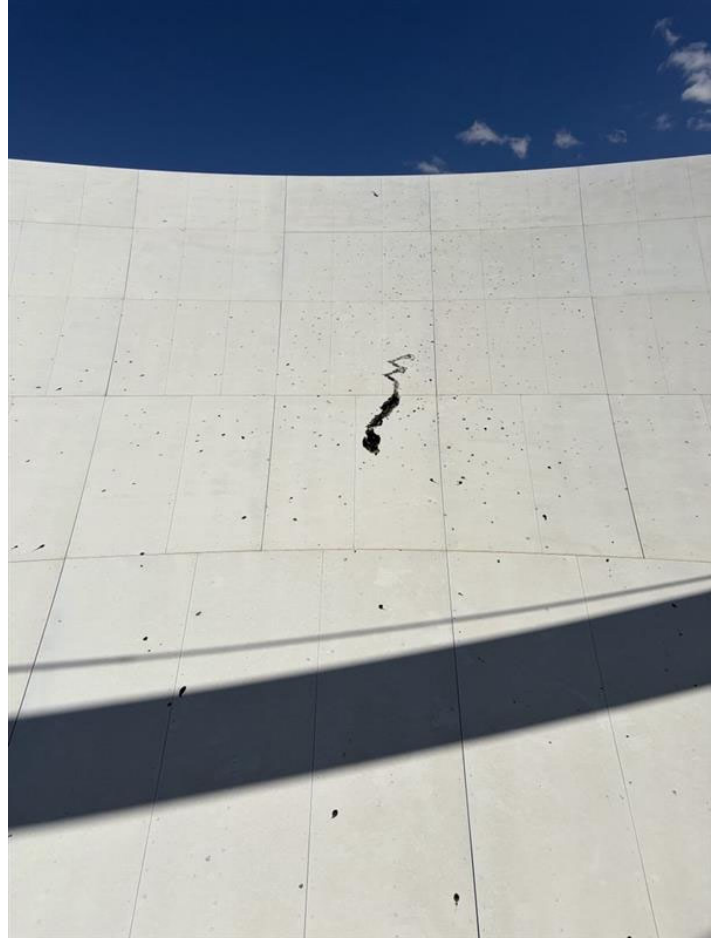
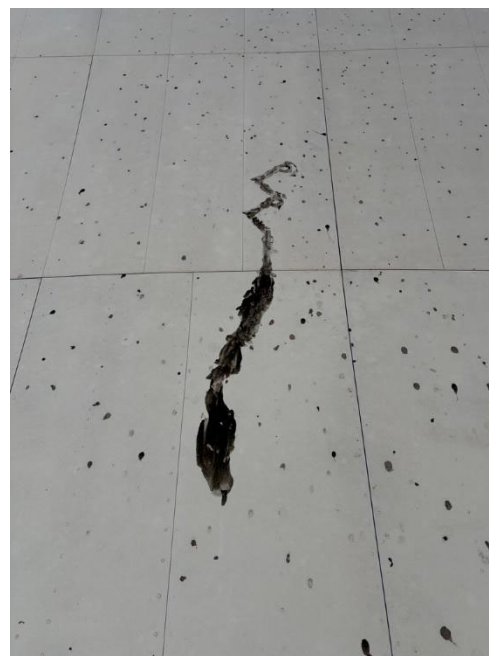
Slightly northeast of the vertex room hatch door, several panels were stained with a hardened black residue seen in Figures 39 and 46. Some components of the feed cone were also found with similar spotting. It was later detected that the FRM bumper material had degraded and leached onto the lower-level structures. Despite minimal staining, the feed cone is well maintained. Though the feed cone is minimally insulated, walls showed no visible problems. Though the feed cone is minimally insulated, walls showed no visible problems, such as cracks and insulation delamination. No actions required

Figure 39: Dish Panels

Figure 46: Panels

Clean stained panels

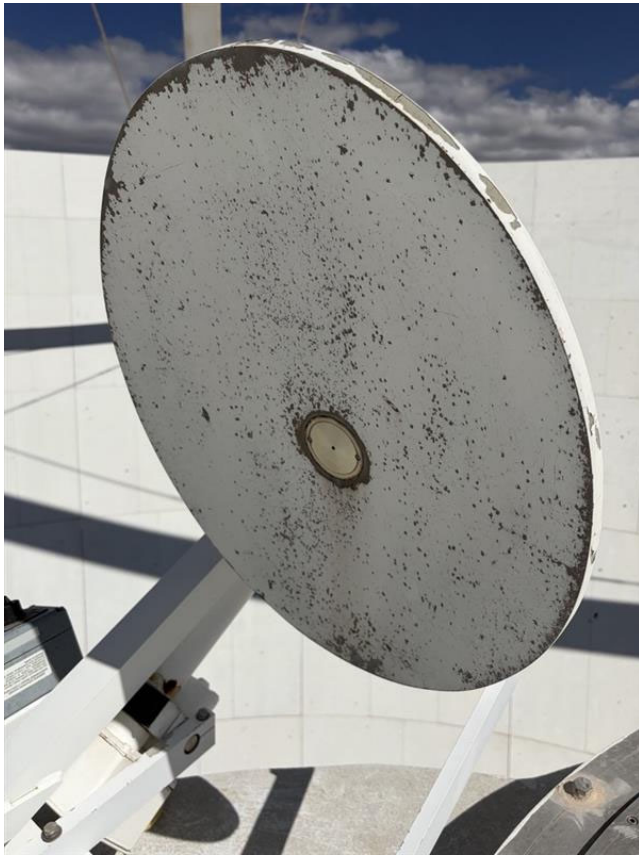
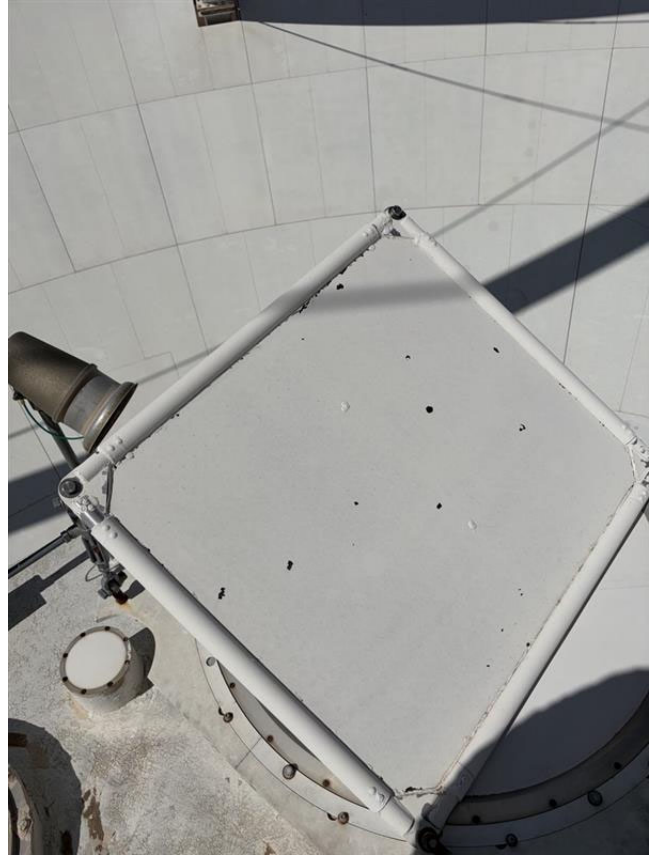
The dichroic panel has sustained better paint adhesion and longevity of the two components of the SX system as shown in Figures 42 and 43. Mounting attachments for each of these structures were securely connected. During the upcoming scheduled maintenance of the subreflector, it will be recommended for both the ellipsoidal reflector and dichroic panel to be painted (Goldstone #7 High Infrared Reflectance Water Based White Topcoat).

Figure 42: Ellipsoid

Figure 43: Dichroic Panel

Repaint ellipsoid and dichroic panel (S-X)

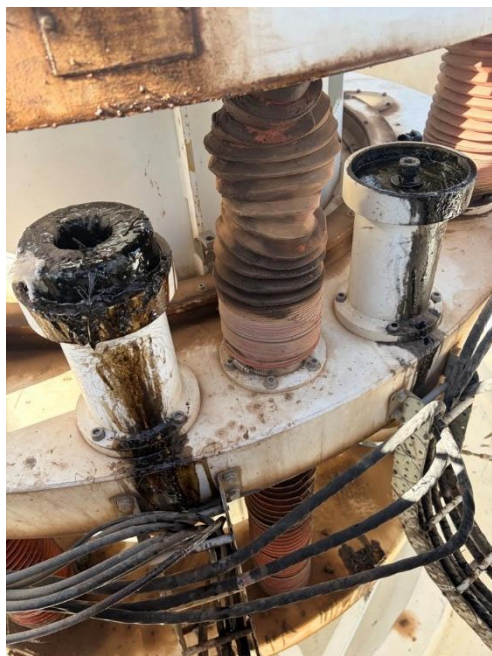
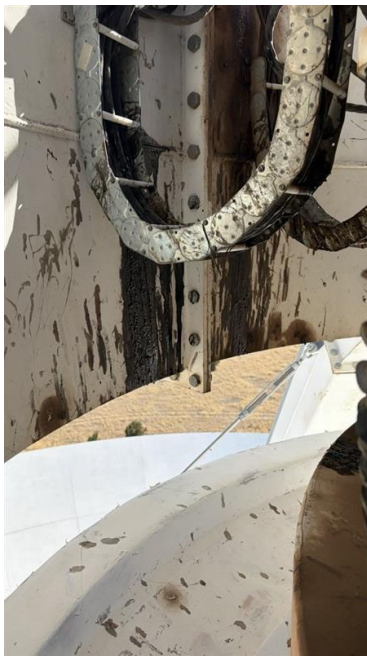
All four FRM rubber bumpers were found to have deteriorated most likely due to excessive heat exposure. The bumper material had melted, and a significant amount of rubber residue had leaked onto portions of the apex structure, cable wraps and onto adjacent main dish panels and feedcone as the antenna moved in elevation. All affected areas should be carefully cleaned. The bulk of the leaked material should first be mechanically removed using non-marring scraping tools, followed by cleanup with a mild solvent confirmed to be compatible with the affected painted and metallic surfaces.

Figure 44: FRM Bumpers

Figure 45: Apex Ring and Cable Track

Because the four rubber bumpers failed in service, replacement took place during the visit, using new bumpers requested by the site techs. Regular inspection during future visits is highly recommended to avoid deterioration of the new bumpers beyond their structural integrity, avoiding another leakage event.

Clean stained apex structure

Clean stained rings

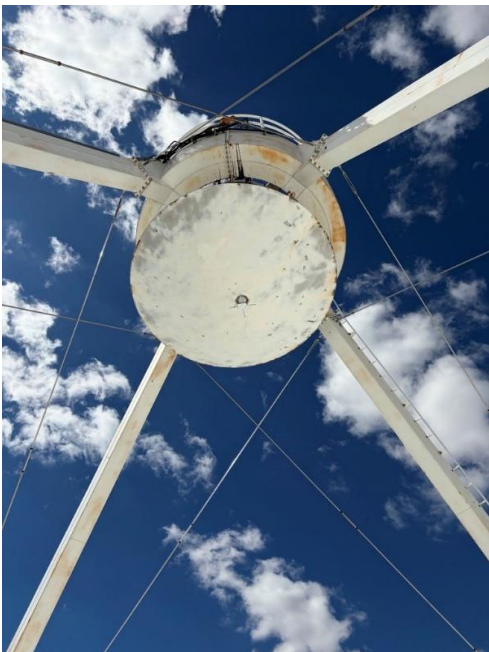
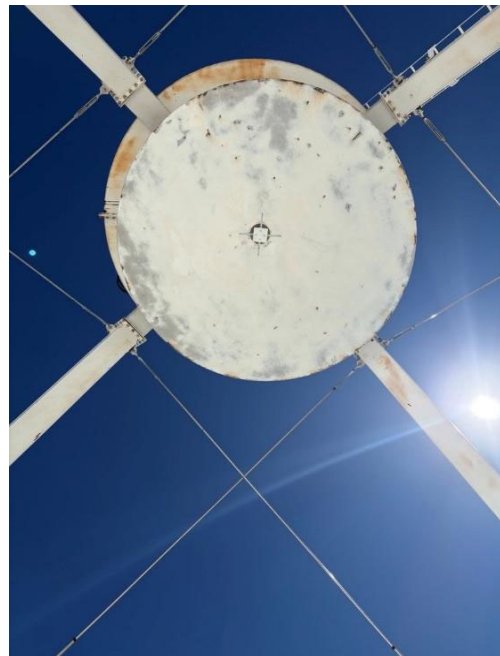
Fading of paint was visible at the subreflector (see Figures 49 and 50). There were moderate amounts of delamination of the topcoat. The subreflector appearance is one of the least affected surfaces with more surface uniformity by comparison to other sites. Preventative measures for the subreflector will include sanding, filling and painting during the next scheduled tiger team. Indexing for the future XKa feed will require retroreflective targets to be placed at the edge of the subreflector (shorter lobe side) and center of the dipole.

Figure 49: Subreflector

Figure 50: Subreflector

Repainting of subreflector

Place targets on subreflector/dipole (indexing)
