1. Trip Summary

An engineering scout trip was conducted at the Brewster, Washington VLBA station on June 10-11, 2026. The engineering inspection was represented by:

This engineering inspection trip report summarizes inspection activities performed at the BR VLBA antenna from June 10-11, 2026 (Figure 1).

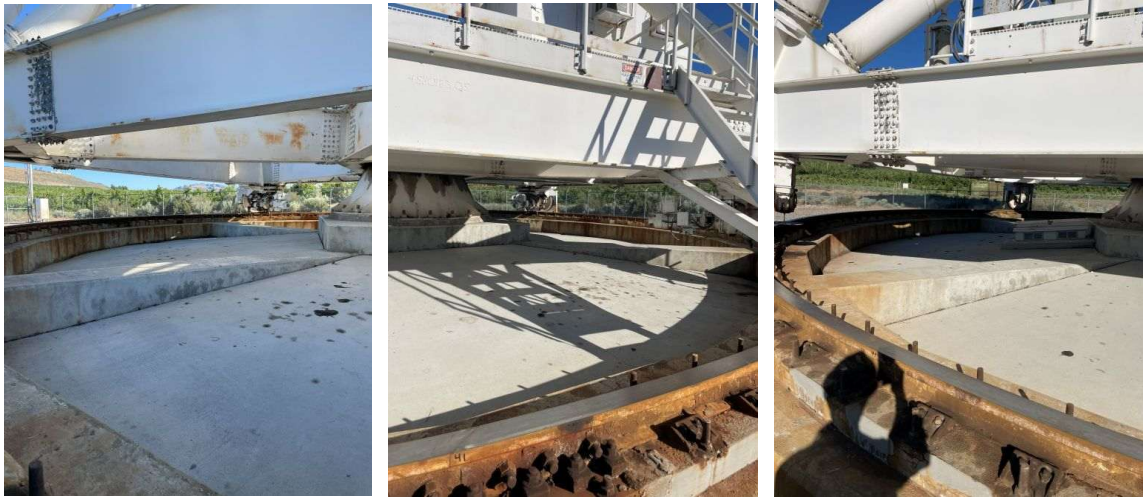
Figure 2: Brewster, WA Concrete Foundation

Overall, the Brewster antenna and site were found to be in good condition. The site landscape was clean and very well maintained, with effective weed control throughout the area. No weeds were observed around the concrete foundation of the pintle bearing room (Figure 2).

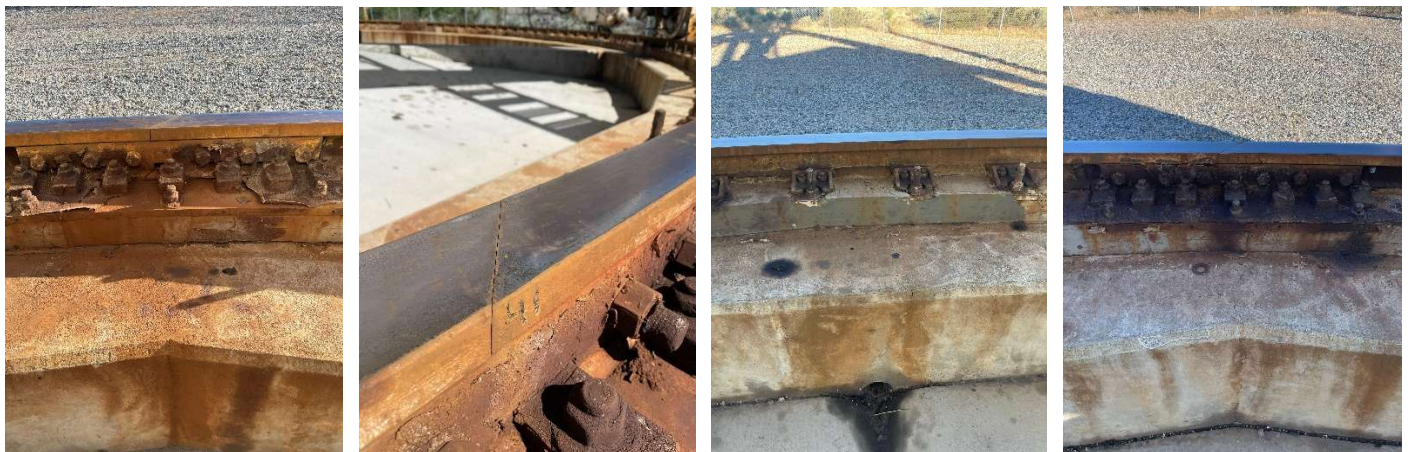
Figure 3: Rail System Condition (Bolt #1, #41, #92 and #101, respectively)

The overall foundation and rail system of the Brewster antenna is in acceptable condition. No major cracks, spalling or visual deterioration between edges and around plates were observed in the concrete rail foundation or grout (Figure 3). All rail clips were found to be of the same type.

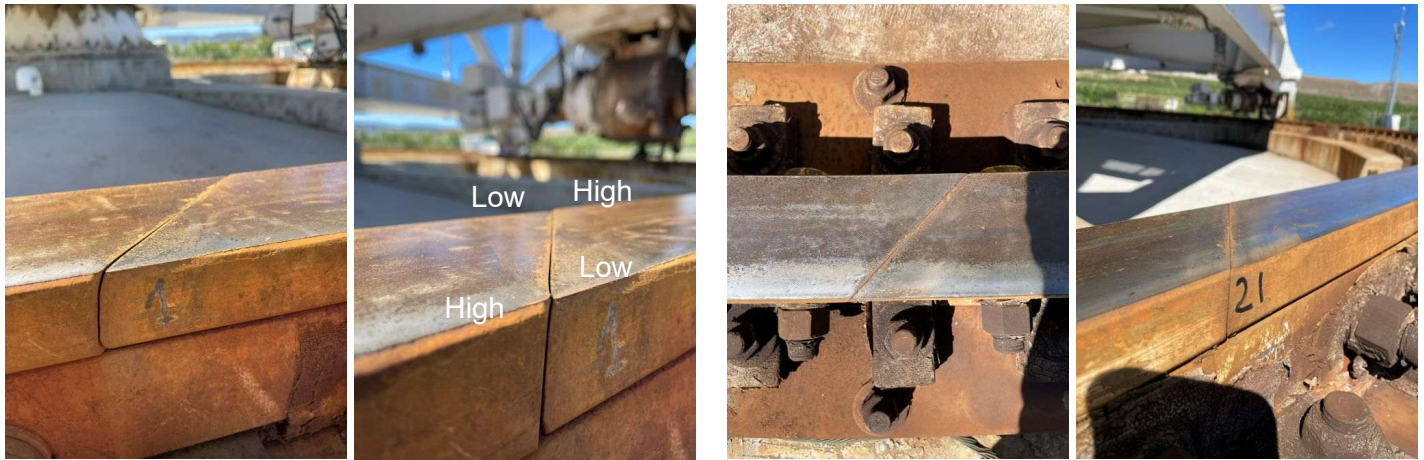
Figure 4: Rail Gaps (Bolt #1 and #21, respectively)

Gaps between rail sections were measured and assessed (Table 1). These gaps are necessary to accommodate thermal expansion and contraction. However, excessively large gaps, as well as the absence of adequate gaps, can potentially lead to running-surface damage, rail creep, or damage to associated components. The maximum gap found was below 1/32 inch, and the rail centerlines were reasonably well matched in elevation (Figure 4, Figure 5, and Figure 6). However, the rail ends were observed to have a slight opposing twist, resulting in slight out-of-level running surfaces, “in” and “out” of the rail ends. Although this condition does not currently indicate a problem, it was documented and will be monitored over time for future assessment.

A dynamic test was also performed by running the antenna across the rail gaps in both clockwise and counterclockwise directions. During this test, the rail ends were observed not only to move vertically as they were loaded and unloaded by the antenna wheels, but also to twist relative to one another as the antenna passed over the gaps. Although it was not possible to measure the vertical motion during this inspection, videos were recorded and will be archived for future reference and comparison.

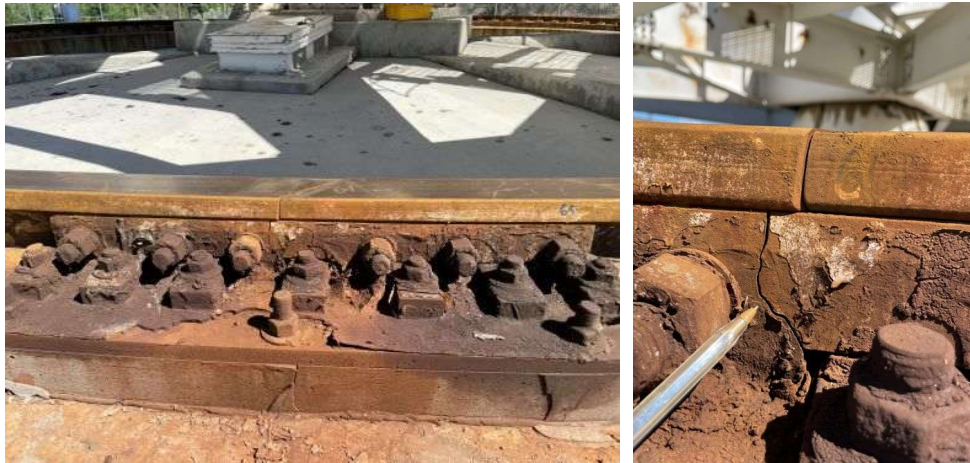
Figure 7: Outer Splice Bar at Bolt #61

Splice joints between rail sections are more prone to failure largely because they are among the weakest areas of the rail system. The inner and outer splice bars were visually inspected at the six intersections around the rail track. Two outer splice bars showed apparent signs of cracking at bolt #61 (Figure 7) and bolt #81 (Figure 8). The crack at bolt #61 was significantly larger than the crack at bolt #81. All splice bars are scheduled to be replaced with new components during this year's upcoming Tiger Team visit. Once the splice bars are removed, it is recommended that the exposed rail ends be inspected by the Tiger Team. Any cracks should be measured and reported to Engineering Services for continued monitoring and assessment.

Replacement of all 12 splice bars (page 5)

Inspect/report rail ends for cracks (page 5)

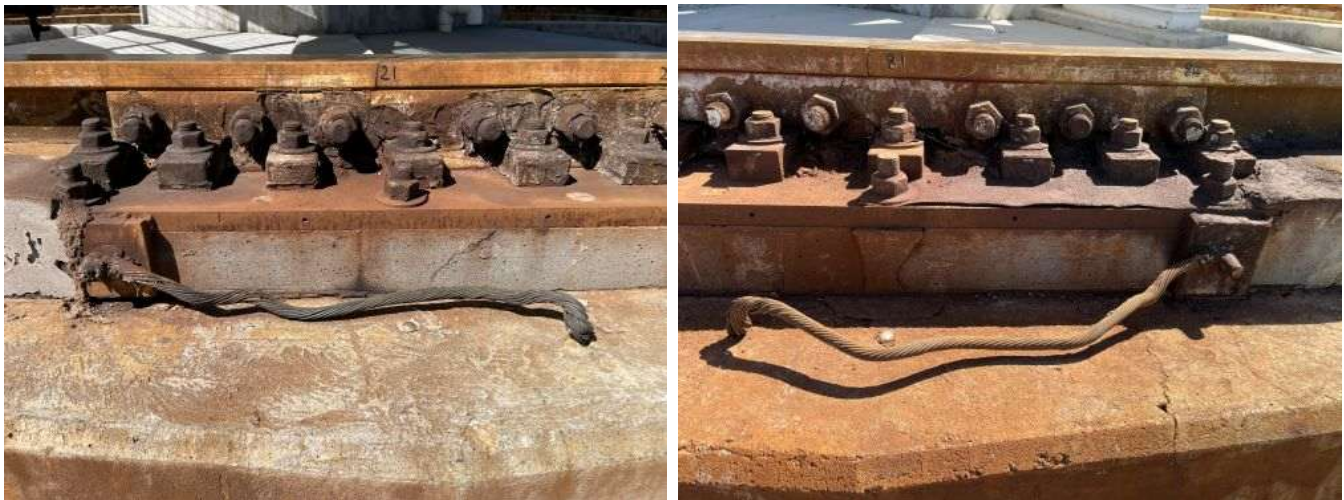
Figure 9: Rail Ground and Grounding Wires

The grounding cables and associated terminations are in good condition as shown in Figure 9, with no visible signs of degradation. These grounding cables are located between bolts #20 and #22, and bolts #80 and #82.

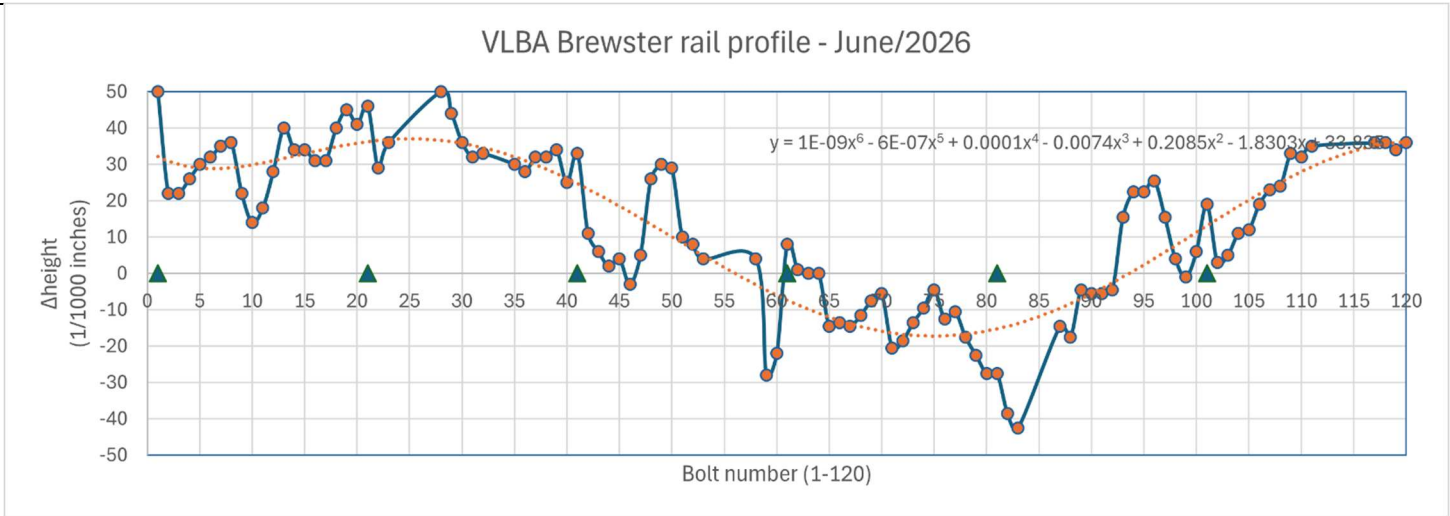
Figure 10: Brewster AZ Rail Elevations

The Brewster rail elevations were measured using a Brunson optical level. Compared with the measurements reported in August 2004 in VLBA Antenna Memo No. 56, the rail profile remains relatively flat. Using the raw data, with no first-order tilt removed, the total elevation variation was less than 0.092 inch (Figure 10). These were static measurements taken with the antenna parked; therefore, no load-related variation from the antenna wheels was present. Measurements were taken from two instrument locations near the Pintle Bearing structure. Four common measurement points were used to combine the two data sets and adjust them to a common elevation reference.

The green triangles along the horizontal axis in Figure 10 identify the bolt numbers corresponding to the rail-section intersections. The orange dotted line represents the best-fit polynomial trendline for the measured data. Bolt numbers with no associated measurements identify locations where the view was obstructed by the drive wheels or idler wheels.

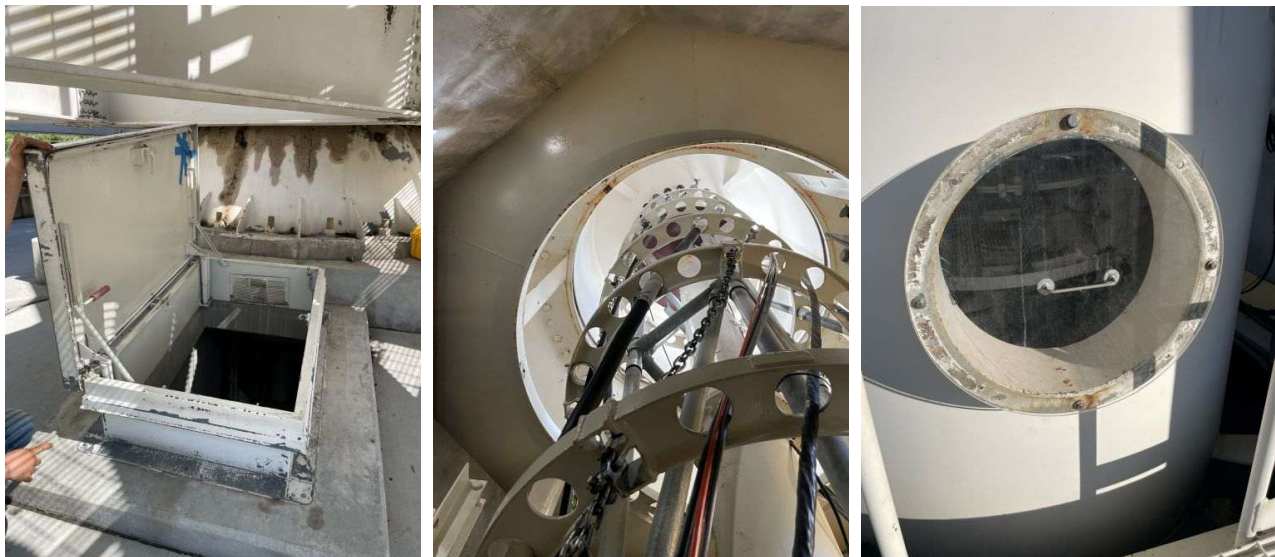
Figure 11: Pintle Bearing Room Access Hatch, Cable Wrap and Port Hole

The pintle bearing room was found to be in good overall condition, externally and internally (Figure 11). No signs of water infiltration or condensation were observed. Only a few minor drops of grease were observed at the pit bottom. The site techs were advised to clean the inner grease gutter whenever grease accumulates in one area, as this could eventually lead to leakage into the bottom of the pit, as well as the cable wrap brackets.

The porthole to the Pintle Bearing Room was inspected and found to be in good condition (Figure 11). However, the plexiglass cover does not currently have a weather seal. Minor superficial rust was observed at the flange interface, suggesting that water may be entering through this area.

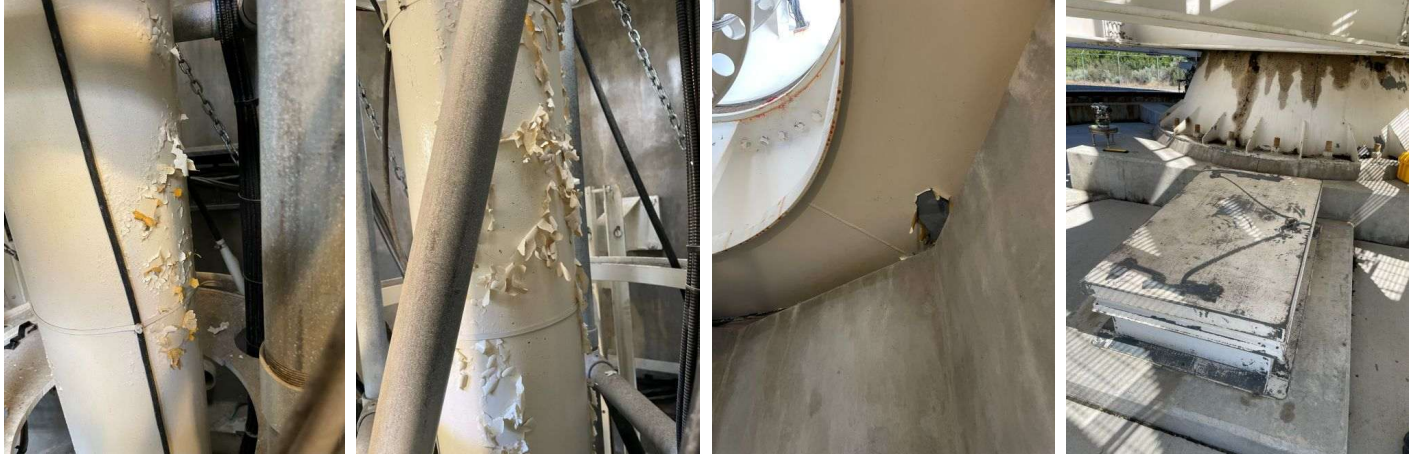
Figure 12: Pintle Bearing Room Access Hatch, Cable Wrap and Port Hole

Paint spalling was observed at several locations inside the Pintle Bearing Room (Figure 12). These areas will require cleaning and may need to be repainted during this year's upcoming Tiger Team visit (time permitting).

Paint spalling cleaning and repainting (page 8)

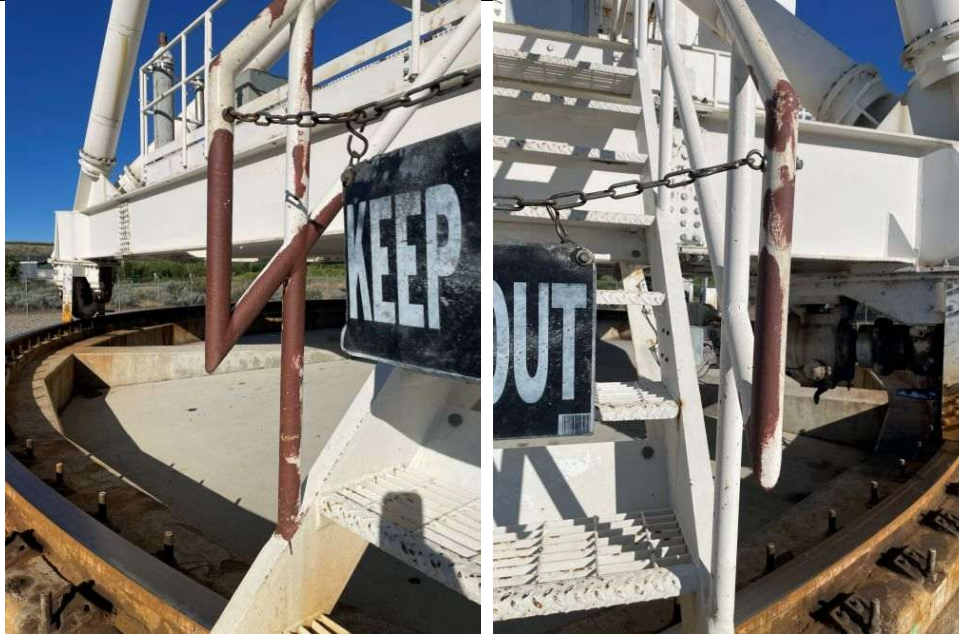
Figure 13: Pedestal Platform - Stairs Handrail

Rust-Oleum primer was applied at a few locations near the pedestal platform (Figure 13). It is recommended that these areas be properly painted during this year's upcoming Tiger Team visit.

Paint areas with rust-oleum and rust (page 8)

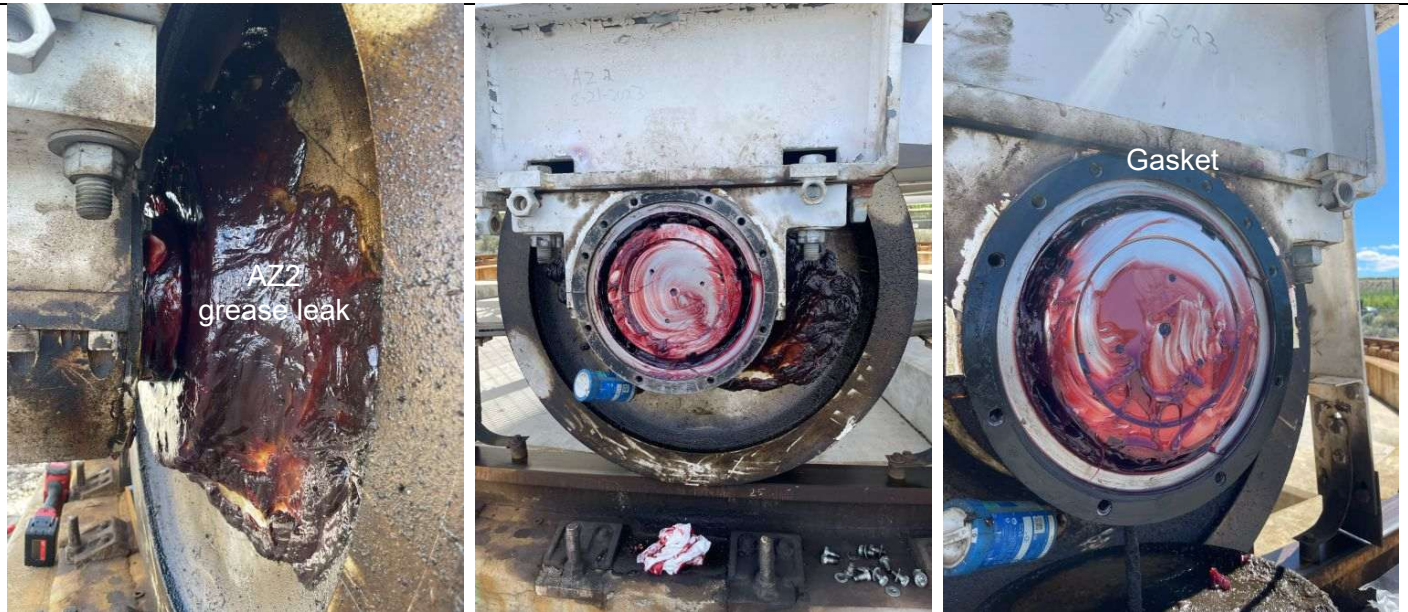
Figure 14: AZ2 drive wheel - bearing leaking, cover removed, and outer rubber gasket installed

The outer bearing of the AZ2 drive wheel leaks grease toward the inner side, possibly due to a damaged seal (Figure 14). This condition appears to be diverting grease away from the outer side of the bearing, reducing lubrication effectiveness and raising concern about the bearing's condition. The issue was observed after the grease cover was removed for inspection. Further inspection is recommended during this year's upcoming Tiger Team visit, along with replacement of the seal on the inner side, as needed. A rubber gasket was permanently installed on the outer side of both AZ drive wheel bearings (Figure 14).

Fix outer bearing leakage of AZ2 drive wheel (new gasket) (page 9)

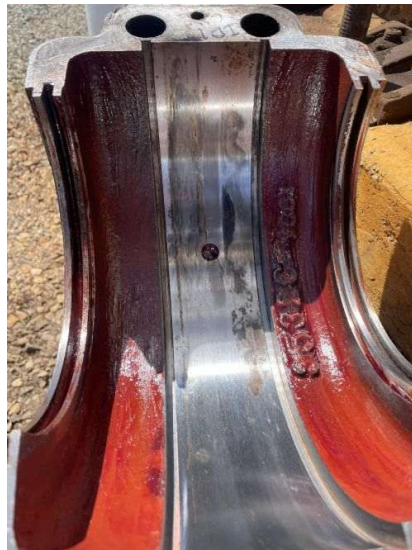
Figure 15: AZ1 idler wheel split pillow block

On the outer bearing of the AZ1 idler wheel, very little grease was observed between the roller elements and the outer race after the split pillow block was removed. Minor scratches and evidence of light grinding were also observed on the split pillow block and on the outer surface of the bearing (Figure 15). Further investigation and assessment are recommended during this year's upcoming Tiger Team visit. One possible cause is a restriction or blockage in the grease passage between the grease fitting and the roller bearing.

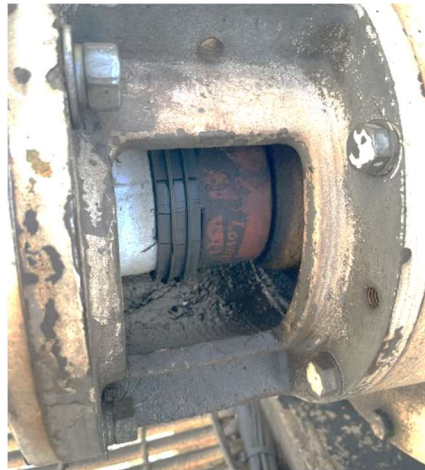
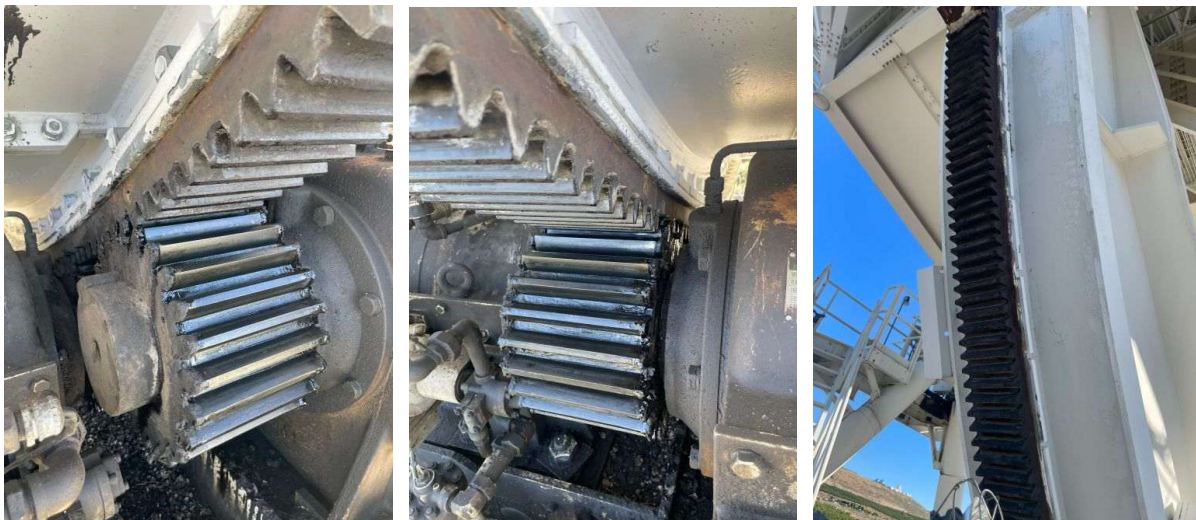
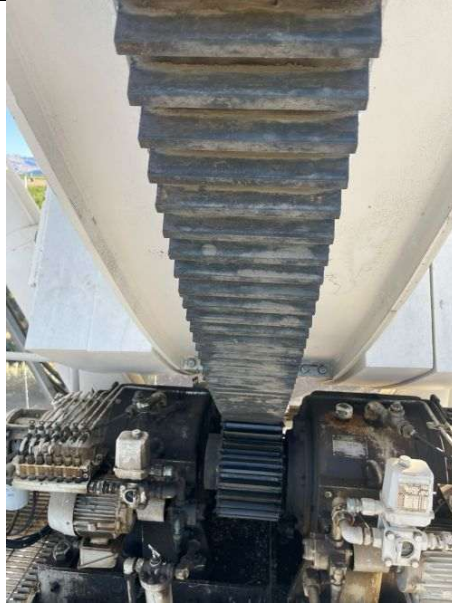
Open-gear grease is used to lubricate the sector (bull gear) and pinion gears (Figure 17). SilverStreak Multi-Lube from Schaeffer's is currently being used at the Brewster site and appears to adhere well to the gear surfaces without running off. No signs of abnormal wear, misalignment, or unusual noise were observed in these components. A few external drivetrain components would benefit from cleaning and repainting during this year's upcoming Tiger Team visit (Figure 16 and Figure 18).

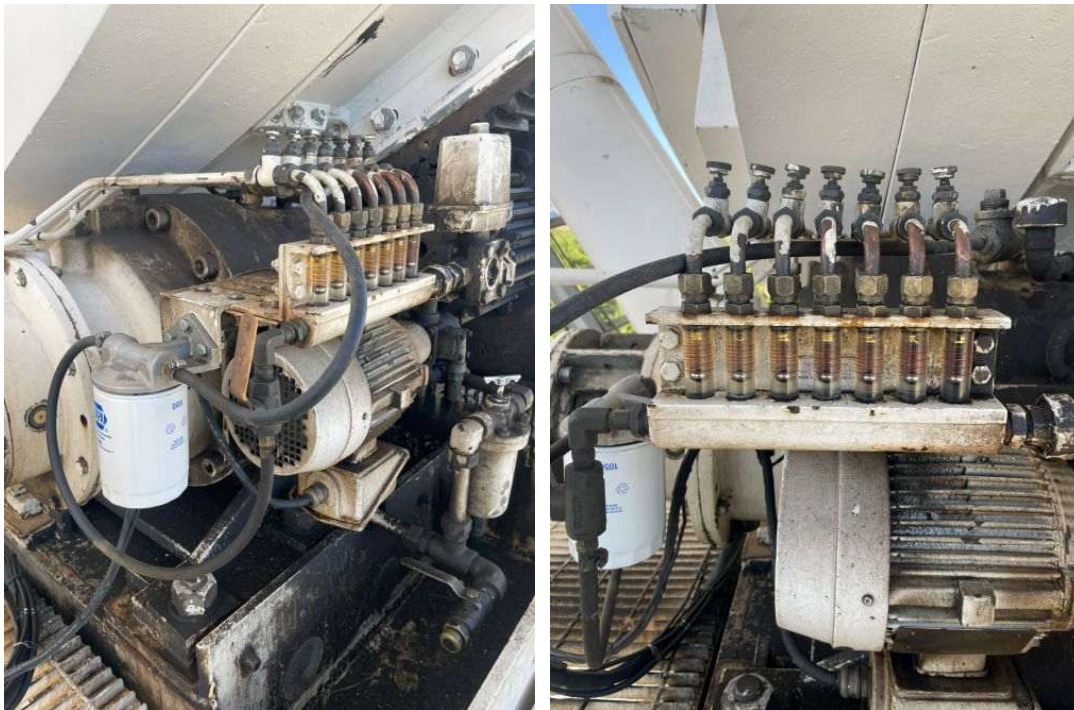
Figure 19: Elevation Drive EL1 Bypass Hose Lines and Filter Lines

The bypass filtration system for the EL gearboxes, including the nitrile/neoprene hose lines, was inspected and appears to be in good condition (Figure 19 and Figure 20). No hose cracking or history of frequent hose replacement was reported.

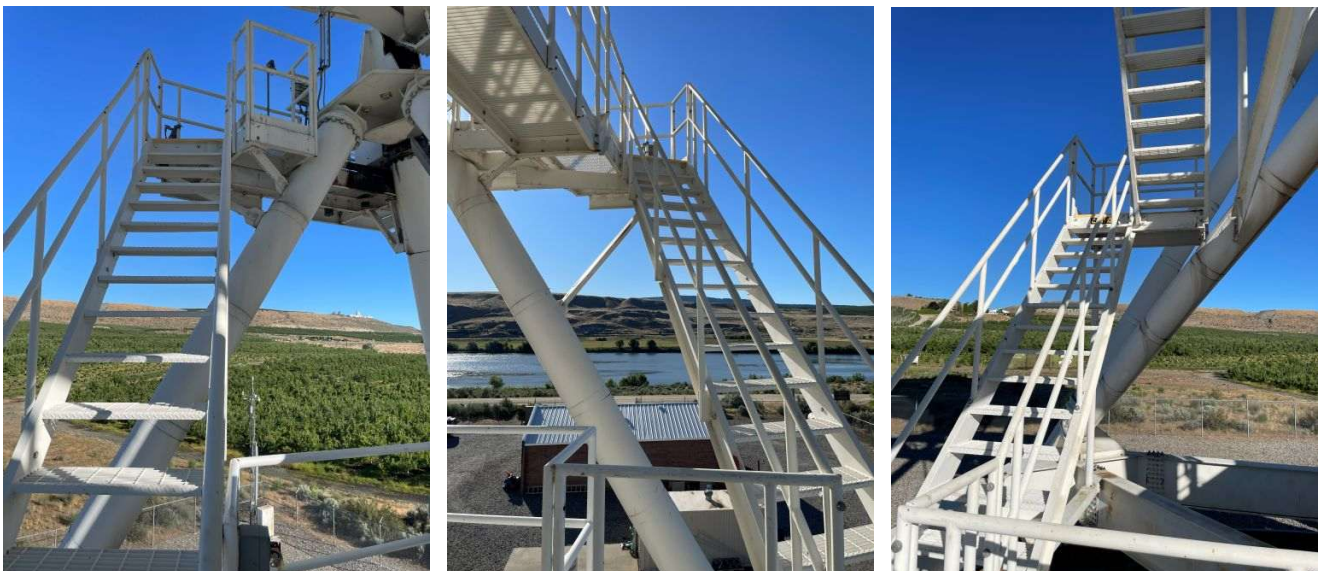
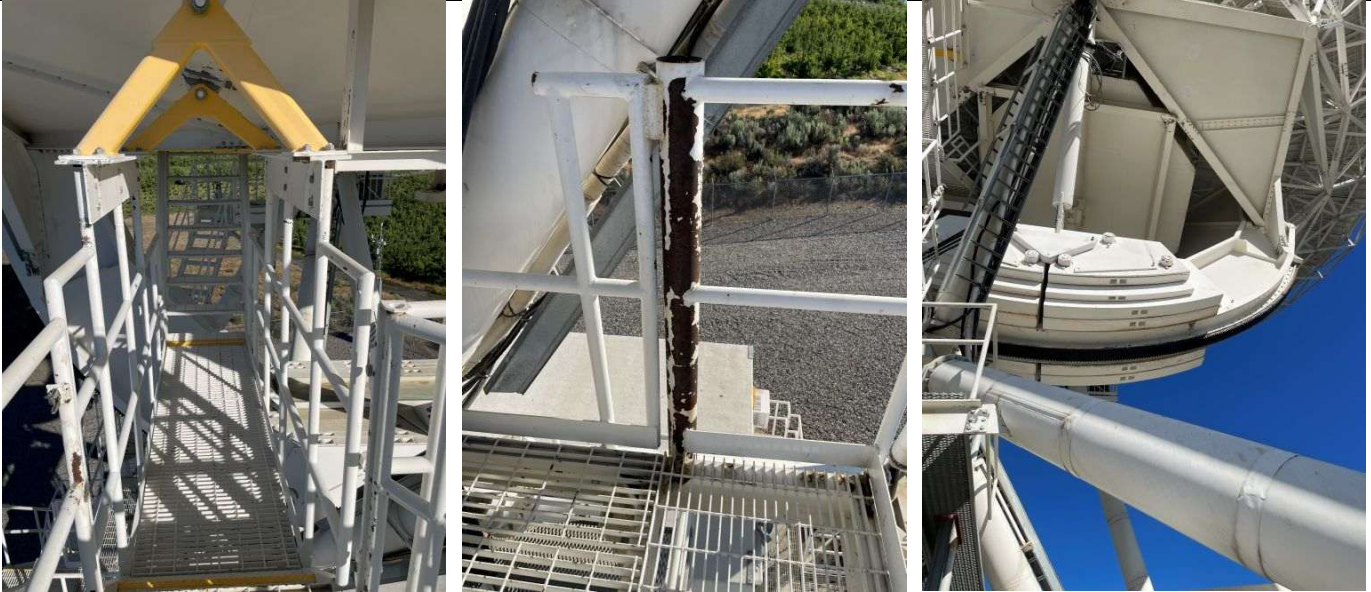
Except for very minor areas of surface rust, the structural components associated with the elevation and yoke platforms were found to be in good condition. This includes platforms/gratings, stairways, counterweight, backup structure, and associated fasteners (Figure 21 and Figure 22). No significant signs of structural deformation, cracking, loose members, or advanced corrosion were observed during the visual inspection. It is recommended that some of these areas with rust be painted during this year's upcoming Tiger Team visit.

Clean and repaint minor rusted areas (page 13)

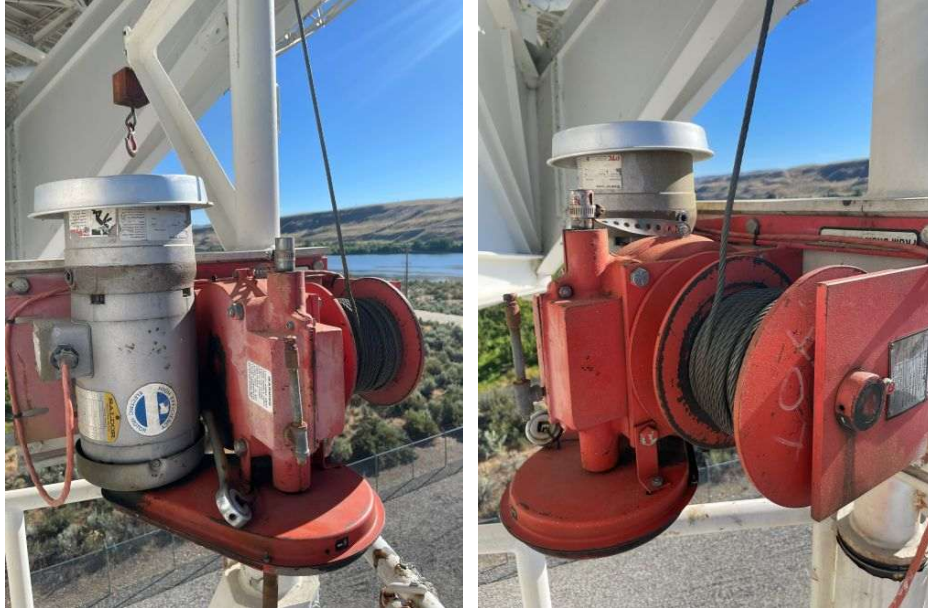
Figure 23: Jib Crane on the Elevation Encoder Deck

The jib crane appears to be the original unit and is in good overall condition (Figure 23). However, given its age, it is recommended that the cable be replaced with a new one as a preventive maintenance measure.

Replace jib crane steel cable (page 14)

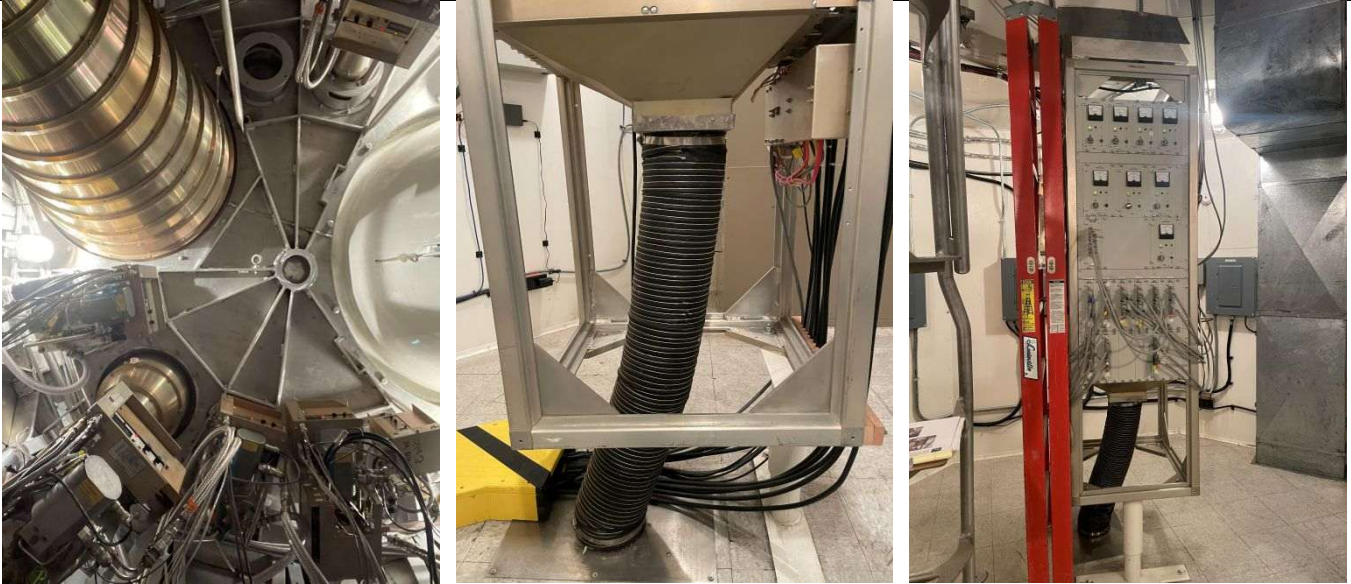
Figure 24: Views of Vertex Room

The vertex room has been well-maintained with no concerns identified (Figure 24).

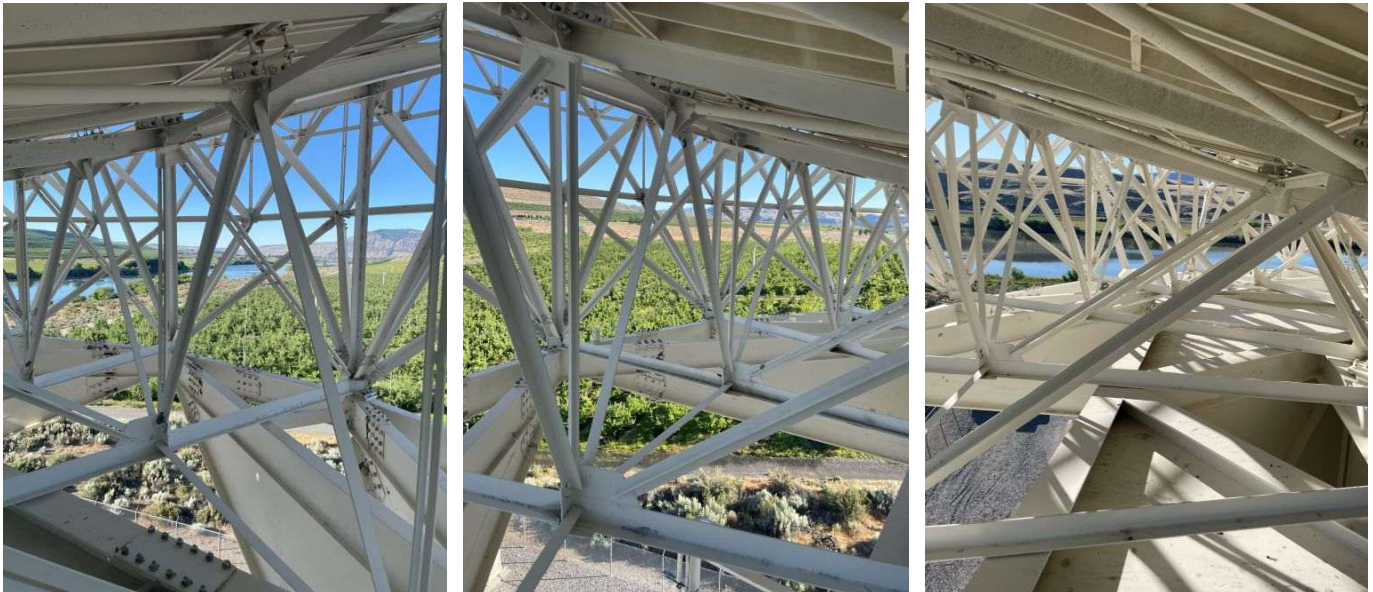
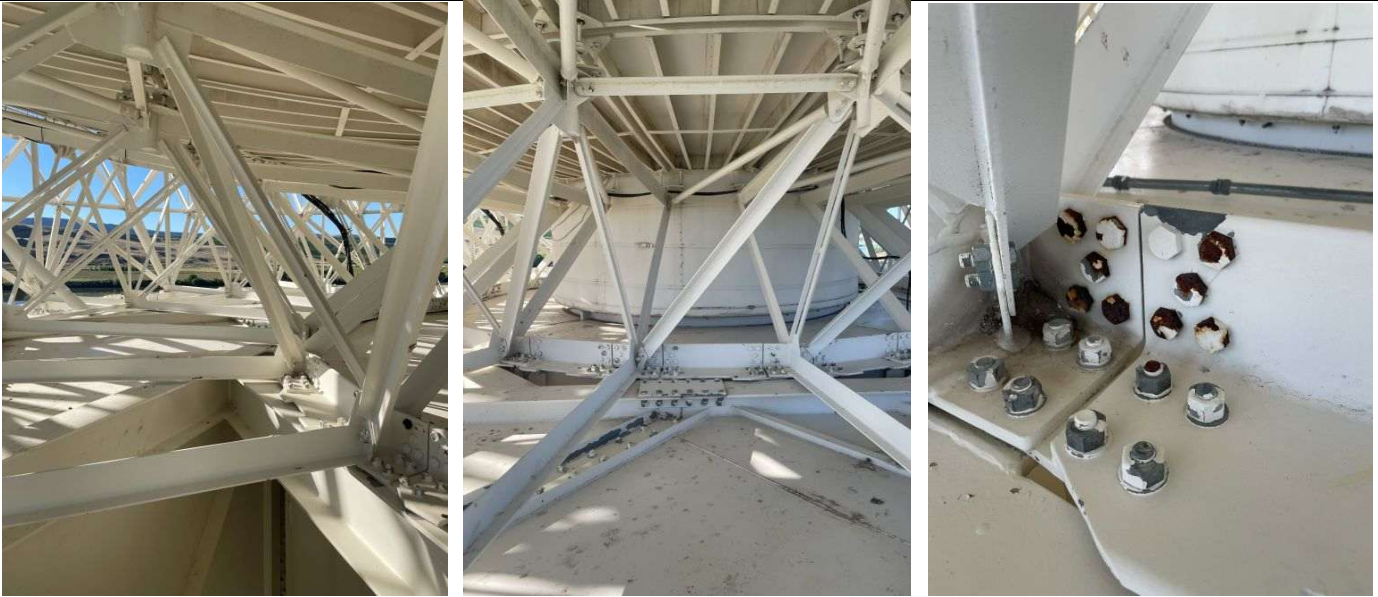
The main-dish backup structure is a trussed network that supports the reflector panels, subreflector support structure, elevation bearings, and the sector gear/counterweight structure. No significant corrosion requiring paint remediation was identified (Figure 25 and Figure 26). Only a few minor rust spots and affected fasteners were observed. It is recommended that these areas receive protective paint coatings during this year's upcoming Tiger Team visit.

Paint minor rusted areas of backup structure (page 15)

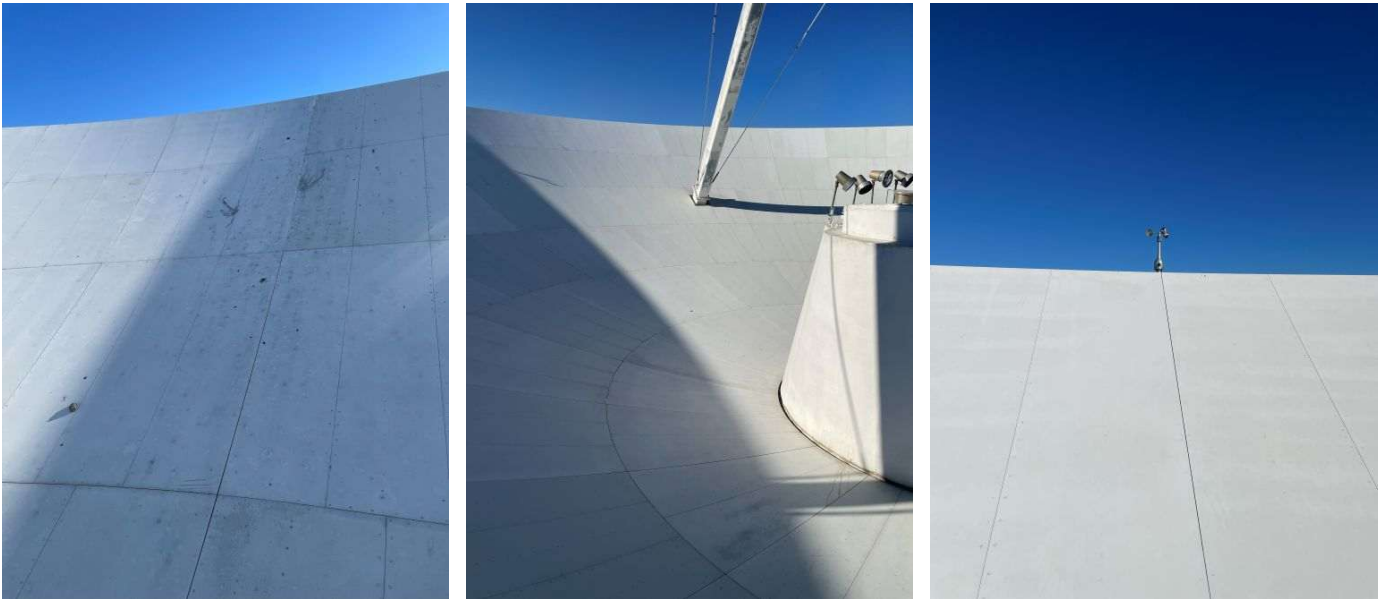
Figure 27: Main Dish Panels Top Surface

The dish panels were visually inspected and found to be in good condition, with no apparent issues in alignment or mating between adjacent panels (Figure 27). Minor cleaning of the top surfaces can be performed during this year's upcoming Tiger Team visit (time permitting).

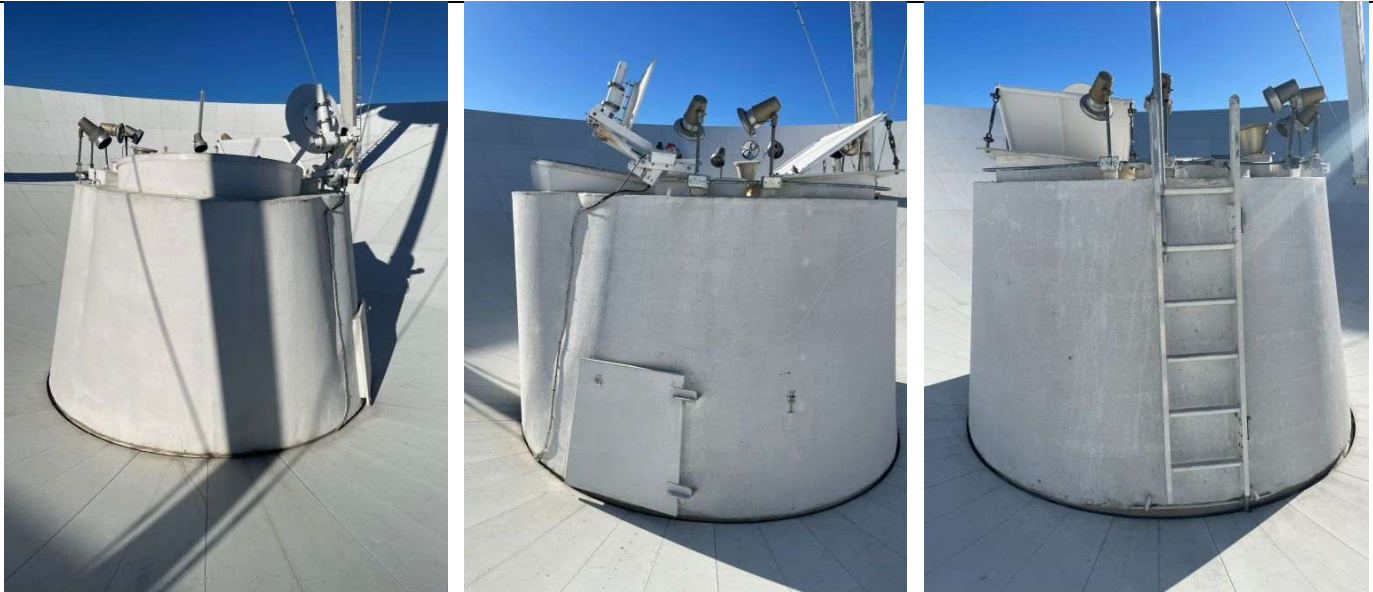
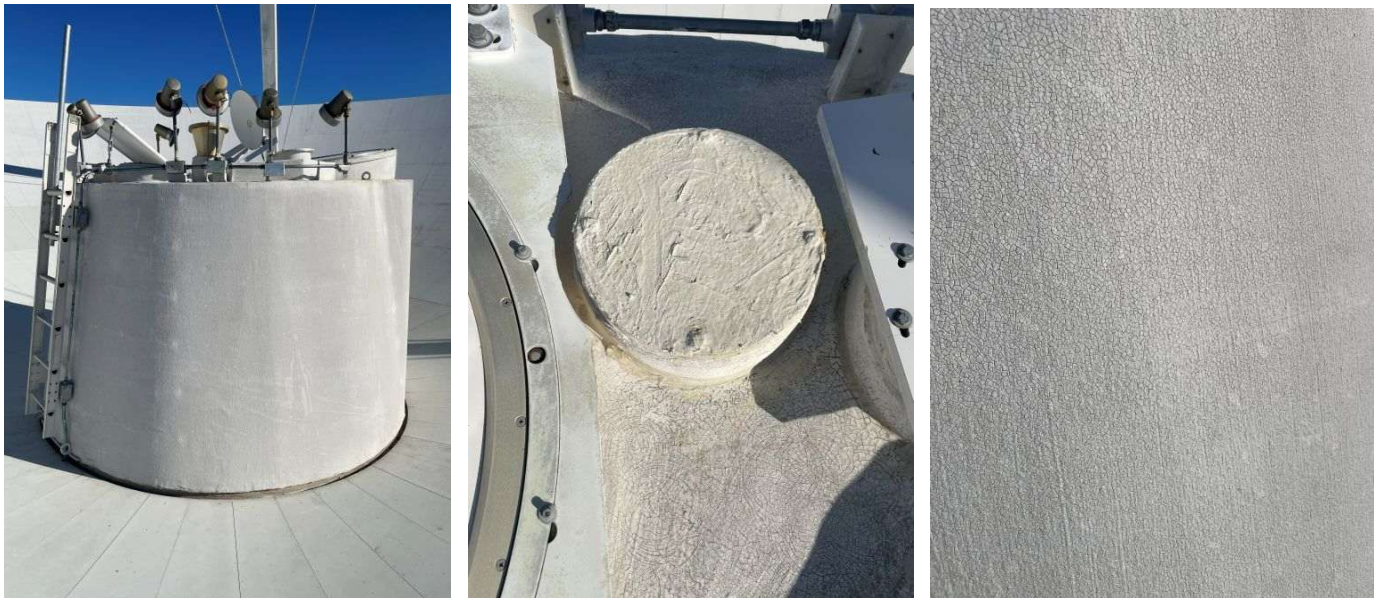
The feed cone was found to be very well maintained, with no visible cracks, insulation delamination, or accentuated discoloration of the textured surface (Figure 28 and Figure 29). All feed-heaters are in good condition. No action is required at this time.

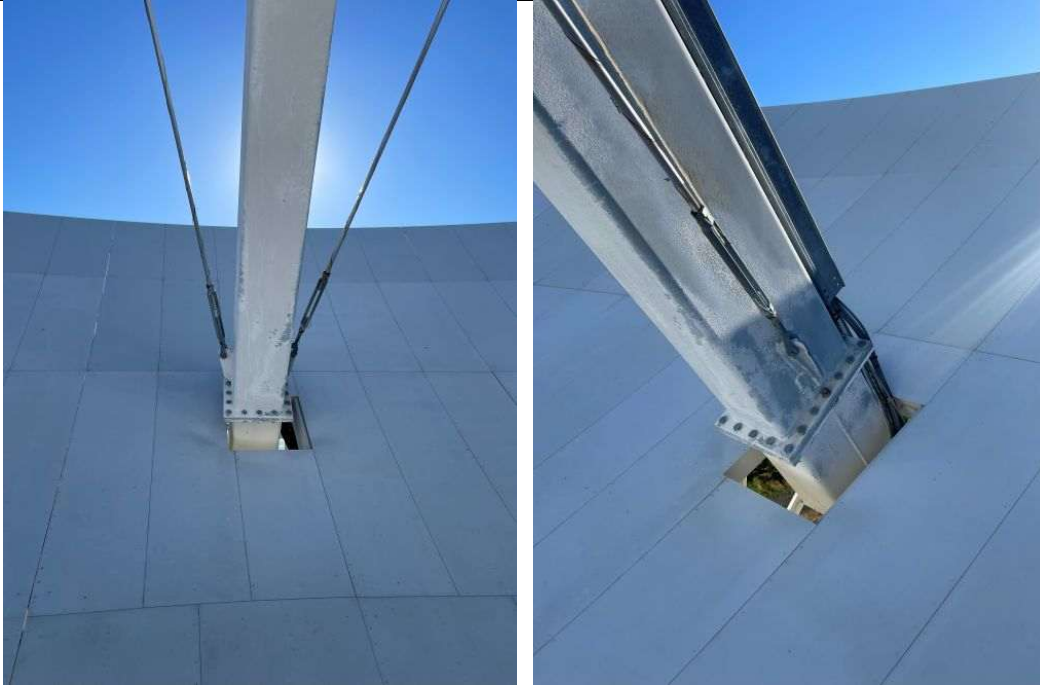
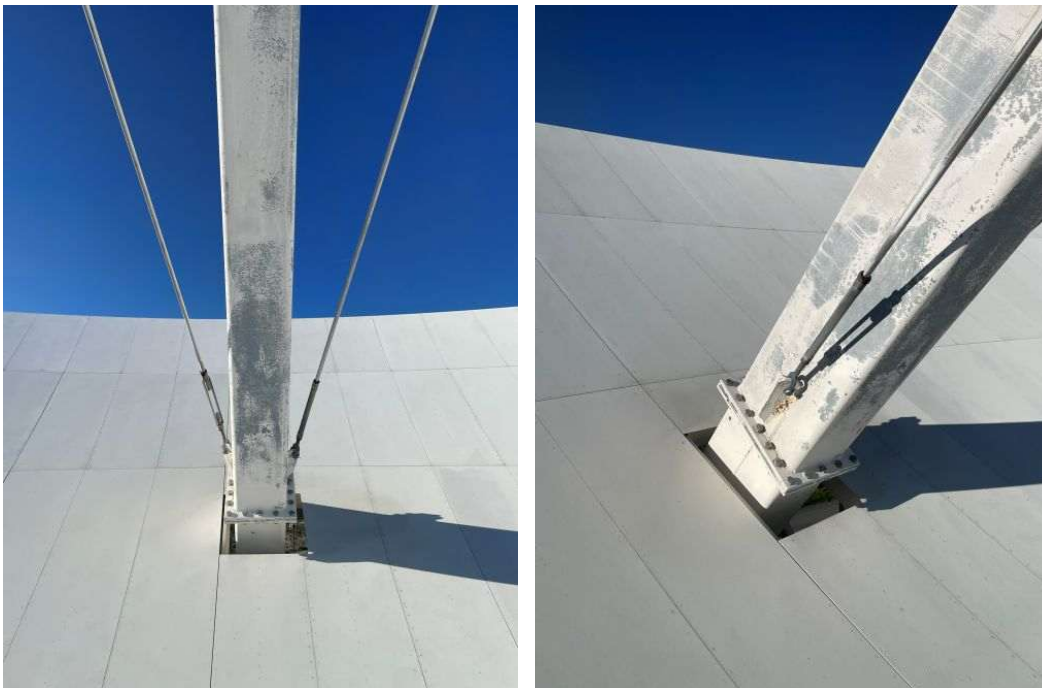
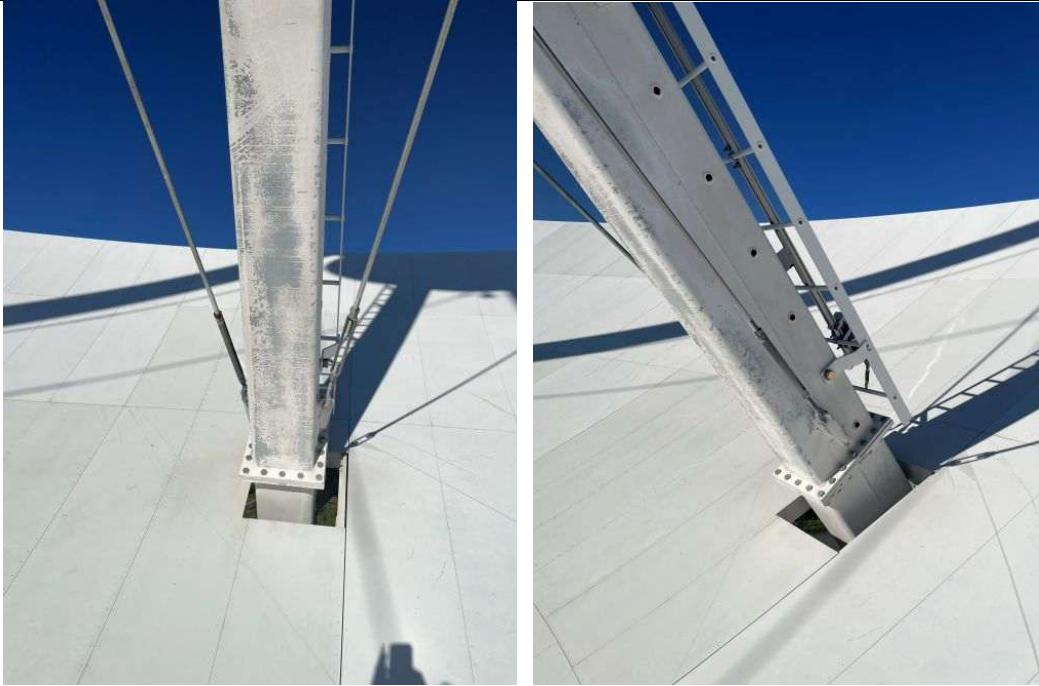
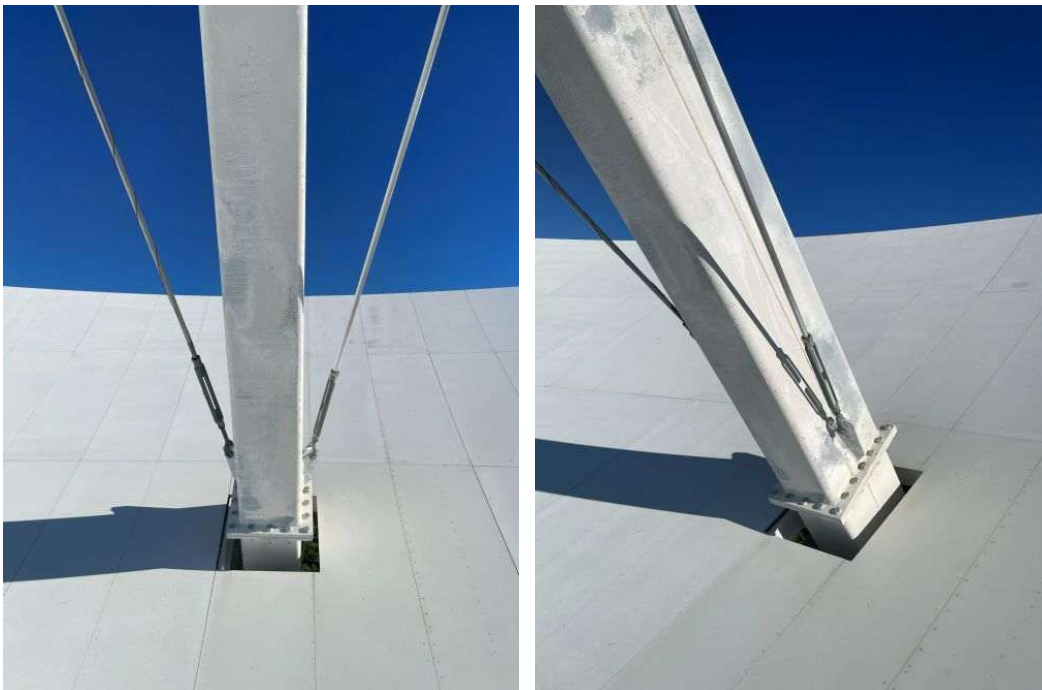
Two torsion-rod assemblies are attached to each of the four Apex Quad-Legs, providing a stiff load path for the guywire system. No significant sag was observed in any of the guy wires (Figure 30, Figure 31, Figure 32 and Figure 33). The painted surfaces appear generally with good overall coverage. However, localized areas of uneven finish and light discoloration were observed on structural members from the main-dish area up to the apex. These areas do not appear to show any corrosion or coating failure, but they should be cleaned and monitored. During the next planned painting work, localized surface touch-up coating would improve appearance and provide continued protection.

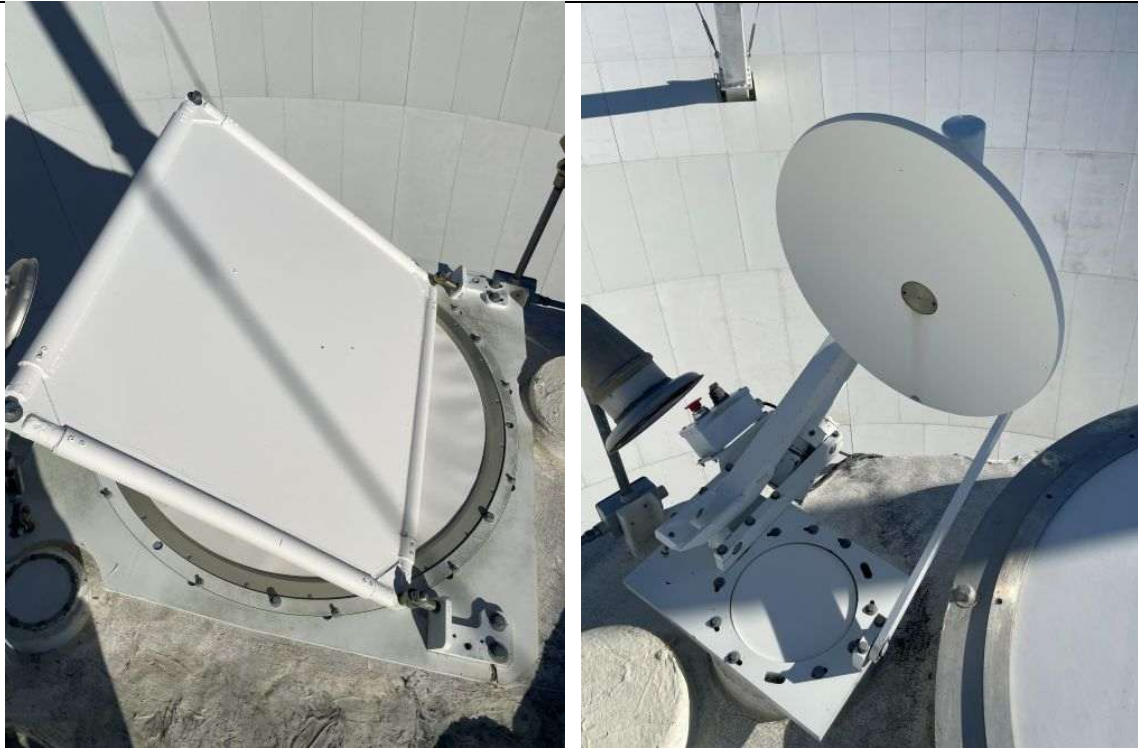
Figure 33: Dichroic Panel and Ellipsoidal Reflector

The dichroic panel and the ellipsoidal reflector were inspected and found to be in good condition (Figure 34). The associated support and attachment hardware also appear to be in good condition.
