1. Trip Summary

An engineering scout trip was conducted at the Brewster, Washington VLBA station on June 10-11, 2026. The engineering inspection was represented by:

This engineering inspection trip report summarizes inspection activities performed at the BR VLBA antenna from June 10-11, 2026 (Figure 1).

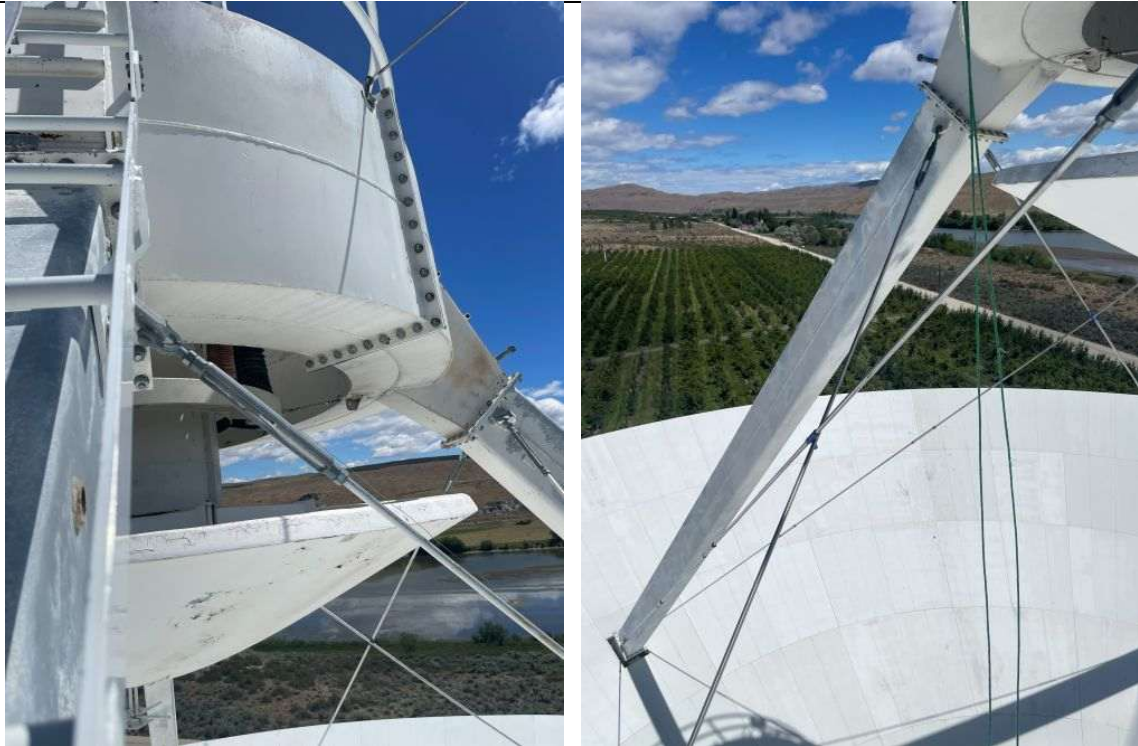
Figure 34: Apex Structural Assembly

The apex structural assembly was thoroughly inspected and was found to be in good condition (Figure 34). No significant corrosion, distortion, cracking, or other signs of structural degradation were observed. Surface condition was generally good, with no visible issues affecting the integrity of the assembly.

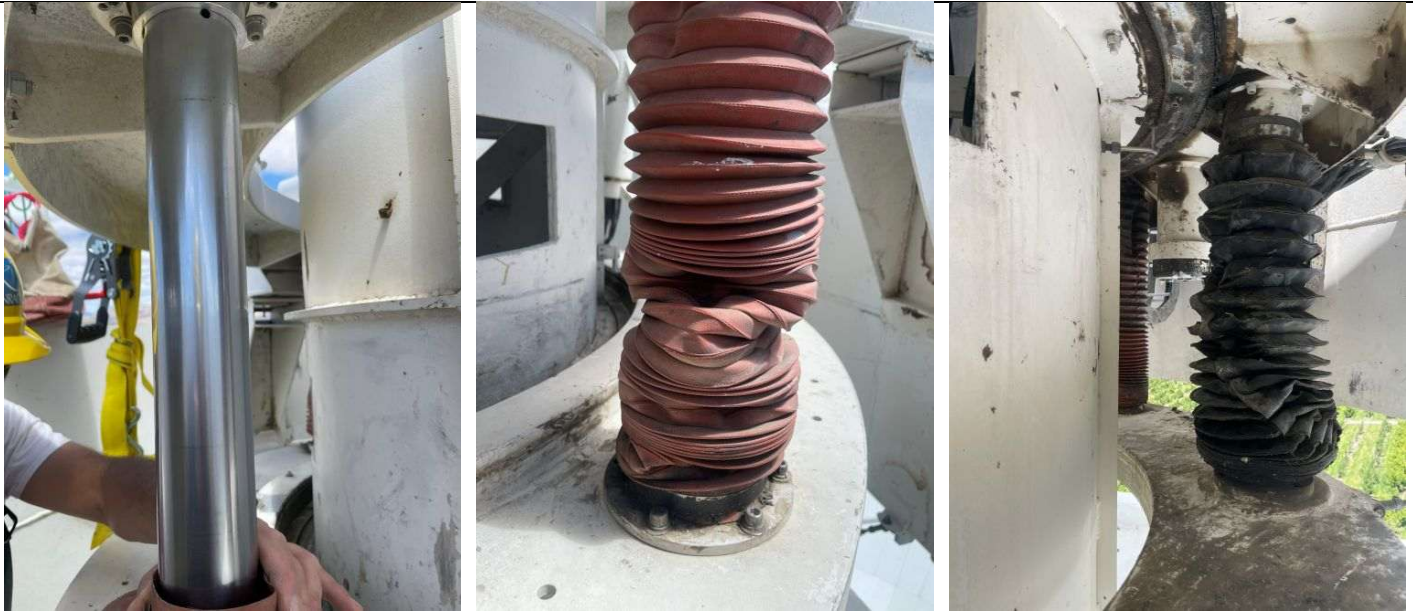
Figure 36: FRM Linear Shaft and Dust Cover Bellow

Two of the four FRM linear-shaft bellows were opened to allow visual inspection of the enclosed linear-shaft surfaces (Figure 36). The shafts were found to be in good condition, with no significant dents, scratches, scoring, or other visible damage. Lubrication also appeared adequate on the inspected shafts. A few orange and black bellows are in poor condition and should be considered for replacement during this year's upcoming Tiger Team visit to provide continued protection for the FRM internal components.

Replace deteriorated red/black bellows (page 20)

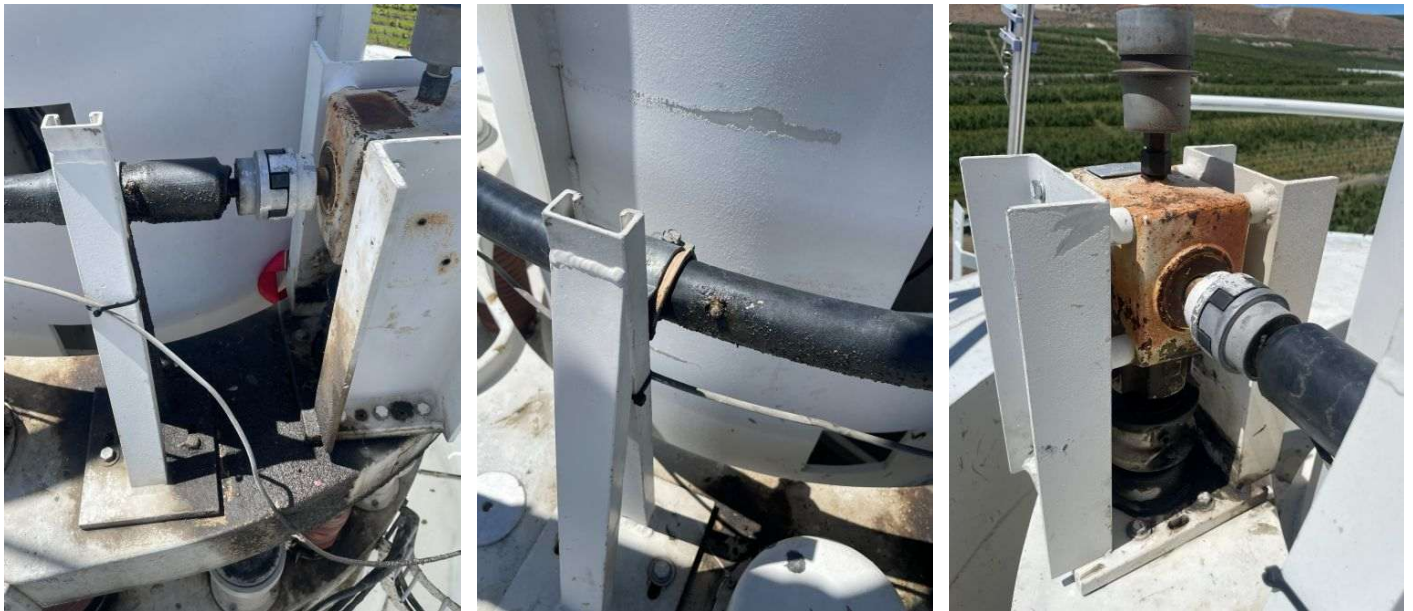
Figure 37: FRM Flex Drive

The FRM flex drive shaft was also inspected and found to be in good condition, with no visible signs of wear. There are some initial signs of leaking that should be monitored and reported (Figure 37).

Inspect/report FRM flex drive shaft for leaks (page 22)

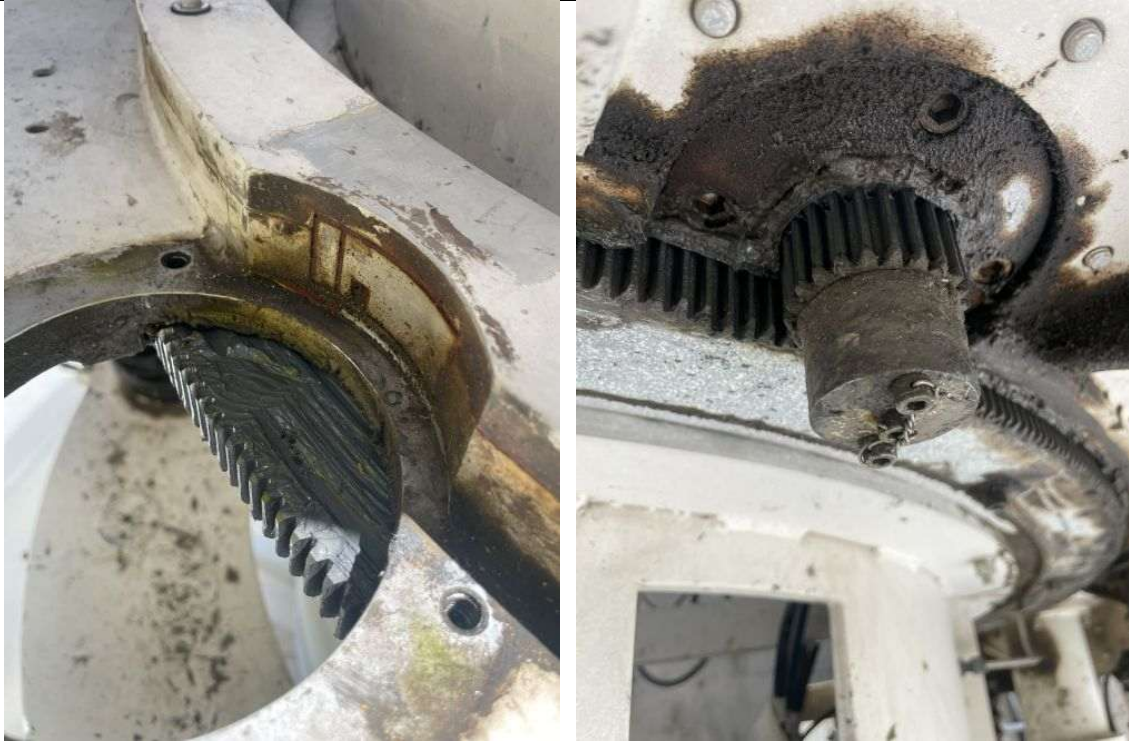
Figure 38: FRM Rotation Gear Ring and Pinion

Actions were taken to better understand and assess the FRM rotation issue reported in WO-27786, “BR rotation not getting to position.” This included a thorough discussion with the site techs and the development of a proposed set of mechanical inspections for the FRM. The gear ring and pinion were inspected and showed no signs of wear or damaged teeth (Figure 38).

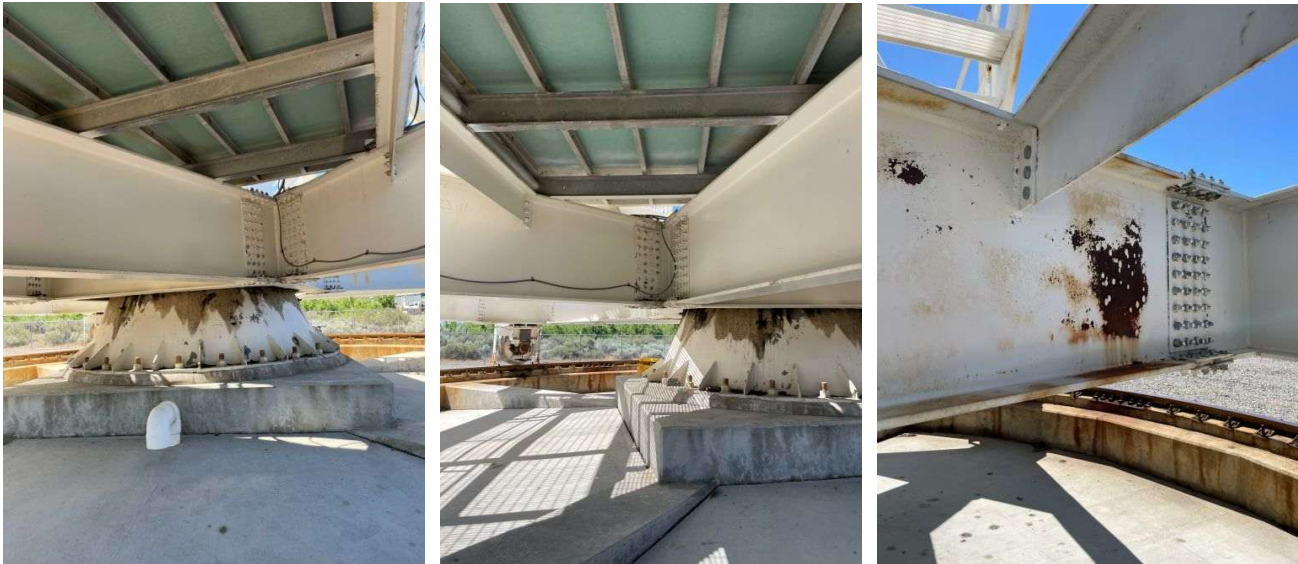
Figure 39: Lower Structure

The Lower Structure was visually inspected and appears to be in good condition overall, aside from minor areas with corrosion, paint failure and paint spalling (Figure 39). It is recommended that these areas be repainted during this year's upcoming Tiger Team visit. Also, a few fasteners on the Lower Structure are rusted, with corrosion present on some bolt heads and on some nuts only (Figure 40). They appear to be #3/4-20 hex-head bolts, approximately 3 inches long. It is recommended that these fasteners are replaced with galvanized fasteners during the upcoming Tiger Team visit. An updated count of fasteners needed can be requested, if required.

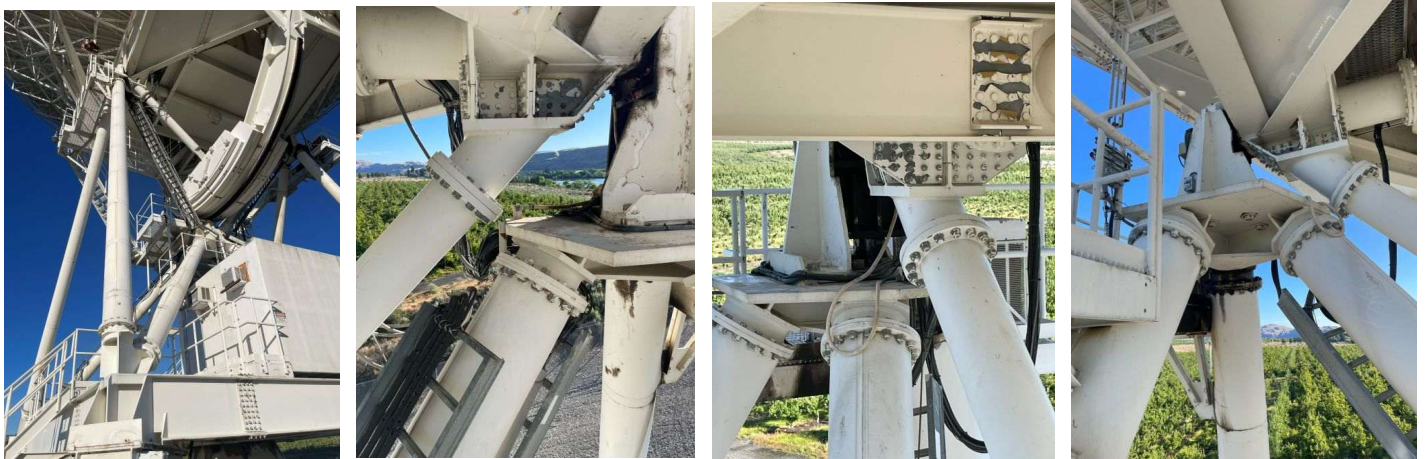
Figure 41: Quadrapod Support and Adjacent Structure

The Quadrapod Support Structure was also visually inspected and appears to be in good condition (Figure 41).

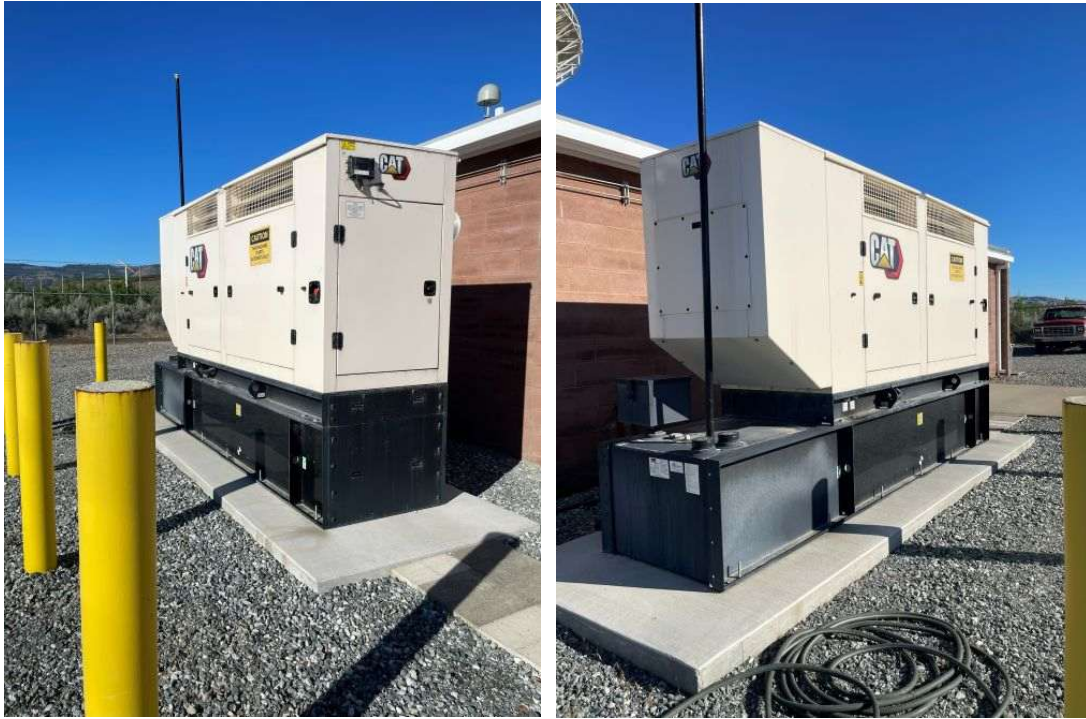
Figure 41: Site Generator

The Brewster site has a new generator installed on a new concrete slab (Figure 41).
