**National Radio Astronomy Observatory
Socorro, New Mexico**

VLBA Antenna Memo Series No. 12

Brewster, WA VLBA Site Azimuth Rail Maintenance, July 14th

Bob Broilo
August 5th, 1998

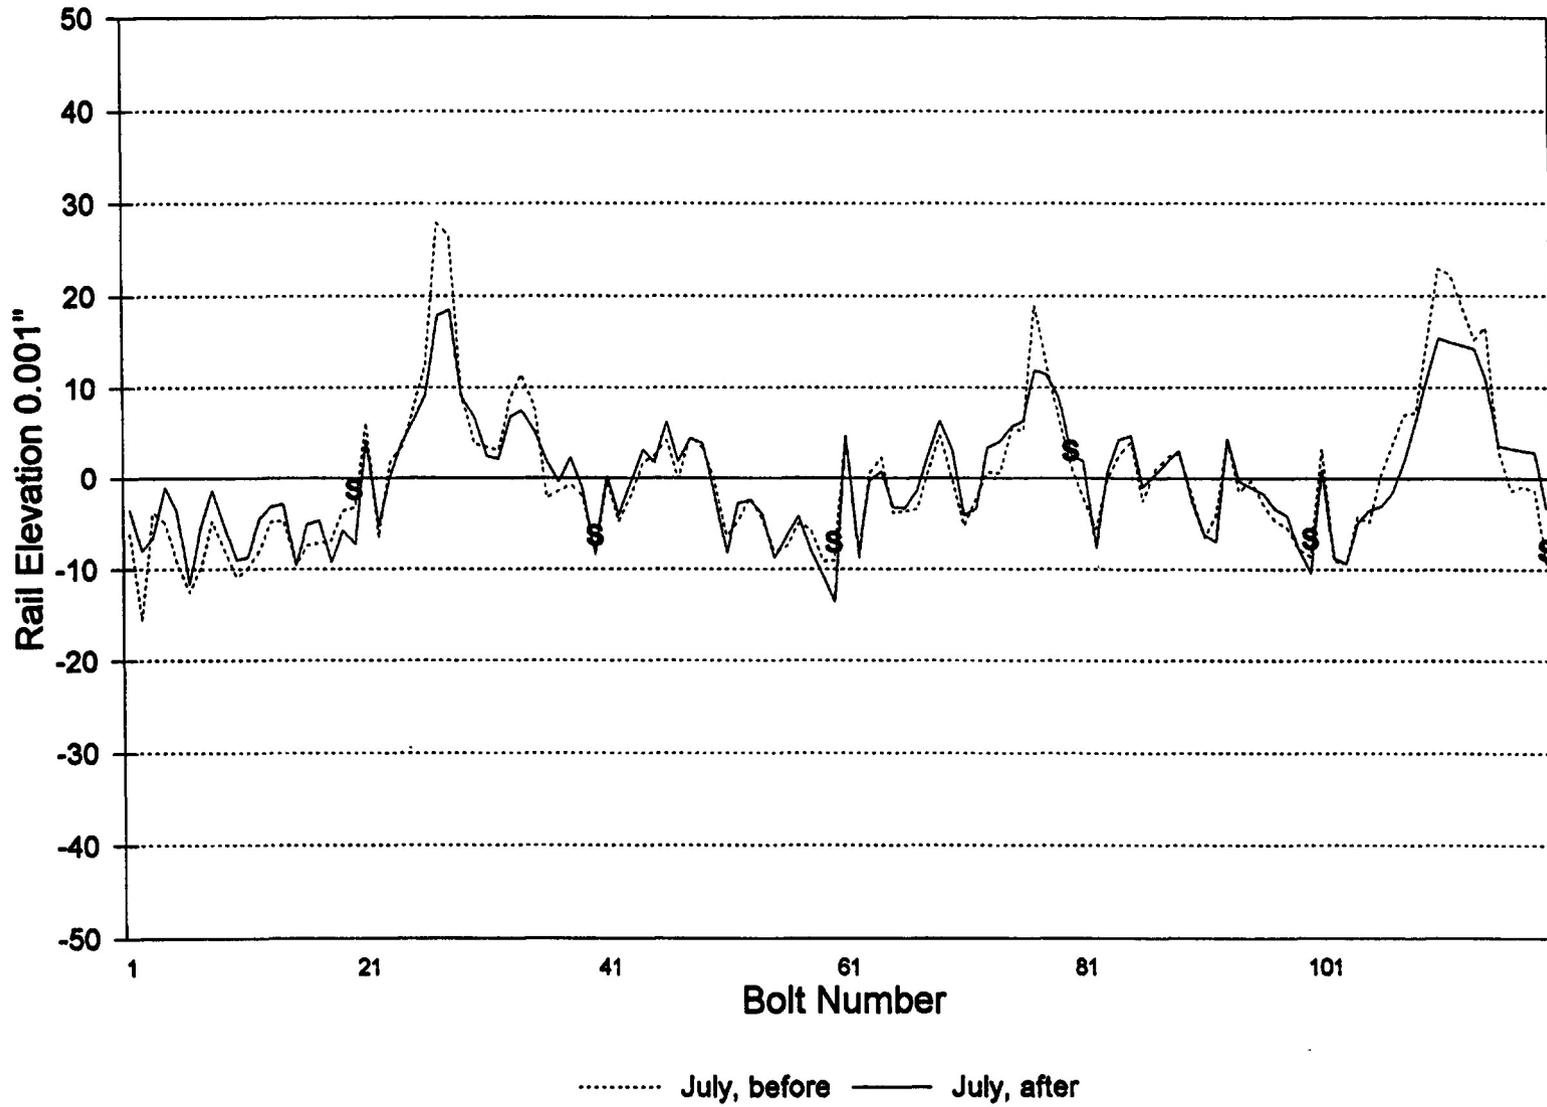
BR Azimuth Rail Repair 1998

The two charts following this report show the progression of the sag forming at Brewster from 1994, and the effects of our spot repair.
