**NATIONAL RADIO ASTRONOMY OBSERVATORY**  
**Socorro, New Mexico**

VLBA Antenna Memo Series 17

**VLBA Panel Repair**

R. Gutierrez, J. Thunborg, J. Wall  
April 29, 1999

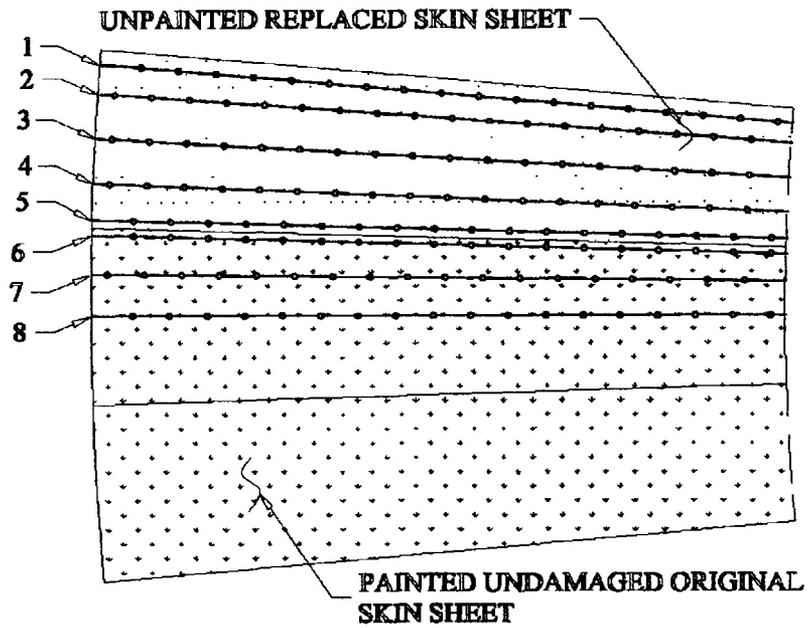
**Figure 1. Location of panel surface measurements. The surface was measured at 2" intervals along each chord (36 measurements/chord).**

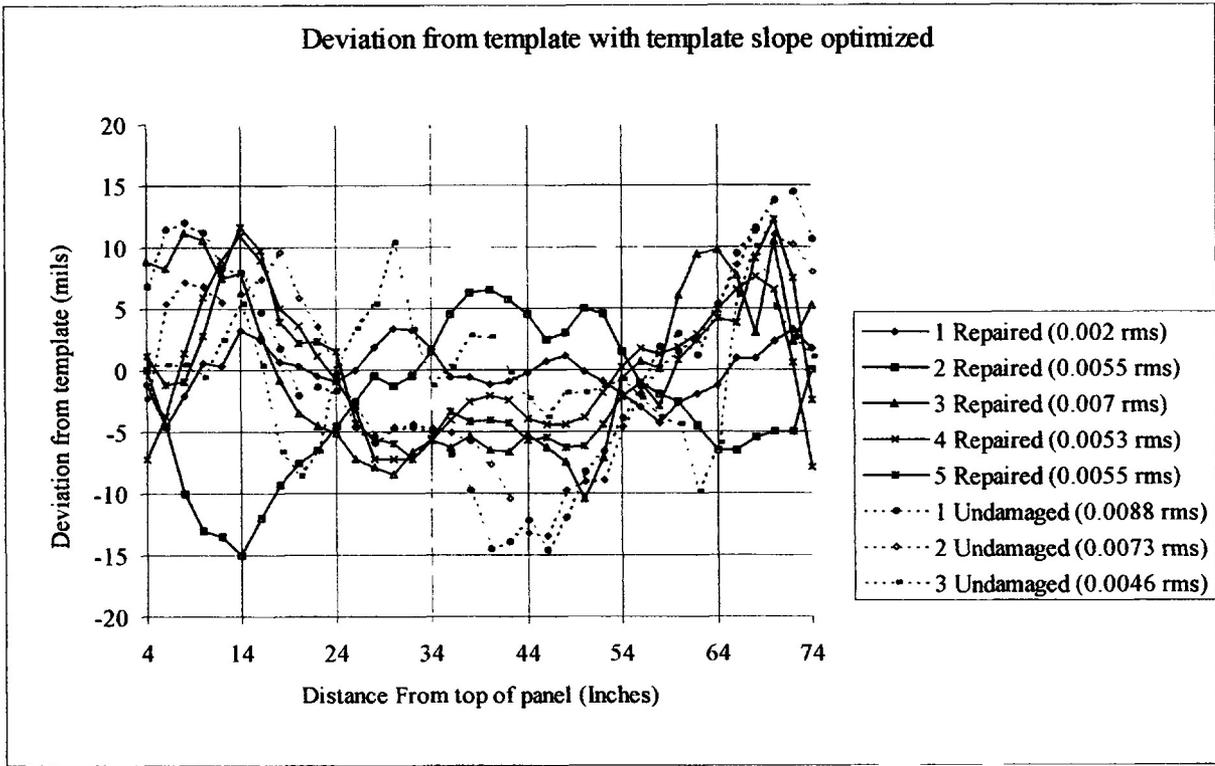
**Figure 2, Results of individual chord measurements.** The data clearly shows that the unpainted repaired surface is more accurate than the painted original surface. With consistent paint thickness this panel will be as good as original.
