NATIONAL RADIO ASTRONOMY OBSERVATORY
Socorro, New Mexico

VLBA Antenna Memo Series No.18

St. Croix Maintenance Visit, June 22 - 28, 1999 - Trip Report

J. E. Thunborg
July 7, 1999

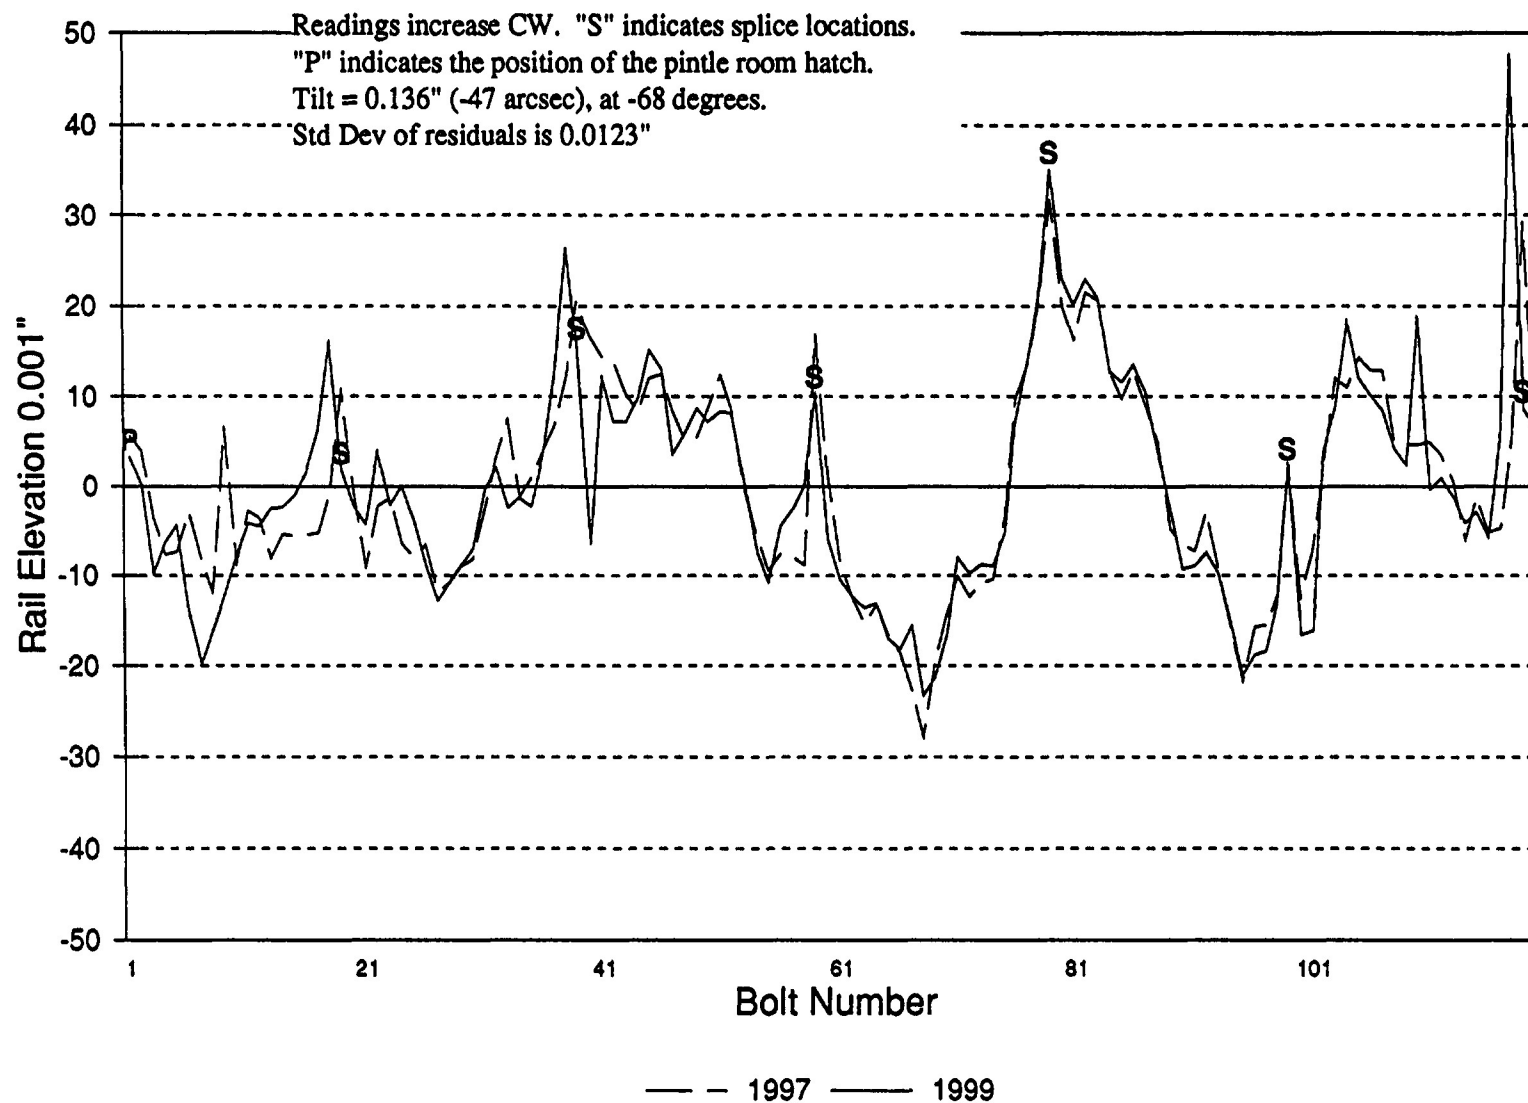
SC Azimuth Rail

Measured 6/28/99
