NATIONAL RADIO ASTRONOMY OBSERVATORY
Socorro, New Mexico

VLBA Antenna Memo Series No.20

St. Croix Corrosion Report

J. E. Thunborg
August 7, 1999

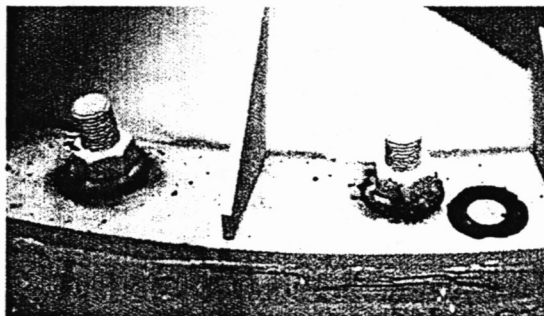
Starting this discussion at the bottom of the antenna and working towards the top. The pintle bearing support structure is reasonably free from rust except for the 2" washers on the pintle bearing bolts. Not all of these washers were bad. If the paint over a washer was not broken it remained in good condition. However the rust spread very rapidly as soon as the layer of paint was compromised. The rusted washers were

replaced with galvanized washers and repainted during the maintenance visit. The nuts and bolts did not corrode like the washers because they were originally hot galvanized.

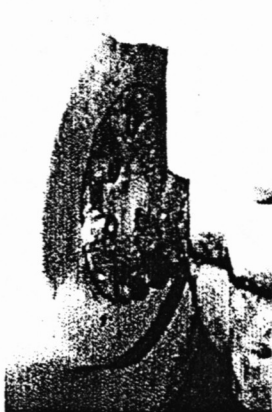
The wheels and track also showed signs of corrosion. This corrosion was not structurally significant, but it does increase the coefficient of friction between the wheel and track. This high coefficient of friction coupled with poor wheel alignment may be the cause for the premature azimuth wheel bearing failures occurring in St. Croix. The bolts on the wheel couplings need to be protected with paint before they rust so much that they can not be removed. This can be a very hard area to paint especially on the drive wheels where space is very limited, and the grease accumulates between the pillow block and the wheel.

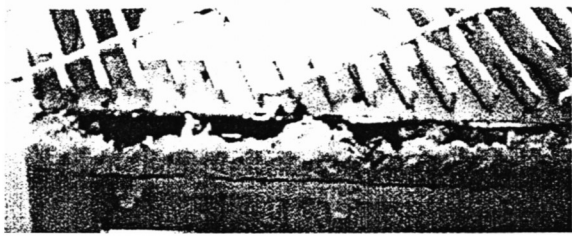
The stairways and walkway grating also had places where the rust was severe. The rust on the stair tread shown was so bad that the metal could be broken off by hand. The rust was particularly bad in this location because the structure trapped water. The stair tread shown is the only one that requires repair at this time

The majority of the metal grate is in decent structural shape with the exception of a few pitted areas where the rust has removed about 75% of the strength. The grating is at greater risk from rust as the paint gets scraped off on the top edge of the metal by normal work activities.

but the stairs and grating should be inspected occasionally to insure that a safety problem does not develop.

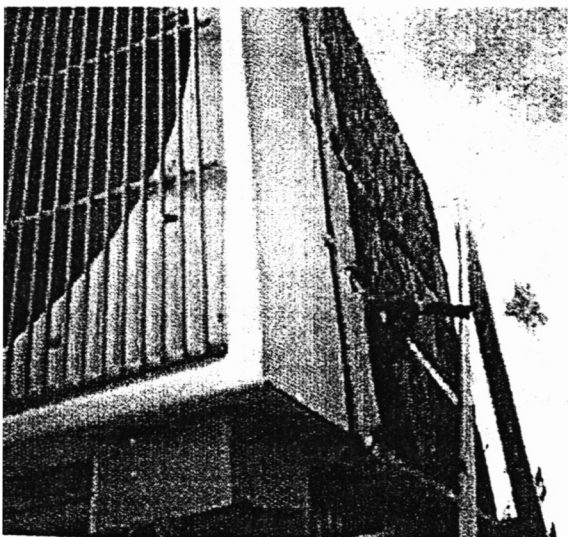
The nonstructural elements of the antenna seem to be most susceptible to rust. The vertex room condenser side panels shown were so badly corroded that the metal could be flaked off by hand. These panels were replaced during the maintenance visit but the rest of the condenser is still in poor shape. The unistrut that holds the condenser to the platform was also in very poor condition and will need to be replaced soon. Several pipe hangers and other hardware were also so badly corroded that they had to be replaced by the tiger team. The bottom of the vertex room door was also completely rusted out.

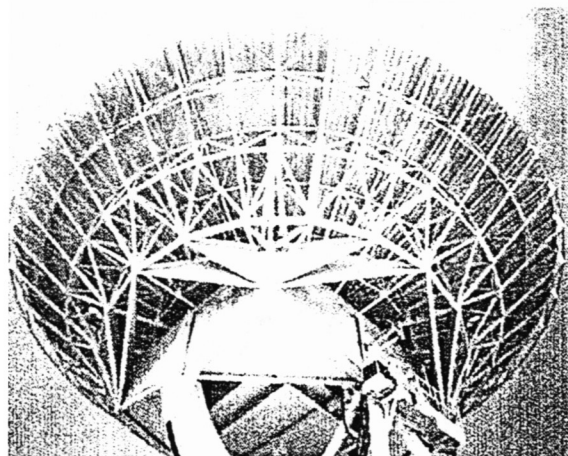
The backup structure was in good condition. This is because the painters have been asked to spend the majority of their time on this part of the structure. The fasteners in this area were in good shape and the rust that was present was only superficial.

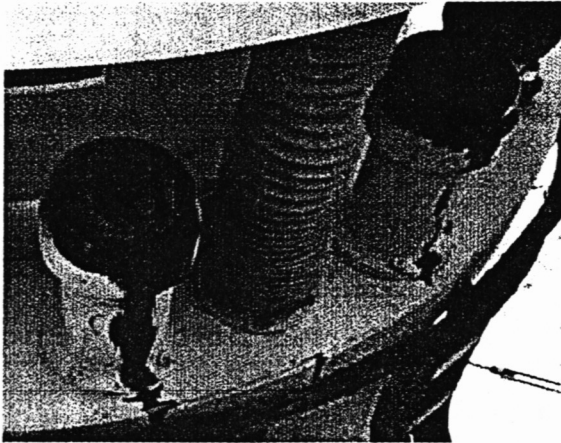
Another interesting phenomenon at St. Croix involved the total deterioration of the hard polyurethane rubber FRM stops. These stops went completely soft and started dripping on the structure. One of the stops was replaced during the maintenance visit. This new polyurethane rubber stop deteriorated overnight. It is interesting to note that an identical stop stored in the shipping container showed no sign of deterioration.

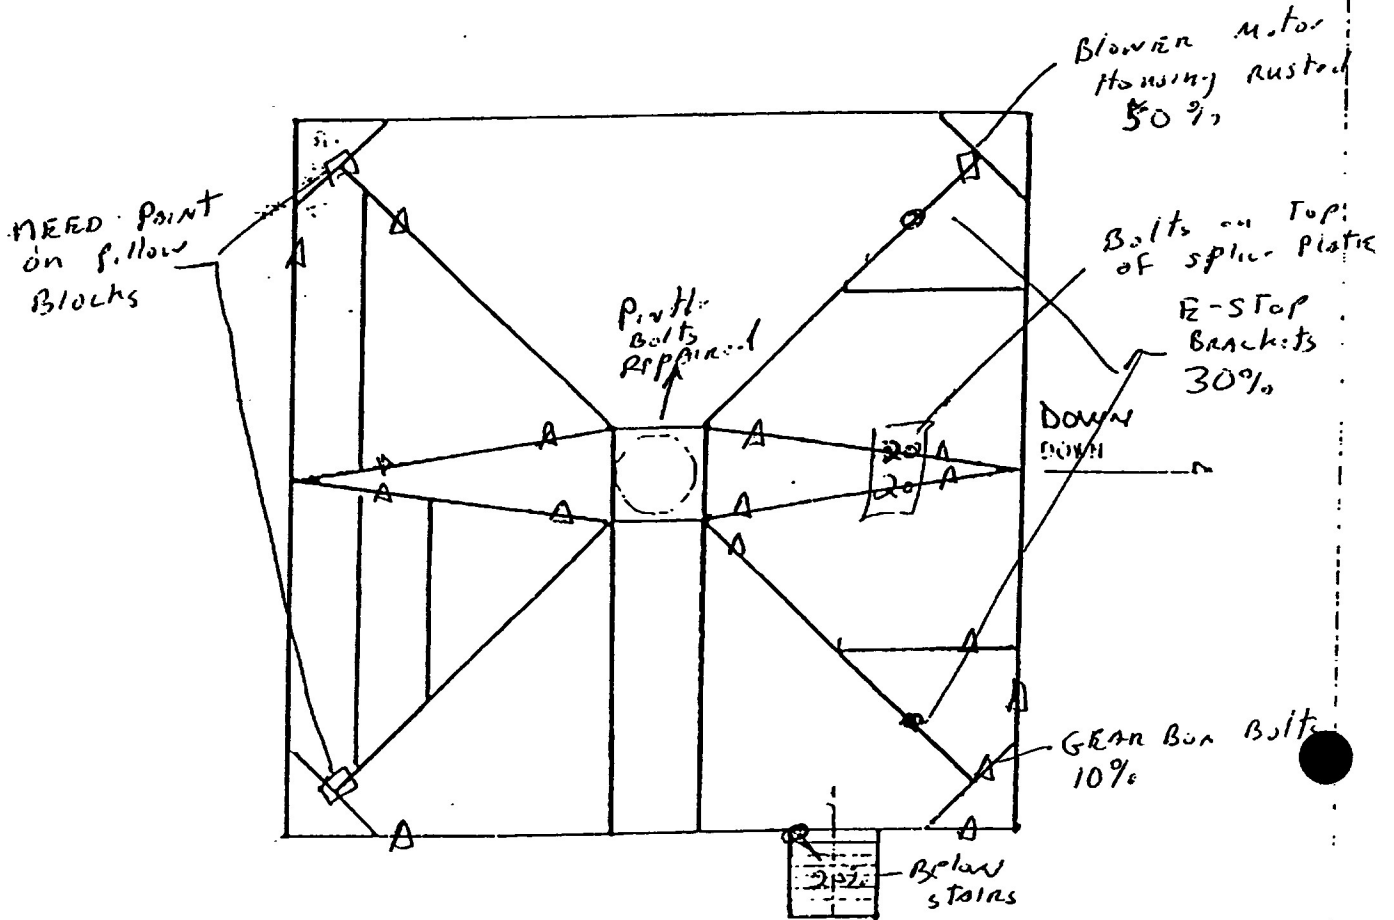
AZIMUTH LEVEL PAINT CONDITIONS - DATE:

- notes
1. Wheel Bolts 20%
 2. MAIN Tube flanges some Bolts 10-20%
 3. STAIRS to elevation 10% on connection Bolts
 4. Grating at knuckle 10%

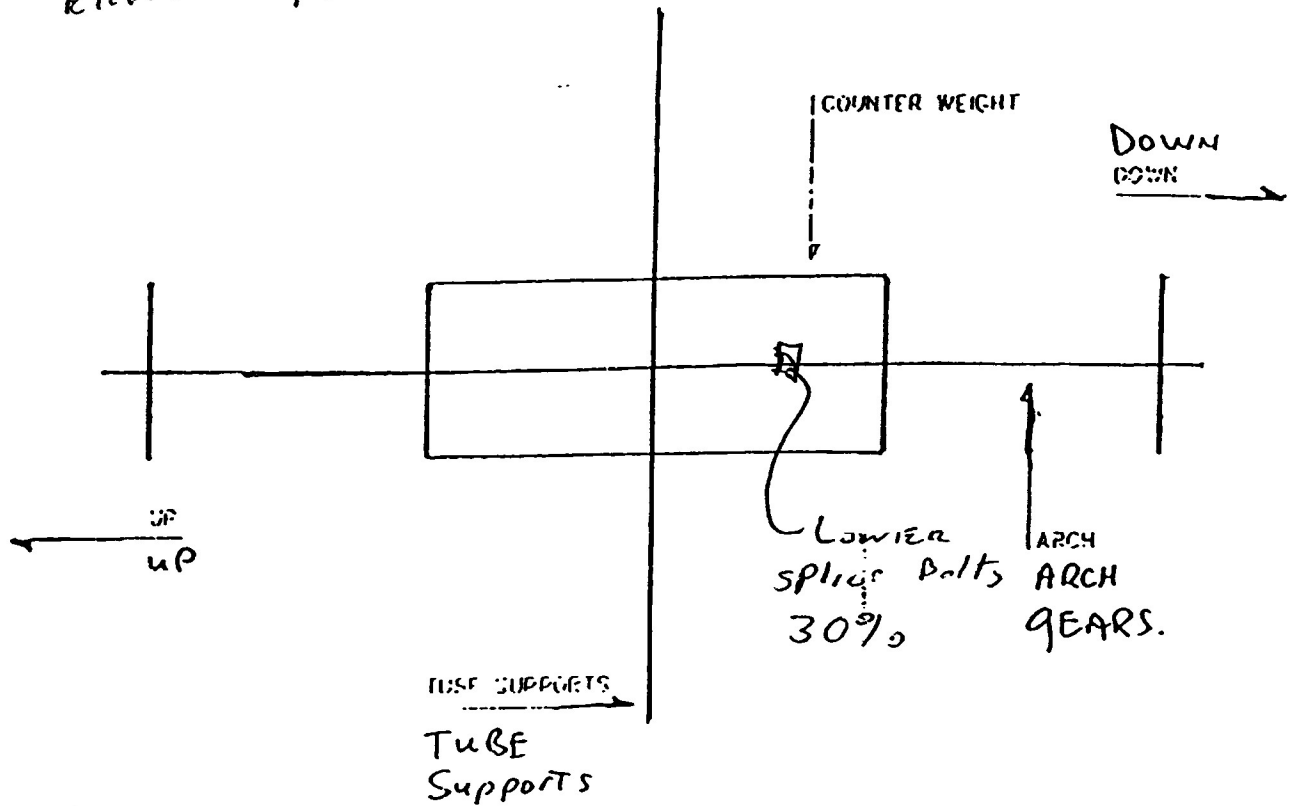
COUNTERWEIGHT PAINT CONDITIONS

1. Tubes And splices Look Good - only slight discoloration on Bolts
2. STAIR Gratings 10-30% in spots
3. Vertex Room Condenser in very poor condition mount needs Repair Also
4. Hoist Bolts Replaced - need painting
5. Severe Rust in Elevation Platform corners where WATER WAS TRAPPED

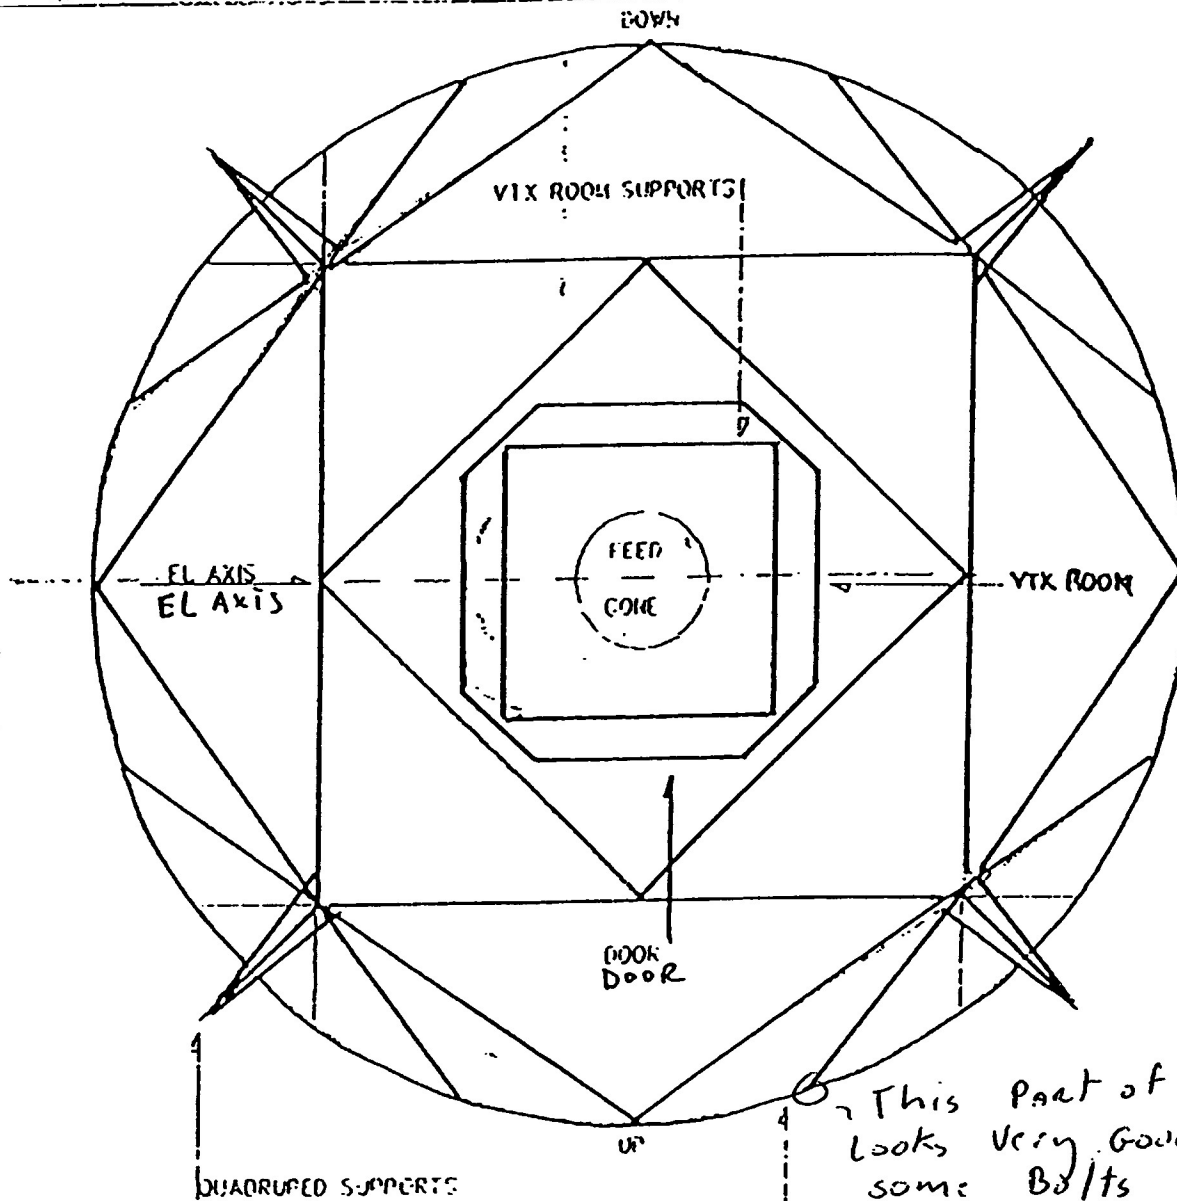
VERTEX LEVEL PAINT/CONDITIONS AS OF DATE:

This part of structure looks very good some bolts 10%

Vertex Room door needs replaced 50% rust on bottom

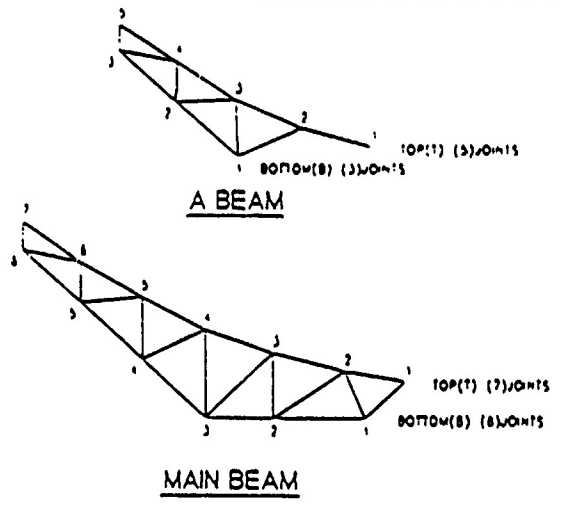
*Backup structure looks good
Painters have made progress
Some bolts 10% (slightly discolored)
More discolored bolts on outside
edges of structure.*

- * ANGLE PEELING
- ** WF BEAM AROUND VERTEX TOUCHUP
- *** SMALL RUST SPOTS

NOTE - INSPECT CONE ASSY INTERNALLY
REPAIR/PAINT AS REQUIRED

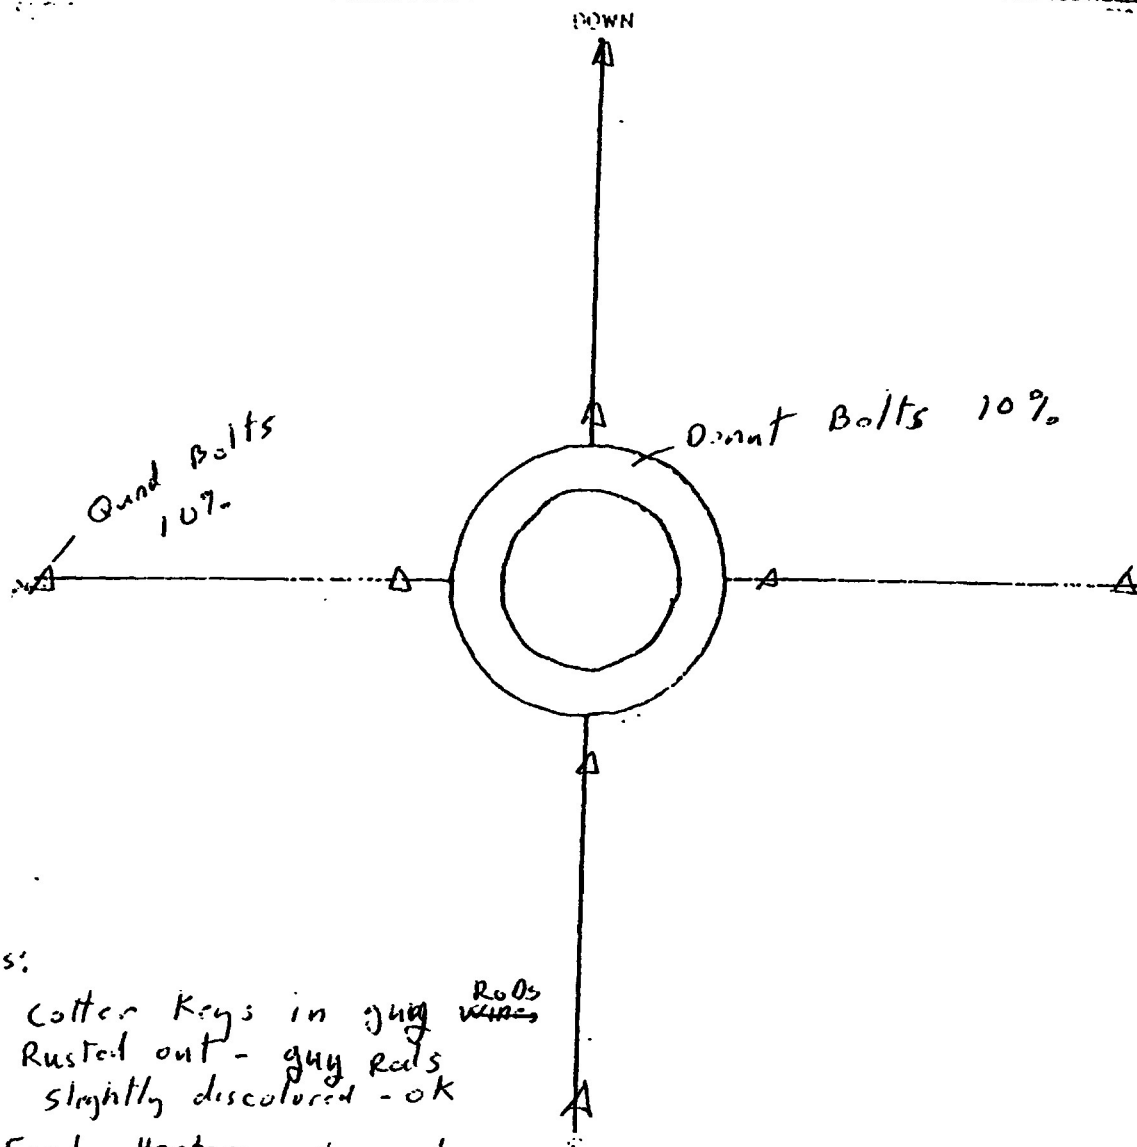
QUADRUPED PAINT CONDITIONS

1. Copper Keys in ^{Rods} ~~guy~~ ^{wires} Rusted out - guy Rats slightly discolored - OK
2. Feed Heaters 0% need Replaced
3. several Feed Bolts 50%
4. Di Chasic Rod Ends 20-30%
5. Elipsoid actuator shows some RUST - needs work - springs replaced
6. FRM Remote control Box 20-30% needs Replaced
7. Steel Washers on Lightning Rods 50%
8. Gorp Track Bolts 30-40%
