**NATIONAL RADIO ASTRONOMY OBSERVATORY**  
Socorro, New Mexico

VLBA Antenna Memo Series No.24

**St. Croix Maintenance Visit, January 15 - 20, 2000 - Trip Report**

J. E. Thunborg  
January 30, 2000

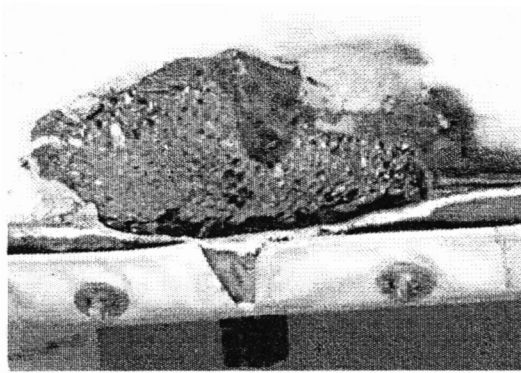
Before

The 6 by 10-inch gash shown below was found on the edge of the subreflector. Bondo was used to repair the Subreflector. However, a reflective surface was not installed over the Bondo. The systems engineers who understand these sorts of things should consider the effect of this repair on antenna performance. The cause of the gash is not currently known.

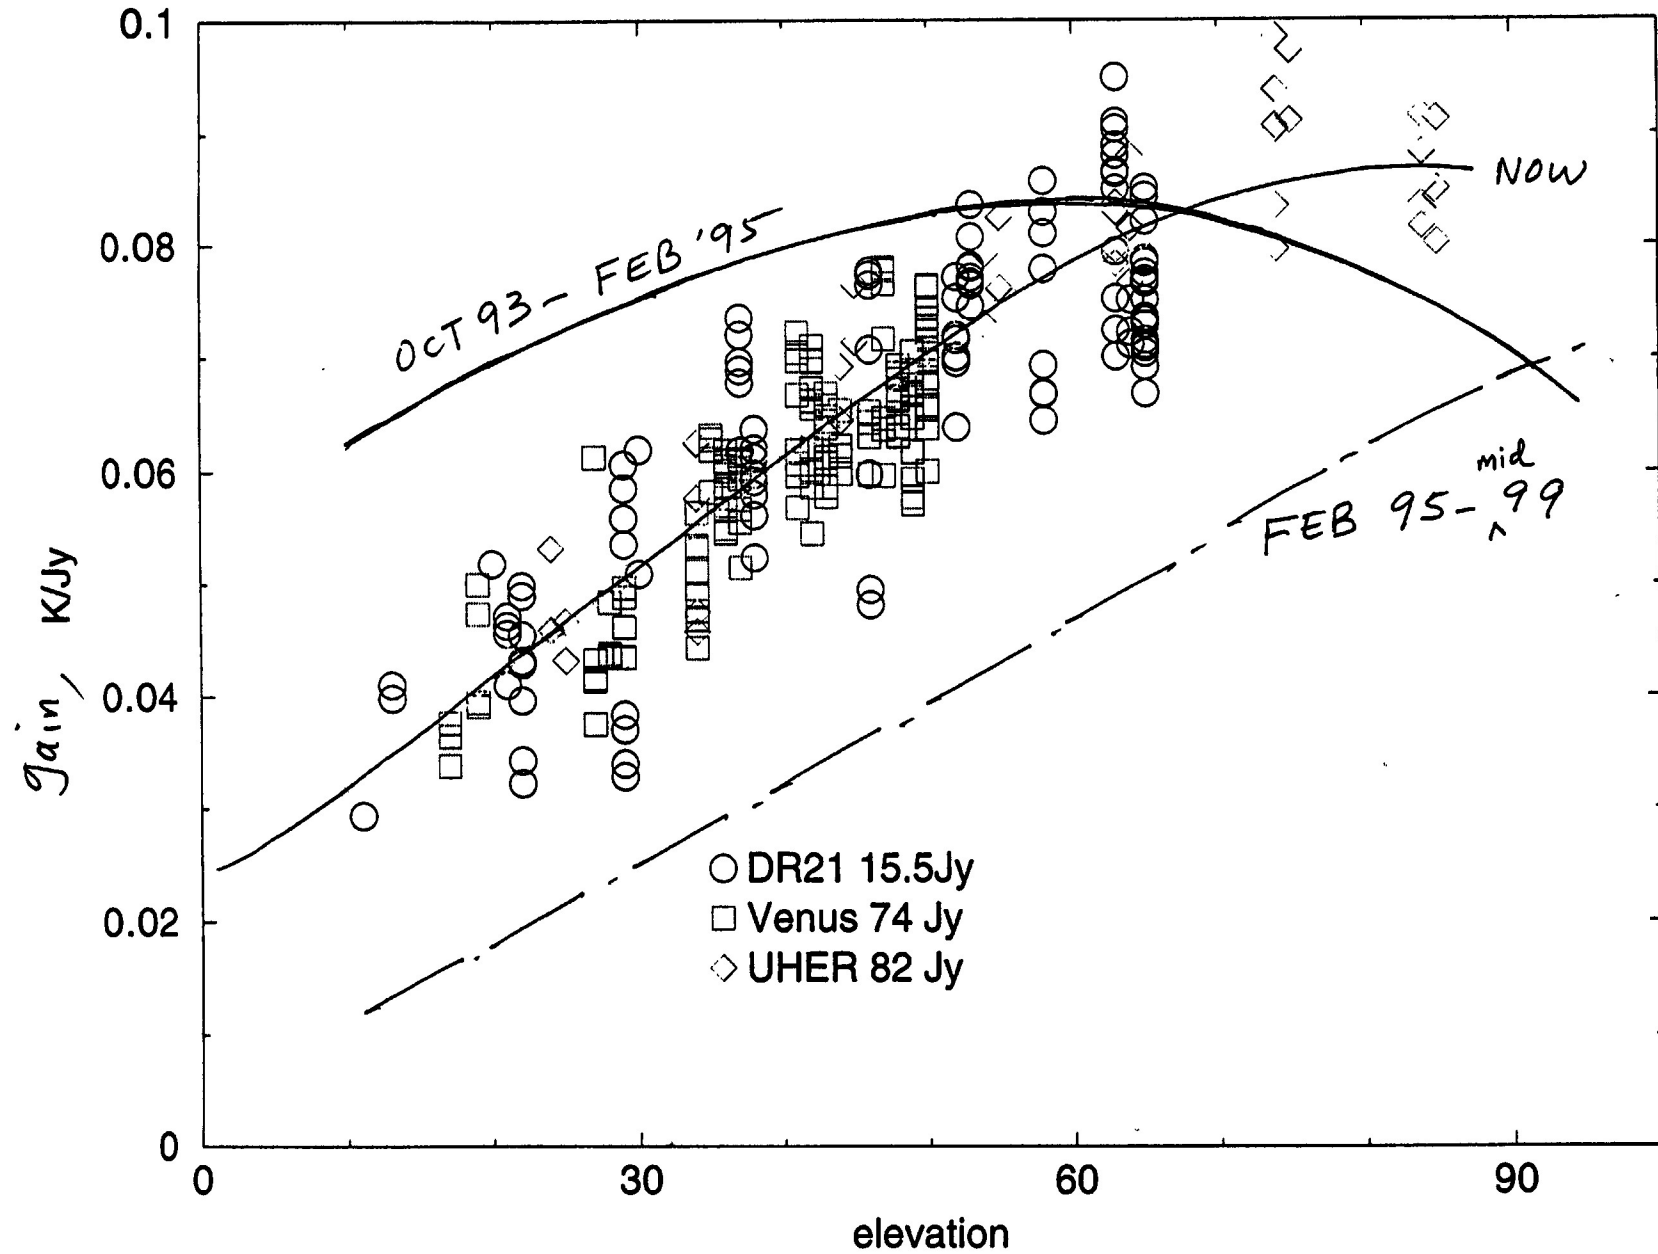
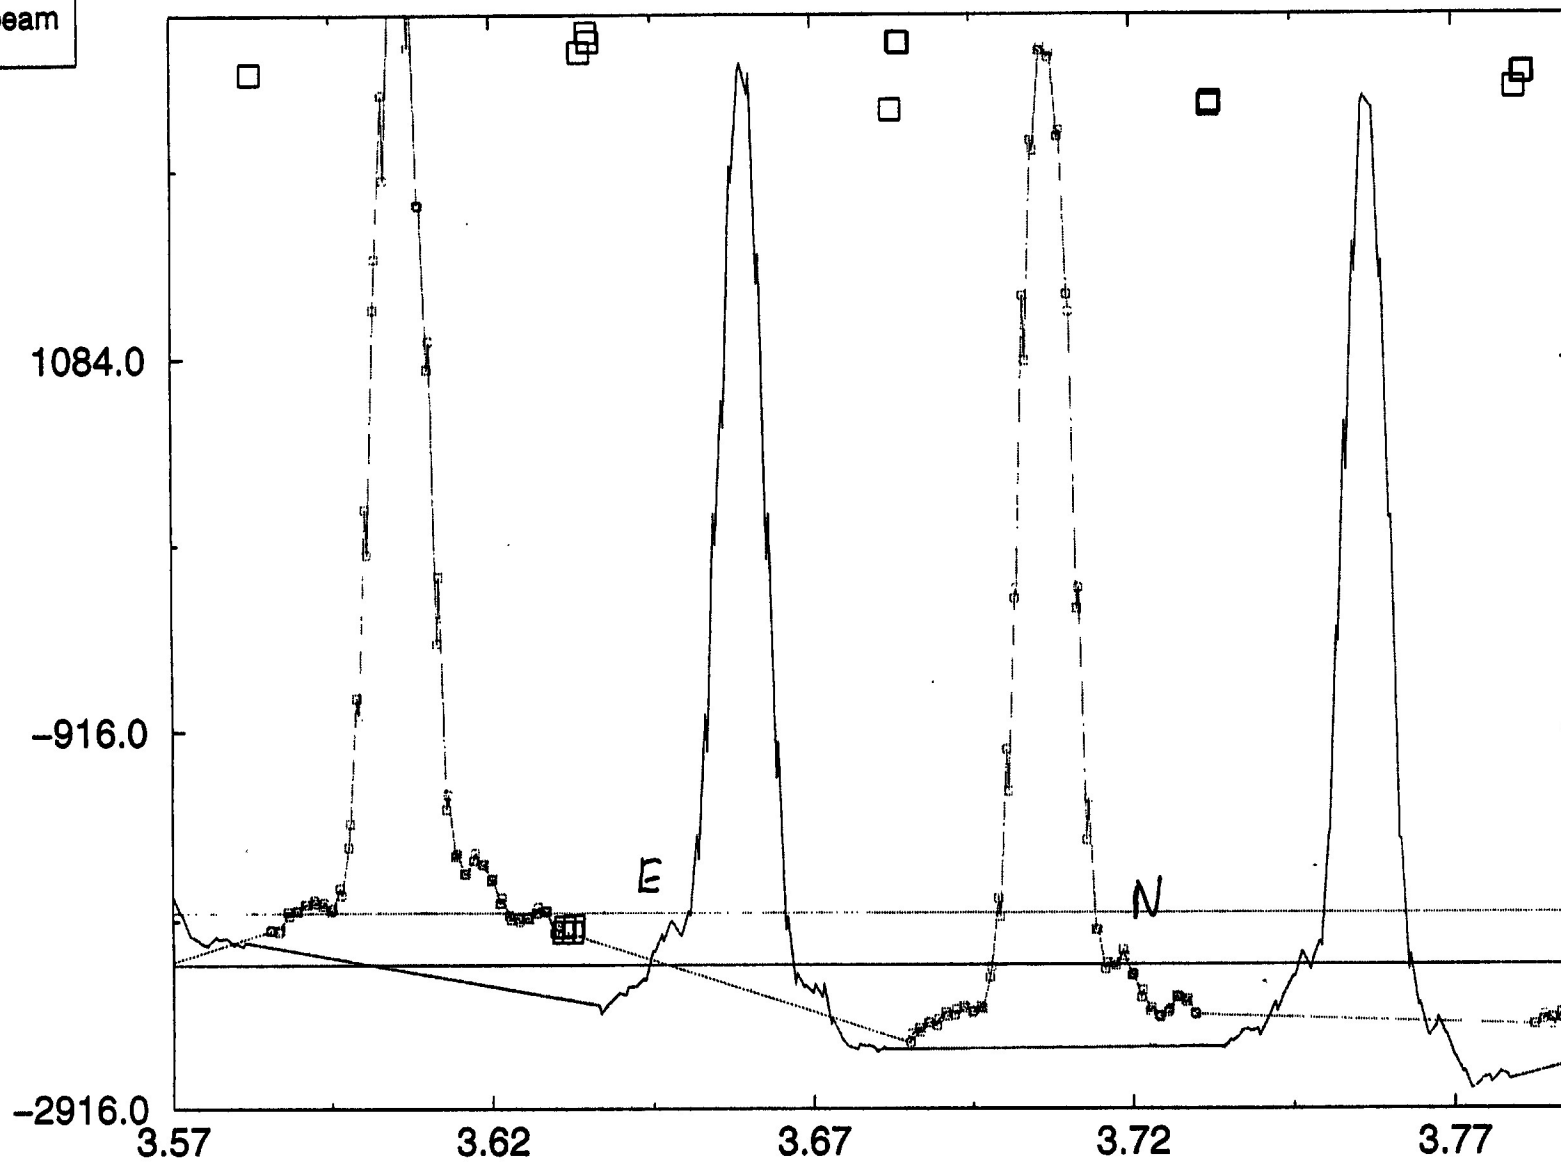
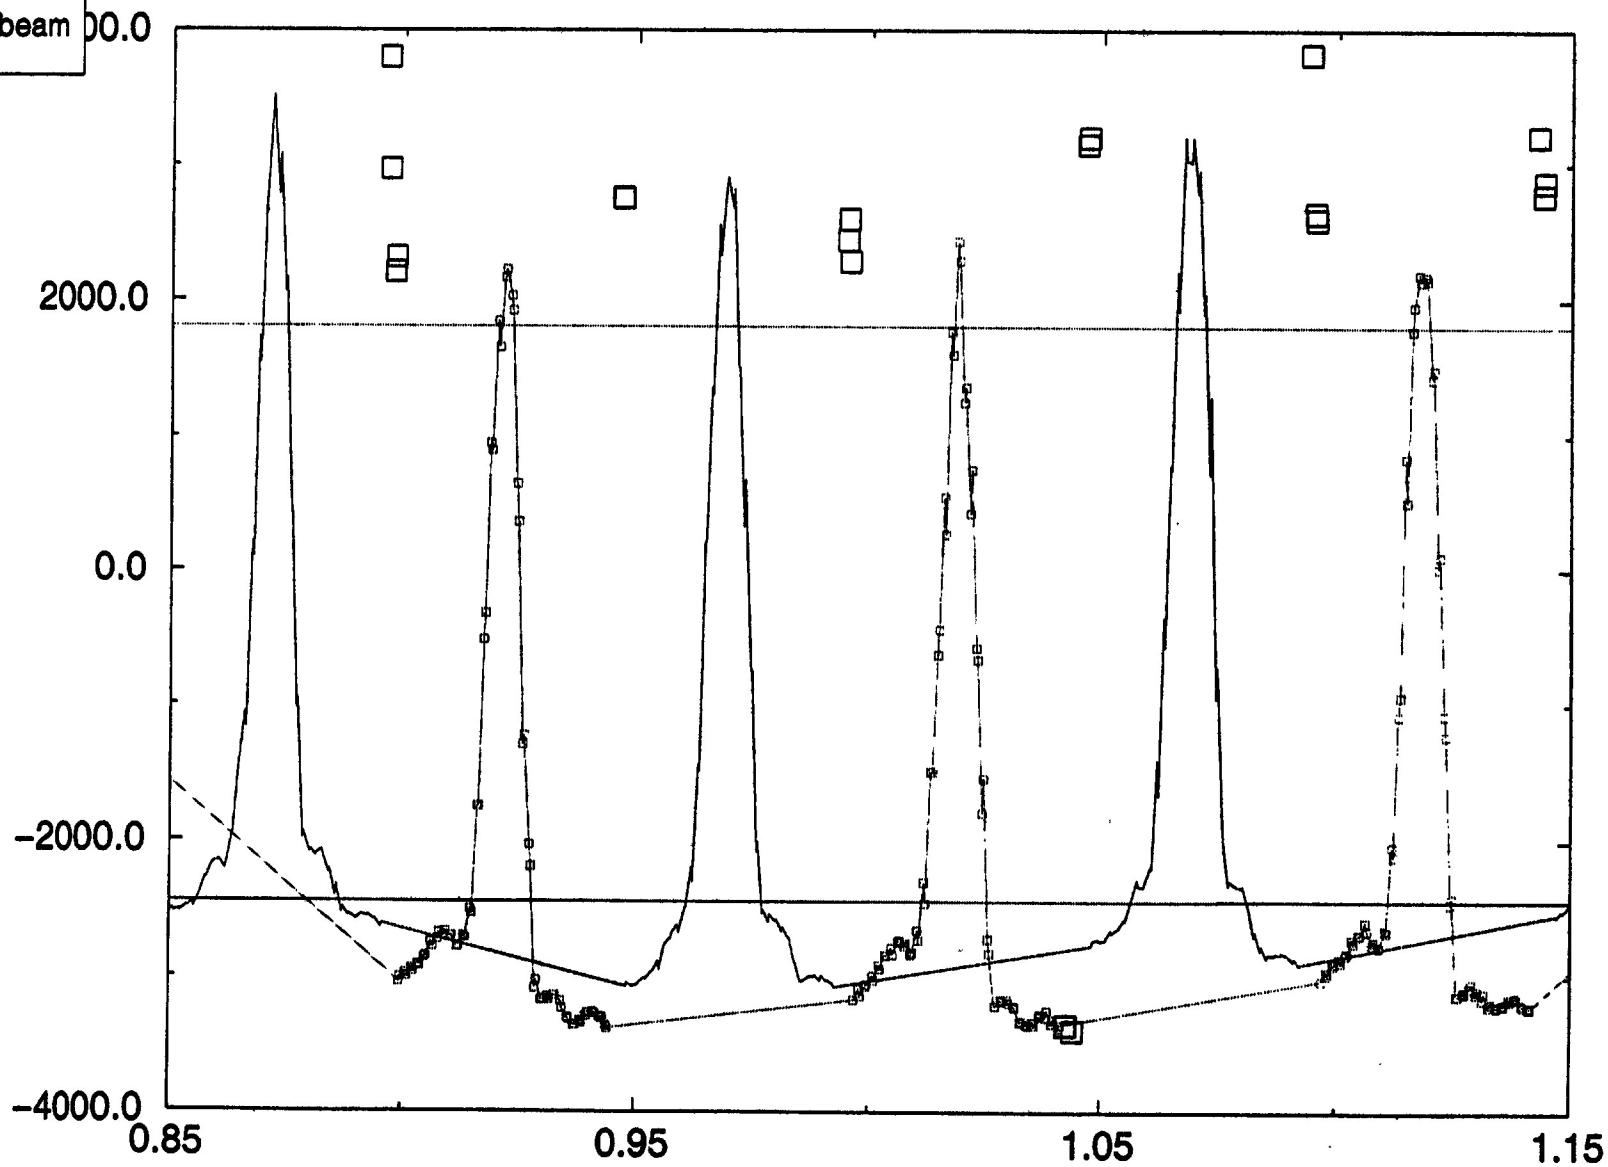
1. The FRM subreflector was moved. Repositioning the subreflector improved the antenna performance somewhat but it has still not recovered to its pre 1995 status. See attached for plots generated by Vivek Dhawan. Current theory is that there may something loose in the FRM. This will be checked using digital dial indicators on the next visit to St. Croix.
