**VLBA Antenna Memo #28**  
**Los Alamos Drive #2 Wheel Replacement**  
Jim Ruff  
12/19/00

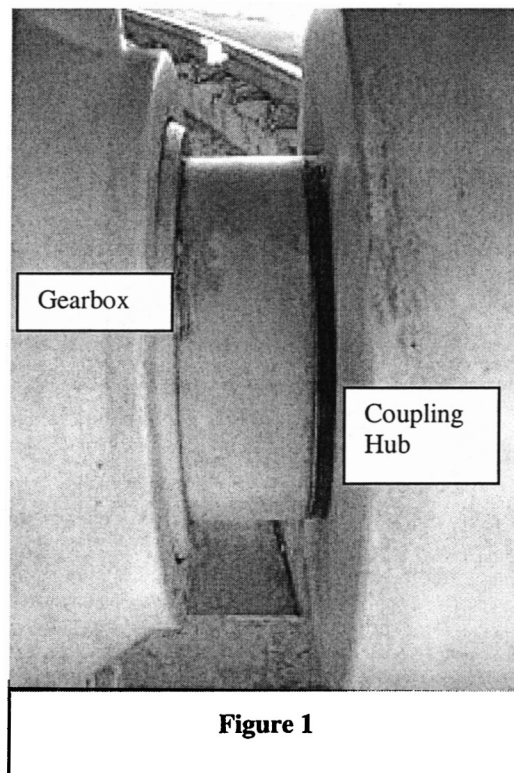
Upon inspection, it was found that the entire axle had pulled away from the gearbox approximately ¼ inch. (Figure 1).

The rigid coupling hub was installed on the gearbox improperly by RSi. It appears as though the hub siezed to the shaft about 1 inch short of its correct position during the shrink fit operation. There were numerous hammer marks where they apparently tried to beat it into place. The resulting short shrink fit made it easier for the hub to pull out from the shaft.
