**VLBA Antenna Memo #29**  
**Los Alamos Elevation Bearing Replacement**  
Jim Ruff                      Photos by Gene Dunn  
1/30/01

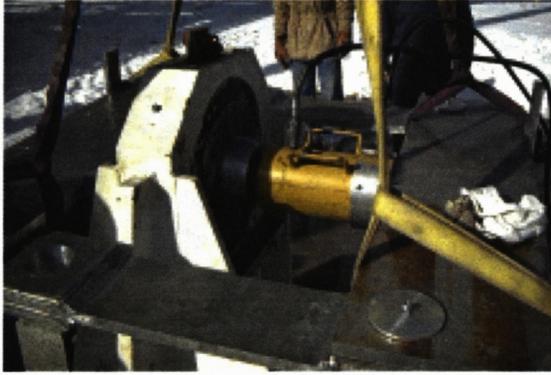
**Figure 7: Pressing out the old bearing**

The old bearing was pressed out using the 100 ton press. Cleaned up the bore, applied NeverSieve, and put in the new bearing. Cleaned and inspected the axle. Installed a new taper sleeve on the axle. Cleaned and smoothed the base plate.

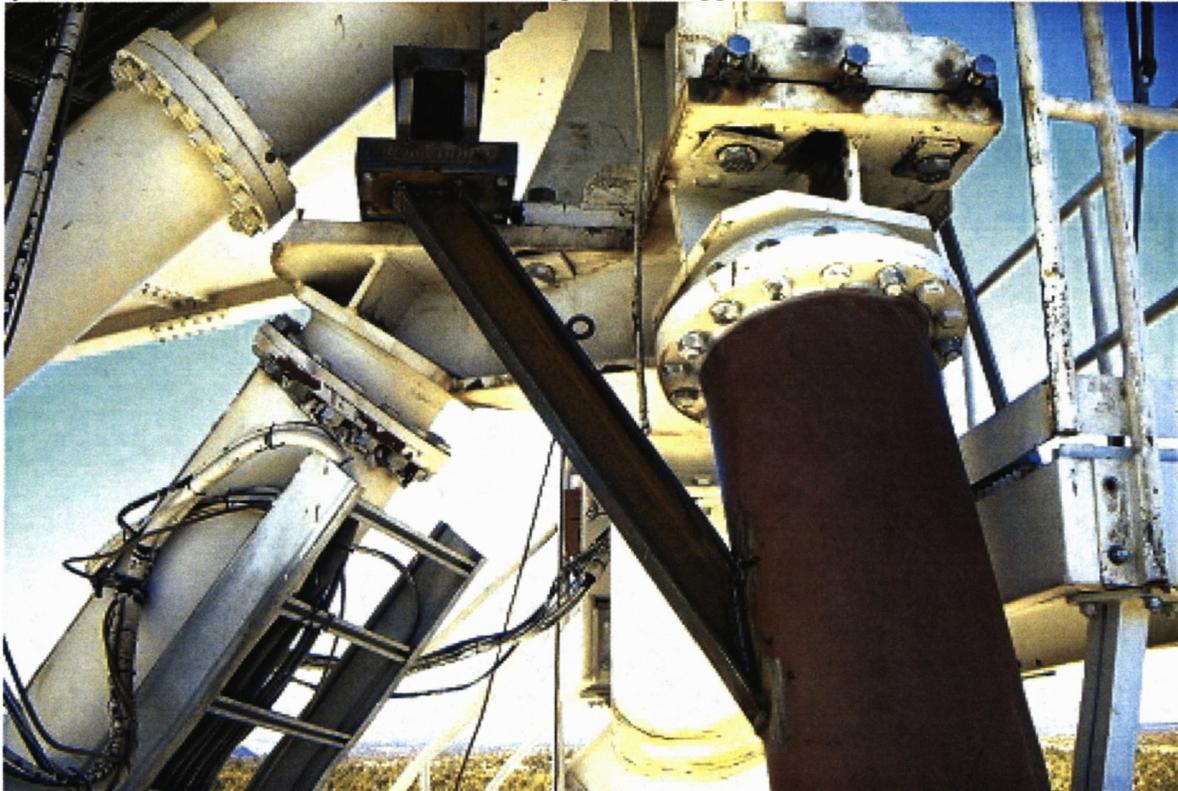
**Figure 9: Support Beams and pillowblock jack screws**

The pillow block came down in a different position from the original. To put it back, we welded jack screws in appropriate locations, raised the axle, and jacked the pillow block into the correct position.

Reinstalled pillow block covers and pillowblock bolts. Torqued the bolts to 1900 ft-lbs using the hydraulic wrench. Removed the anti-rotation pin, jack support and brace beams.

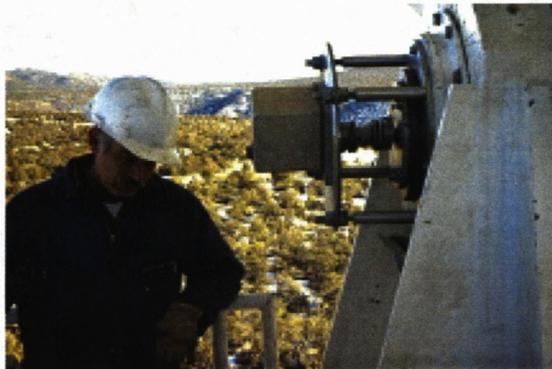
**Figure 10: Synchro Reinstalled**

Reinstalled the elevation synchro. Note that the synchro was very poorly centered to the axle. We improved the alignment somewhat by enlarging the bolt holes, but it's still not very good. We also had trouble reinstalling the seal covers because of sloppy bolt circles. Future teams should be sure to bring a set of large drills to allow enlarging the holes. All we had was a taper reamer, which was not very effective. Checked angular alignment of the new bearing. The spec is  $1.5^\circ$  or better. Measured misalignment:  $1.2^\circ$ . Checked the precision level. It showed  $0.0005''/\text{ft}$  (9 arc sec) off from zero. Replaced the condenser. Site clean-up.

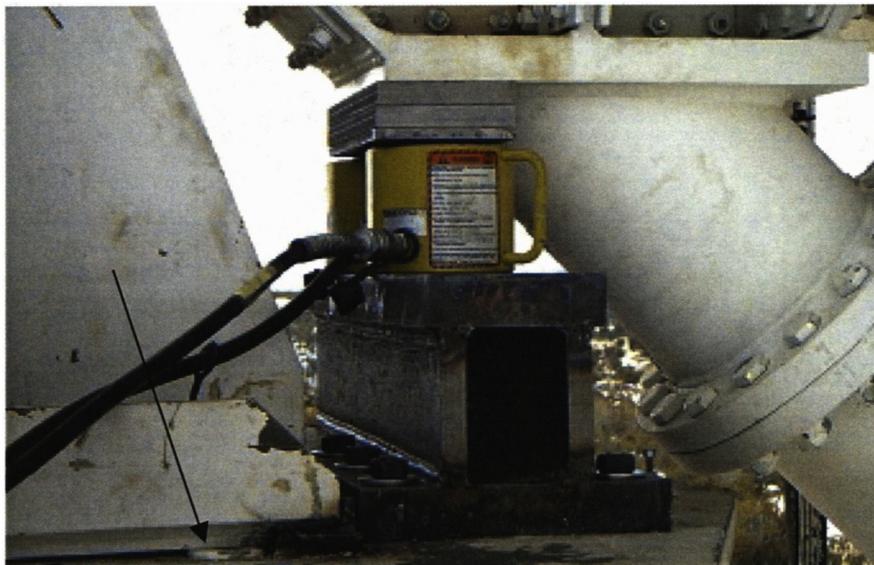
**Figure 12: Detail of jacks. Note washers RSi used for shims under pillowblock.**

Lifted the axle. Note that it took about 6200 psi and over ½ inch of jack travel to get adequate clearance - 1/8 inch - under the pillowblock. When in position, we put horseshoe shims around the jack rods to prevent drift. Positioned the crane and used 3 small Porta-Powers to release the bearing taper. The pillowblock was attached to the crane using a 1.5 ton come-along and safety chain. Lowered the pillowblock to ground level and installed the axle support.

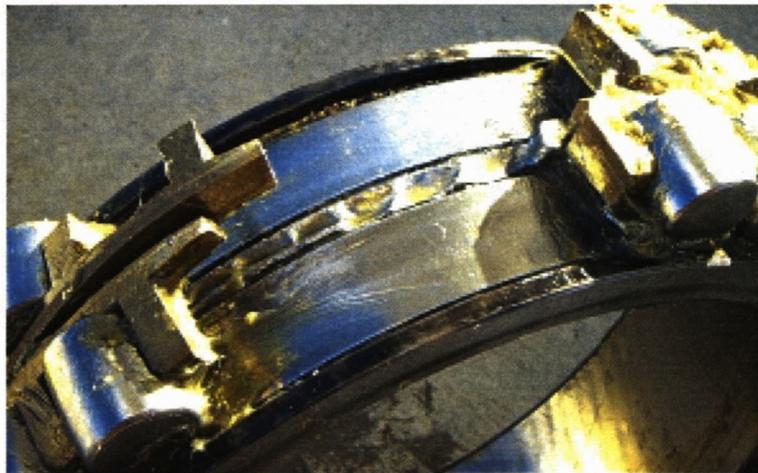
**Figure 13: Old Bearing**

Metal was found in the grease from the condenser-side elevation bearing late in October 2000. The decision was made to replace the bearing. A team consisting of Steve Aragon, Ramon Gutierrez, Steve Troy, John Wall and Jim Ruff went to do so during the week of January 8<sup>th</sup>, 2001. This was the first time a VLBA Elevation Bearing had been changed in the field.

As figure 13 shows, the bearing did indeed need changing!
