NATIONAL RADIO ASTRONOMY OBSERVATORY
Socorro, New Mexico

VLBA Antenna Memo Series No.30

VLBA Azimuth Axle Failure – Follow UP

J. E. Thunborg
March 22, 2001

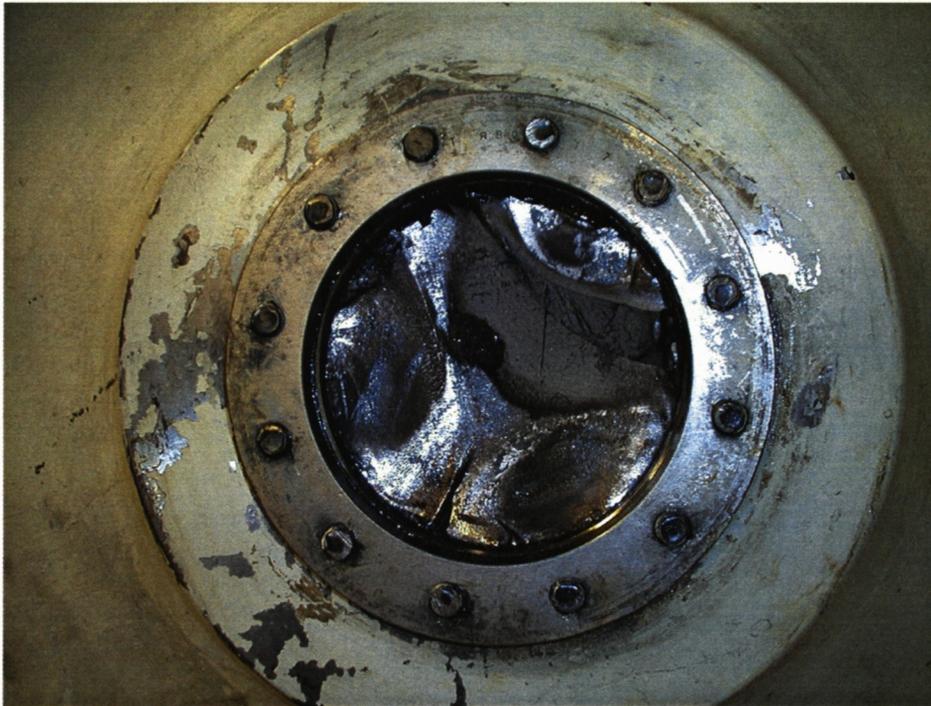
The VLBA Azimuth wheel axle shown below failed after 11 years of service. Jim Ruff documented the replacement of this axle in VLBA Antenna Memo Series #28. It is important to understand the reason for this failure, so that we can reasonably predict if other axles in the field are about to fail. The ability to predict axle failures is of critical importance for elevation axles where a failure could be catastrophic. This memo attempts to document the results of the follow up investigations.

Fatigue is one suspected mode of failure for the axle. The axle broke at a high stress location near the wheel. The wheel is connected to the axle by a tapered coupling that presses the wheel and the axle together. This tight fit is a discontinuity in the cross section, which can concentrate the stress in a localized area. Due to the unknown variables associated with the press fit, it would be very difficult to simulate the failure using finite element analysis. Since we would have little confidence in an FEA model, we acquired additional information by testing axles that were subjected to similar conditions.

Another theory for the failure, presented by Jim Ruff, suggests that the bearing that failed 2 months earlier may have seized causing extremely high torsional stresses in the shaft. This cracked the shaft and it took 2 months for the crack to progress to the point where the axle failed. If this is the case, then it may be wise to inspect axles when bearings are changed.

If funds become available, we should purchase an ultrasonic flaw detector. We should inspect all new axles before they are installed on antennas to expose defects in the raw material. We should inspect both the VLBA azimuth and elevation axles during maintenance team visits. We should also inspect all of the VLA elevation axles. Elevation axles are not likely to fail, but an elevation axle failure could result in a catastrophic collapse of an antenna. The ultrasonic flaw detector should also be used in other high stress areas on the antennas, such as the VLA azimuth gearboxes.
