**National Radio Astronomy Observatory  
Socorro, NM**

**VLBA Antenna Memo Series #32**

**Los Alamos Maintenance Visit  
April 17<sup>th</sup> through 23<sup>rd</sup>, 2001  
Trip Report**

Jim Ruff  
5/1/01

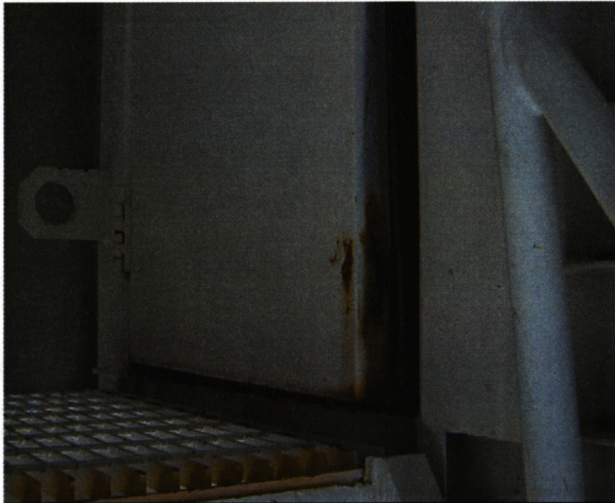
**Figure 1: Vertex house door**

The vertex house door is rusting. (Figure 1) This door should be replaced during the next tiger team visit.

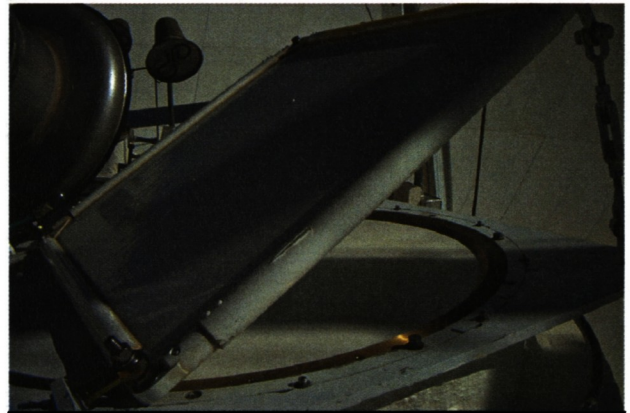
**Figure 2 : Dichroic Panel**

The dichroic panel is in good condition. (Figure 2)

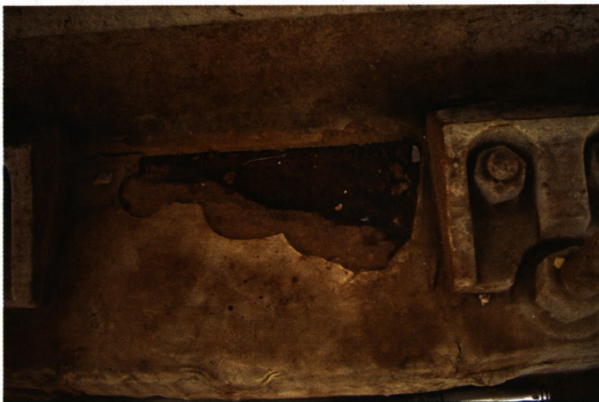
**Figure 3: Bad grout**

The azimuth rail grout is bad in several places. The areas that were previously patched with epoxy grout appear to be holding up well. More patching is called for. (Figures 3 through 6)

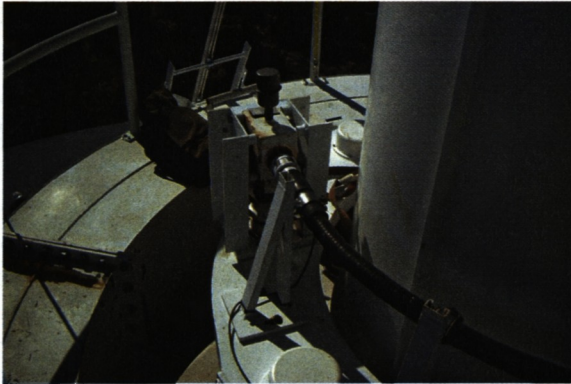
**Figure 7: Apex**

The paint on this antenna is in excellent condition. (Figures 7 through 10) We did some touch up painting around the mid-level handrails, pedestal structure, and the elevation bearing that was changed last January.

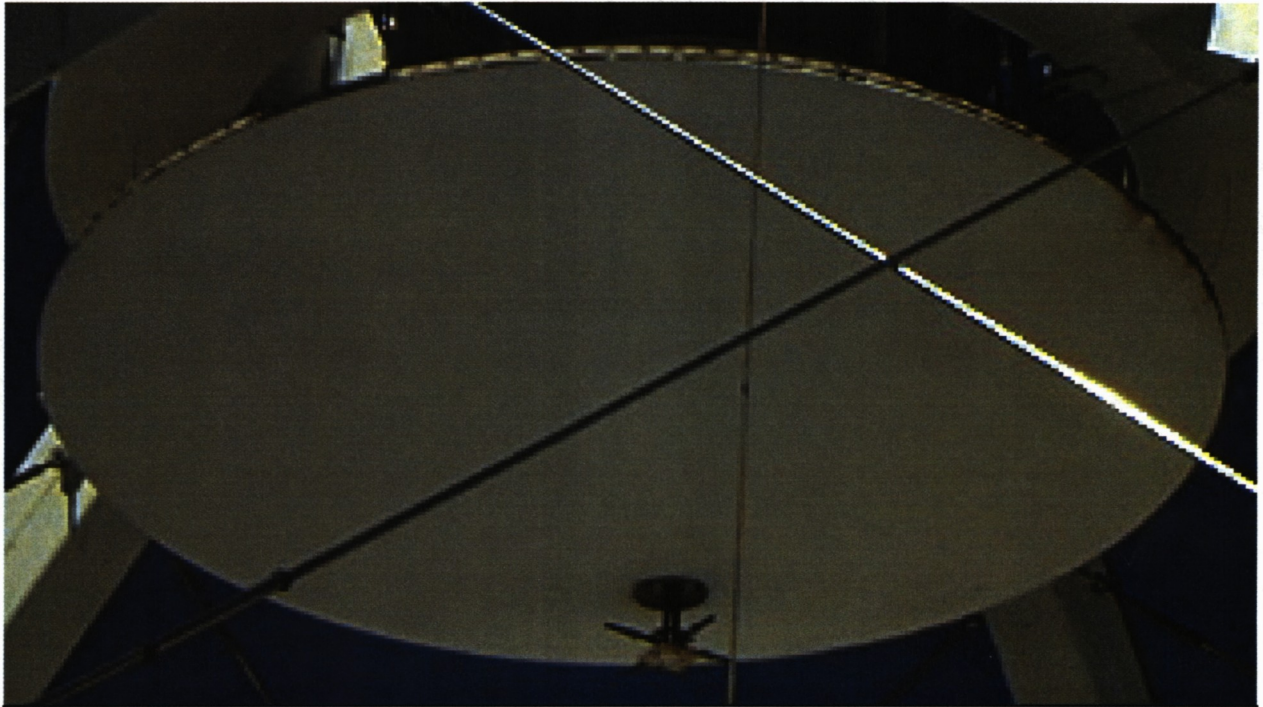
**Figure 11: Subreflector**

The subreflector is showing some small dark spots, but otherwise looks OK. (Figure 11)

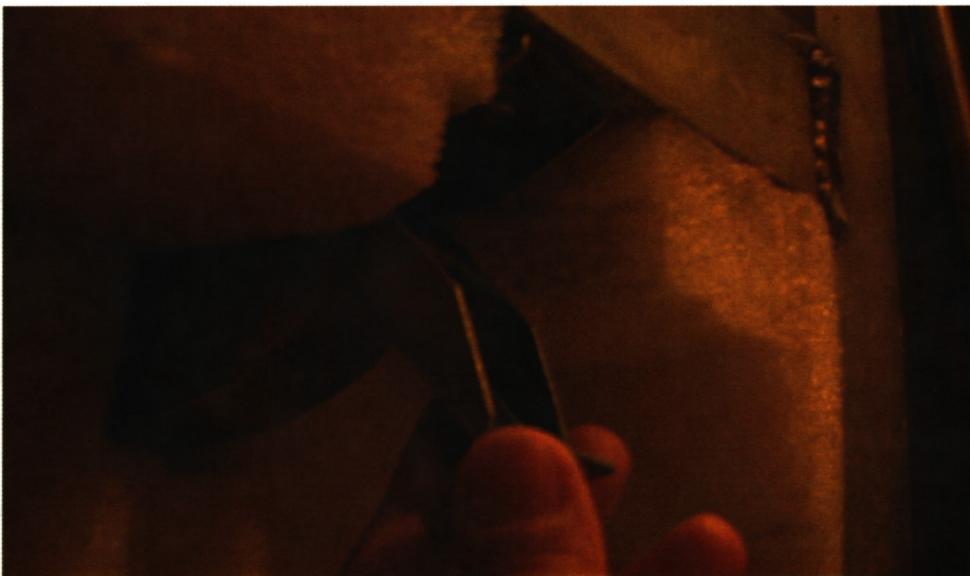
**Figure 12: New vertex room latch**

A modified Southco #9770-220-11 latch was tried out for the vertex room hatch. It worked well, so more have been ordered and we will begin replacing broken rubber latches with these. (Figure 12)
