**National Radio Astronomy Observatory  
Socorro, NM**

**VLBA Antenna Memo Series #33**

**Owens Valley Maintenance Visit  
June 11<sup>th</sup> through 17<sup>th</sup>, 2001**

**Jim Ruff  
7/10/01**

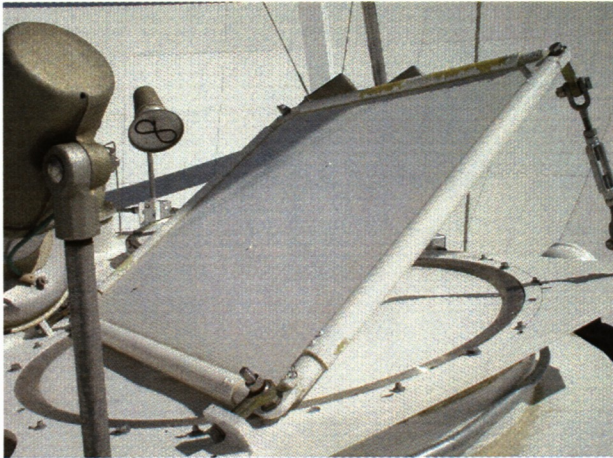
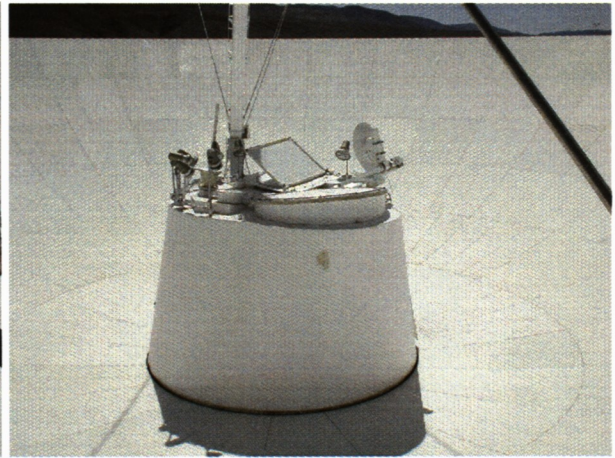
The dichroic panel is in good condition, but the paint on the frame needed touch-up.

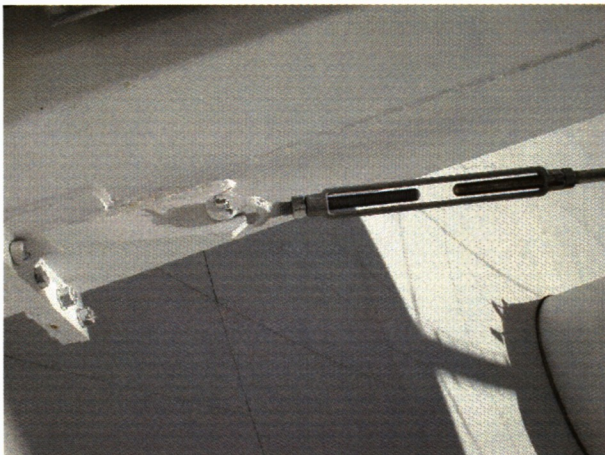
One quad leg t-buckle jam nut needed tightening.

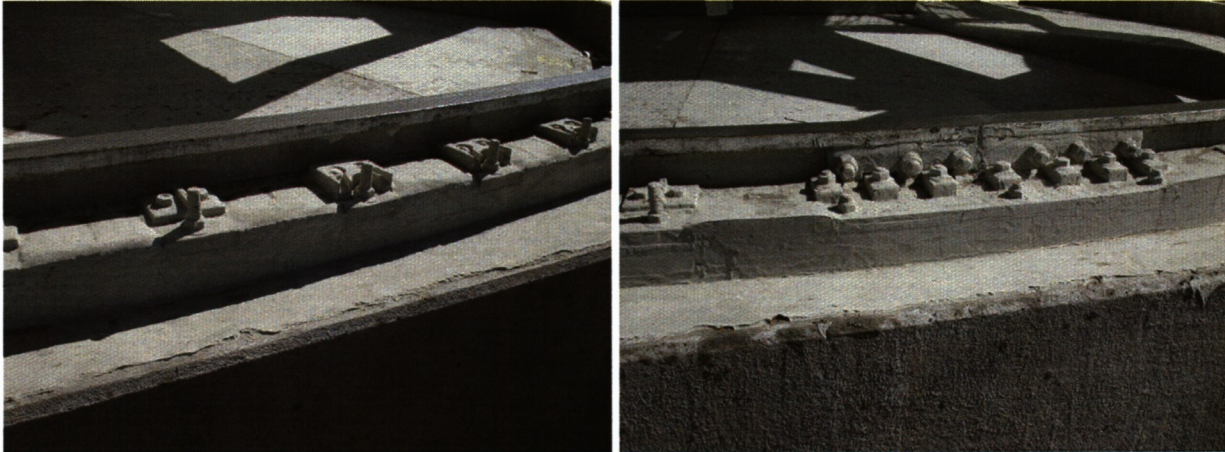
The azimuth rail grout and Vulkem are in excellent condition.

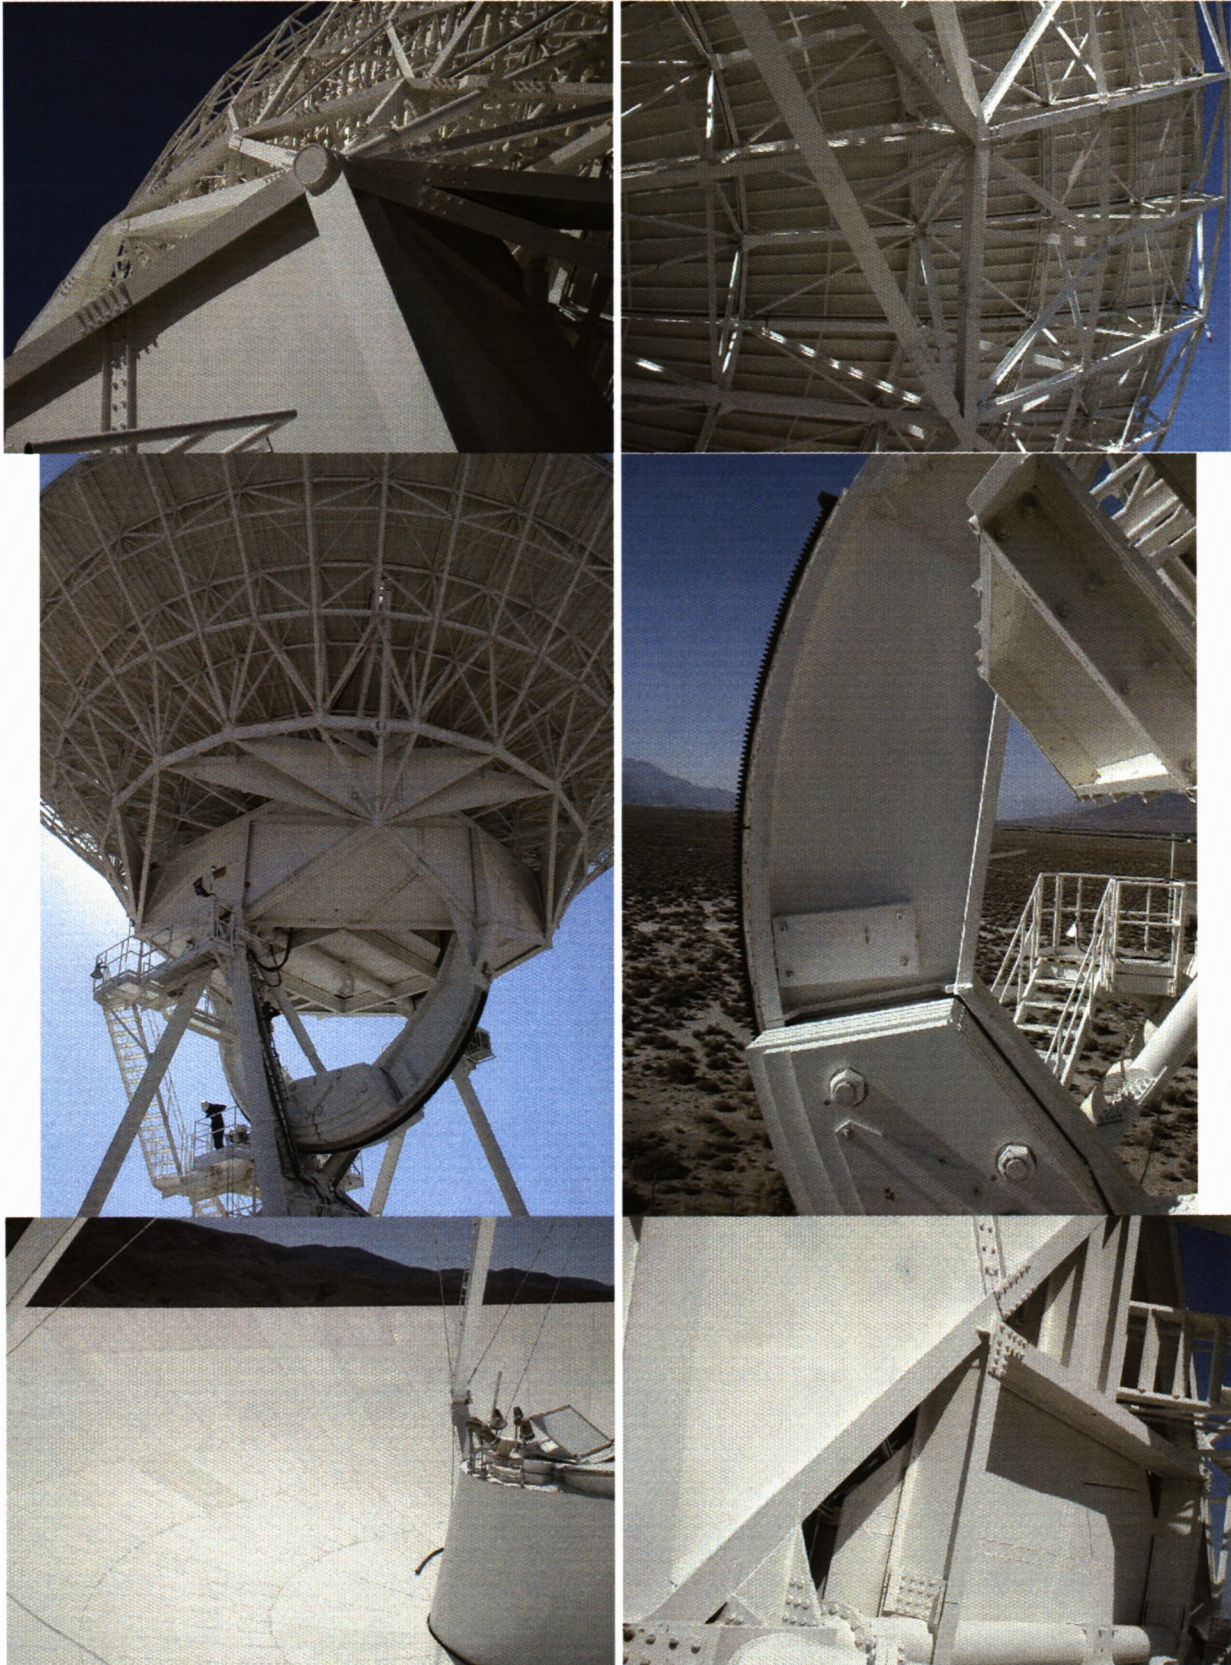
The paint on this antenna is in excellent condition.

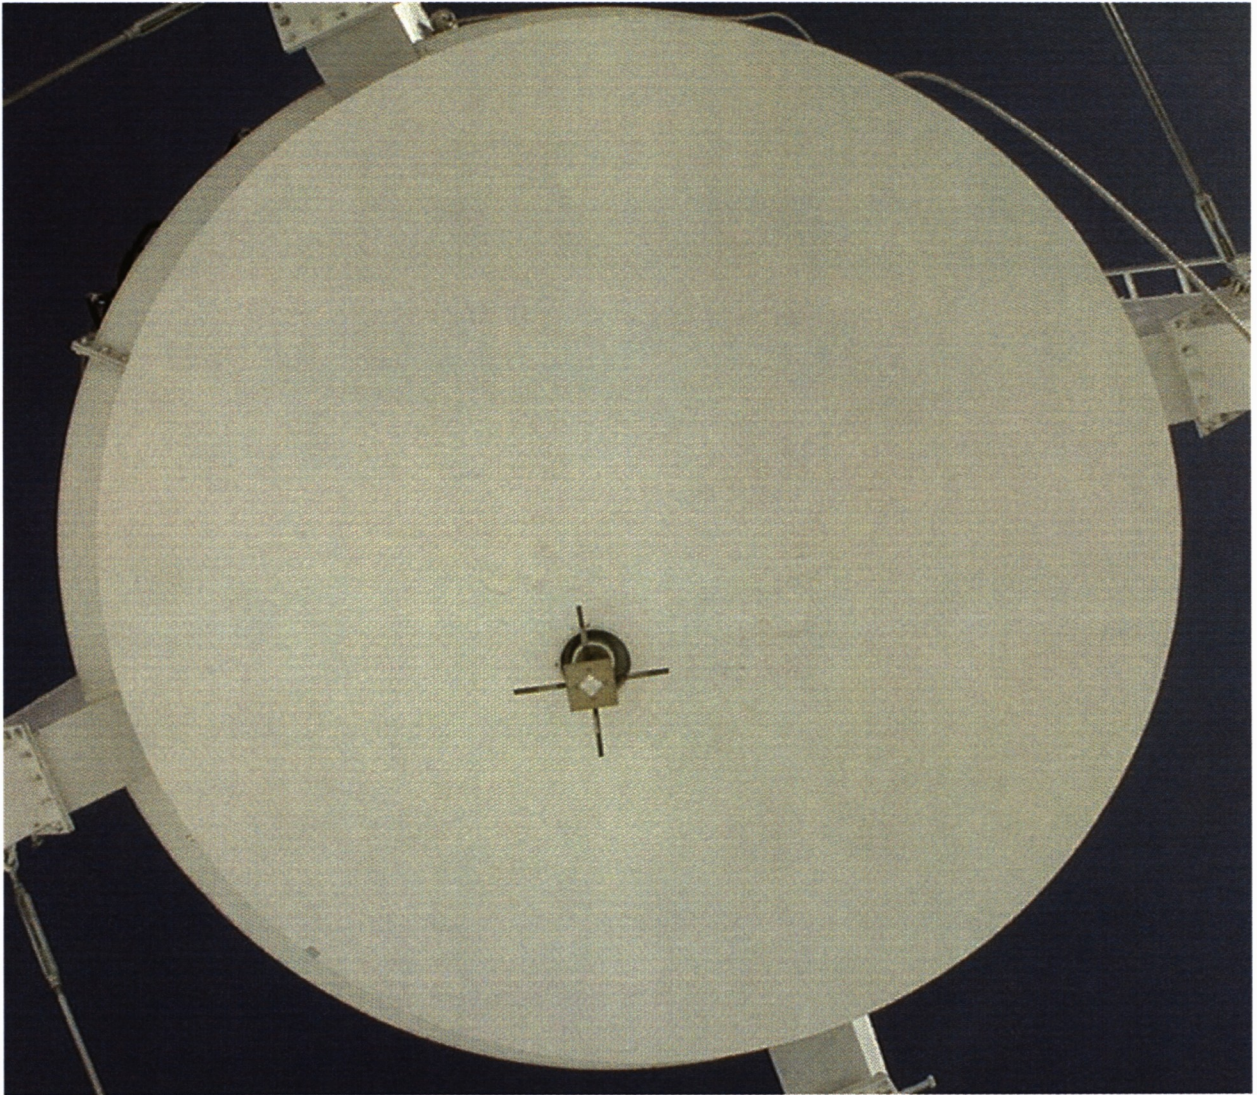
The subreflector is in good condition.
