National Radio Astronomy Observatory
Socorro, NM

VLBA Antenna Memo Series #34

Brewster Maintenance Visit
July 23rd through 30th, 2001

Jim Ruff
8/2/01

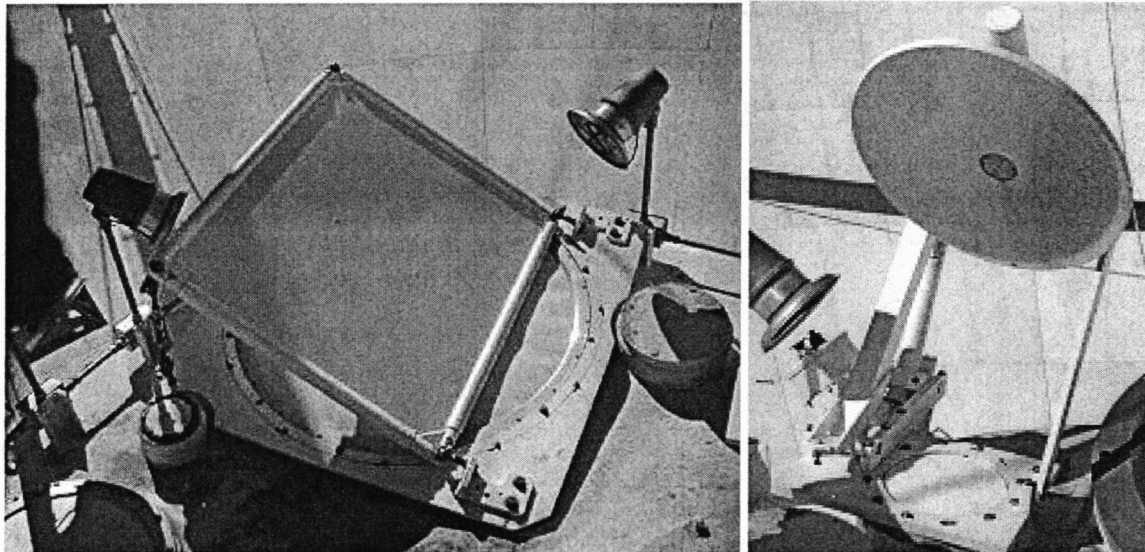
The dichroic panel is in good condition. The dish tipper overtravel springs were replaced because they were showing some rust.

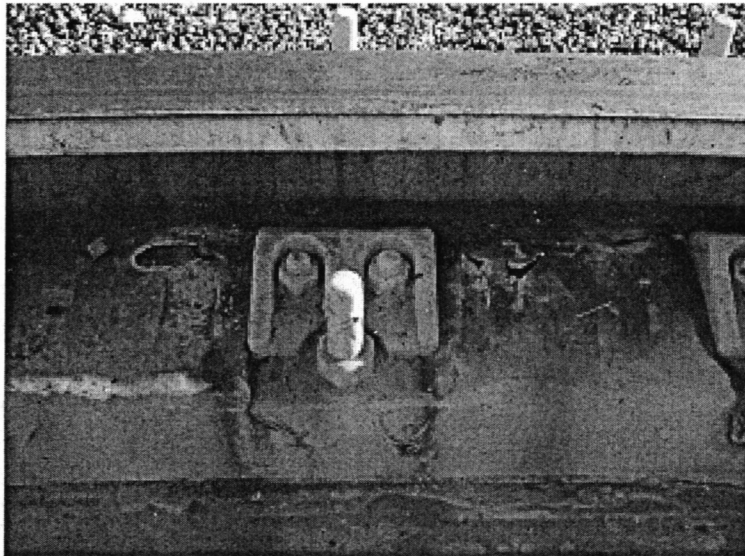
The azimuth rail grout and Vulkem are in good condition, but the grout is crumbling in a few areas.

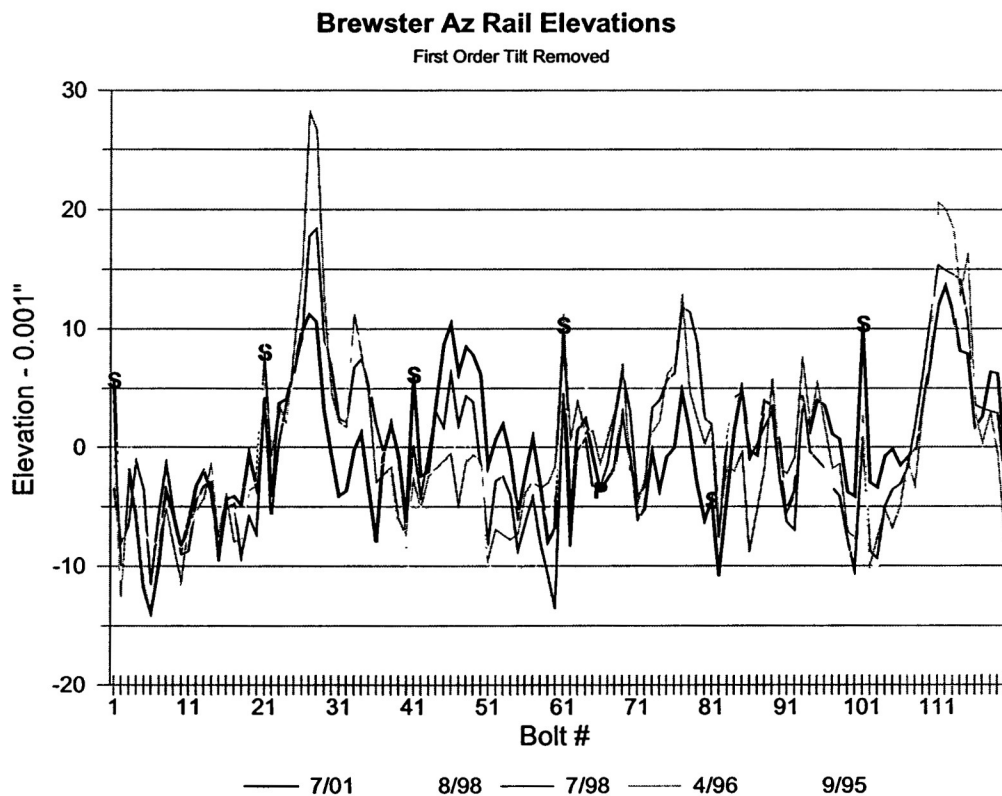
The rail at Brewster is very flat, with less than 0.030" deviation in elevation after the tilt is removed. The first order tilt is only 6 arcsec.

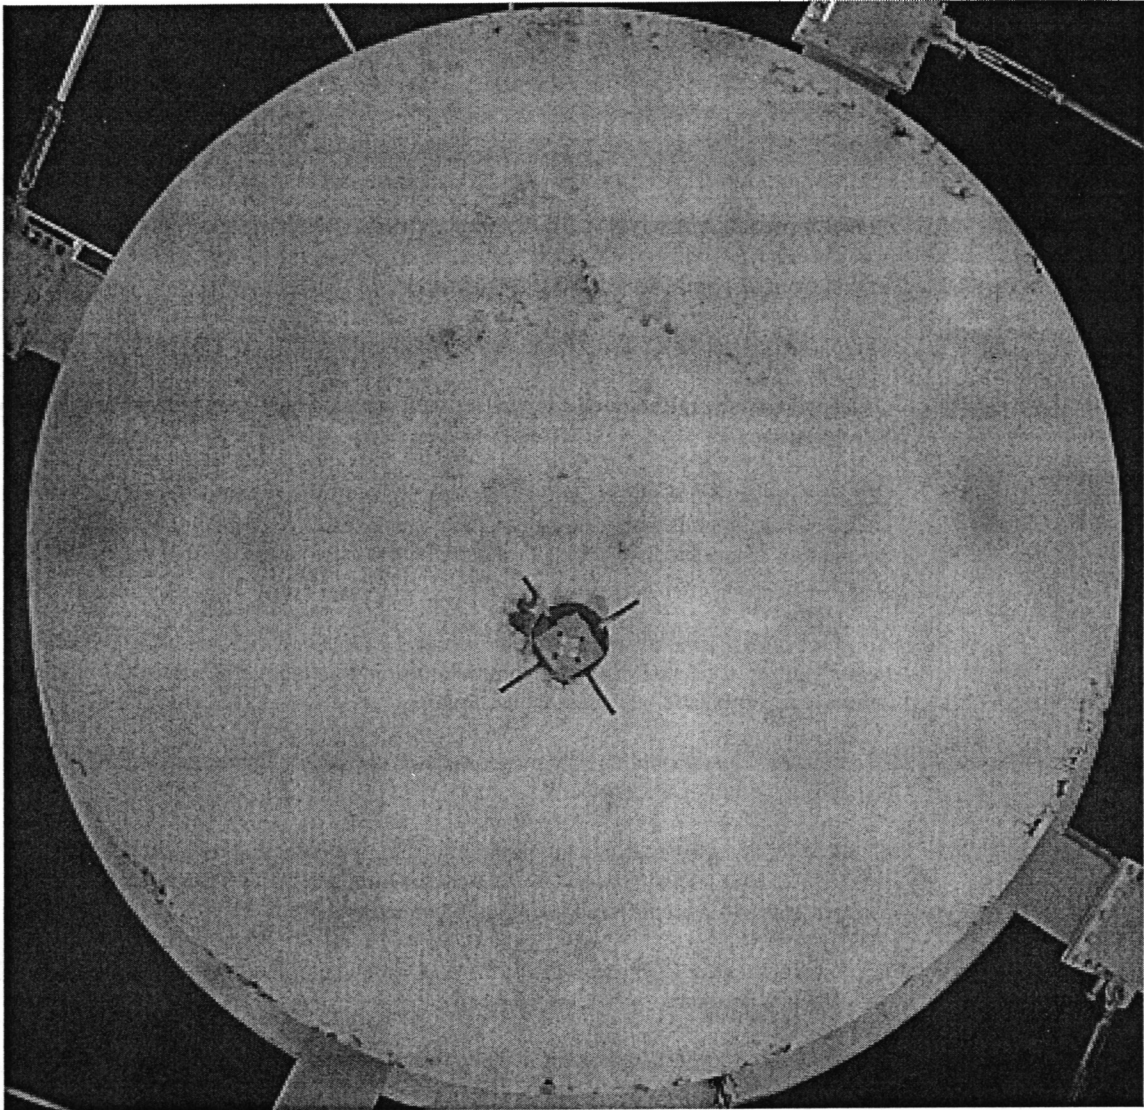
Some of the paint on the subreflector is peeling.

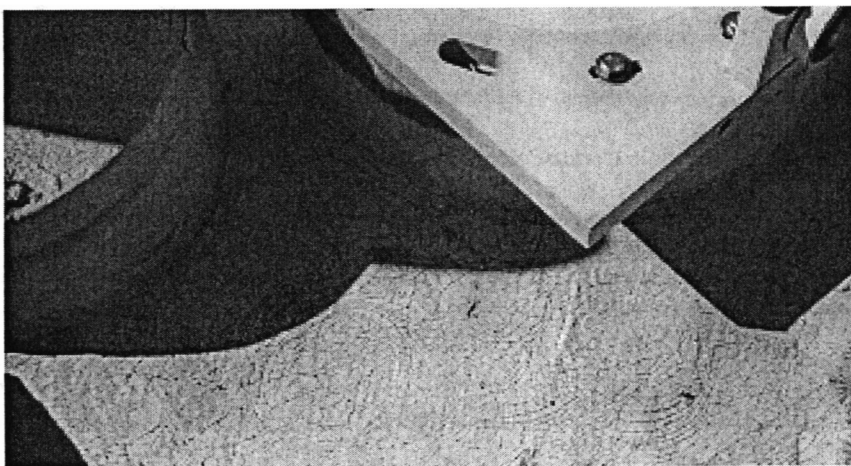
The feed cone finish is checked

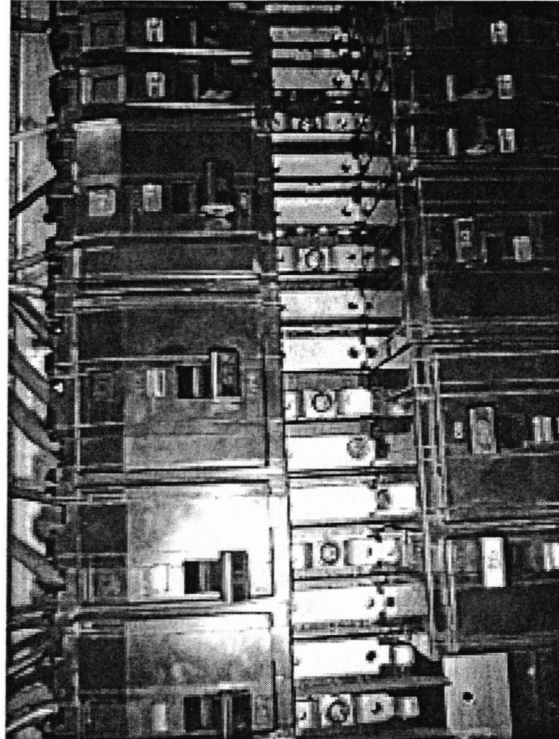
Ped Room Breakers

Also while I was doing the IR. Thermometer checks in the ped. Room electrical panels, Steve Troy noticed that the buss for the breakers is a screw in type and the breakers themselves are not the screw in type. So the breakers will pop out if the panel cover is off. Steve Troy notified Tom Baldwin of the problem and Tom will follow up on it.
