**National Radio Astronomy Observatory
Socorro, NM**

VLBA Antenna Memo Series #36

**Pie Town Maintenance Visit
2001**

**Jim Ruff
1/04/02**

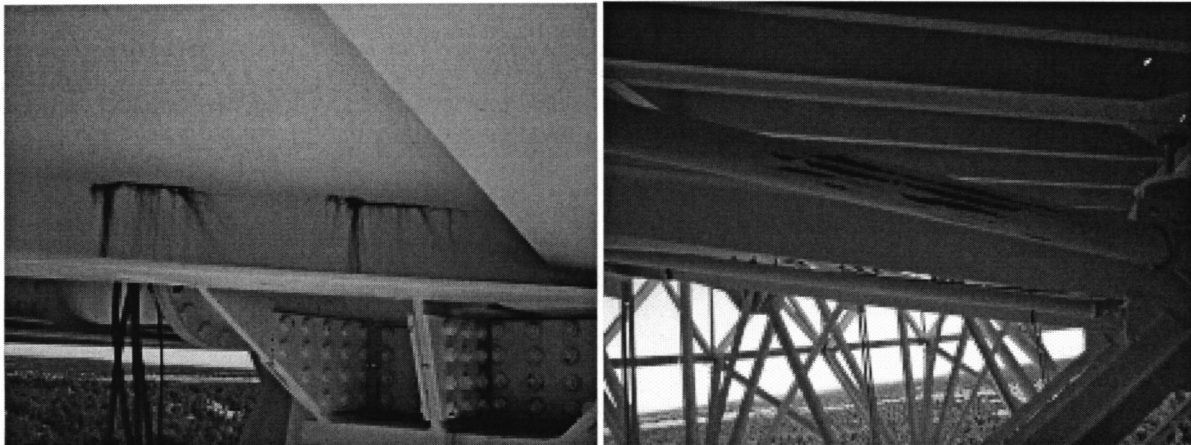
Structural cracks found previously had not progressed. A backup structure tube with freeze cracking was found.

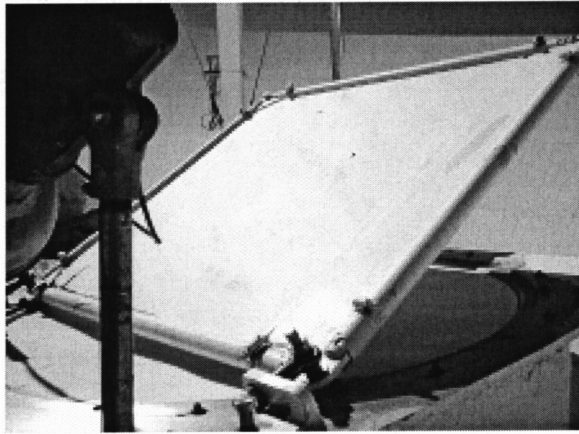
The dichroic panel is in good condition.

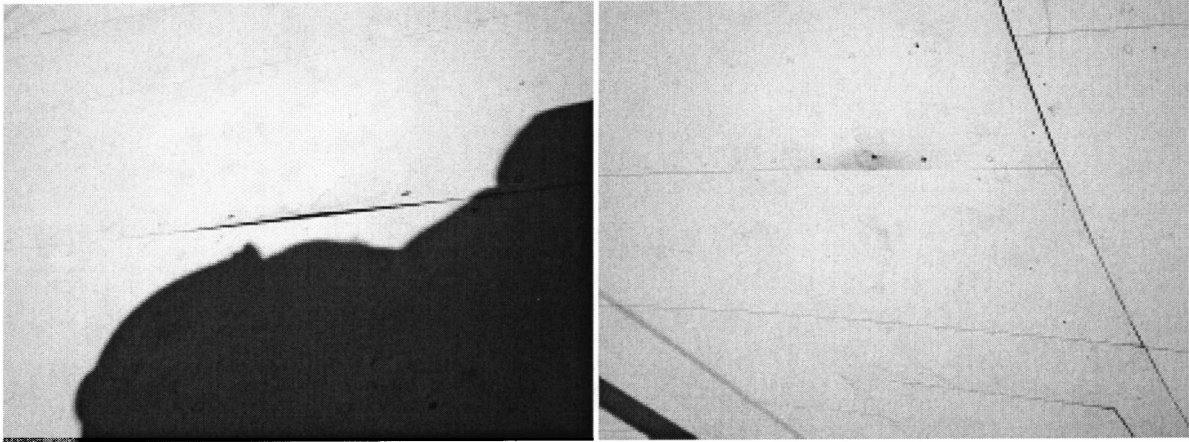
There is a dented panel near the main dish access hatch.

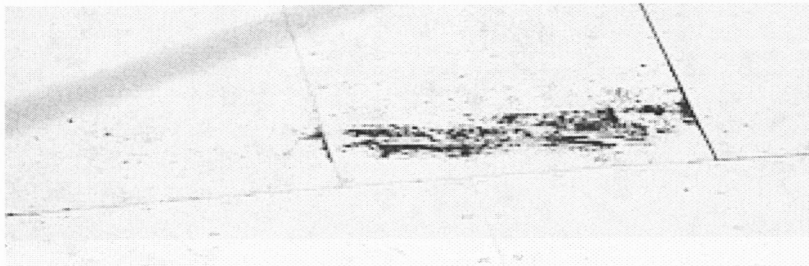
There are areas of eroded paint on some of the panels.

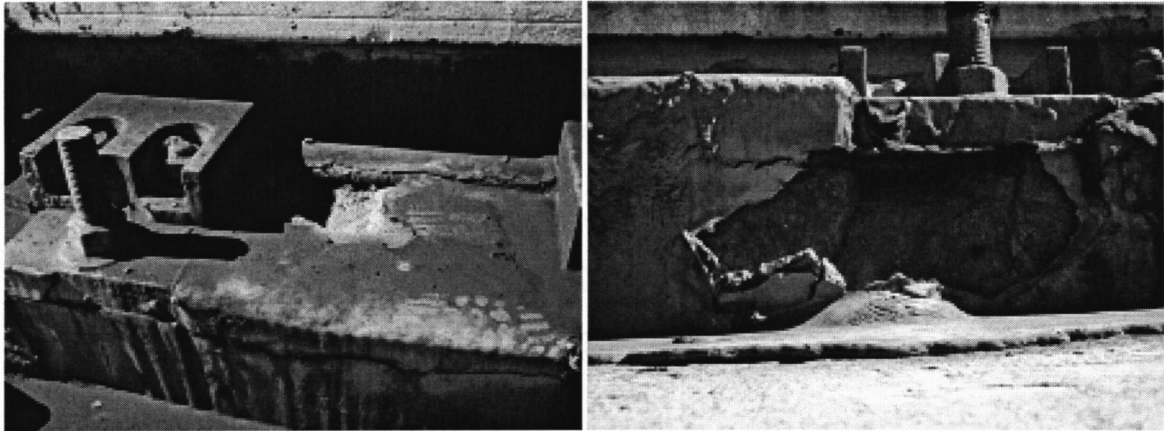
The azimuth rail grout is in need of spot patching. There are damp spots under the Vulkem that may promote further degradation.

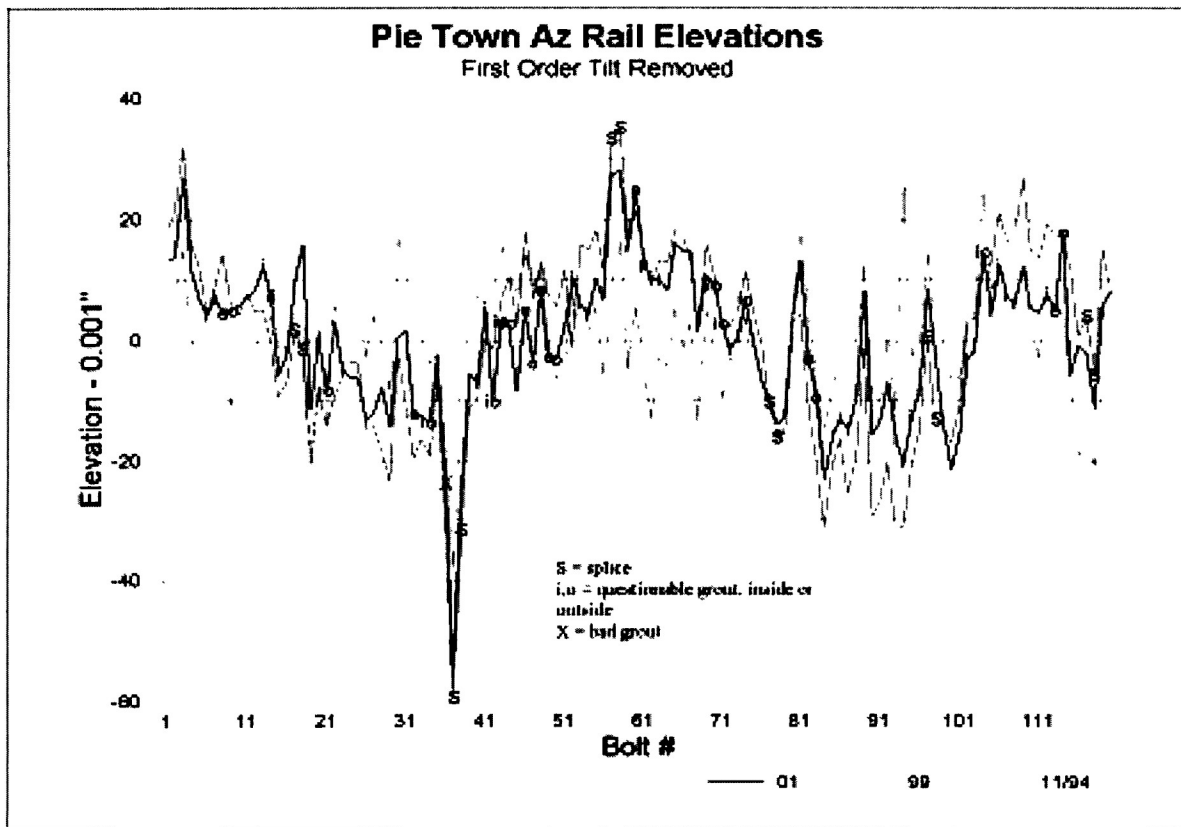
First order tilt is 0.31 inch (3' 32").

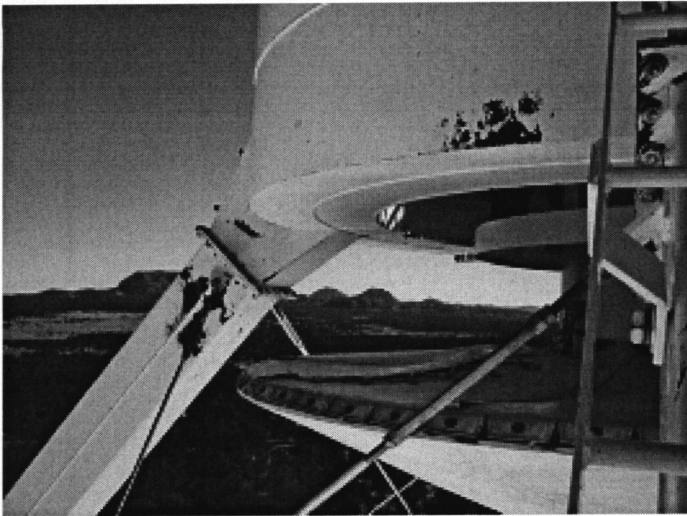
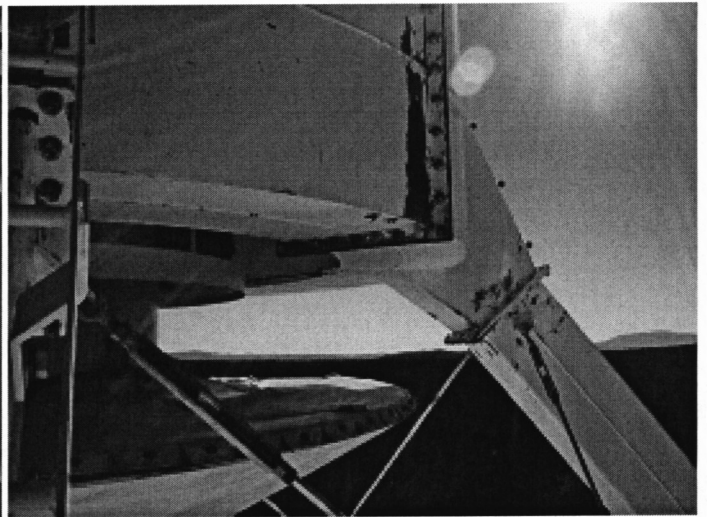
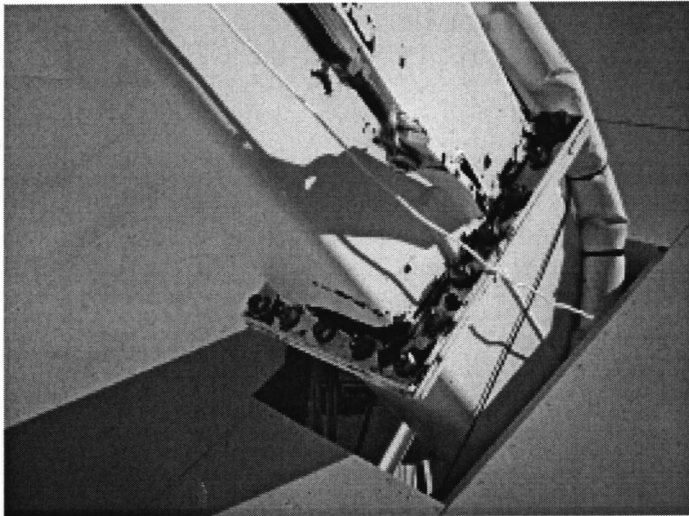
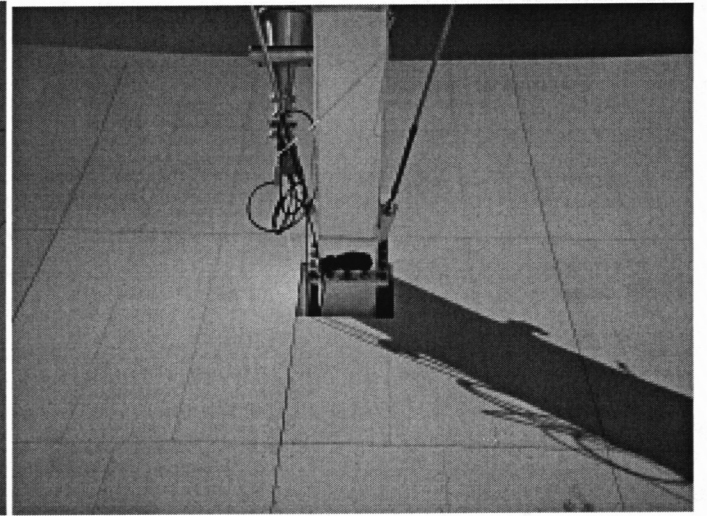
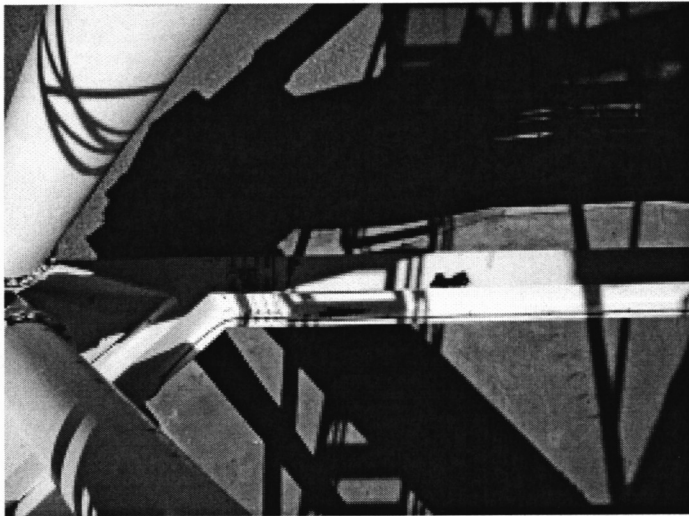
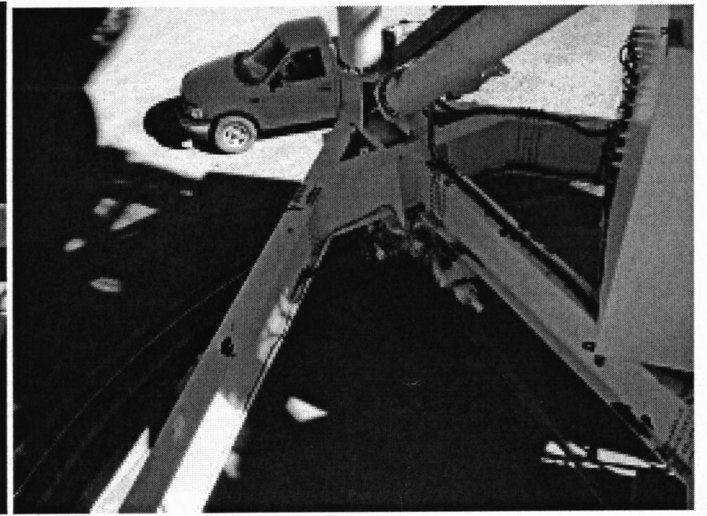
The paint on this antenna is in need of touch-up.
