NATIONAL RADIO ASTRONOMY OBSERVATORY
Socorro, New Mexico

VLBA Antenna Memo Series No.37

Owens Valley Gearbox Repair

J. E. Thunborg
April 26, 2002

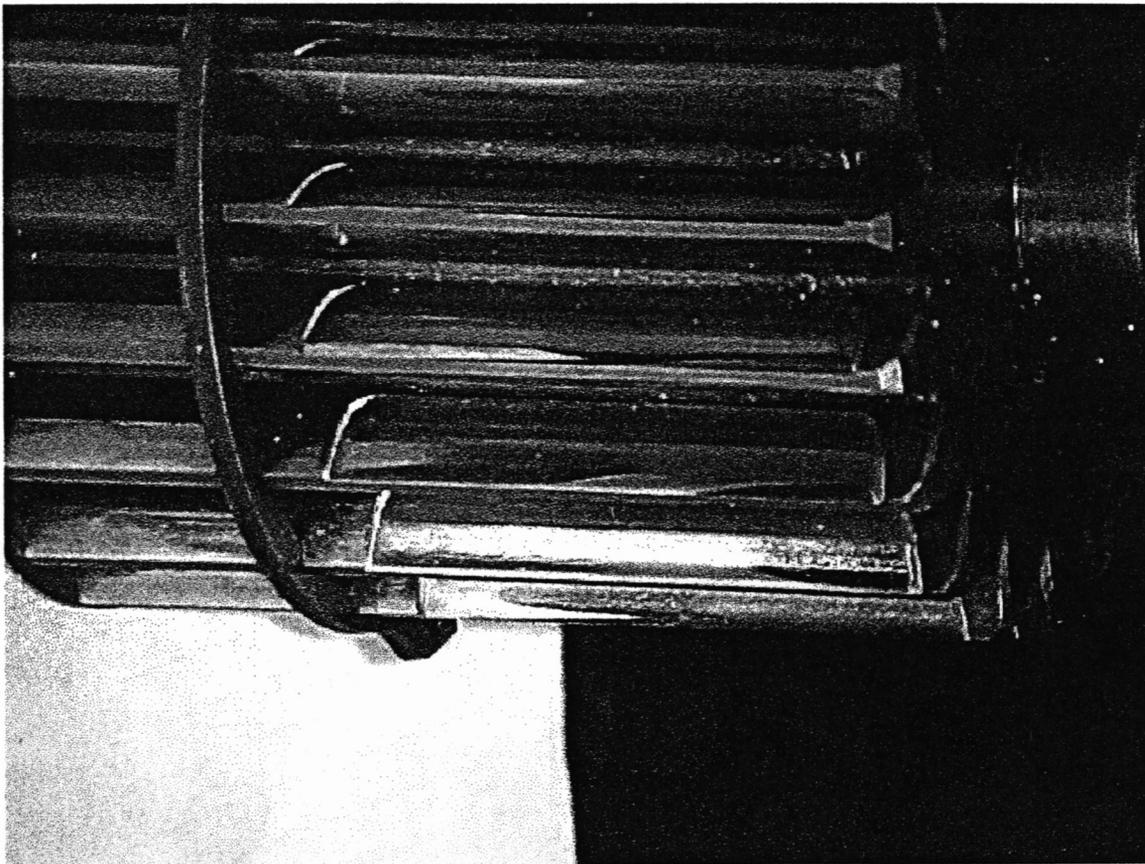
A groove matching the profile of the planetary gears was worn into one side of the sun gears. A typical groove is shown in the photograph below. The depth of the grooves was between 0.010 and 0.015 inches. The deeper grooves were on the latter or slower moving stages of the gearboxes. The surfaces of the grooves were very shiny, almost a lapped appearance. There were no scratches in the gear teeth that would indicate foreign particles in the oil. The fact that the slower running, higher loaded, later stage gears showed more wear than the faster running, lighter loaded, early stage gears may indicate that we should use a higher viscosity oil.

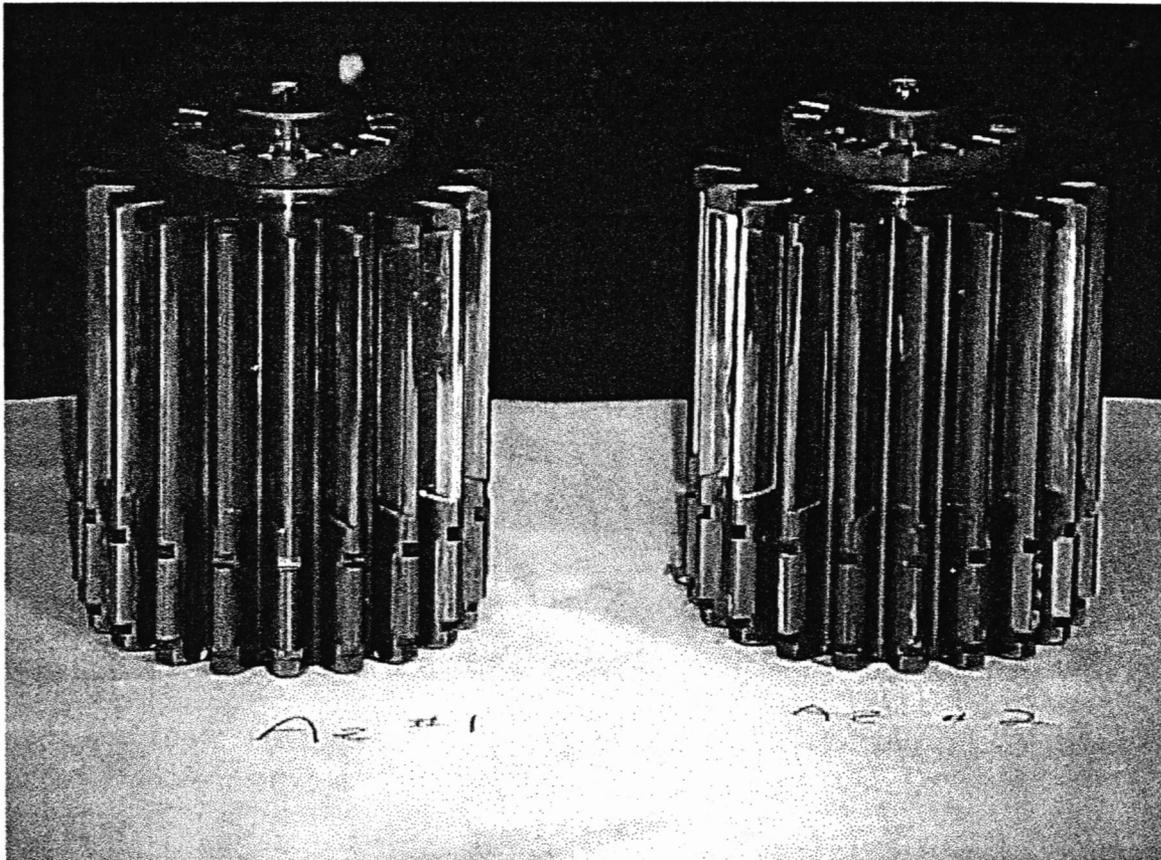
The photograph below shows that the sun gears in Az#1 gearbox are worn on the counter clockwise rotation side while the sun Gears in Az#2 gearbox are worn on the clockwise side. The sun gears show very little wear on the opposite side. This uneven wear is probably due to the 30% servo preload used to reduce backlash. If this is the case, we should be able to extend the life of the gears by reversing the direction of the preload or swapping the gears from one gearbox to another.

During maintenance visits to other sites, we will open up the gearboxes and inspect them. If these gearboxes show identical wear patterns, then we should immediately reverse the preload or the exchange the gears in the gearboxes.
