**NATIONAL RADIO ASTRONOMY OBSERVATORY**  
Socorro, New Mexico

VLBA Antenna Memo Series No.39

**Los Alamos – Drive #1 Axle Repair**

**June 18-19, 2002 - Trip Report**

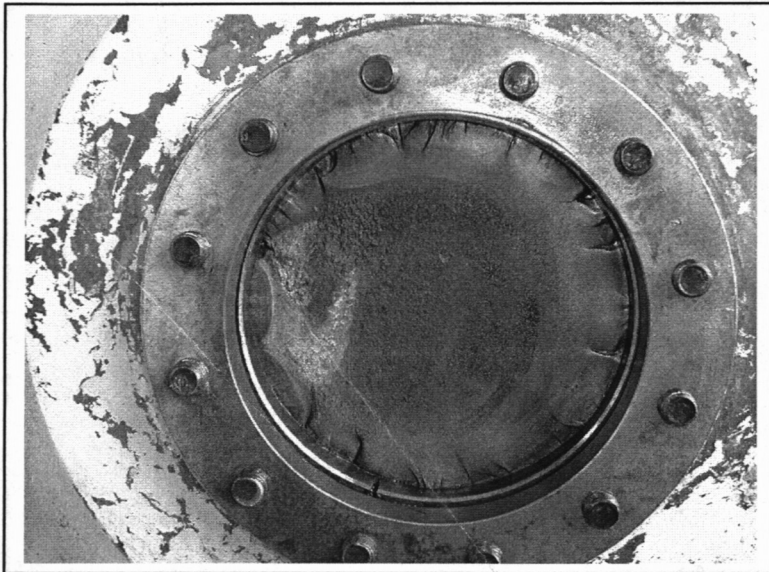
The azimuth drive #1 wheel in Los Alamos started making popping noises. The 7" diameter axle subsequently broke a few days later. The axle broke about 1 inch inside the edge of the taper coupling between the wheel and the outside bearing. The break and place of the break were very similar to the previous axle failure on Drive #2 of the Los Alamos antenna (VLBA antenna Memo's #28 and #30).

The paint on the gearbox drive shaft revealed that the coupling on the shaft had moved out approximately 1/4". This most likely occurred when the axle broke, as it was not detected when the wheel started making popping noises.

During the maintenance visit in April 2001, Jim Ruff and company found that the angular alignment of this drive wheel was off by 0? 4' vertical and 0? 1.5' horizontal. It is unknown whether this misalignment contributed to the failure.

Gene Dunn, Ramon Gutierrez, Paul Johnson, Jim Ruff and John Wall replaced the wheel/bearing assembly on June 18. The author of this report showed up on June 19 after the bulk of the work was done.

On June 19 the following alignment parameters were recorded for the new axle/wheel assembly. The antenna rotated smoothly without popping sounds.

<b>Measured</b>	<b>Specified</b>
Conic radius	299.97"	300" 1/4
Coupling	0.013 TIR	Not Specified
Axle Vertical Slope	93? 27' 14"	93? 26' 23" ? 1.4'
Axle Horizontal error	1' 38"	< 1.4'
