**National Radio Astronomy Observatory
Socorro, NM**

VLBA Antenna Memo Series #40

**St Croix Maintenance Visit
April 8th through 25th, 2002**

**Jim Ruff
6/24/02**

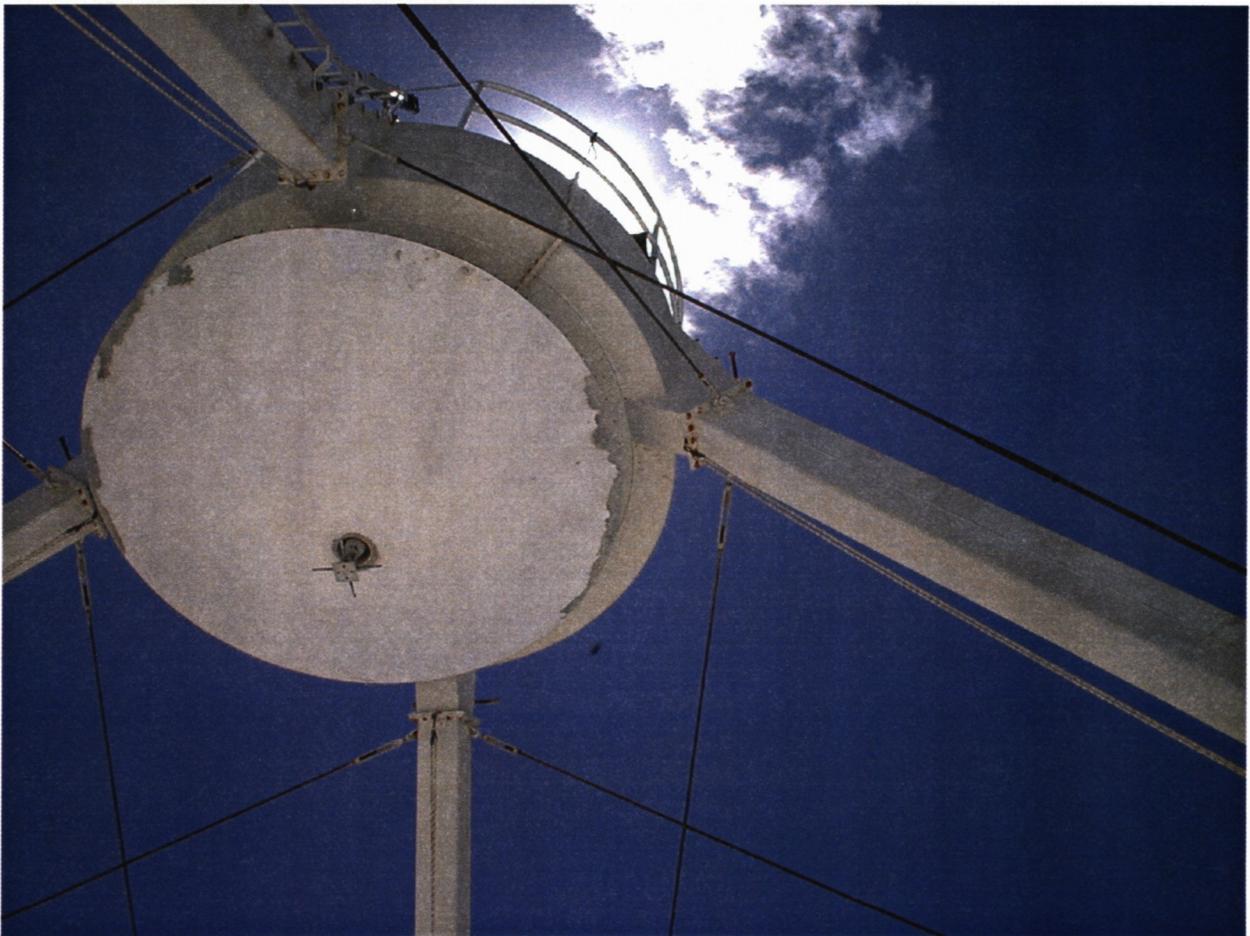
A quad leg ladder and Sellstrom fall arrest system were installed. (The handrail was installed previously.) The site techs were treated to a training session on use of the Sellstrom system and general fall protection. Note the corroded guy wires in the photo above.

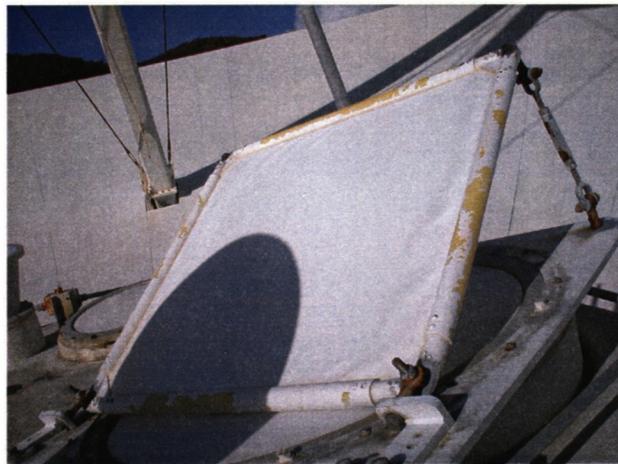
The dichroic panel is delaminating. (The frame was repainted after this picture was taken.)

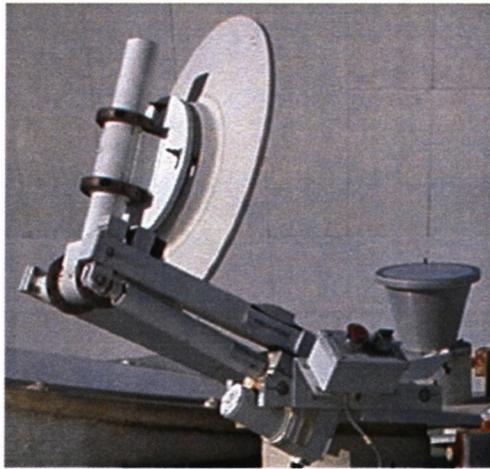
The dish tipper looked fine.

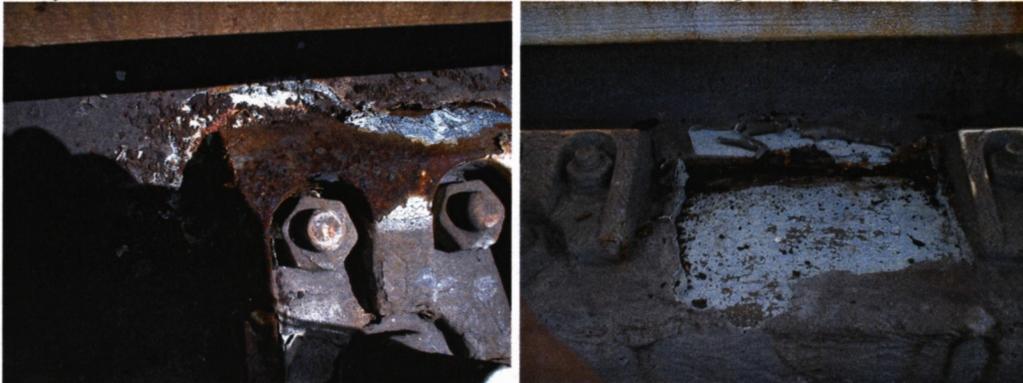
The rails and rail clips on this antenna are rusting. The Vulkem has cracked to the point where it no longer keeps water away from the metal. In fact, it holds water in, facilitating rusting (if that's possible at STX!)

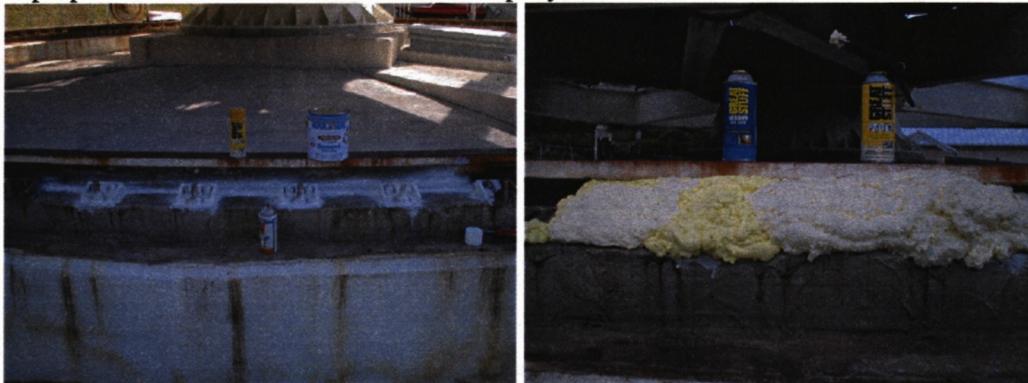
I did some experiments on ways to slow the deterioration. I scraped off the Vulkem in some bad areas and applied "Rust Cap" primer to the bare metal. Then I sprayed "Great Stuff" foam over half of the primed areas.

We need to monitor these patches, consider other alternatives, and decide how to proceed. I think we can wait a while before doing something, but the longer we wait, the more rust we'll have to deal with. In the mean time, the site techs are removing vulkem in their spare time.

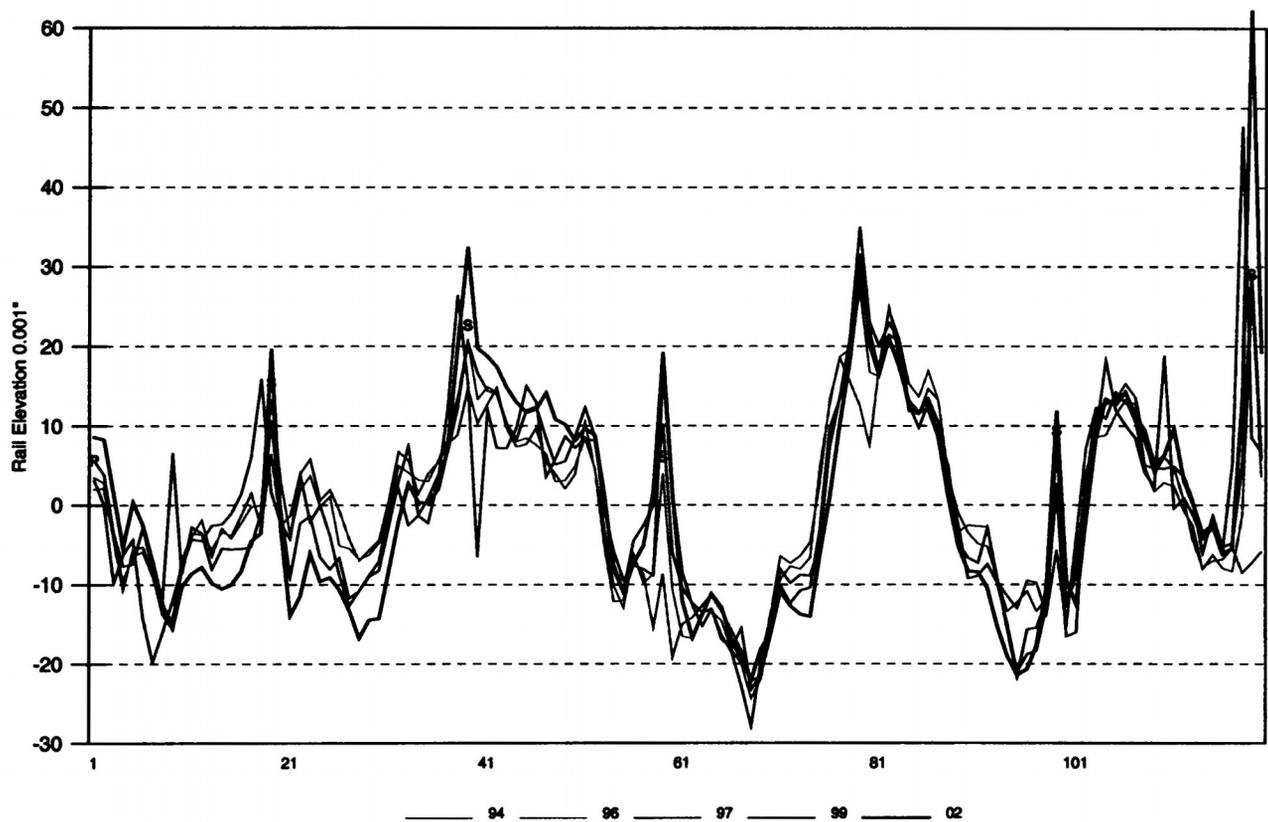
SC Azimuth Rail

The SC rail has a first order tilt of nearly 0.3" peak-to-peak.

The splice at bolt #119 appears to be sinking over time. Similar behavior was seen at NL by the rail grout repair crew this year. It appears the rail is being slightly, slowly squashed at the splices. This should be repairable by shimming.

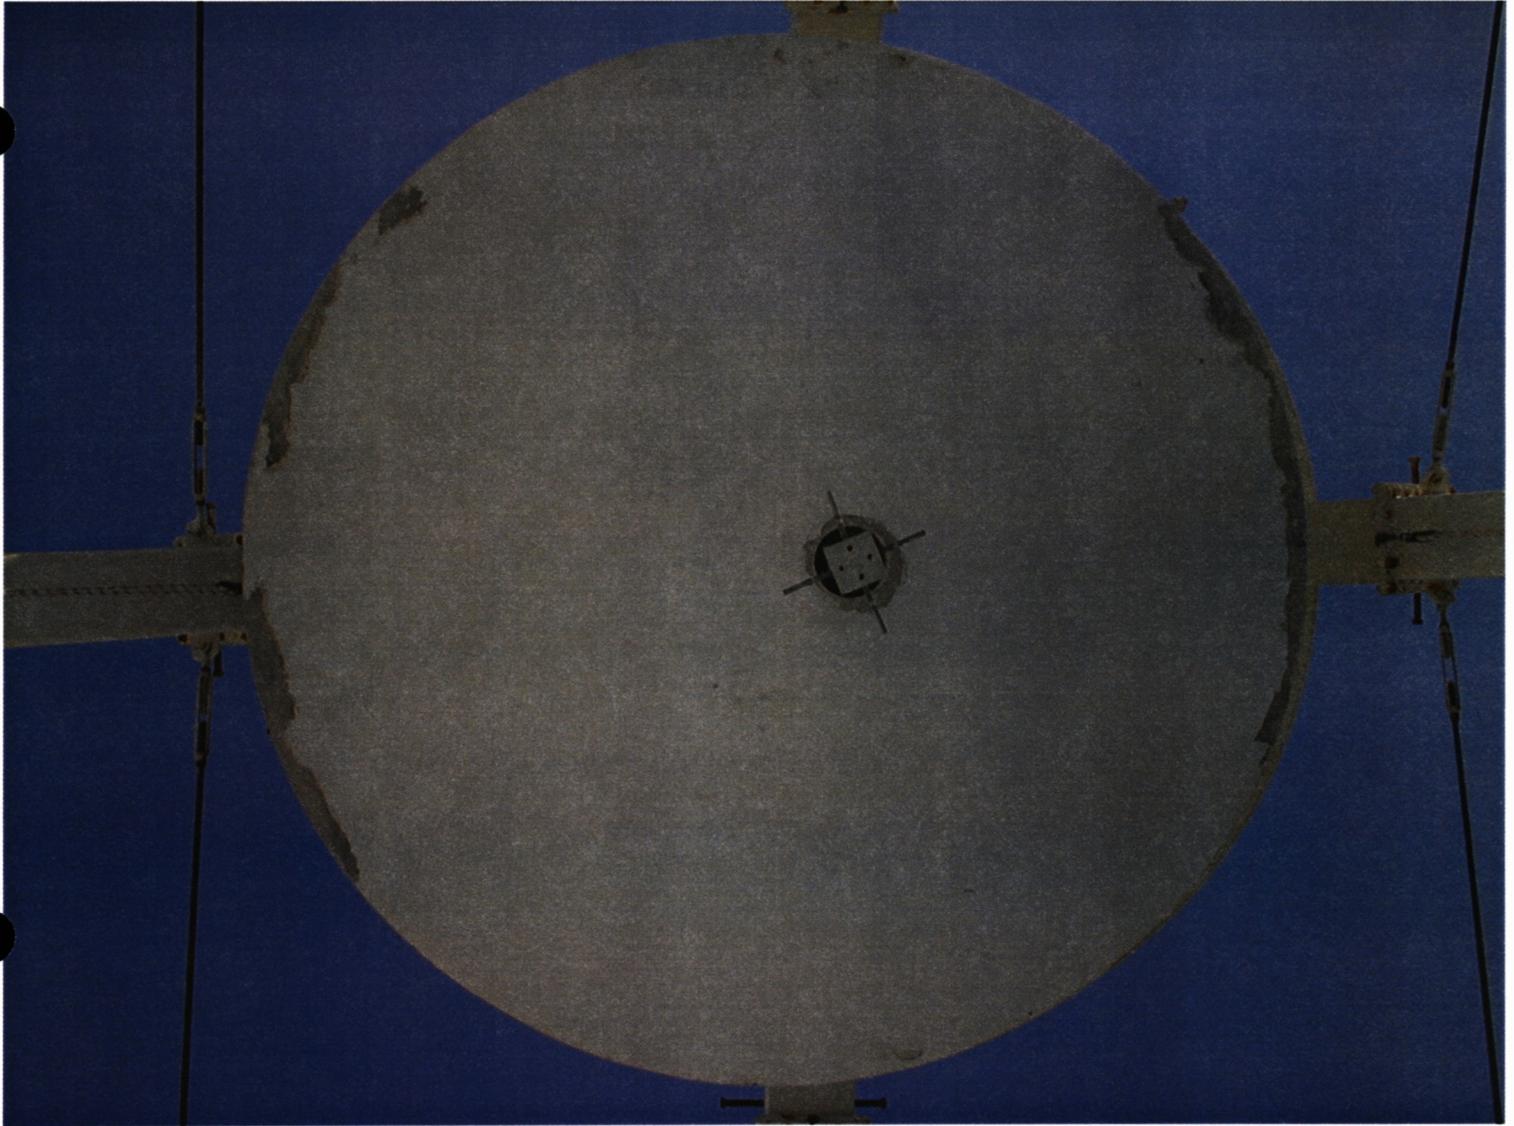
Some of the paint on the subreflector is peeling.

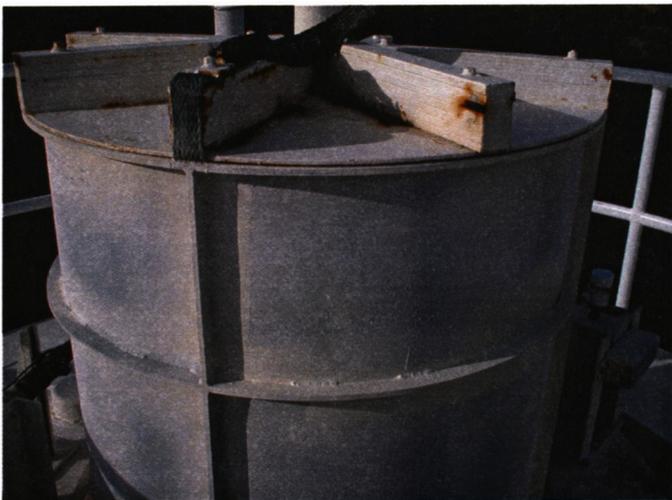
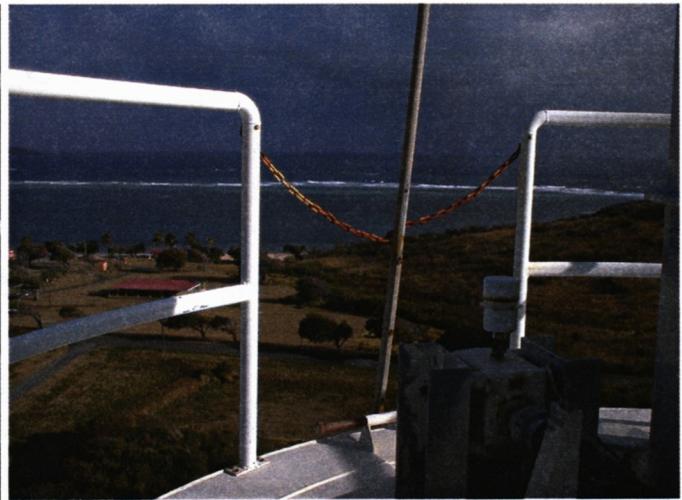
Some of the SR counterweight screws and the handrail chain were replaced.
