**National Radio Astronomy Observatory  
Socorro, NM**

**VLBA Antenna Memo Series #41**

**Hancock Maintenance Visit  
June 3<sup>rd</sup> through 10<sup>th</sup>, 2002**

**Jim Ruff  
6/25/02**

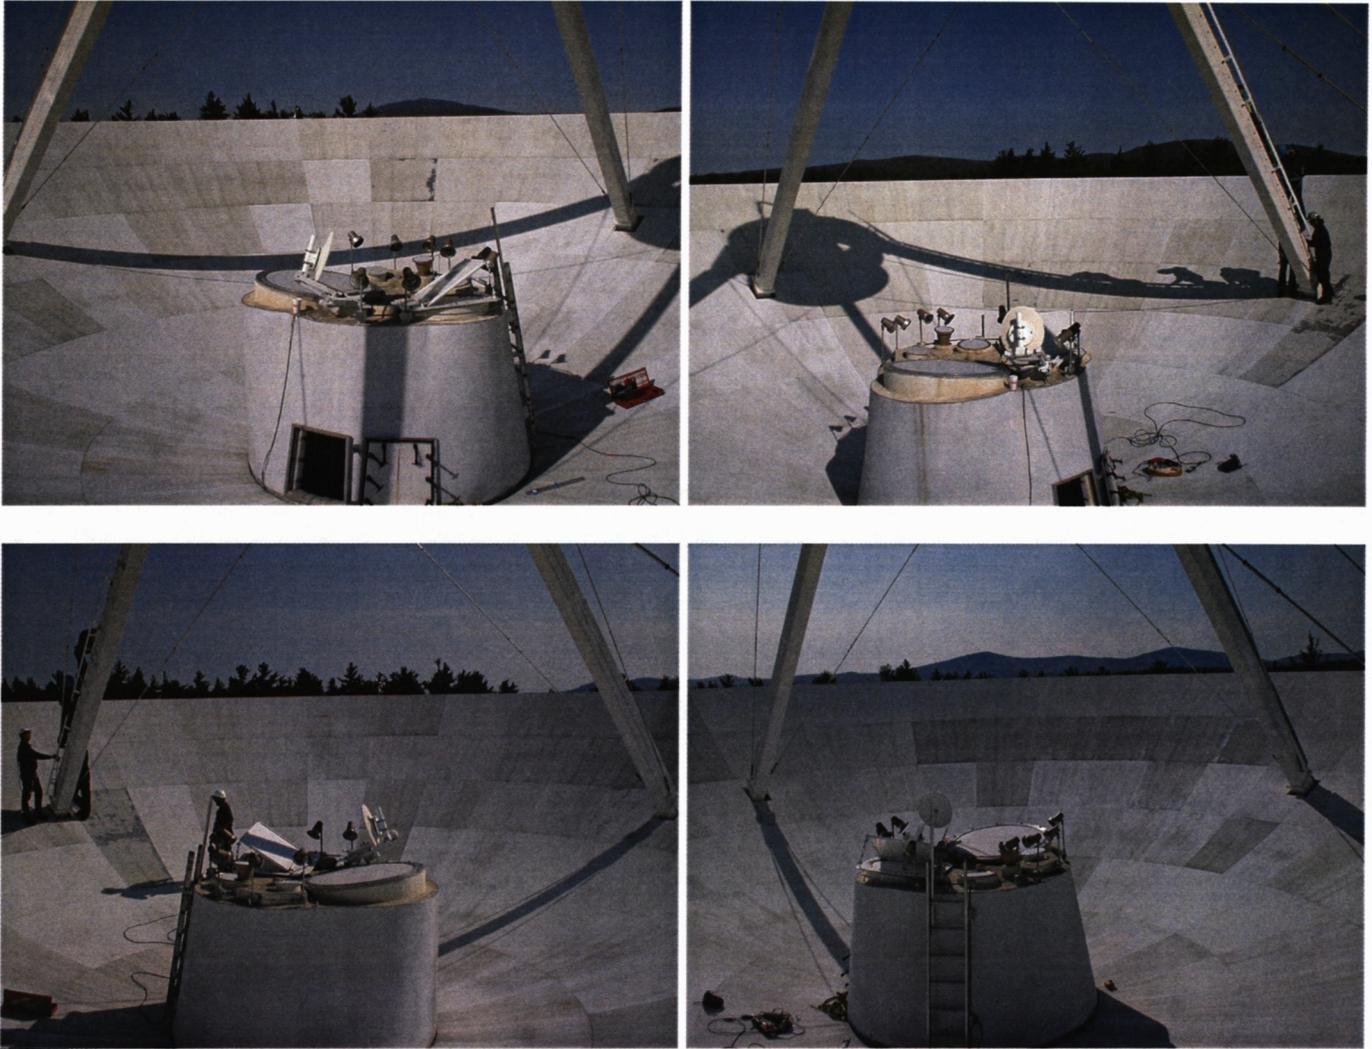
Antenna Surface Panels

**Many of the panels on this antenna are losing their paint. The paint on these panels comes off down to bare metal with a shoe swipe. The panel next to the ladder had large bare spots due to extra traffic. The bare spots are slippery, so we swapped this panel with one from a less-traveled location. The next four photos show each quadrant of the dish. (These photos were taken before we swapped panels.)**

16. Jim Ruff, Ramon Gutierrez, Mark Alfero, and Bob McGoldrick transposed two panels in the dish for safety reasons; the panel to the right of the quadruped leg with the ladder was replaced by the fifth panel in the same row while it was put in the latter's position. The aforementioned panel was missing much paint and it was slick.

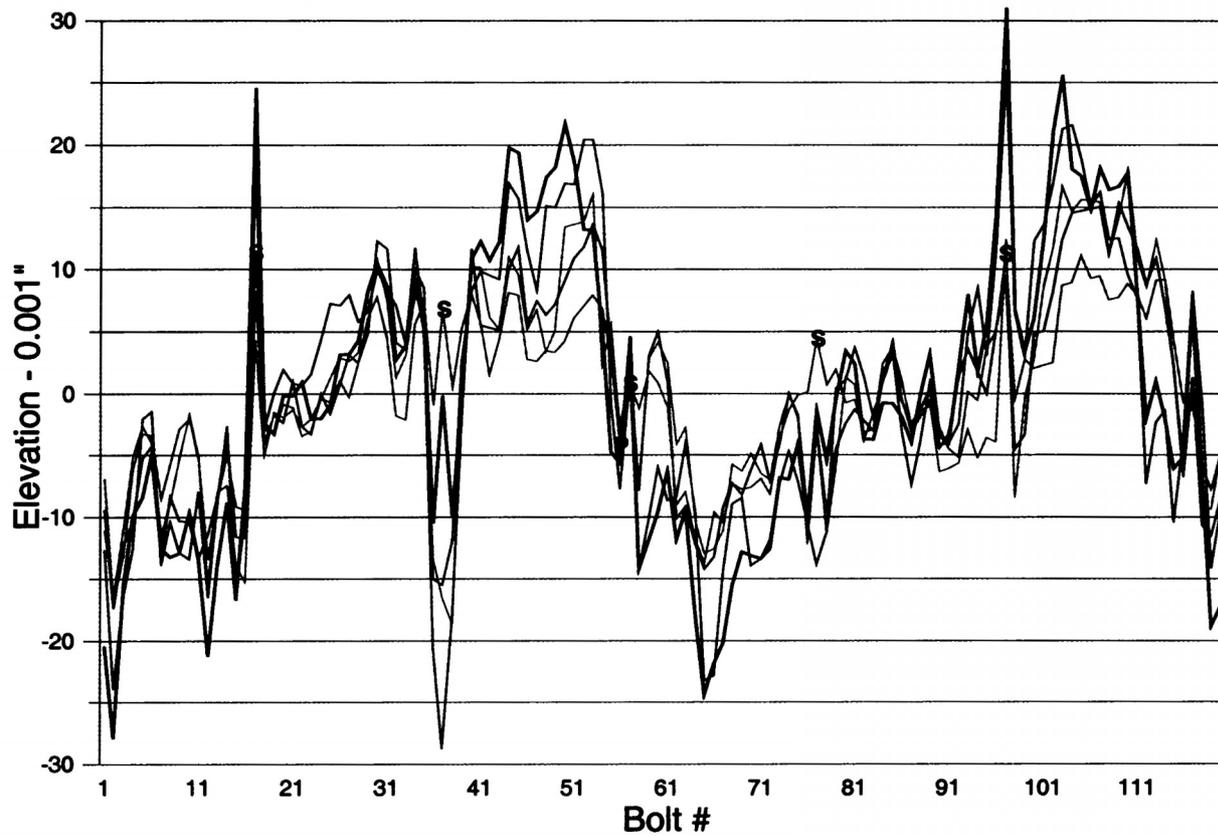
### Hancock Az Rail Elevations First Order Tilt Removed

The azimuth rail grout and Vulkem are in fairly good condition. We removed Vulkem and inspected the epoxy grout at all splices. The grout looked fine.

The first order tilt amplitude is 0.018"

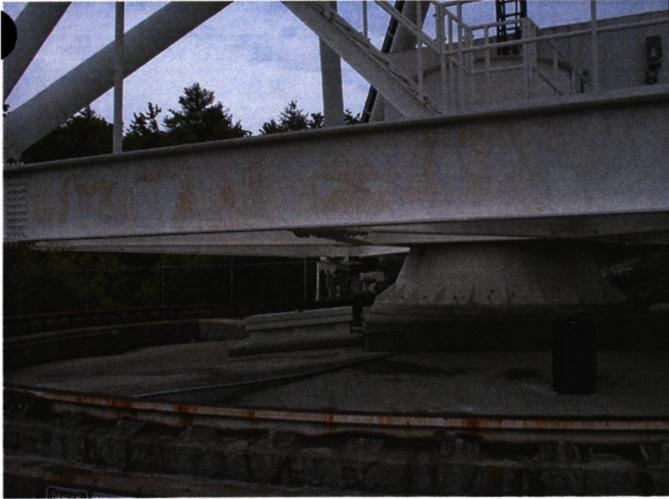
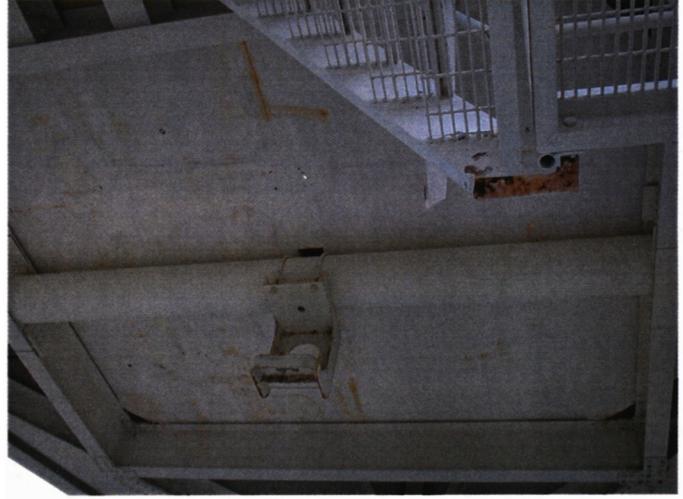
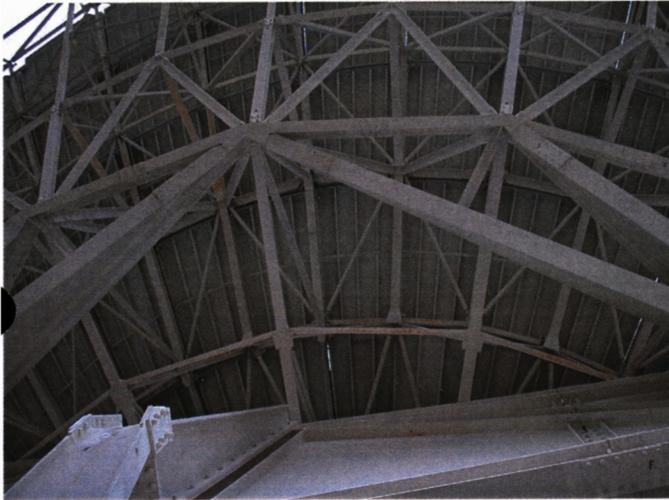
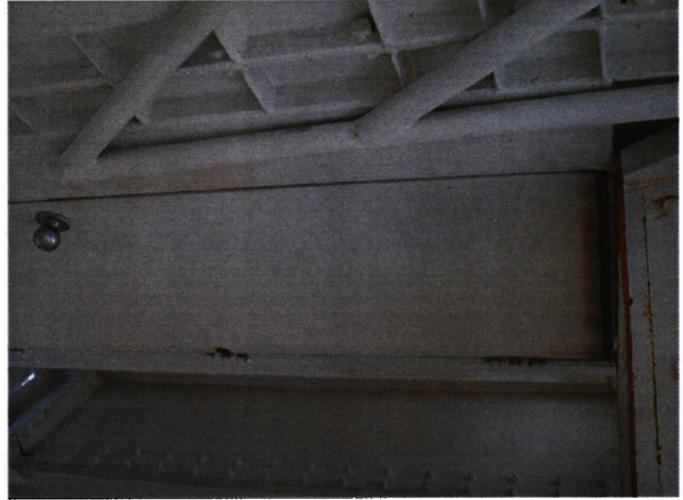
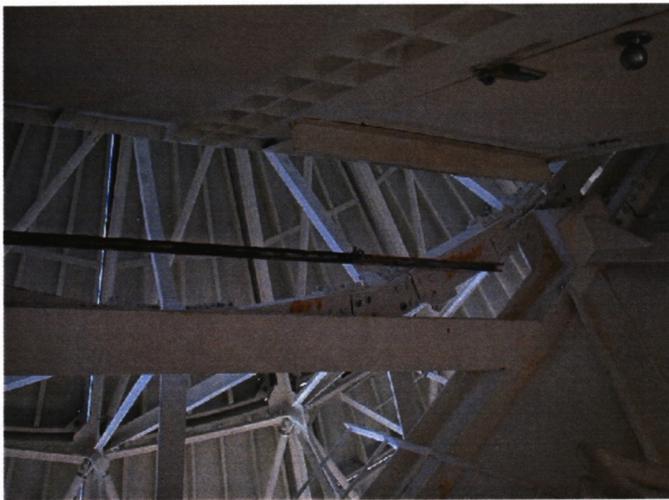
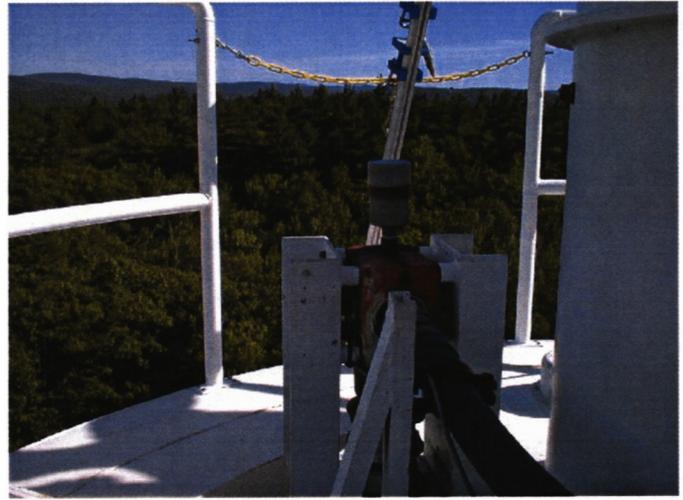
**The subreflector is stained.**

The paint is fairly good, but there are many areas where rust appears to be bleeding through. There are also some large areas where newer paint is peeling off of older paint.
