NATIONAL RADIO ASTRONOMY OBSERVATORY
Socorro, New Mexico

VLBA Antenna Memo Series No. 44

Los Alamos Rail Repair

J. E. Thunborg
August 21, 2002

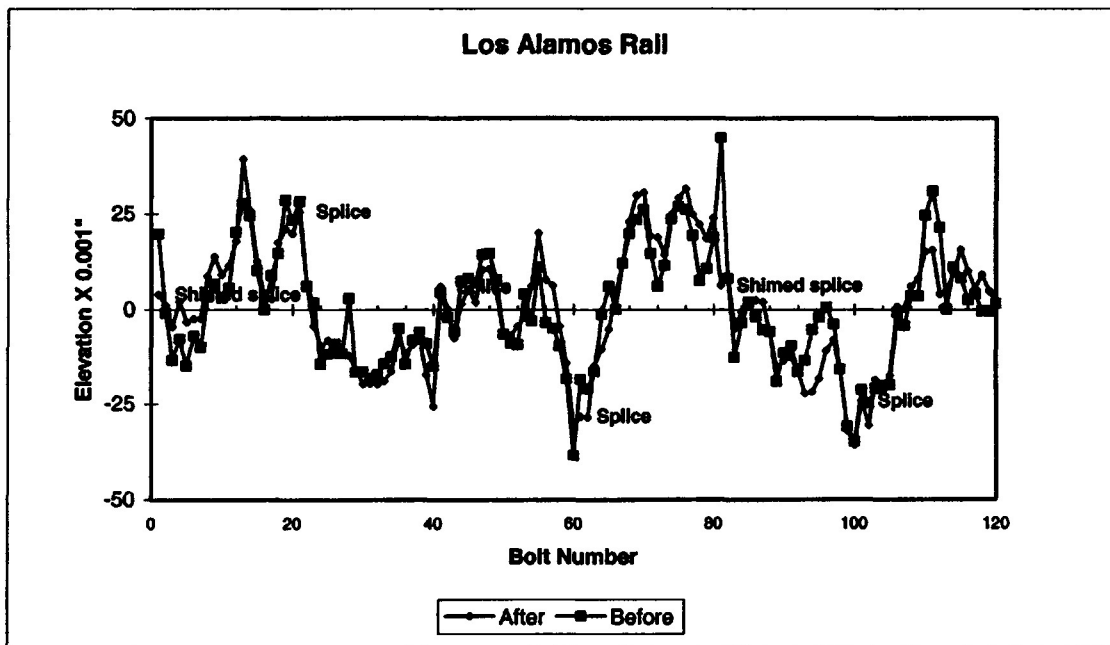
Eleven of the bolts that hold the rail clips to the rail plates were broken. When the loaded rail deflects into a section of degraded grout it causes the rail to lift at the adjacent rail plates thus breaking the rail plate bolts. The grout from below these rail plates was removed so that the broken bolts could be replaced with new ones.
