**National Radio Astronomy Observatory  
Socorro, NM**

**VLBA Antenna Memo Series #45**

**Mauna Kea Maintenance Visit  
August 12<sup>th</sup> through 21<sup>st</sup>, 2002**

**Jim Ruff  
9/30/02**

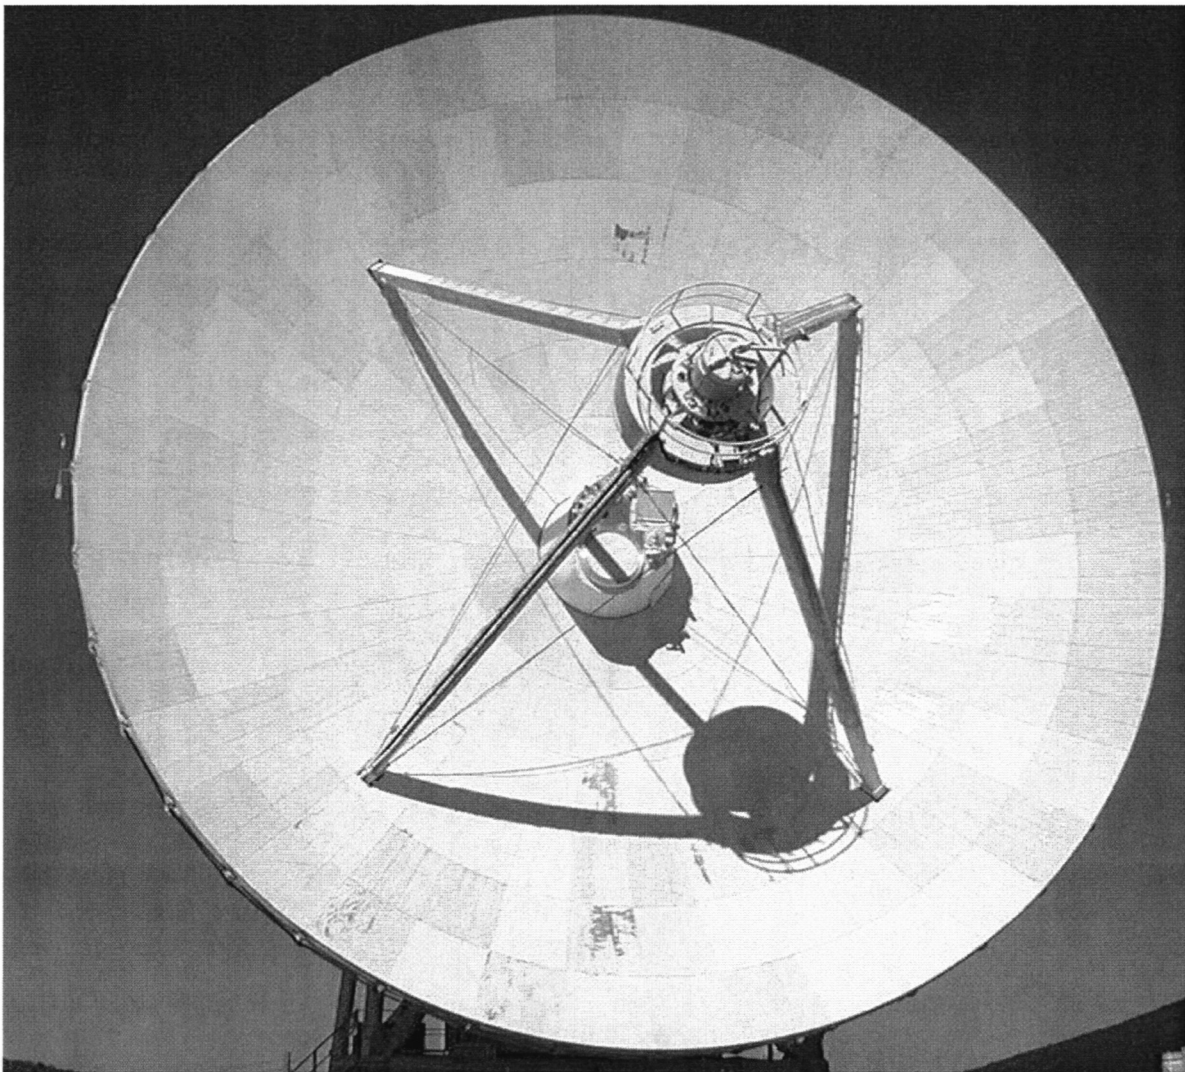
**An apex handrail, quad leg ladder and Sellstrom fall arrest system were installed. The site techs were treated to a training session on use of the Sellstrom system and general fall protection.**

**Some of the panels are losing their paint, but the remaining paint is firmly adhered and not slippery. The guy wire heaters are ineffective because they are not well attached. This should be corrected.**

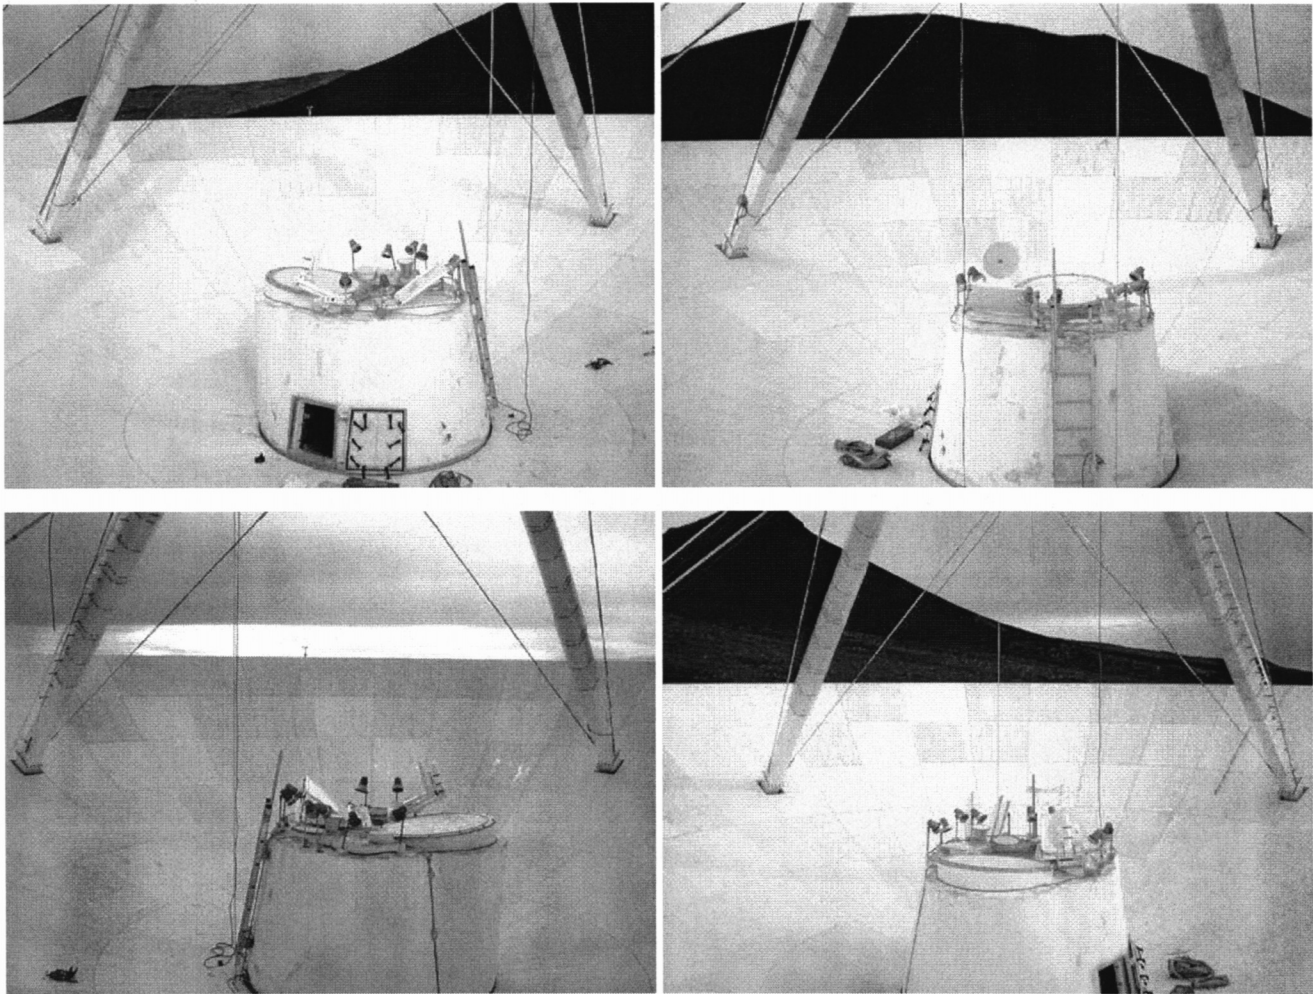
**Antenna Surface Panels**

The vertex room hatch door does not close tightly. We left some of the new latches for the site techs to install.

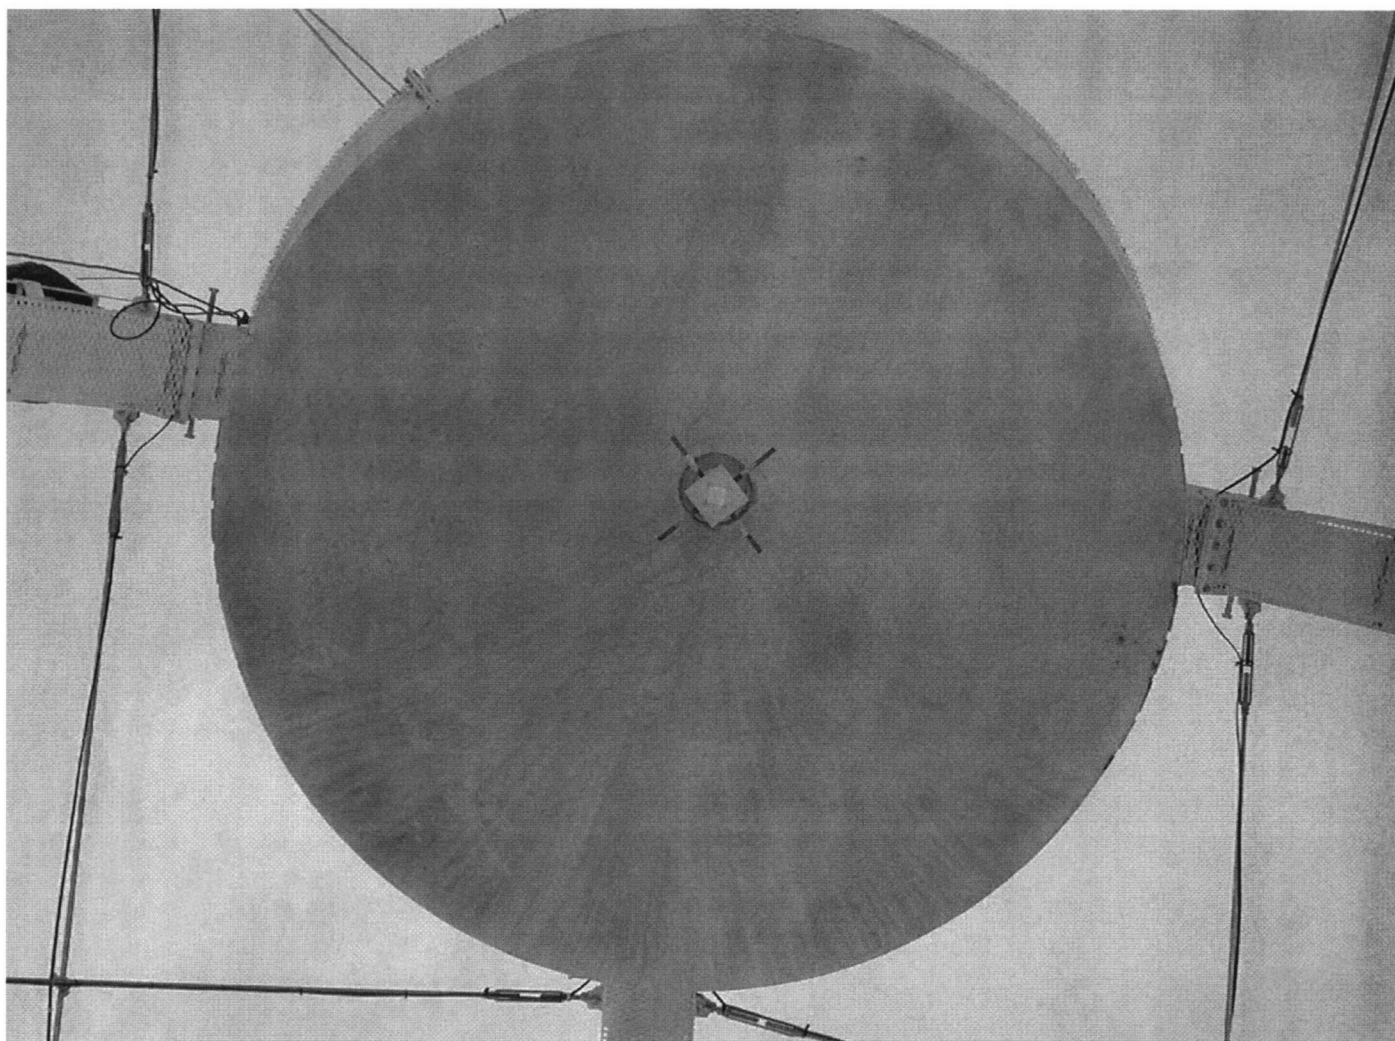
The subreflector is stained, but otherwise in good condition. Some of the cover seams are ripped.

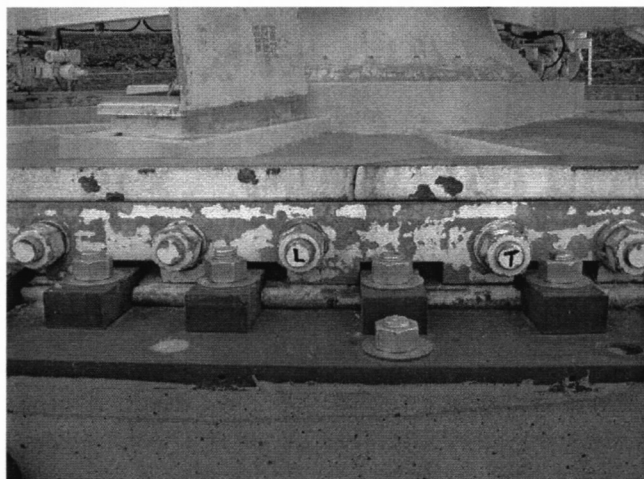
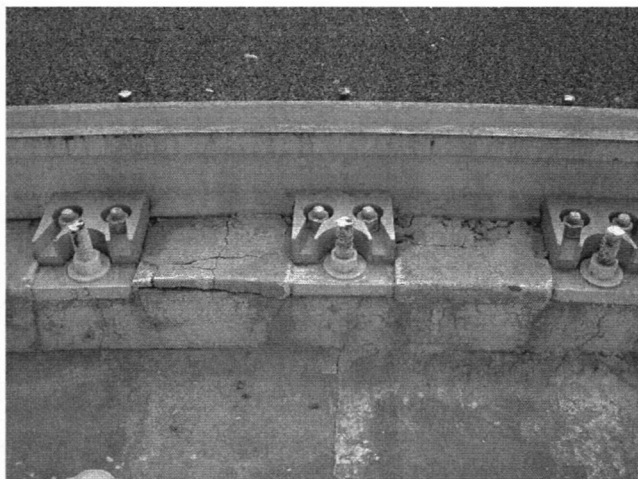
We tightened the rail splice plates. The unpainted base plates are rusting and should be painted with rust conversion primer. All remaining original grout should be replaced – soon.

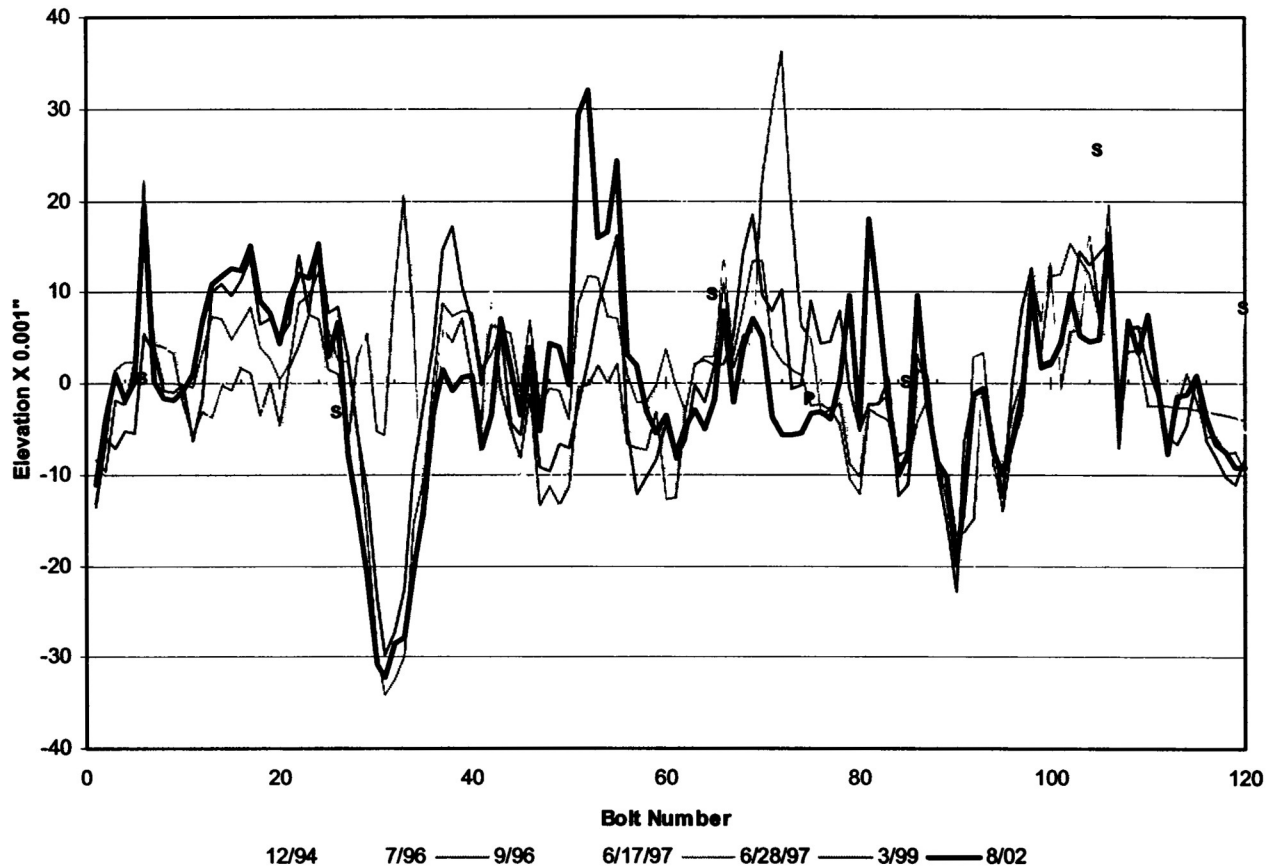
# **Mauna Kea Az Rail Elevations** **First Order Tilt Removed**

Note deteriorating grout around bolts 48 to 58 and 80 to 83. Grout is also failing at bolts 17-22, 44, 98, 110 and 115. All epoxy grout looks good, including partial patches around bolt 62.

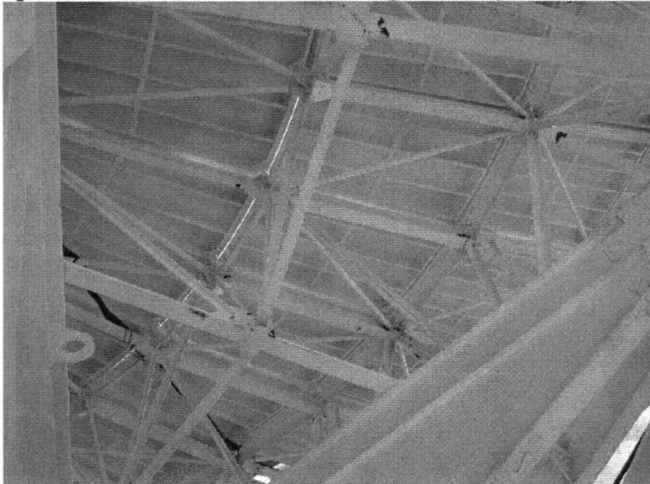
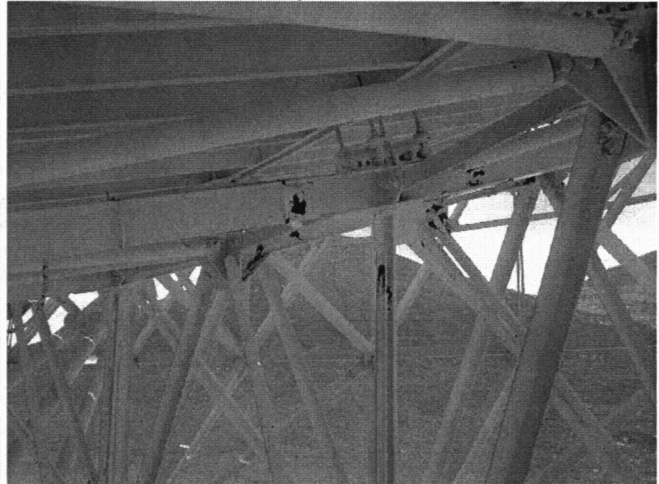
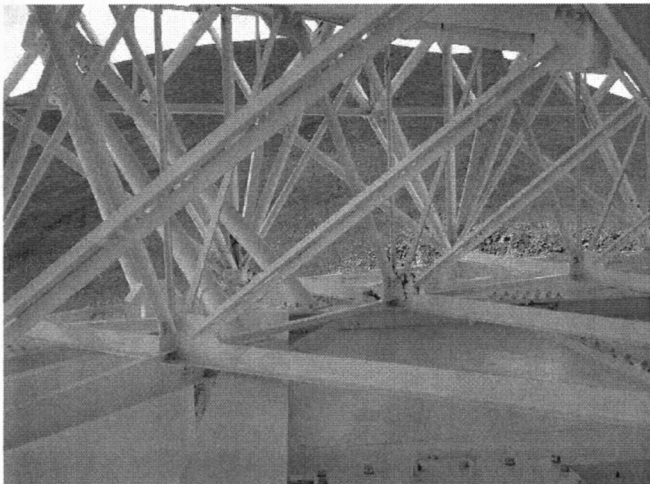
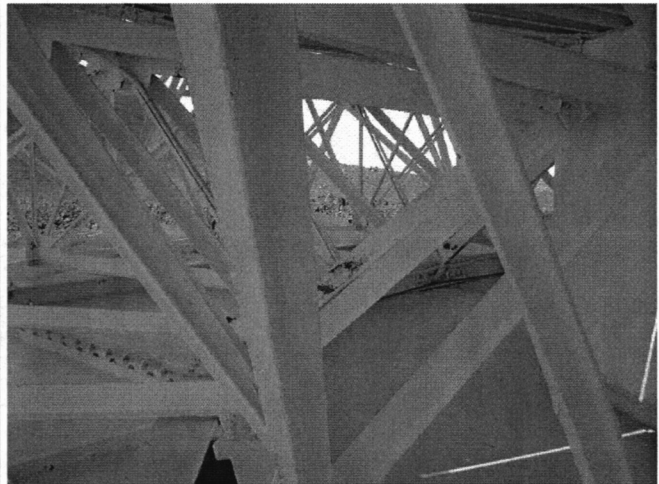
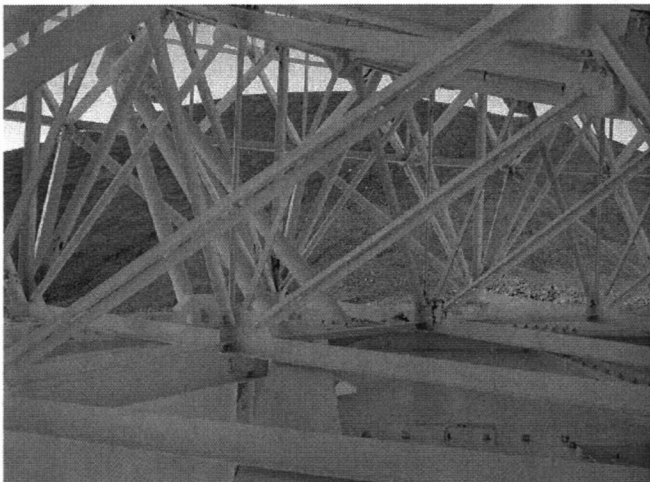
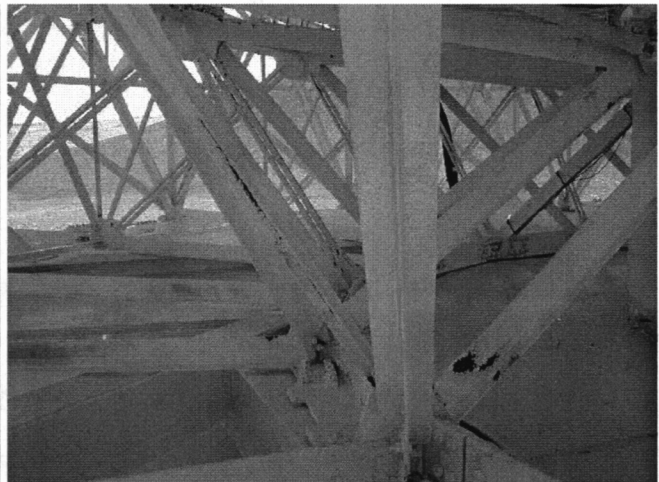
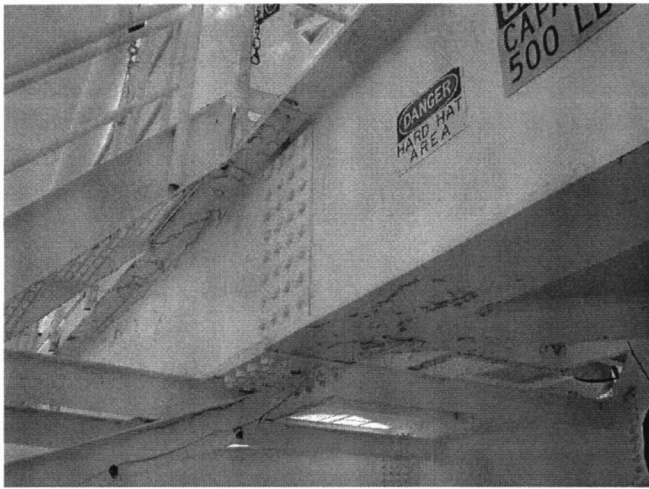
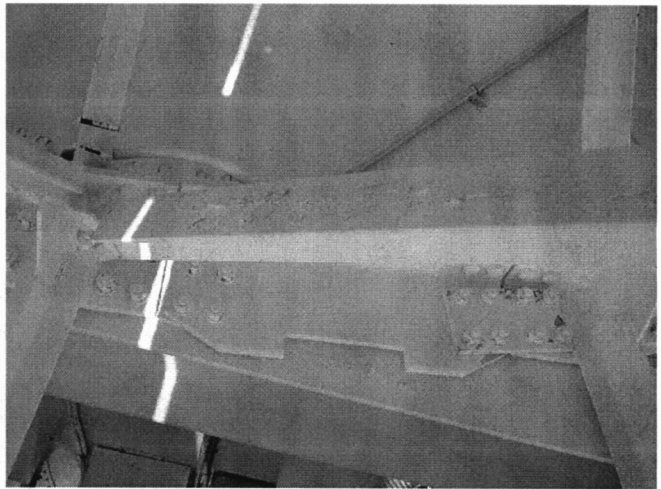
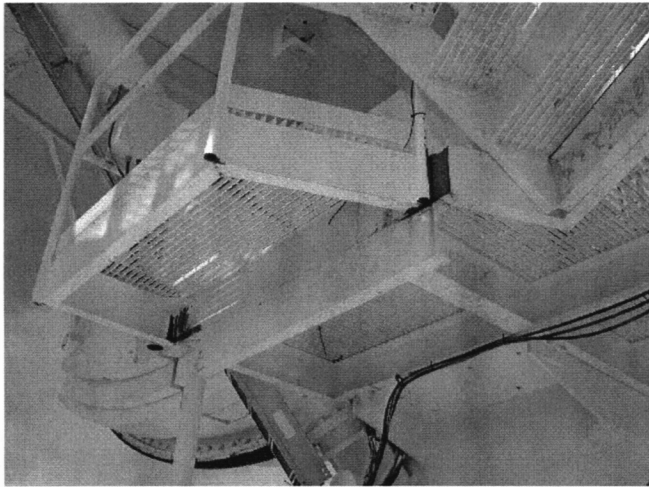
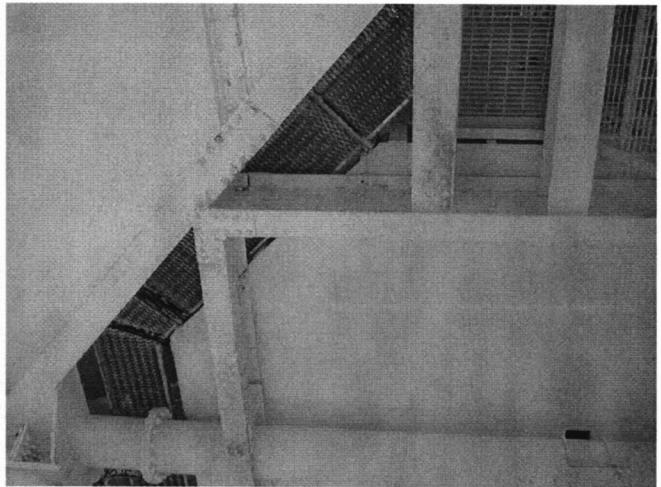
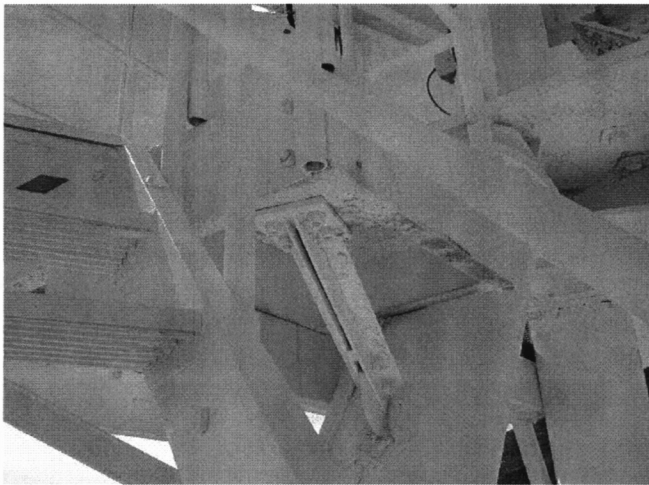
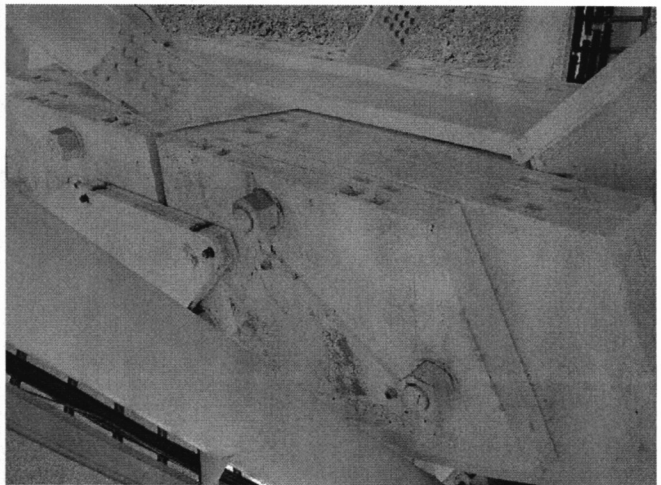
The paint is eroded or delaminating in many areas, but not much rust is evident yet.
