**National Radio Astronomy Observatory
Socorro, New Mexico**

VLBA Antenna Memo # 46

Saint Croix, Virgin Islands Maintenance Visit March 15-25.

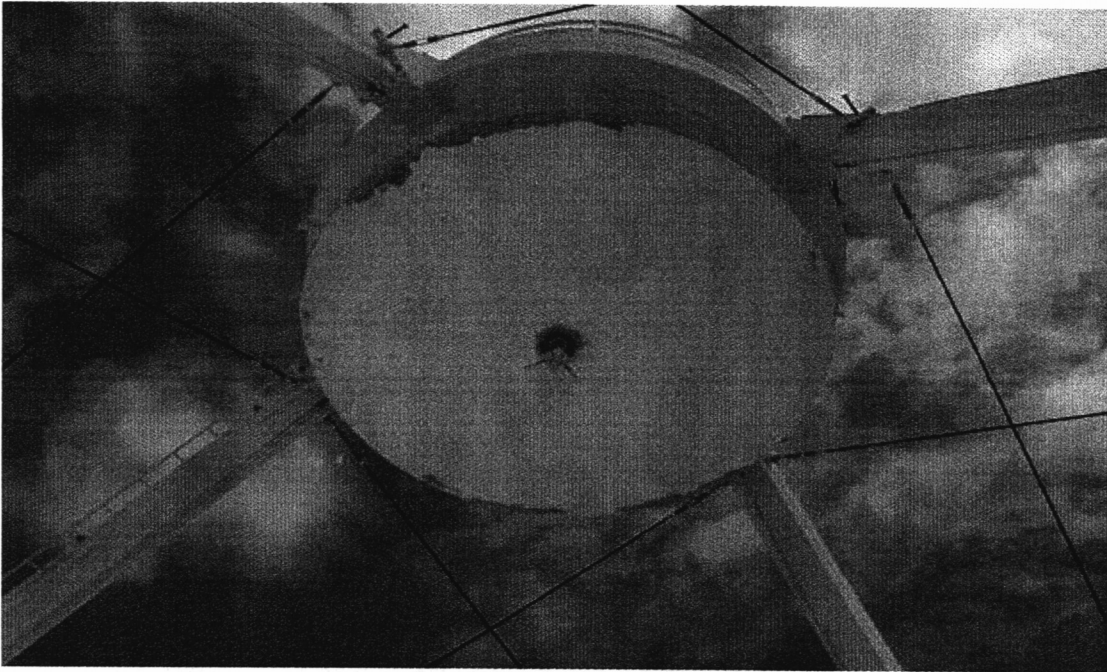
Subreflector has some peeling paint on the outside perimeter, ~ 3" strip.

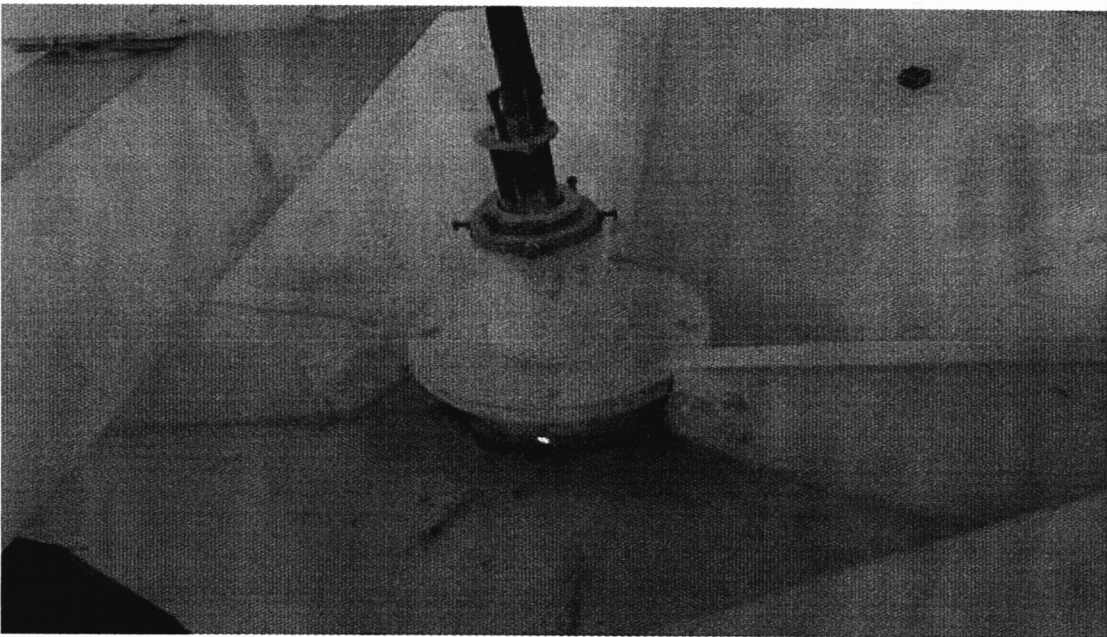
Subreflector drain holes are clear. The di-pole is in good condition but slightly corroded. 90/50cm FE cables are in good condition.

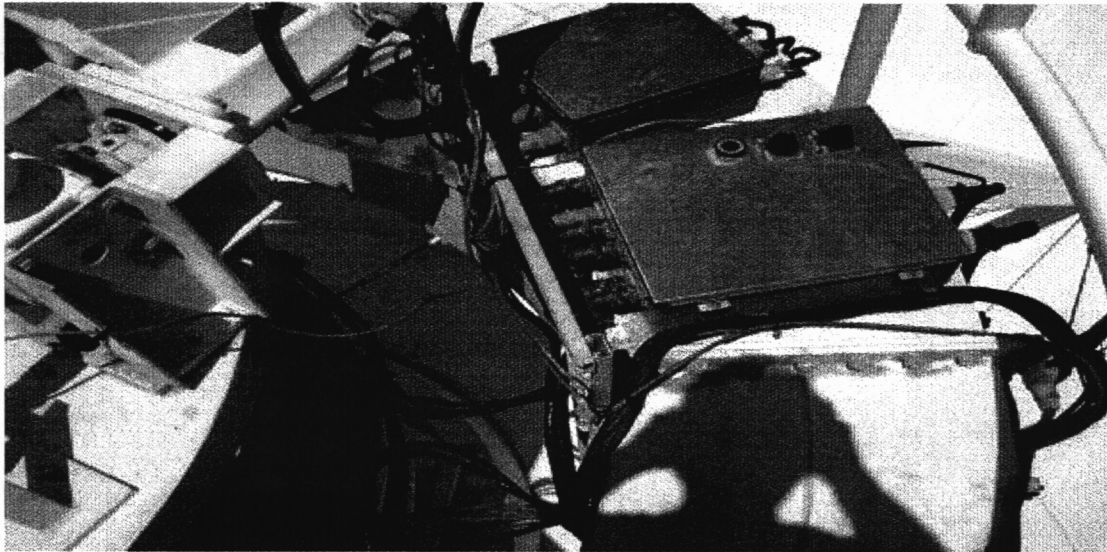
FRM INA BEARING CHECK 50 LBS PULL ON PRIMARY SIDE

Primary Travel: +. 001"	Secondary Side: -.001"
---------------------------	--------------------------

FRM INA BEARING CHECK 50 LBS PULL ON SECONDARY SIDE

Primary Travel: -.001"	Secondary Side: +. 00015"
--------------------------	-----------------------------

FRM motors to j-box cable connectors were replaced. As were the j-box to j-box connectors. The focus flex shaft and a bellows were also replaced.

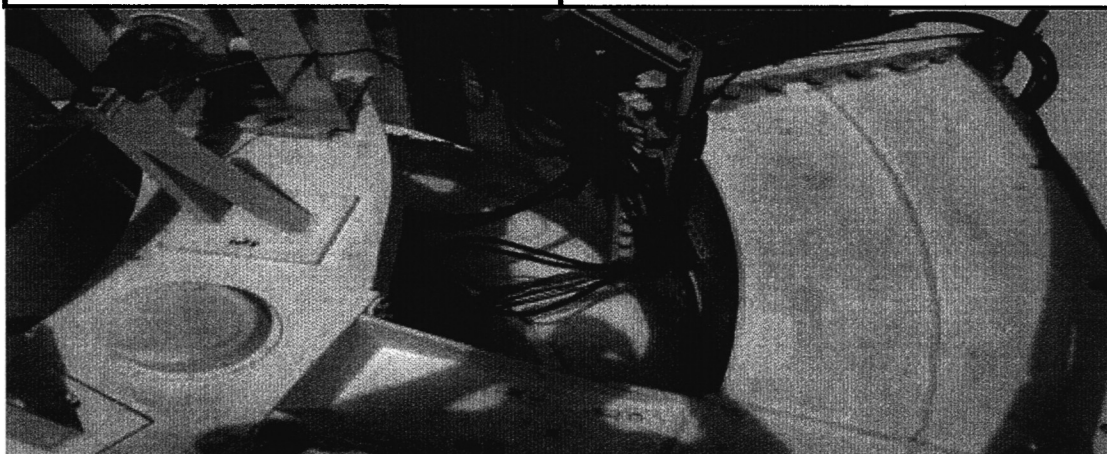
FRM cable strain reliefs were badly rusted and the cable trays were broken. Strain reliefs were replaced with aluminum brackets Ramon made. Cables are lashed to these brackets with ss ty-wraps. The broken cable trays were removed. FRM cables are bundled and looped together with ss ty-wraps.

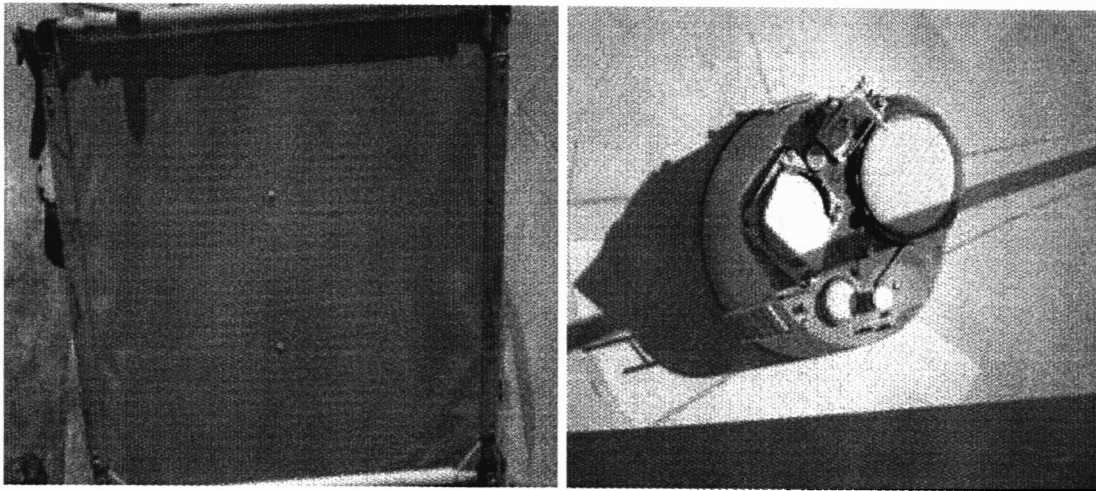
The dichroic reflector is delaminating. View of feed cone and dish panels.

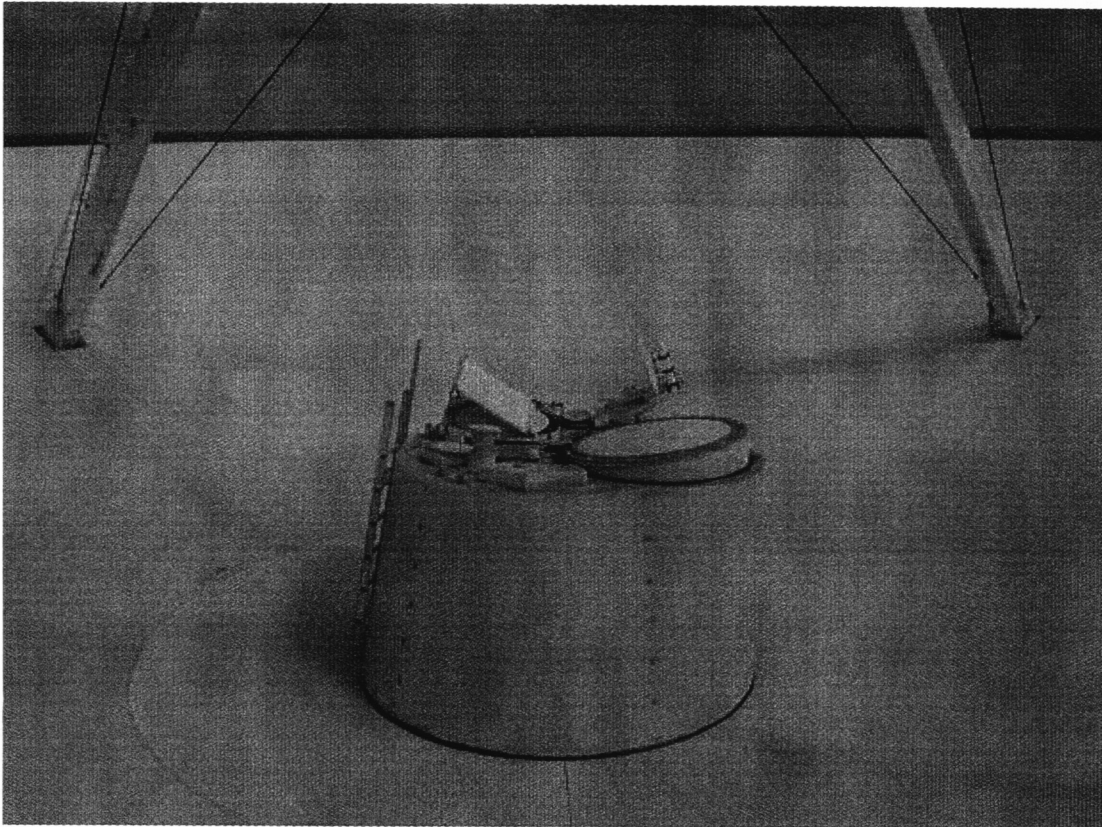
Feed cone insulation, ellipsoid reflector and dish panels are in good condition. Quad legs and guy wires have a little surface rust.

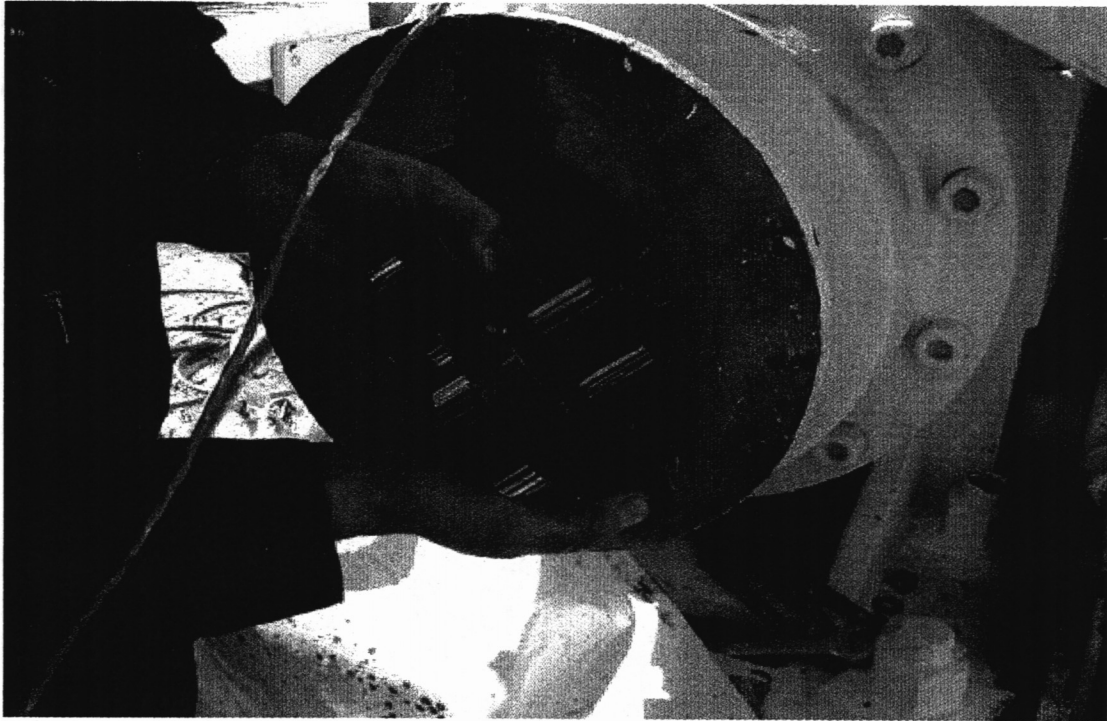
Elevation gearbox #1 pre-load inspection showed very little signs of wear. Both gearboxes oil was changed and several flow gauges were replaced.

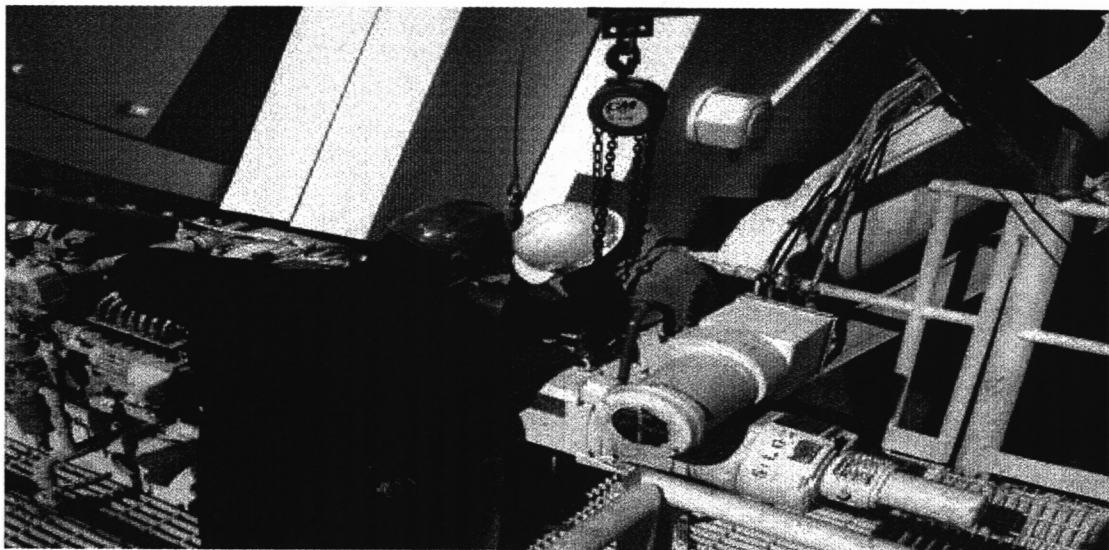
Elevation motor # 1 was replaced. The elevation bull gear is well lubricated.

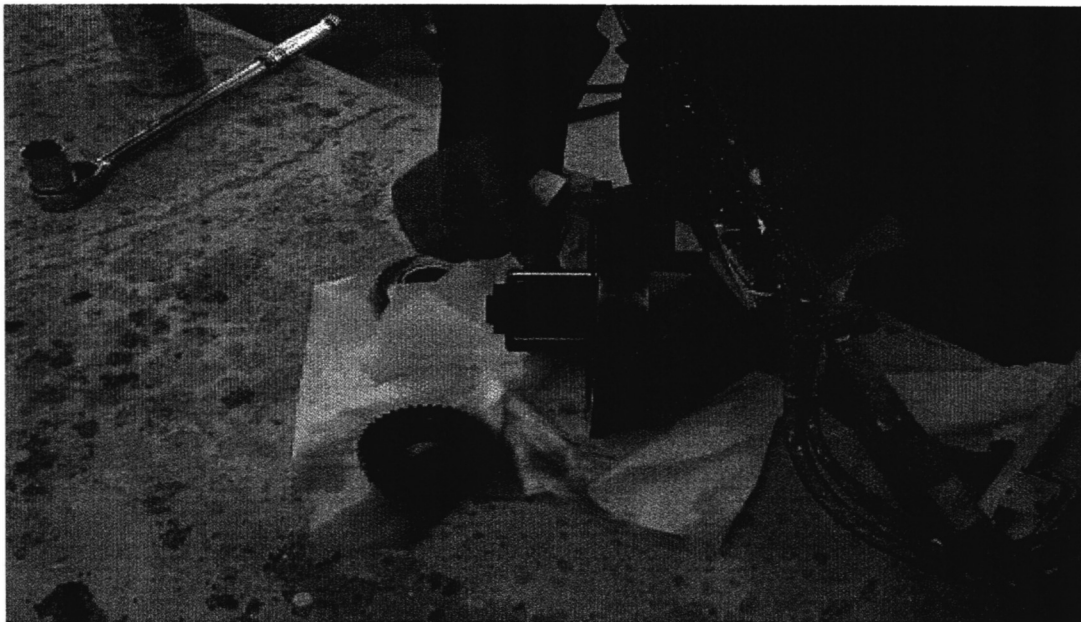
Azimuth #1 gearbox pre-load inspection.

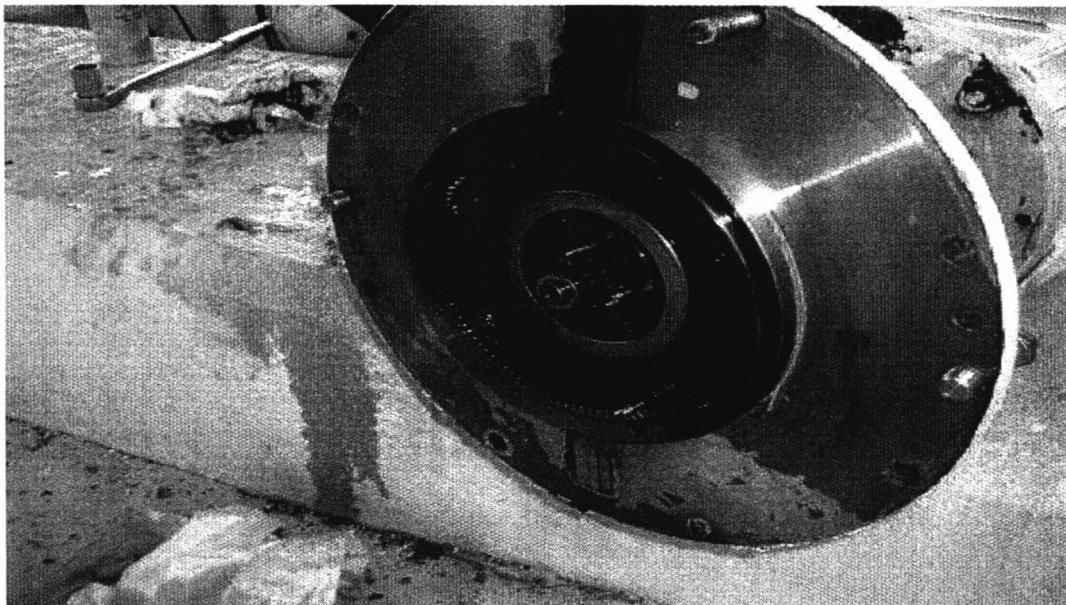
Azimuth #2 gearbox pre-load inspection. Both gearboxes showed very little signs of wear. Both gearboxes oil was changed and several flow gauges were replaced. A gearbox oil seal was replaced on AZ #1.

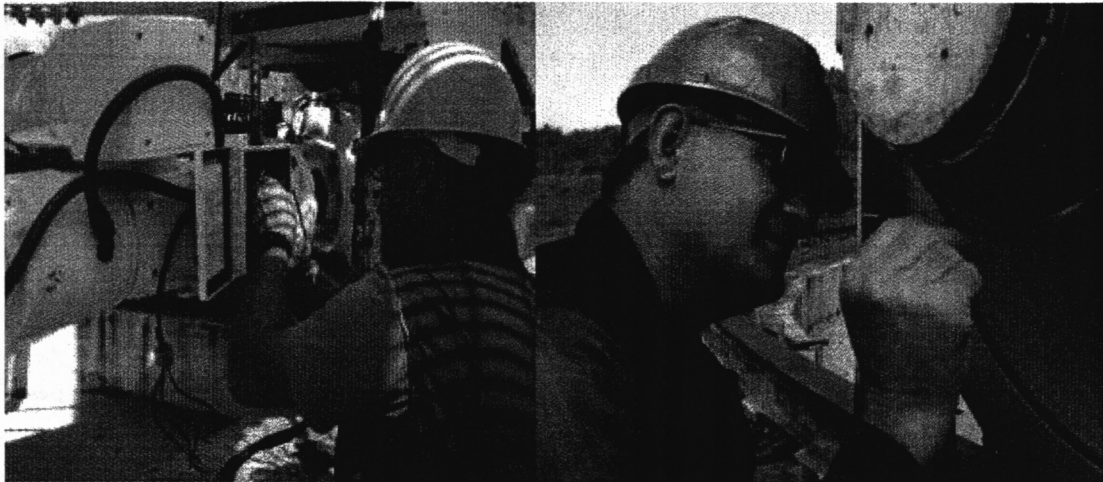
Azimuth motor #2 was replaced.

Azimuth bearings were inspected.

INNER	OUTER
D1	OK	OK
D2	A FEW SMALL FLAKES	OK
I1	A FEW SMALL FLAKES	OK
I2	OK	OK

Idler #2 is making a popping sound. Several tests and a bearing inspection found the inside/outside bearings to be ok. No azimuth bearings needed changing, and all bearings were well lubricated.

EL. Grease inspection/Encoder side	OK
EL. Grease inspection/DGB side	LOTS OF SMALL METAL FLAKES

Elevation bearing seals are ok and there are no visual elevation axle cracks. The DGB side bearing needs replaced. Site techs will flush this EL bearing with grease every couple weeks and take samples for analysis. No metal flakes were found in the pintle bearing grease. Cable wrap and cables are in good condition.

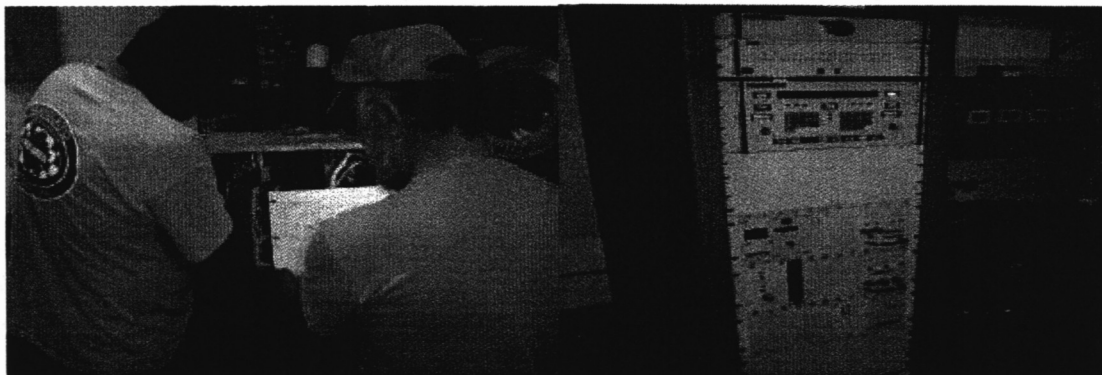
The ACU power supply upgrade was completed. During the ACU retrofit 6 bad TB2 crimps were found and repaired. The AZ synchro was repaired.

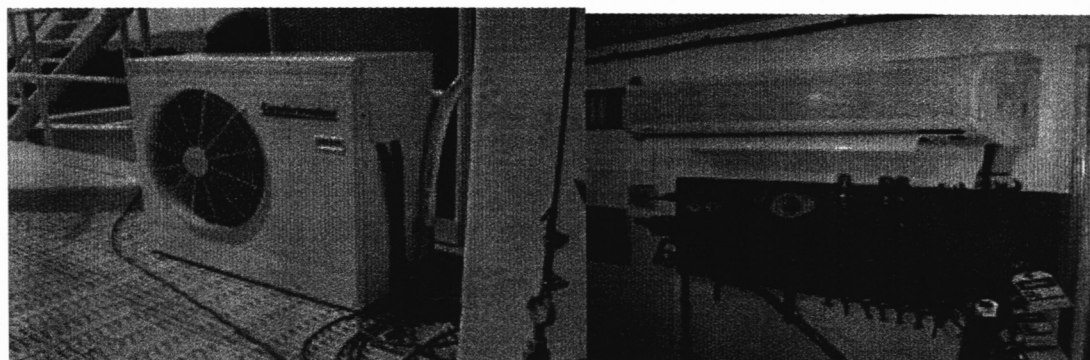
A new back up AC was installed in the pedestal room.

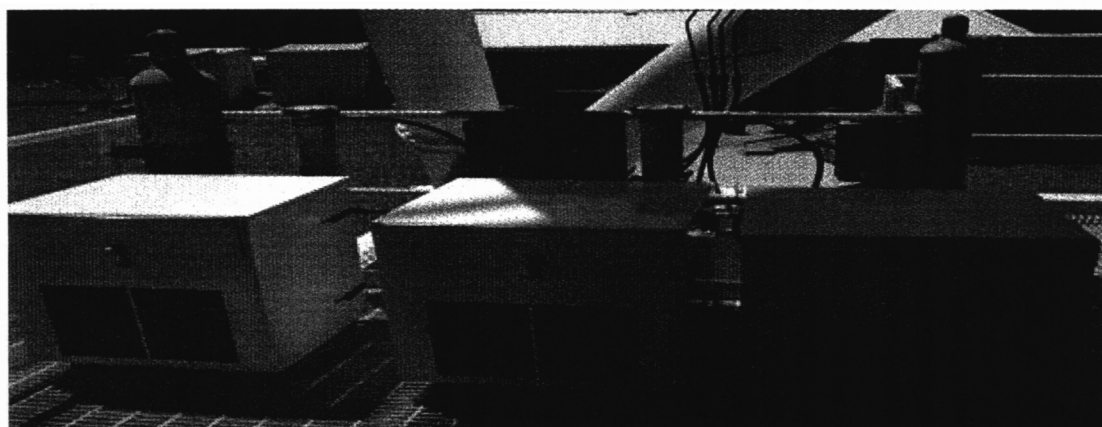
The cryo compressors are in good condition. Shown here with fresh paint.

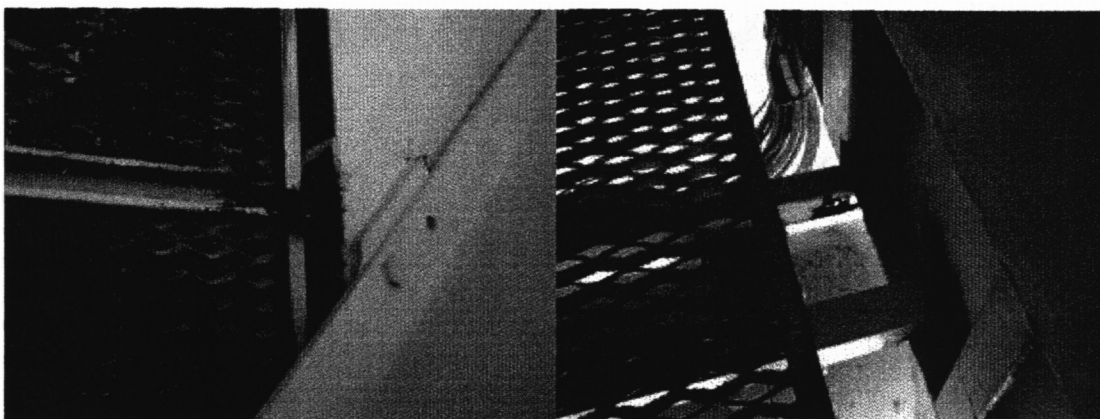
The vertex room catwalk was nearly rusted away and had to be rebuilt.

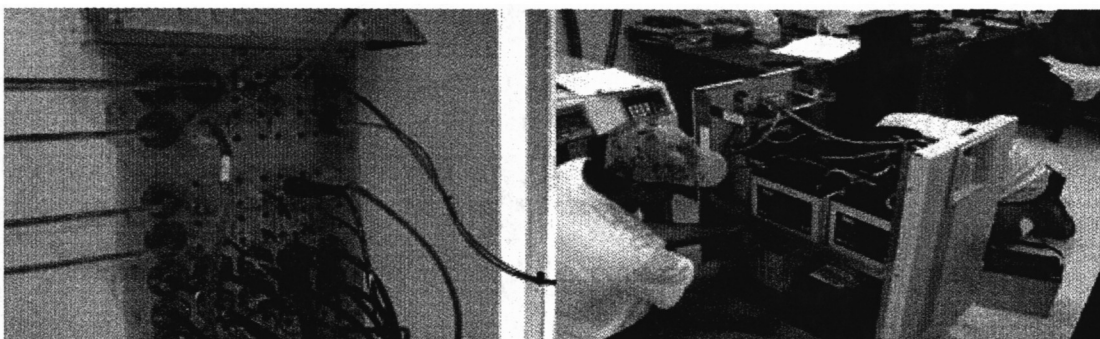
The ellipsoid reflector signal/power cable connectors on the vertex room baulk head were replaced. The station 12.5kva UPS batteries were replaced.

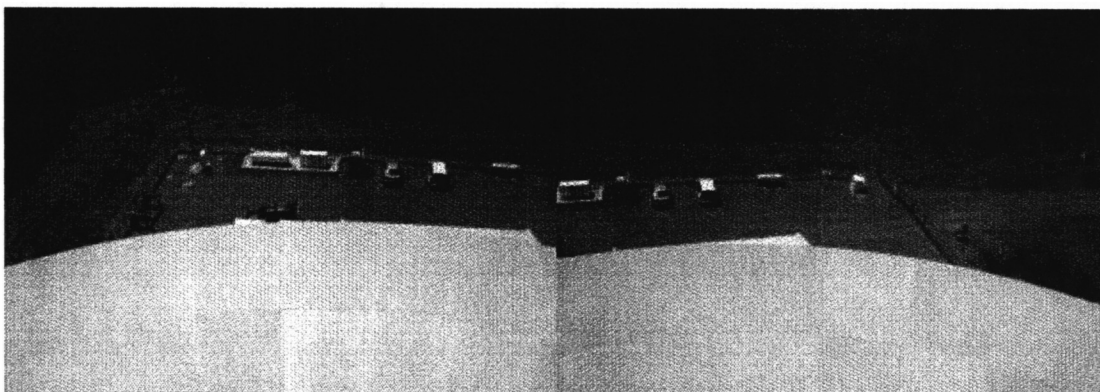
Brush is cut back ~30 feet around perimeter of the VLBA site. The area inside the fence is weed free and orderly.

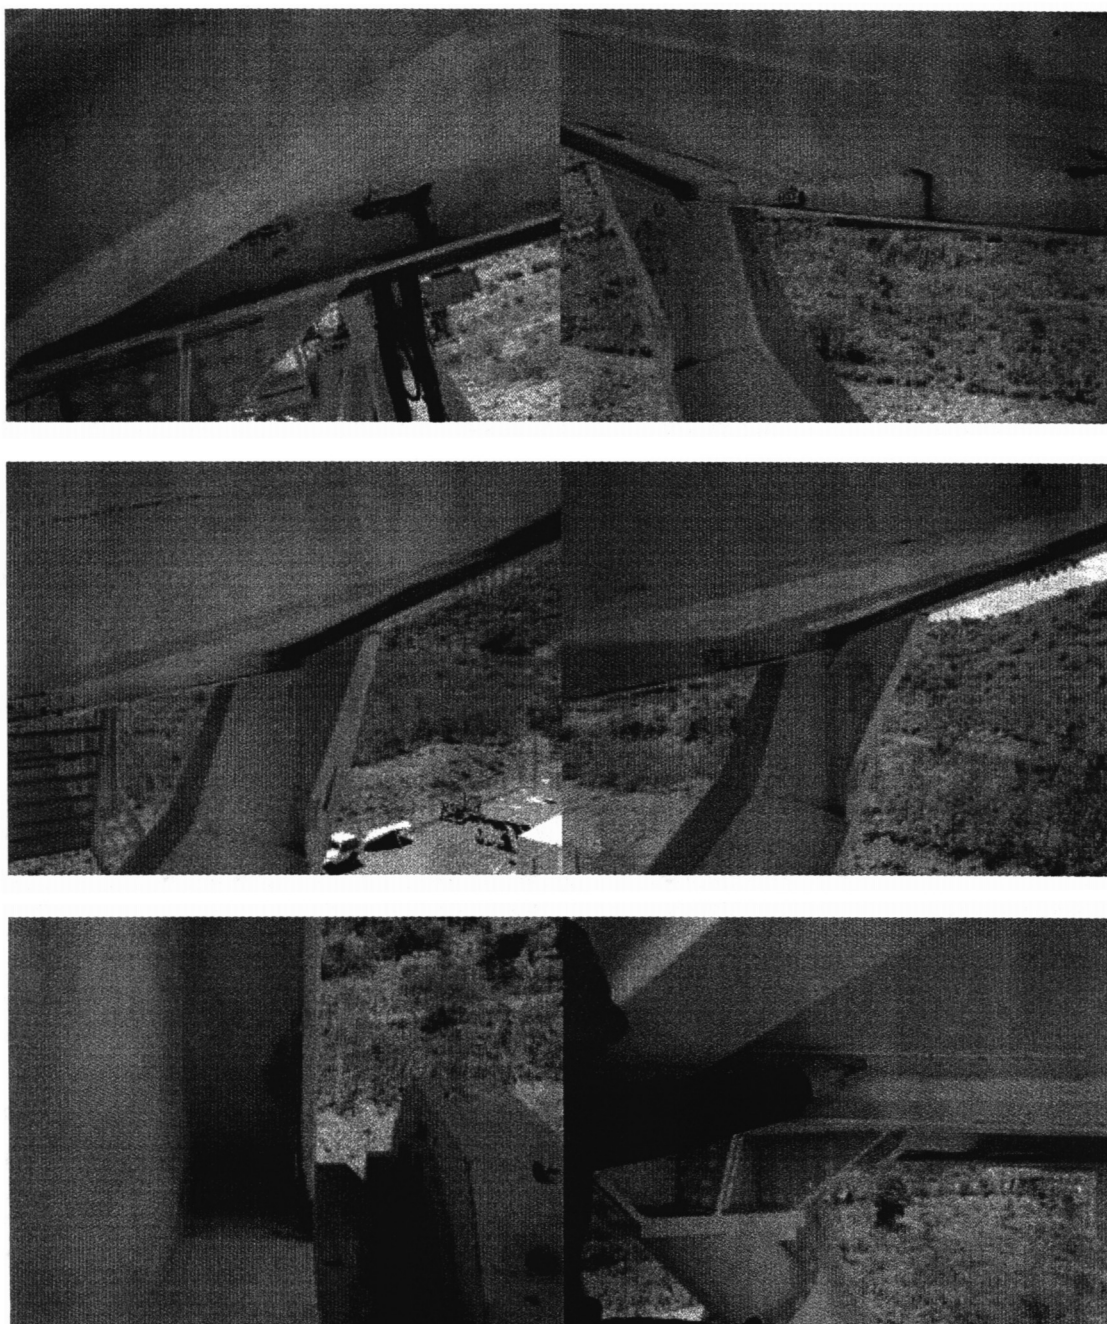
These photos show the worst areas of rust on the antenna. Painters and site techs are doing an effective job keeping up. Steve points to a repair completed during our last maintenance visit in April 2002.

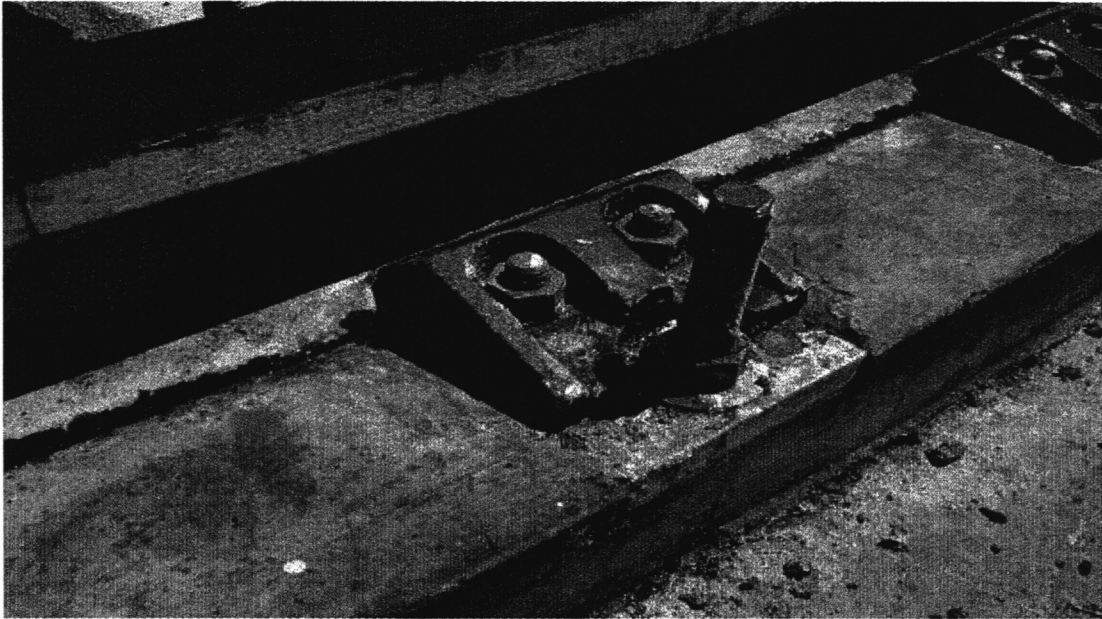
A typical rail clip with vulkem scraped off. Grout is in good condition. Site techs will follow up with chem prime paint on clips and splices as needed.

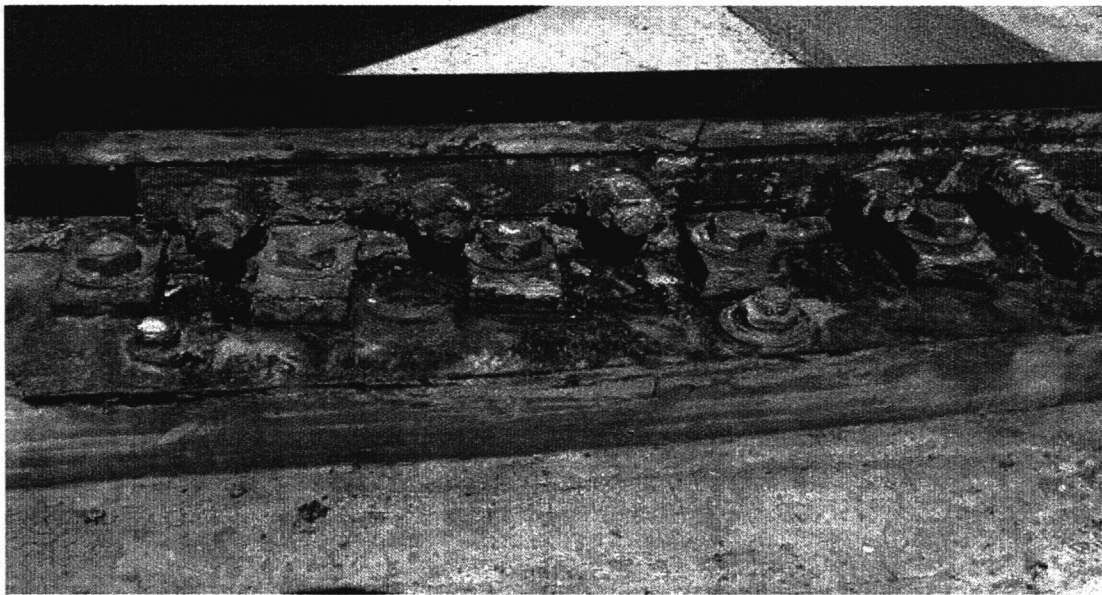
Rail splice with vulkem scraped off. The maintenance team and site techs were able to remove most of the vulkem from the rail during the visit. The rail, clips, and splices are in good condition.

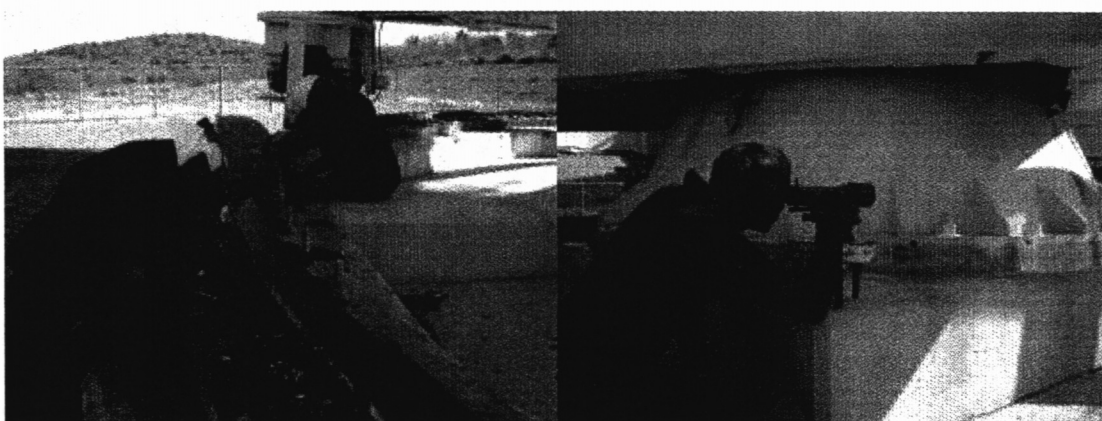
Removing vulkem from the rail.

Ramon measuring the rail.
