**National Radio Astronomy Observatory  
Socorro, New Mexico**

**VLBA Antenna Memo #47**

**Kitt Peak, Arizona VLBA Maintenance Visit June 5-12/03**

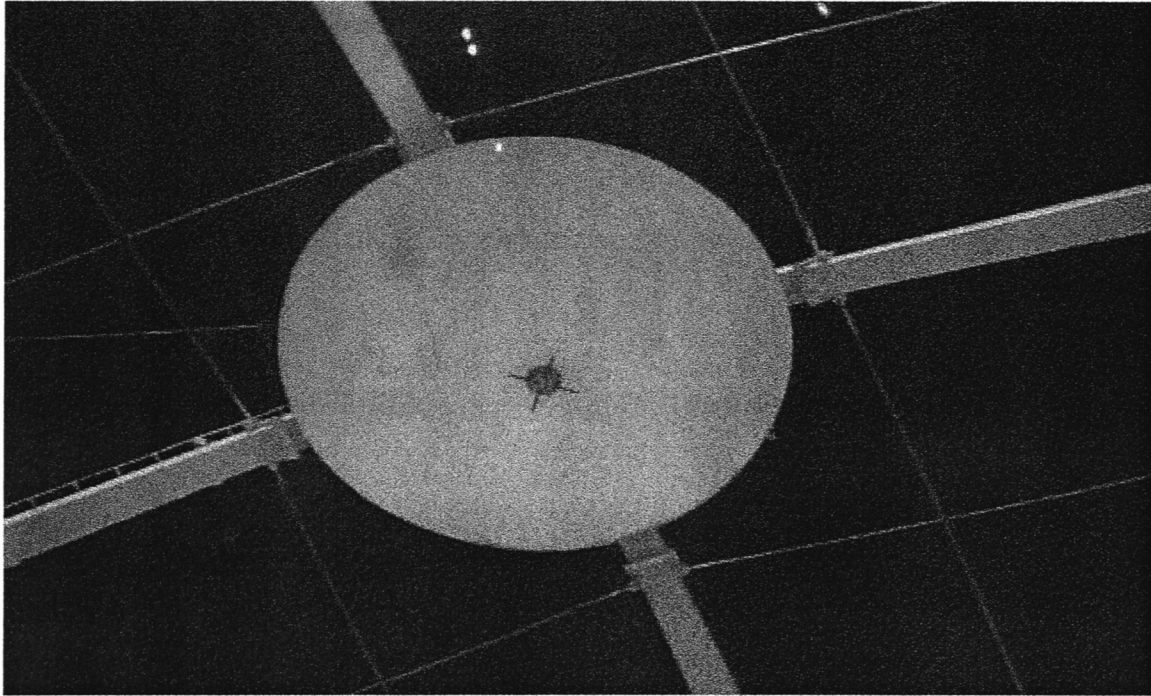
**Subreflector is in good condition.**

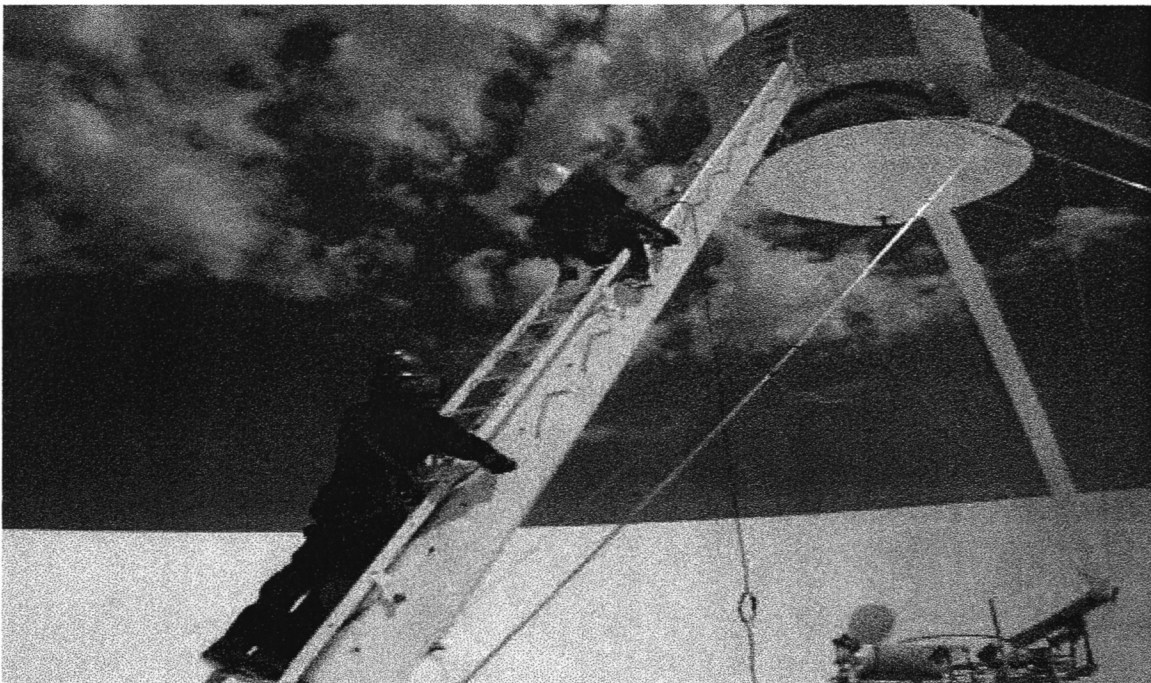
**Ramon and Steve installing a new latter and fall arrest on the quad leg. The site techs were trained on using the new Sellstrom fall arrest.**

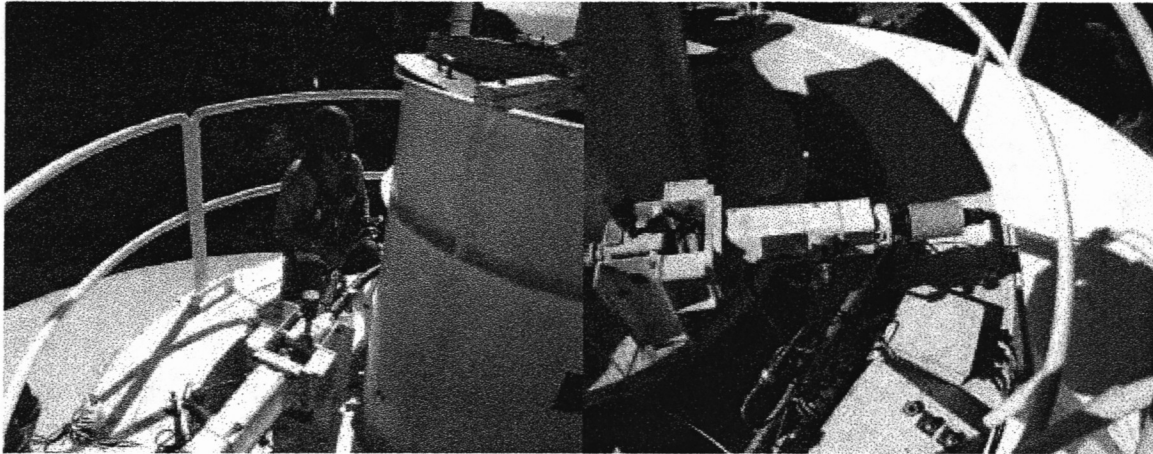
Duane greases the focus flex shaft. FRM is well lubricated and all j-boxes, cables, and connectors are in good condition. During the FRM PM a bellows was replaced. The focus flex shaft was replaced 2 months earlier by the site techs and not replaced by the maintenance team. The focus motor encoder coupling modification had been previously installed by the site techs.

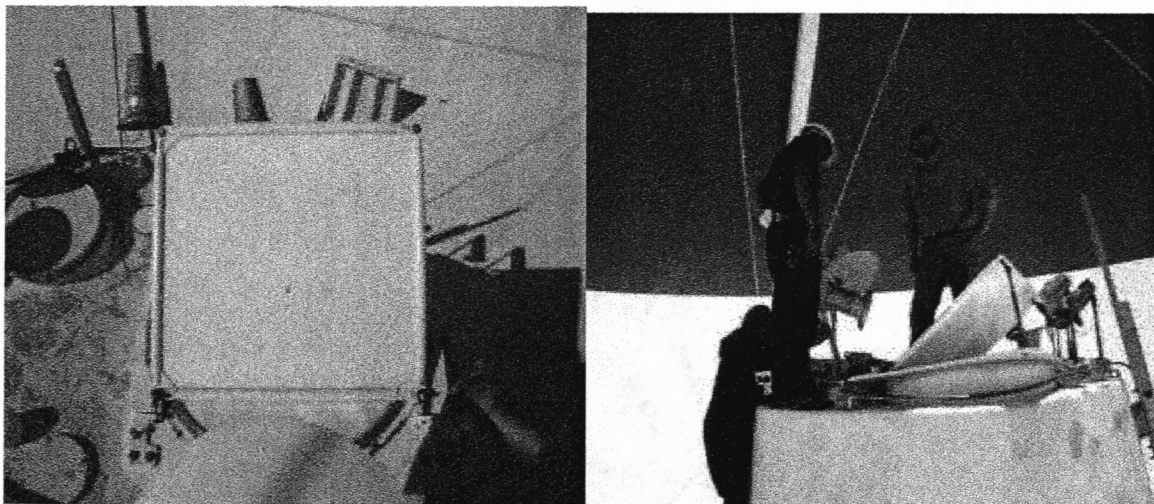
Dichroic reflector is in good condition except for a small delaminating blister in the center running vertically. The dichroic panel and ellipsoid reflectors were both realigned. Notice the feed cone is need of painting.

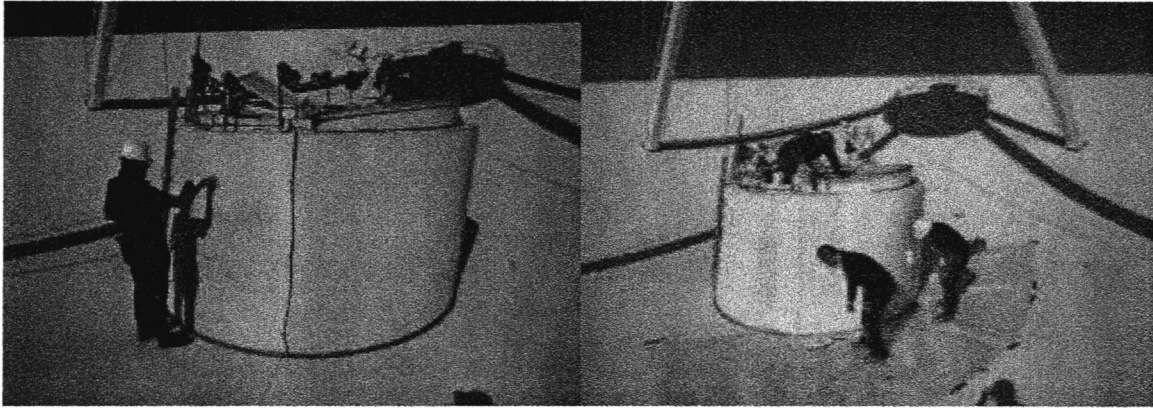
**Bob preps the feed cone for painting. Ray, Bob and Steve then applied 3 coats of Elastomeric paint to the feed cone.**

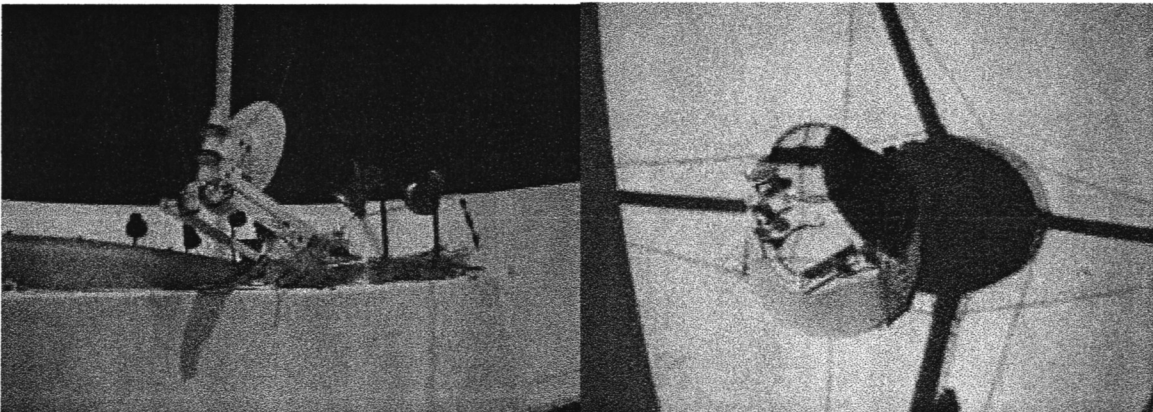
**A spring was replaced in the ellipsoid actuator during alignment. Ellipsoid is in good condition. Feed cone FE windows and heaters are in good condition.**

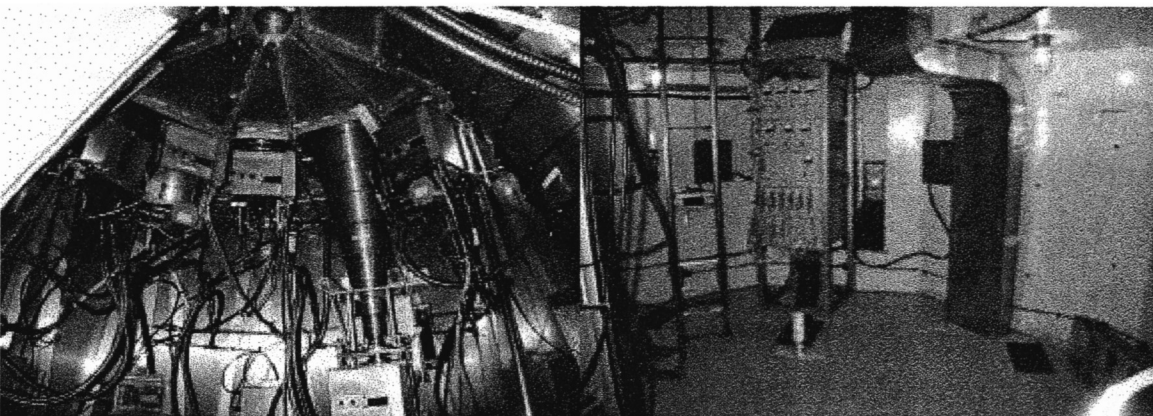
**Feed cone & Vertex room. FE and rack cables are neat, orderly and secure.**

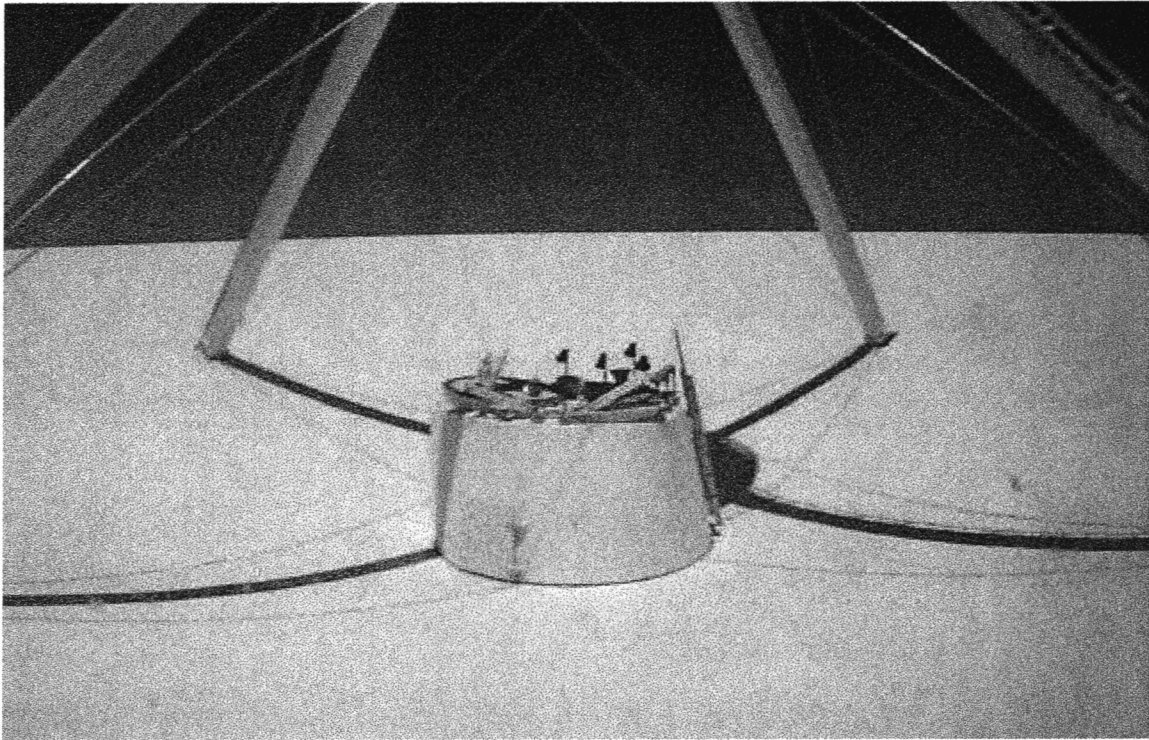
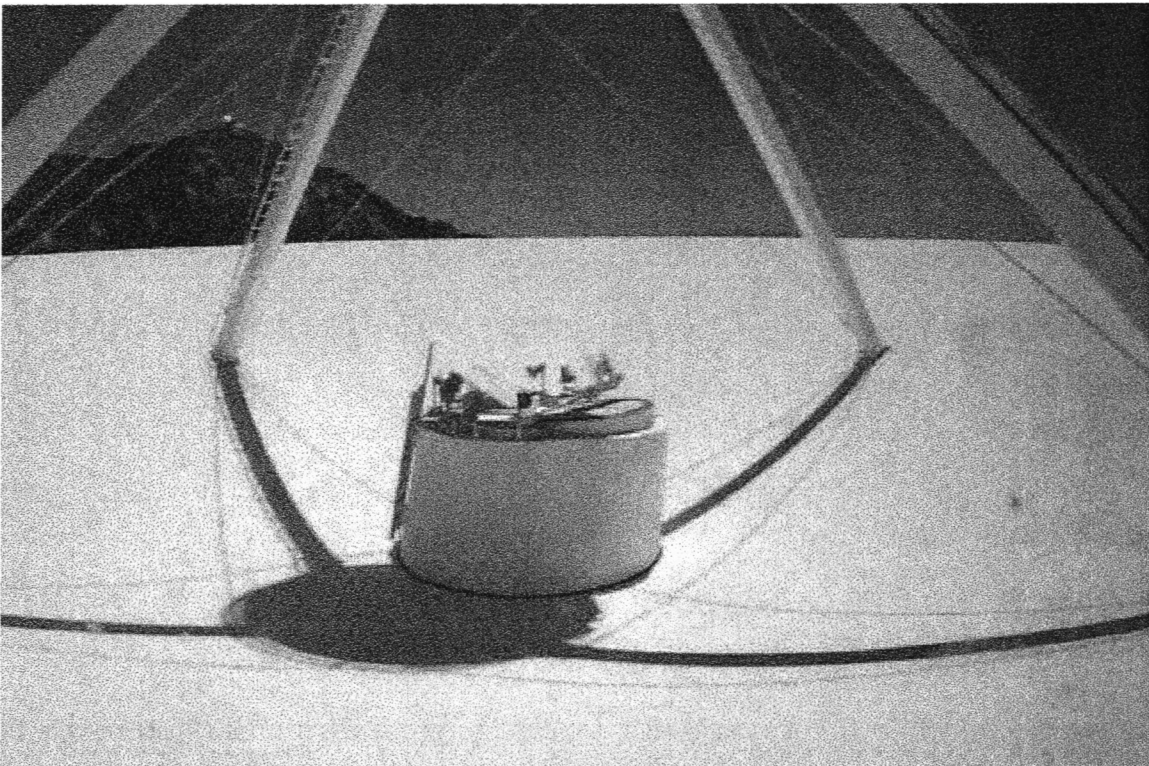
Feed cone insulation is in good condition. Dish panels, and the dish panel's paint are in good condition. Quad legs and guy wires are in good condition.

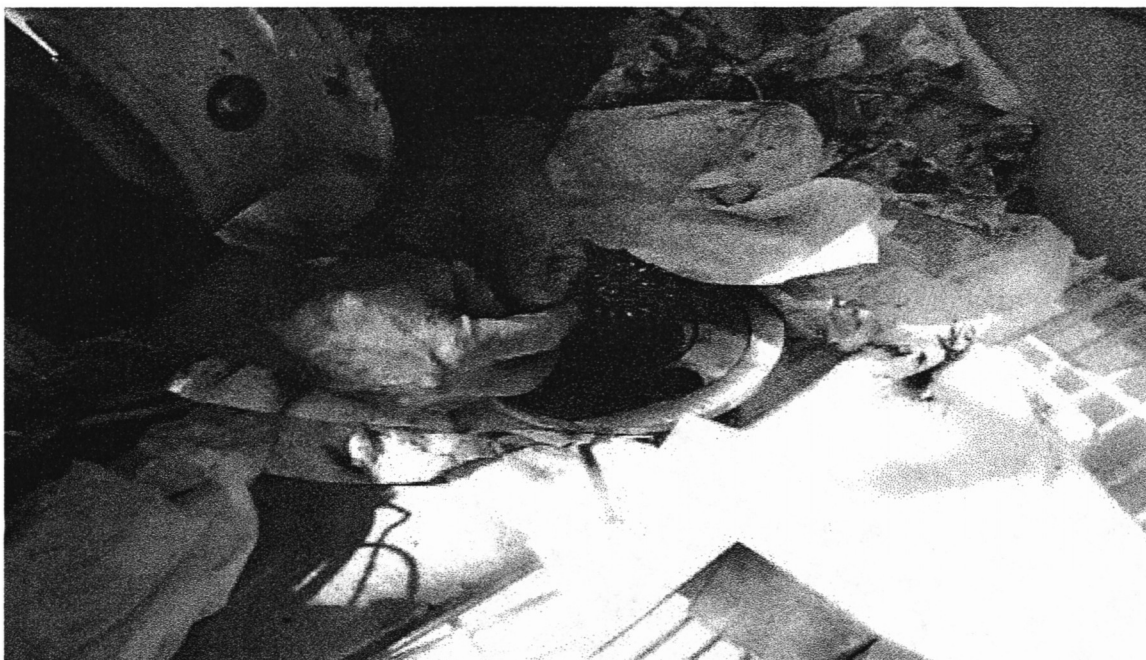
**Steve measures  $\sim .002$  of wear with a feeler gauge showing EL #2 gearbox is in good condition. Both EL gearboxes oil was changed. Fish eyes and flow gauges were also cleaned. EL #1 gearbox was not opened for inspection.**

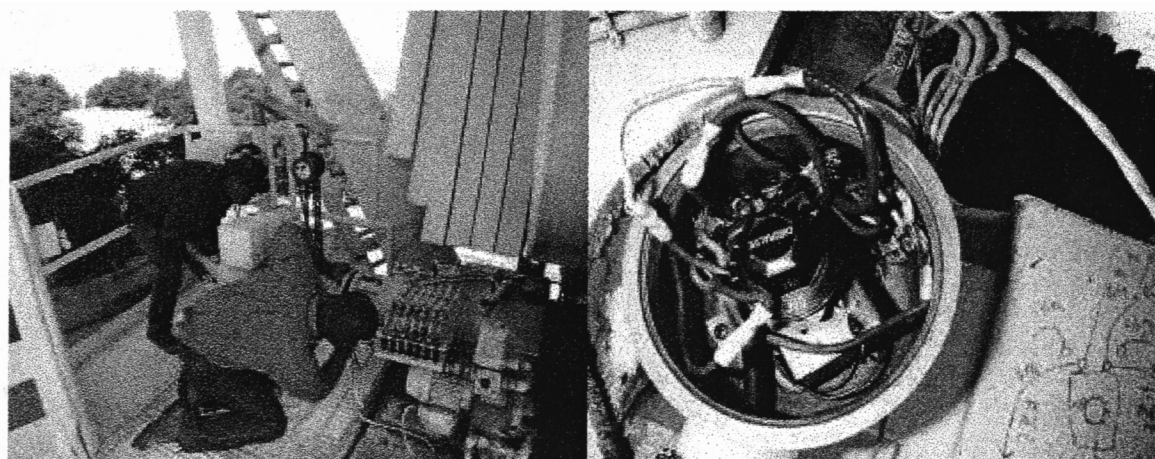
Elevation #1 and #2 motor gearbox rubber couplings (spiders) were replaced. The elevation gearbox heaters were wired in series. This was corrected to parallel and tested. The elevation bull gear is well lubricated and in good condition. Paint in the elevation platform area is in good condition.

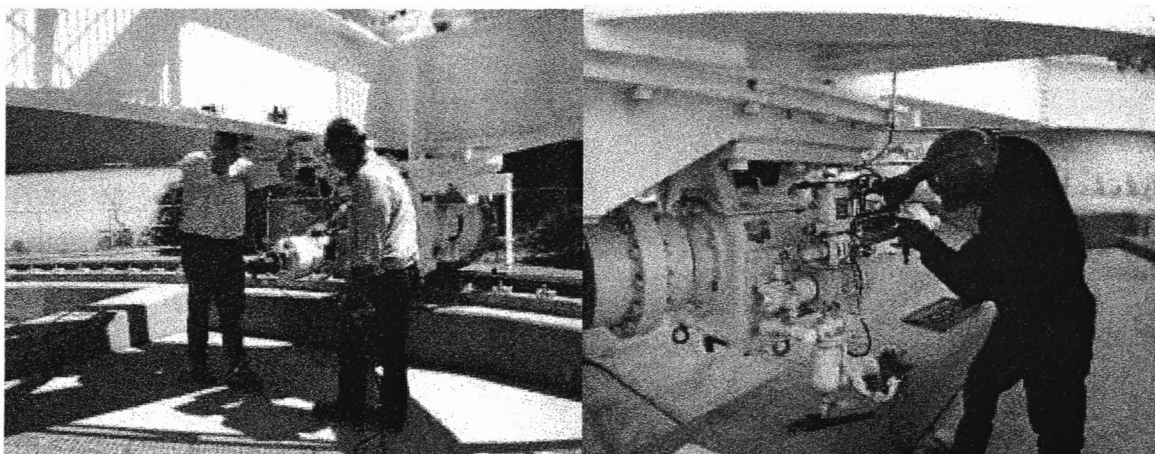
Azimuth #2 motor brushes were replaced and seated. Azimuth #2 tach and blower were also replaced. Azimuth #2 motor has a wobbling tail shaft and a rear motor bearing seal that is leaking into the brake assembly. Azimuth #2 motor was replaced on July 23<sup>rd</sup> during the writing of this report. Azimuth #1 flow gauge manifold was replaced. Azimuth #1 tach was well within spec. and wasn't replaced. Azimuth #1 motor spider was replaced. The antenna paint in the azimuth area is in good condition.

- 1. REPLACE AZIMUTH MOTOR #2.---REPLACED ON JULY 23<sup>RD</sup>.**
- 2. REPLACE VERTEX ROOM DOOR (TEMPERALLY PATCHED).**
- 3. REPLACE FRM LOGIC POWER CONTROL CABLE.**
- 4. ADD STEEL TO PED ROOM GRATING WALK WAY (A TRIP HAZZERD).**
- 5. REPLACE ELEVATION #1 LUBE MANIFOLD WHEN SPARE IS AVAILABLE.**
- 6. PED ROOM PVC POWER FEED THROUGH NEEDS REPLACED.**

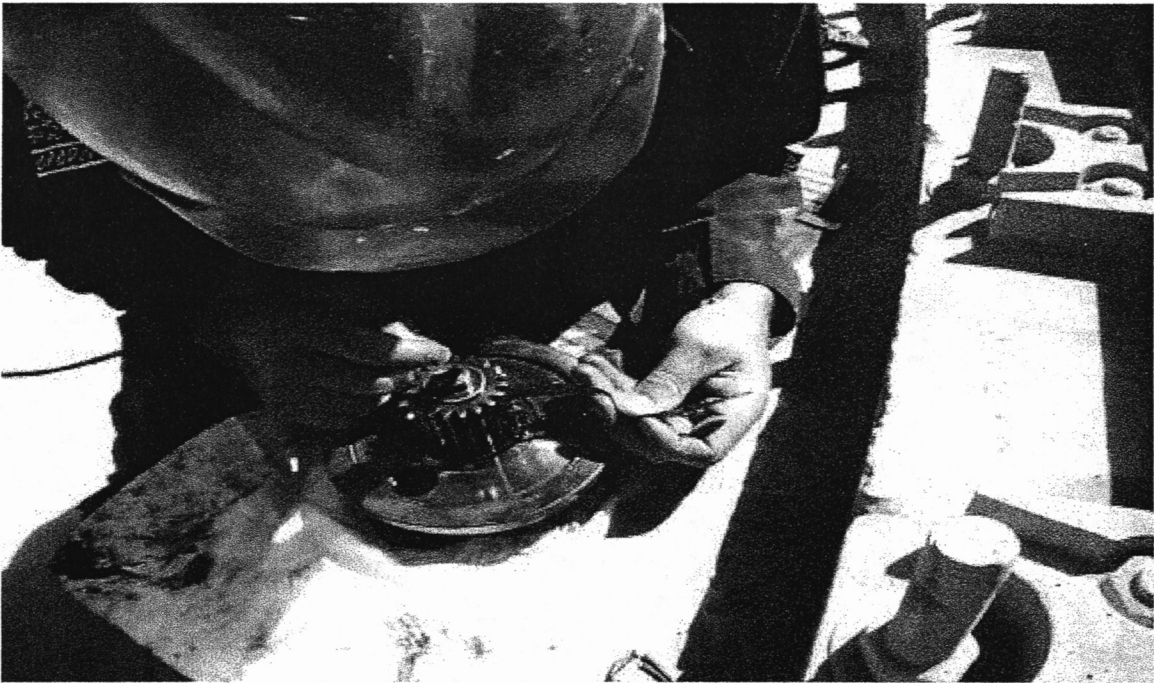
**Steve measures ~.002 of wear with a feeler gauge showing AZ #1 gearbox is in good condition. Both AZ gearboxes oil was changed. Fish eyes and flow gauges were also cleaned. AZ #2 gearbox was not opened for inspection.**

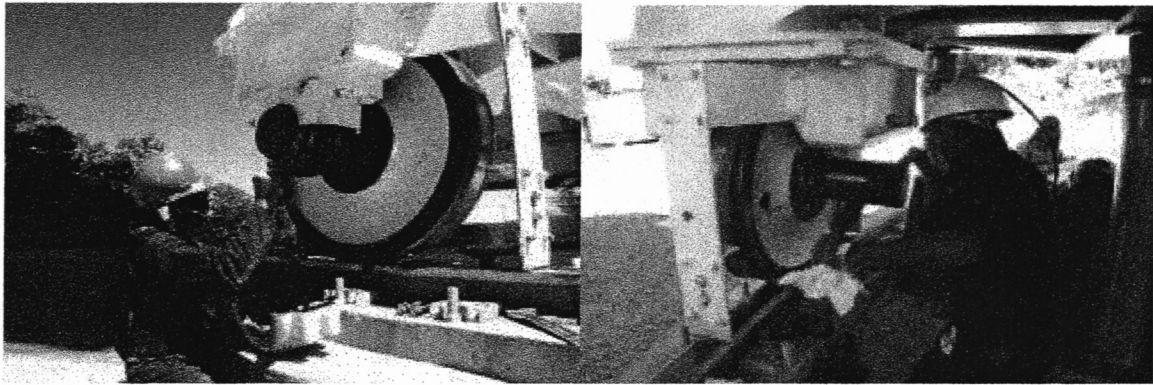
AZ wheel bearings were inspected. AZ #2 idler bearing was replaced. No popping or grinding noises were heard from the AZ bearings or gearboxes.

INNER	OUTER
D1	Very few small flakes of metal.	No metal, smooth races.
D2	Little flakes, slight scratches.	No metal, very smooth races.
I1	Good, small linear scratches.	Small scratches on races.
I2	Changed bearing.	Little flakes, slight scratches.

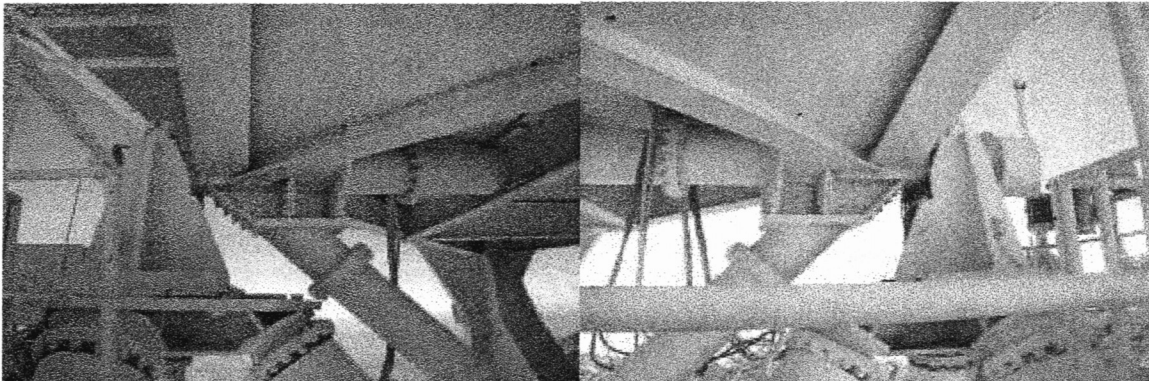
EL. Encoder side	Good with no metal flakes.
EL. Synchro side	Good with no metal flakes.

Elevation bearings are well lubricated. Elevation axle has no visible signs of cracks. Antenna paint in the EL axle area is in good condition. There are no popping and grinding noises heard from the elevation bearings or gearboxes. No metal flakes were found in the pintle bearing grease.

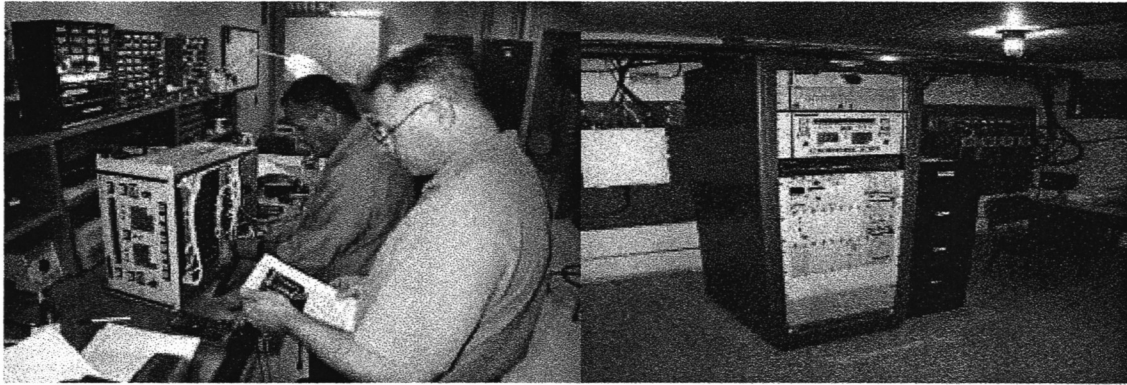
Steve and Ray retrofit the ACU with the new power supply upgrade.

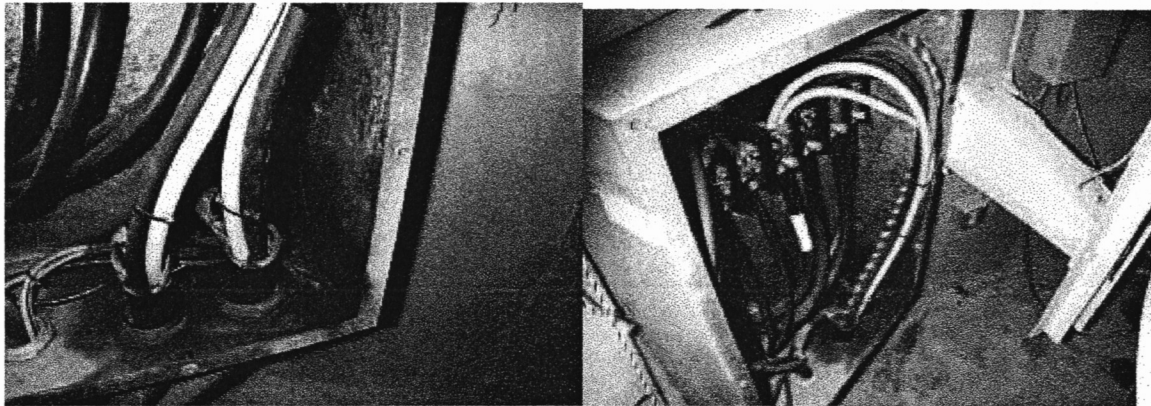
Inside the pintle bearing room power panel Bob found a ground terminal block severely corroded. The terminal block was cleaned and then sealed with primer. The antenna cable wrap and cables are in good condition.

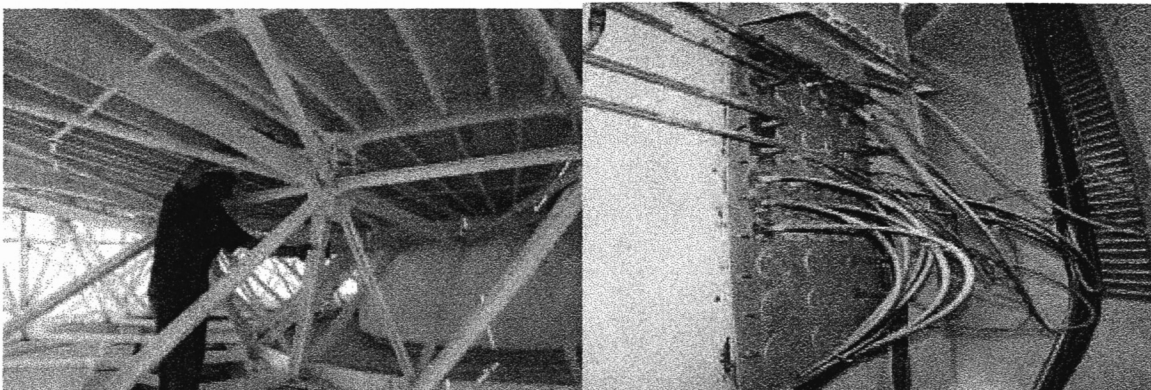
Dish panel bolts were checked.

VTX baulk head is in good condition.

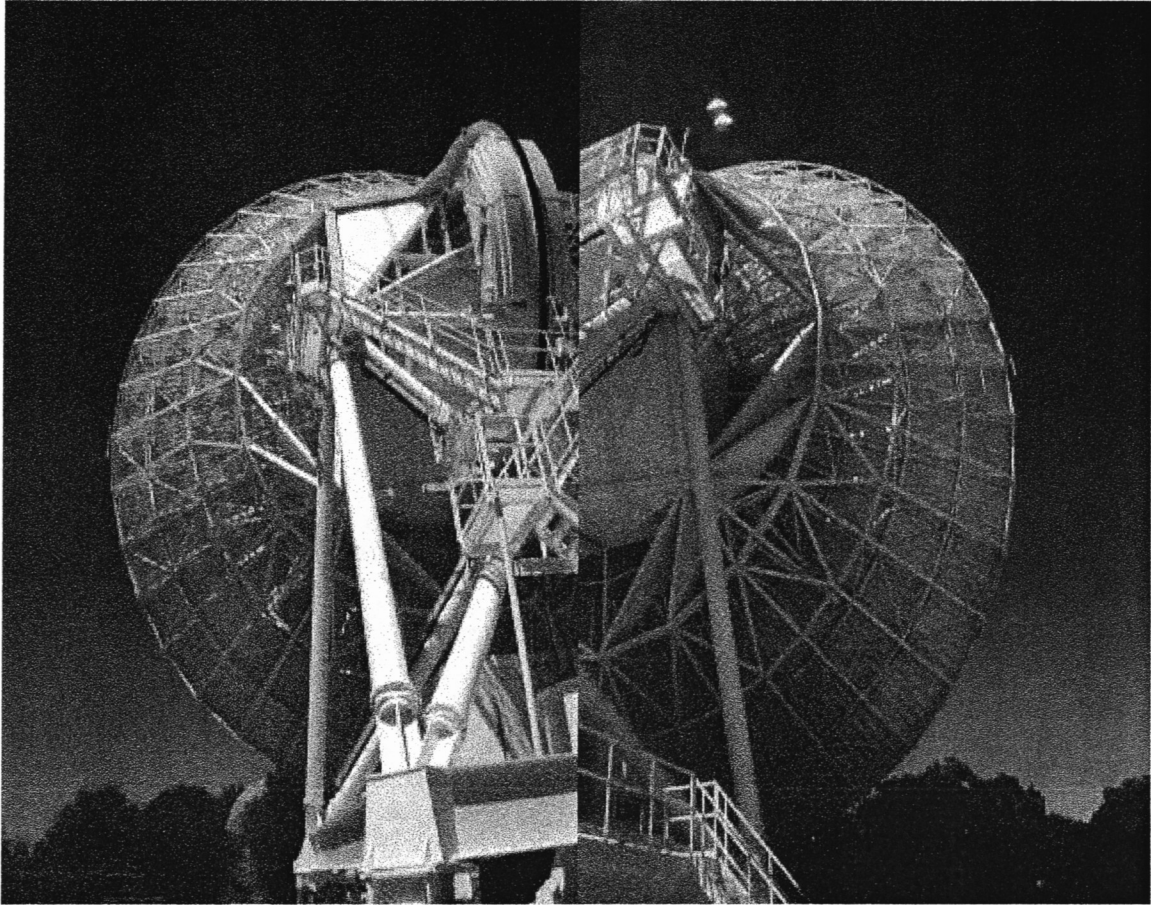
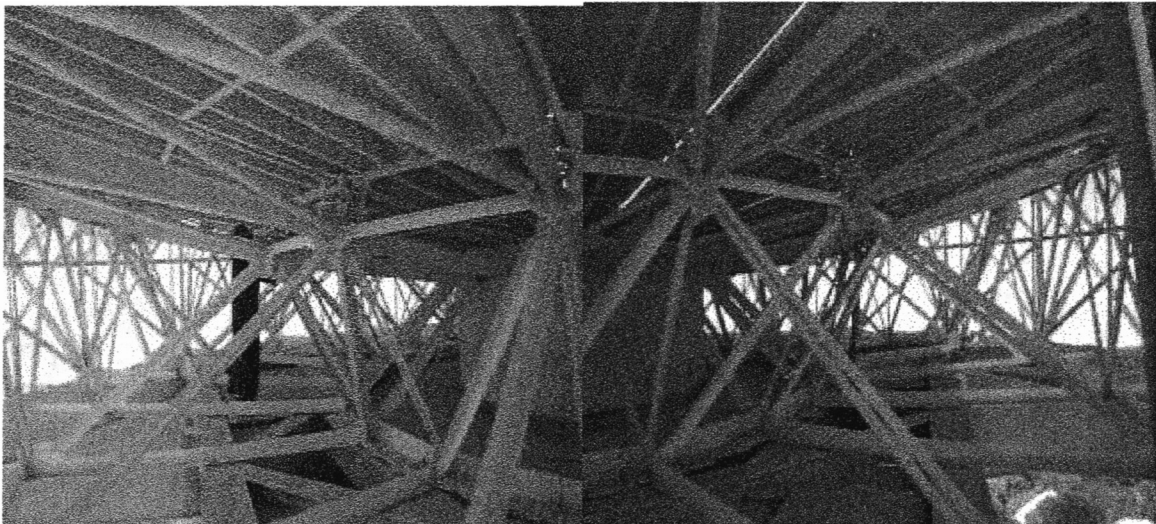
The antenna was repainted in two visits (June 2001 and June 2002). All the photos in this report show what a great paint job John Wall and his crew did.

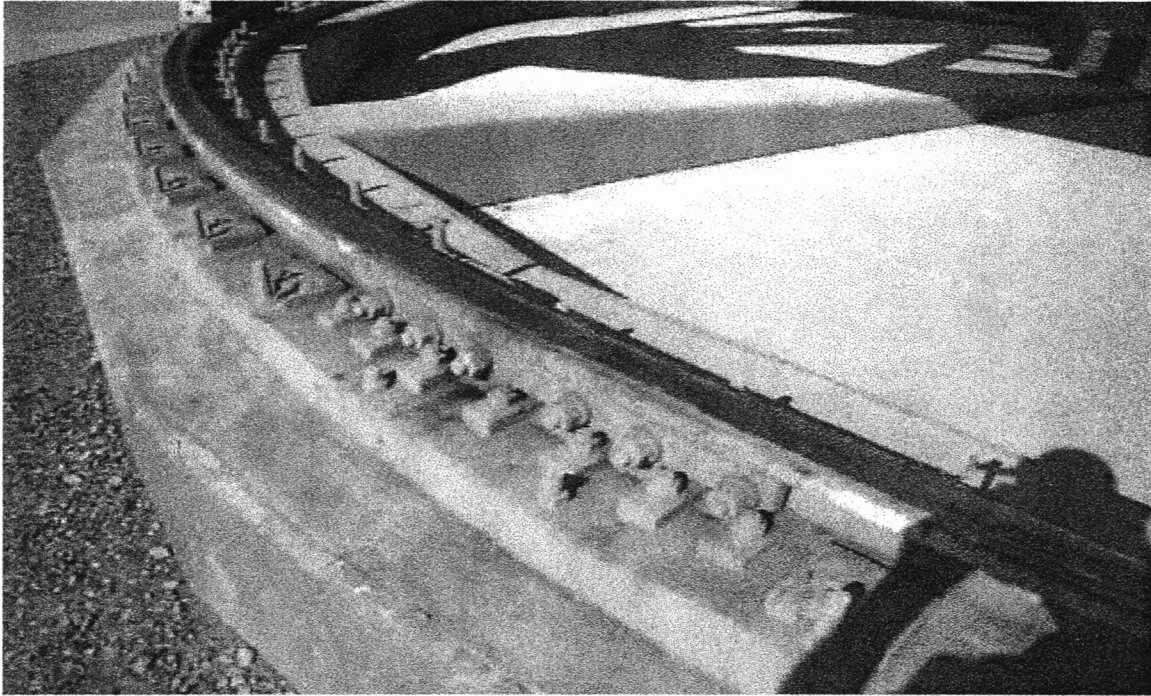
A typical rail splice. Rail splices and vulchem are in good condition.

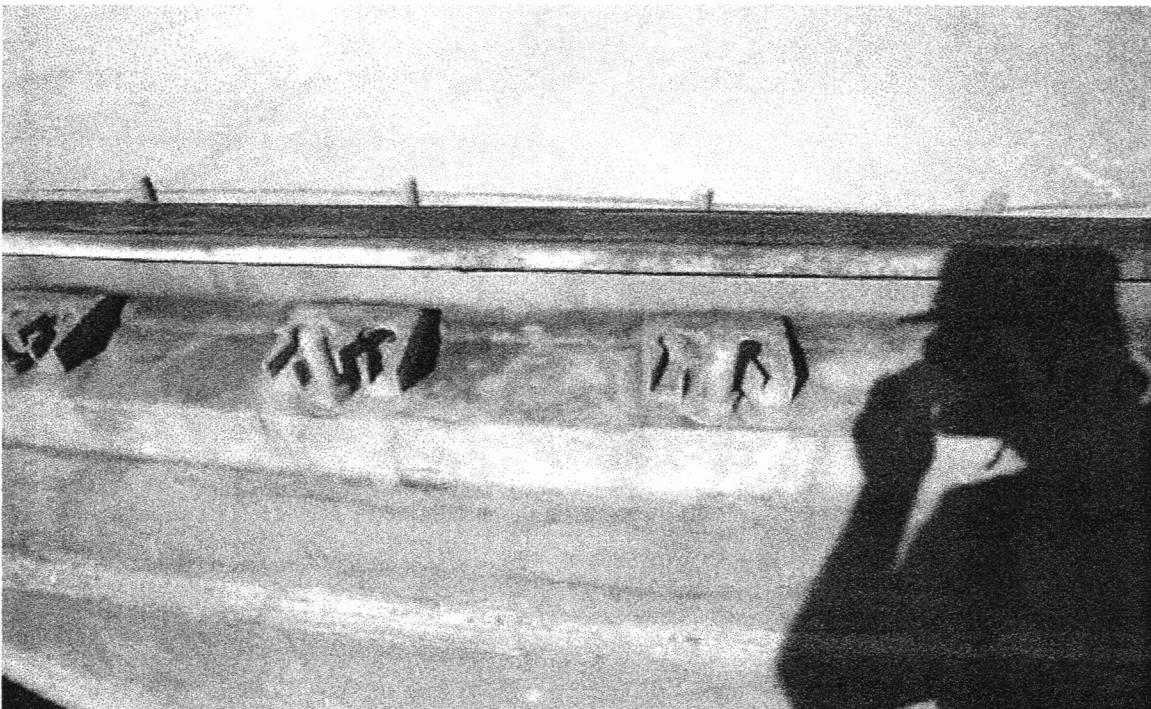
Rail clips and vulchem are in good condition.

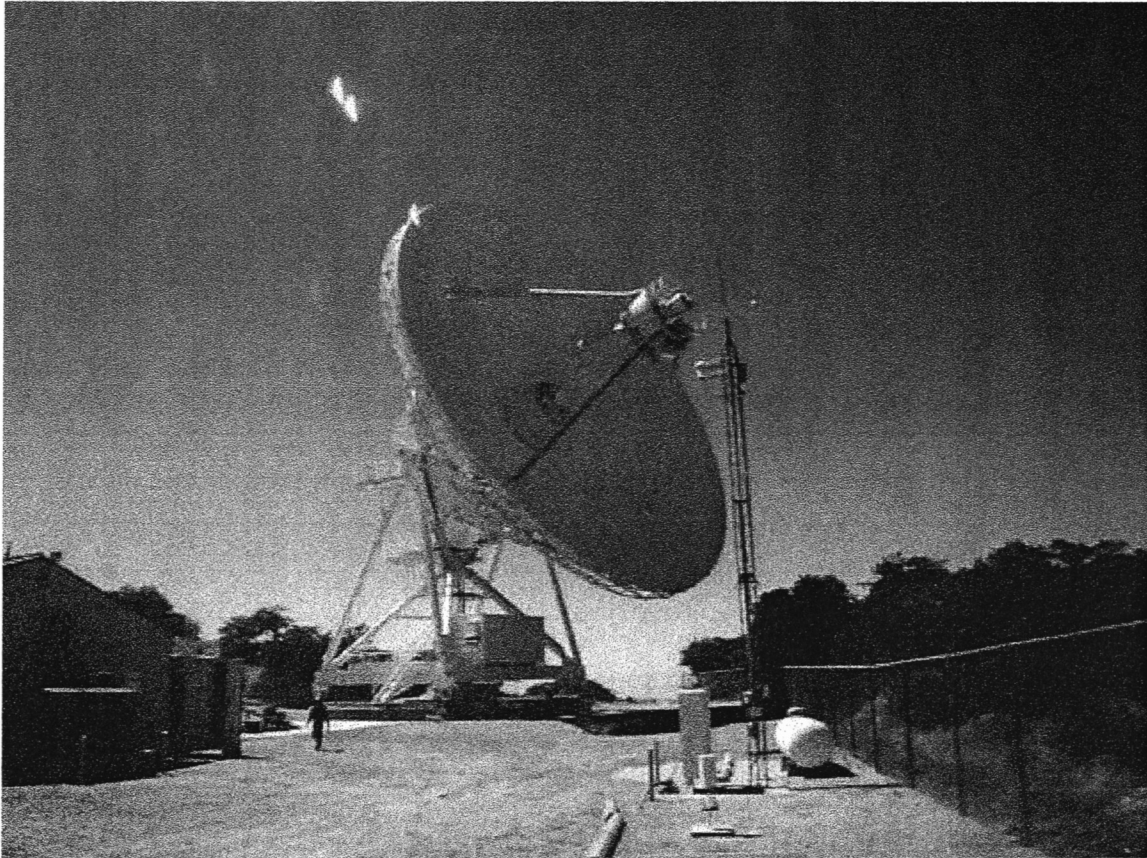
The weather station PM was done. Weather station and generator enclosures are in good condition and rust free. Generator inspection and PM was done.

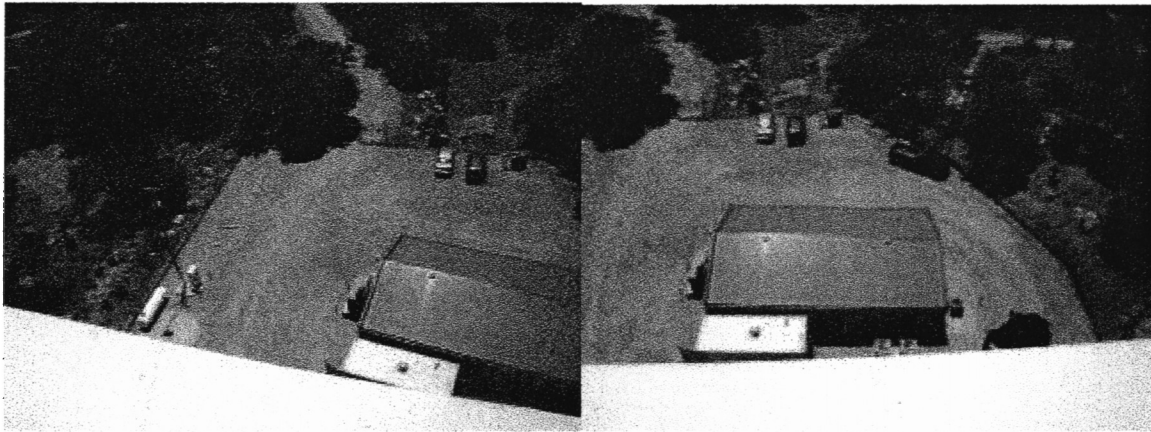
The area inside the fence is weed free and orderly.

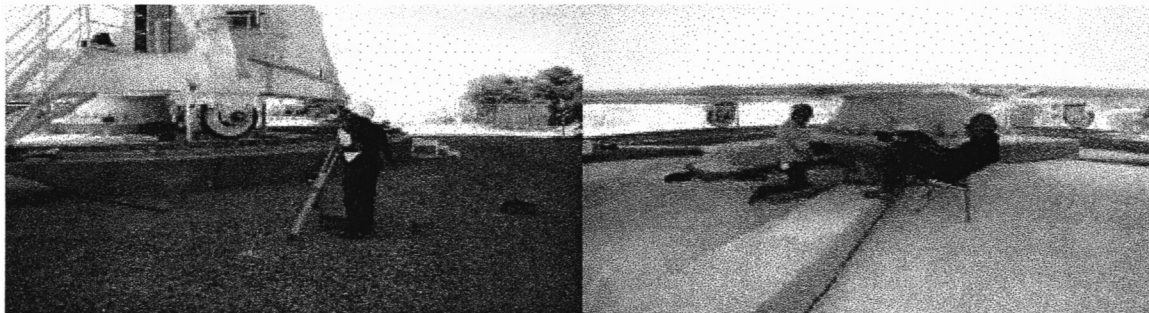
Ramon measures AZ #1&2 drive wheel alignment. The rail was measured.

D1	D2
Horizontal error	0d 00'18"	0d 00'57"
Vertical error	0d 01'02"	0d 01'47"
Radius error	.317"	.135"
