**National Radio Astronomy Observatory
Socorro, New Mexico**

VLBA Antenna Memo #55

Fort Davis, Texas VLBA Maintenance Visit June 10th thru 18th 2004.

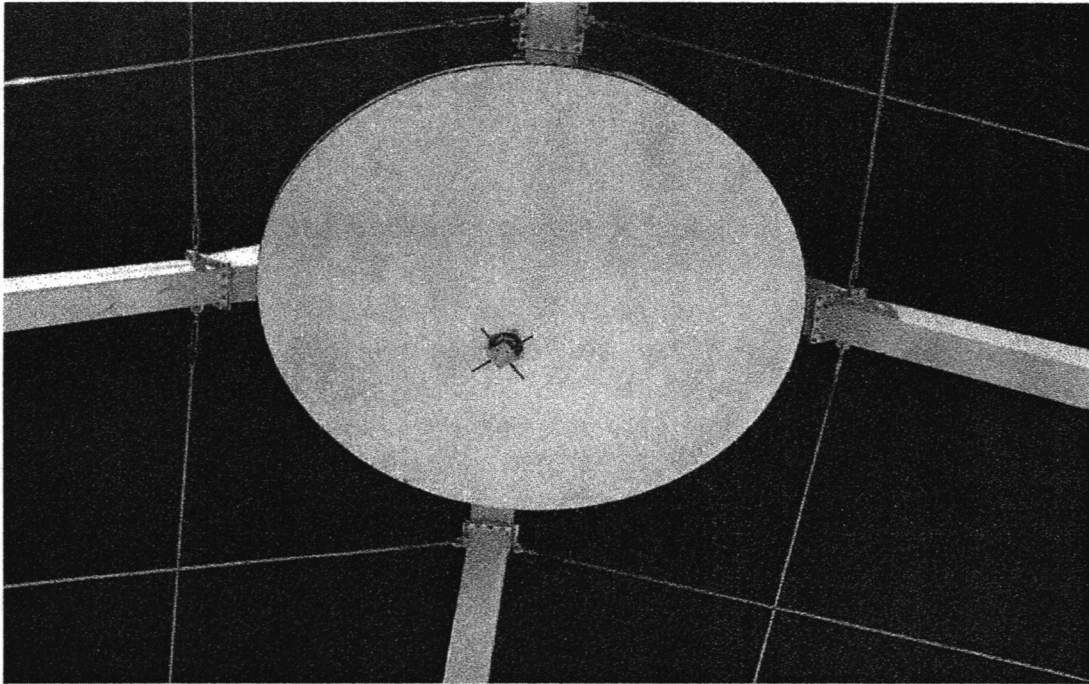
Subreflector is in good condition. A new ladder and fall arrest were installed. Site Techs were trained on using the new fall arrest.

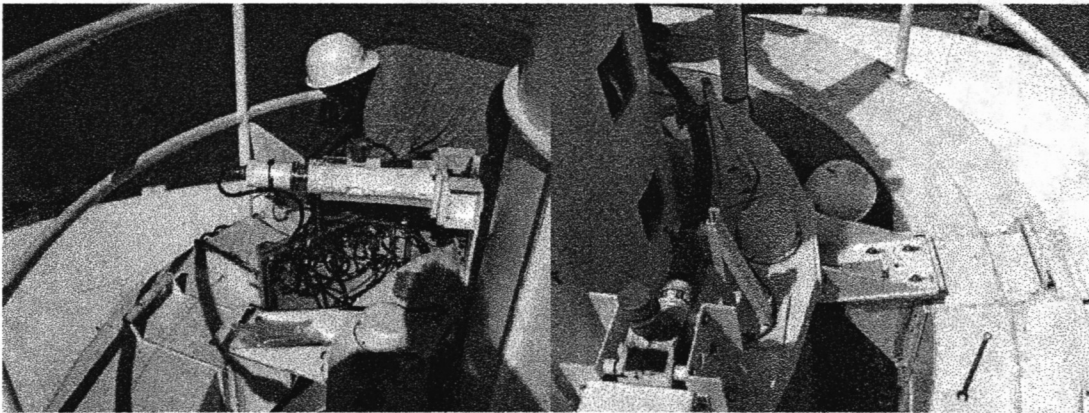
FRM was given a thorough inspection. A focus flex shaft was replaced and the new encoder coupling modification was installed. Focus motion analysis faults were occurring. The problem was found to an unbalanced focus motor amp and water inside the encoder. This was corrected.

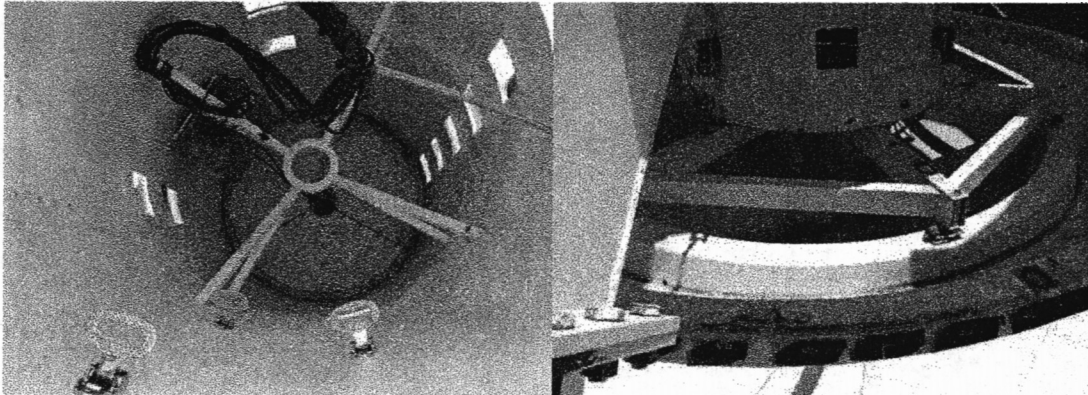
Flip steps were installed for easier access in and out of the FRM tube. 90/50 FE cables and connectors are in good condition. Subreflector drain holes were cleared. Dipole is in good condition.

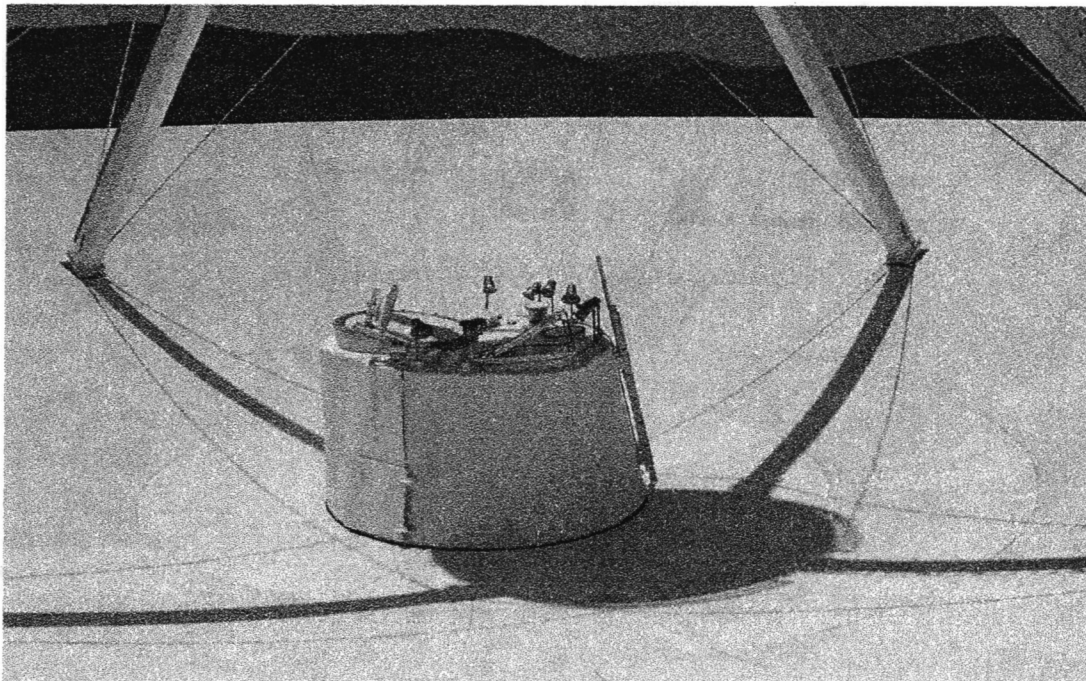
Feed cone was spot sealed and painted with elastomeric

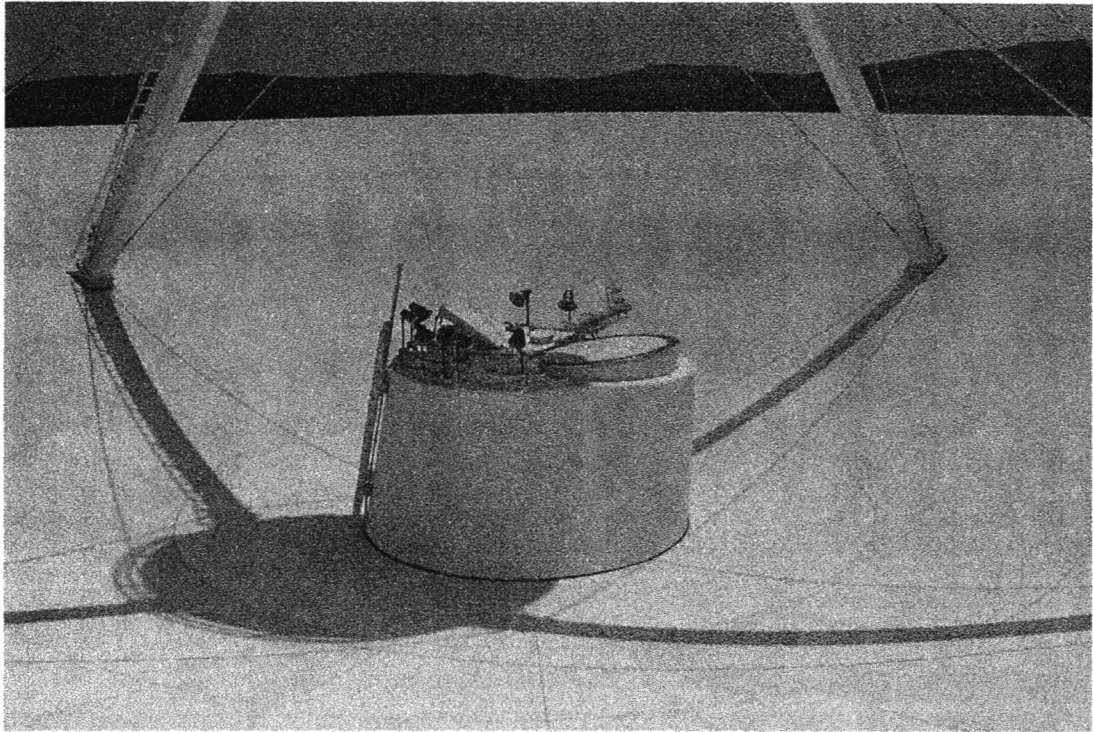
Dichroic reflector was replaced and aligned. Dish panels are in good condition. Panels paint is in good condition. Quad legs paint and guy wires are in good condition.

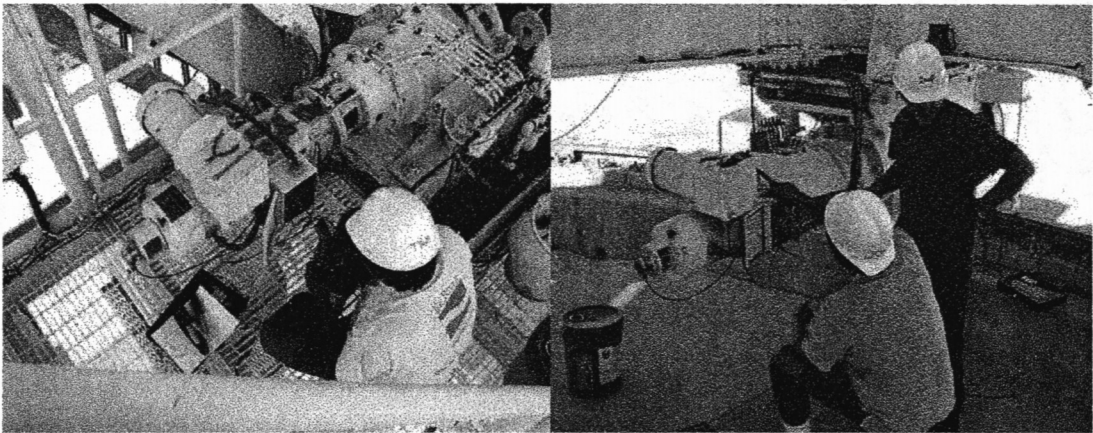
New digital tachs were installed on Elevation and Azimuth motors. Elevation # 2 motor and Azimuth motor #1 were replaced.

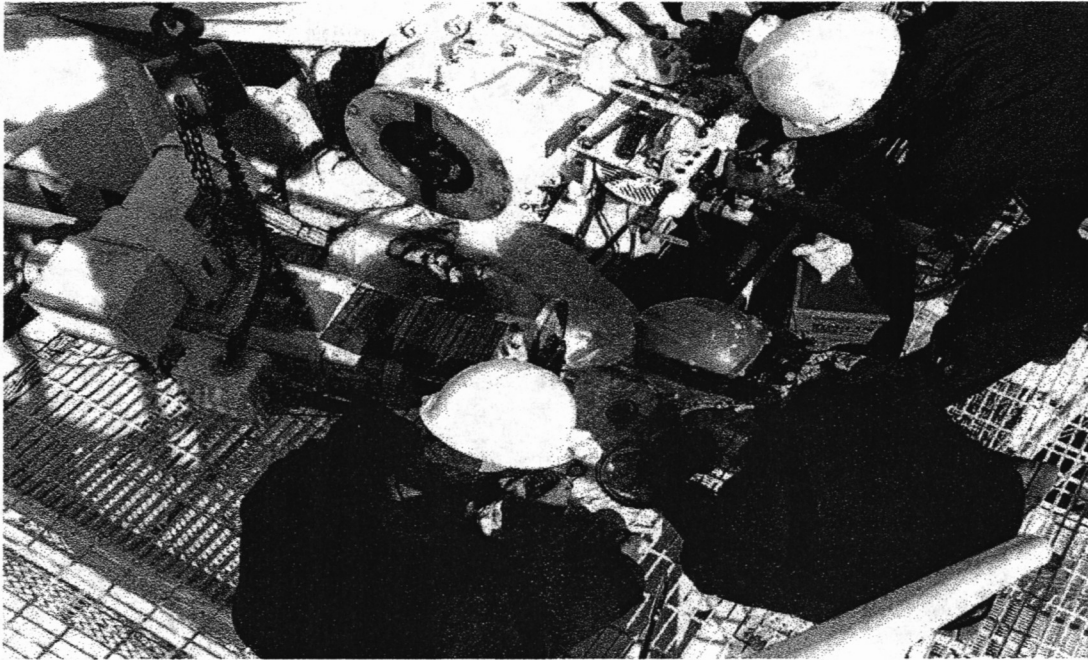
Elevation #1 gearbox, 1st and 2nd stage gear inspection.

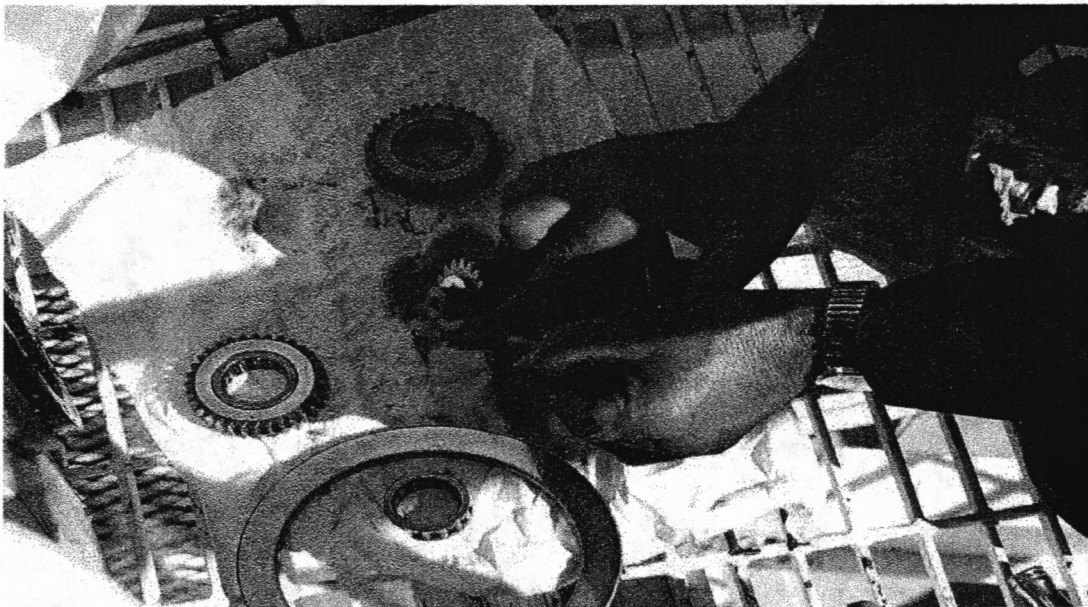
Steve measures ~.003" of wear with a feeler gauge. Elevation #1 gearbox is in good condition. Both elevation gearboxes oil was changed. Fish eyes and flow gauges were cleaned. Elevation #2 was not opened for inspection.

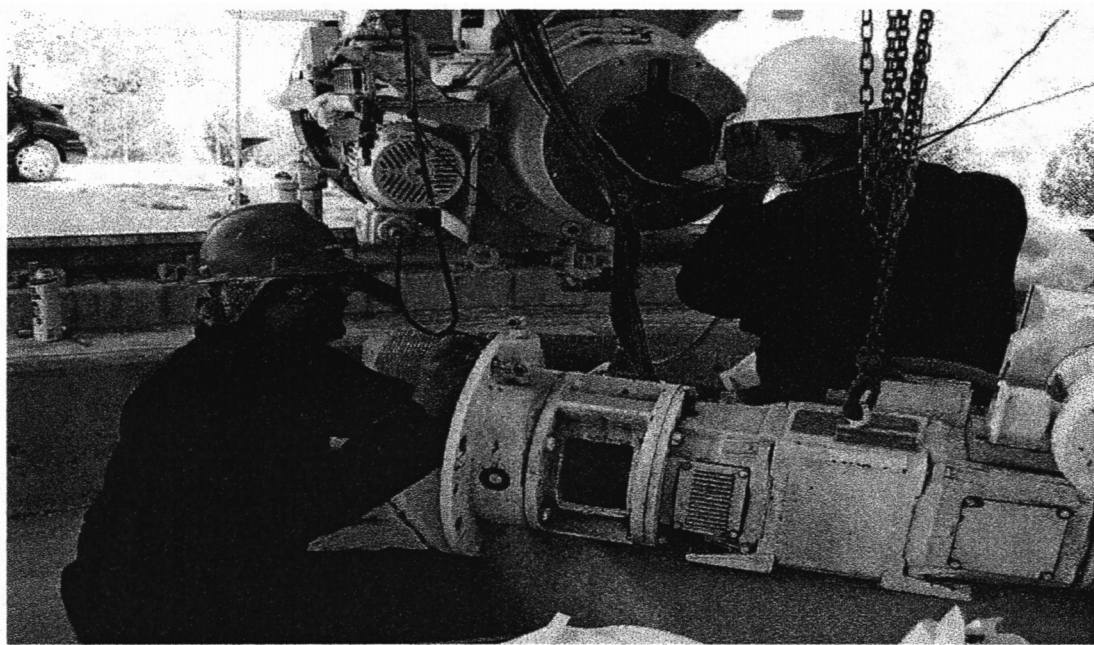
Azimuth #2 gearbox, 1st and 2nd stage gear inspection.

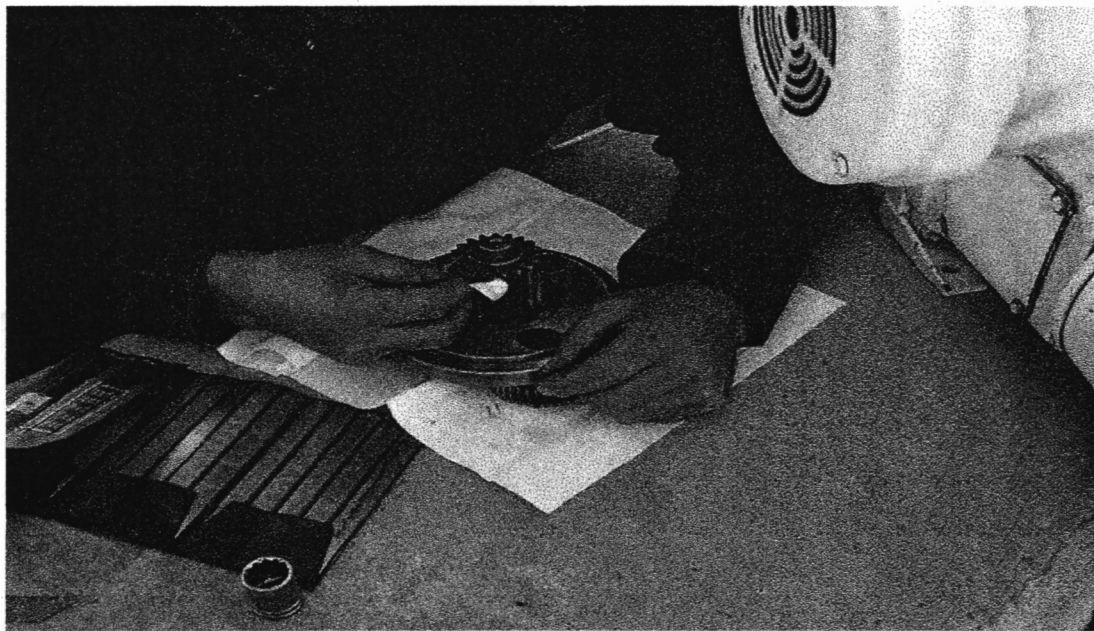
Steve measures ~.002" of wear with a feeler gauge. Azimuth #2 gearbox is in good condition. Both azimuth gearboxes oil was changed. Fish eyes and flow gauges were cleaned. Azimuth #1 was not opened for inspection.

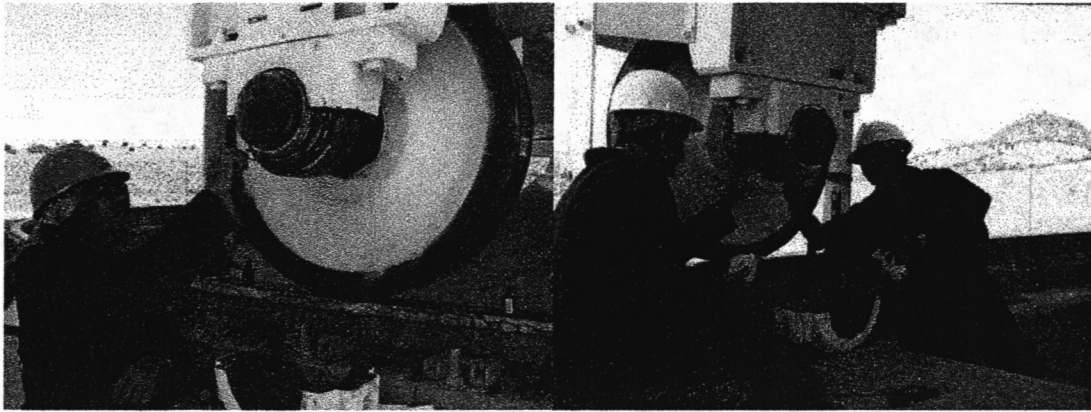
Azimuth bearings were inspected. No azimuth bearings needed replaced.

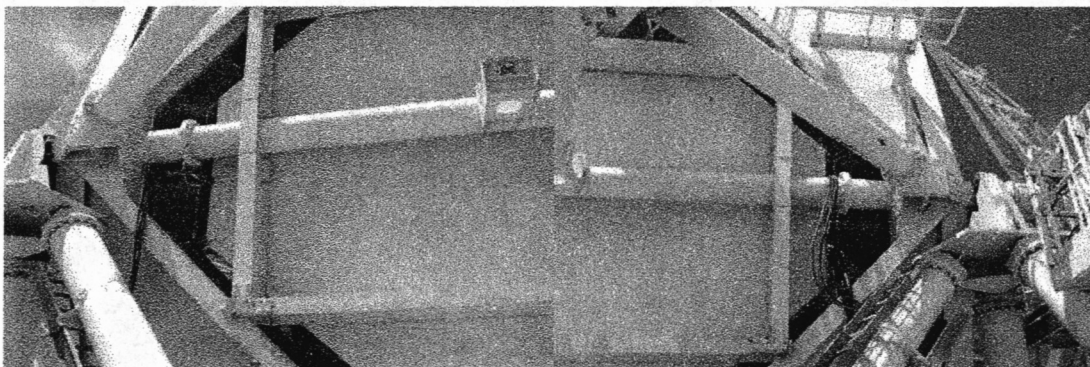
Elevation axle has no visible signs of cracks. Paint is good condition. Pintle bearing is well greased with no metal flakes.

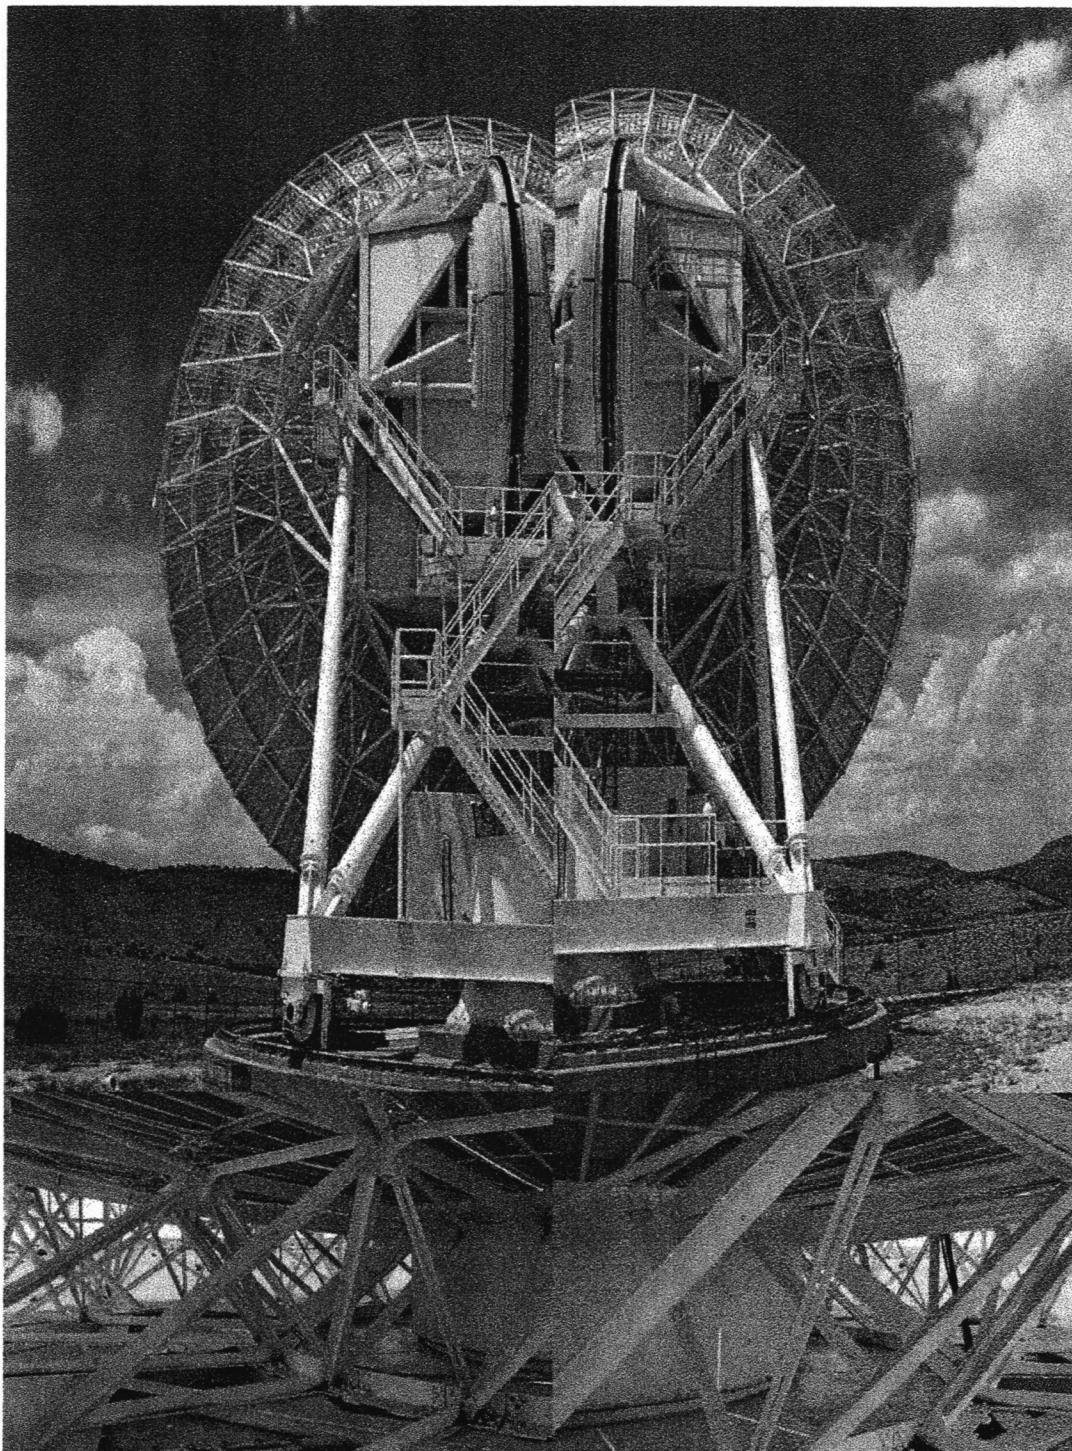
The antenna paint is in great condition.

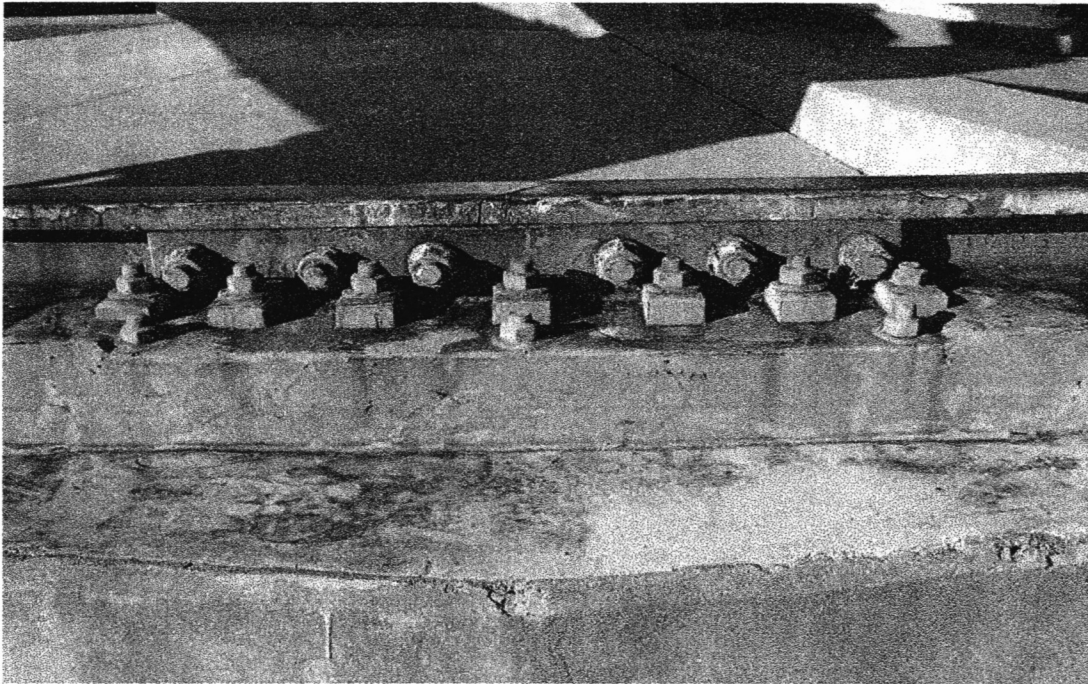
Vulchem is beginning to deteriorate from this rail splice and all others.

Antenna foundation/grout/vulchem. Vulchem needs removed.

- 1. INSTALL PED ROOM BACK UP AC.**
- 2. INSTALL PED ROOM 6KVA LIEBERT UPS.**
- 3. INSTALL NEW ACU BACKPLANE.**
- 4. REMOVE VULCHEM FROM RAIL.**

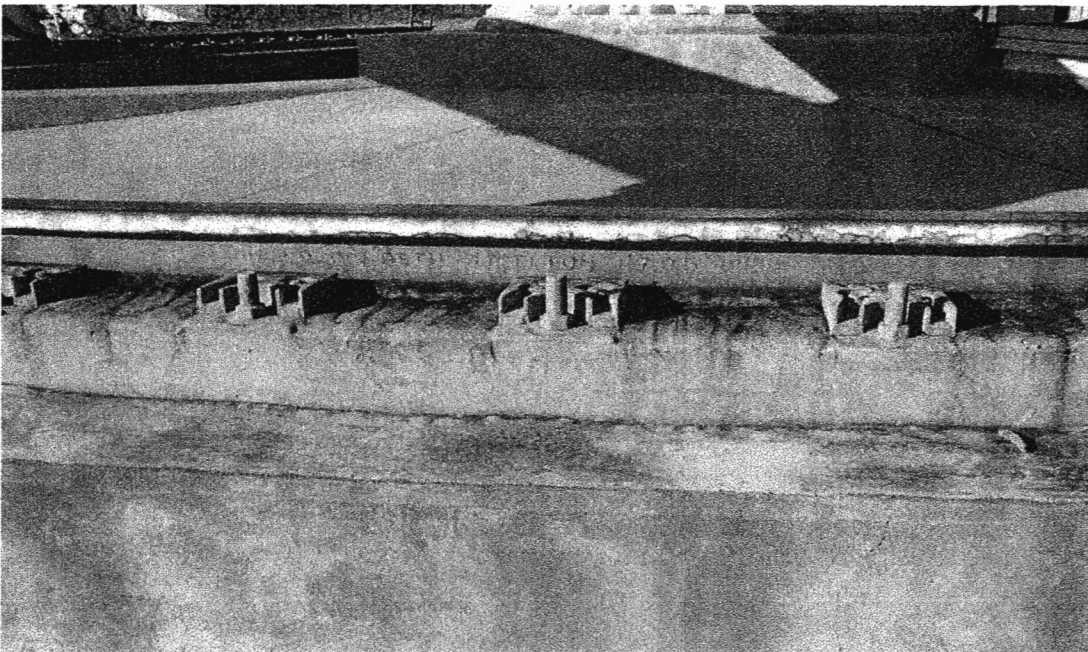
Vulchem is deteriorating off rail clips and will have to be removed.
