National Radio Astronomy Observatory  
Socorro, New Mexico

VLBA Antenna Memo #56

Brewster, WA. VLBA Maintenance Visit July 28<sup>th</sup> thru August 8<sup>th</sup> 2004.

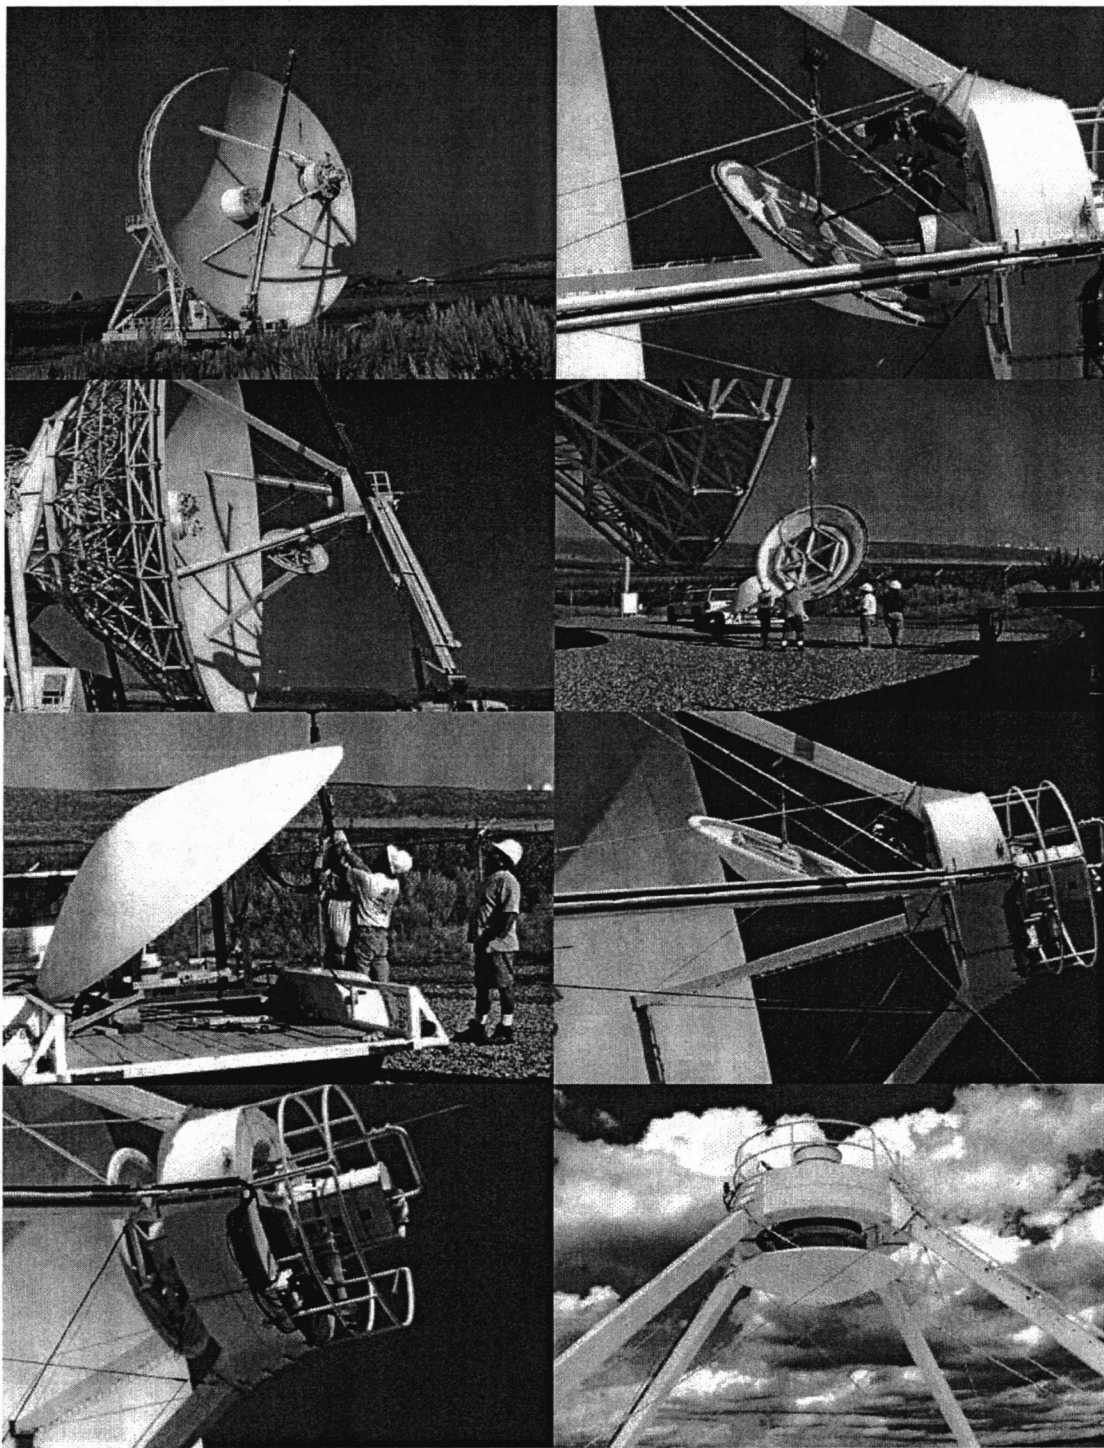
The subreflector was replaced and the new one aligned.

SUBREFLECTOR REPLACED.

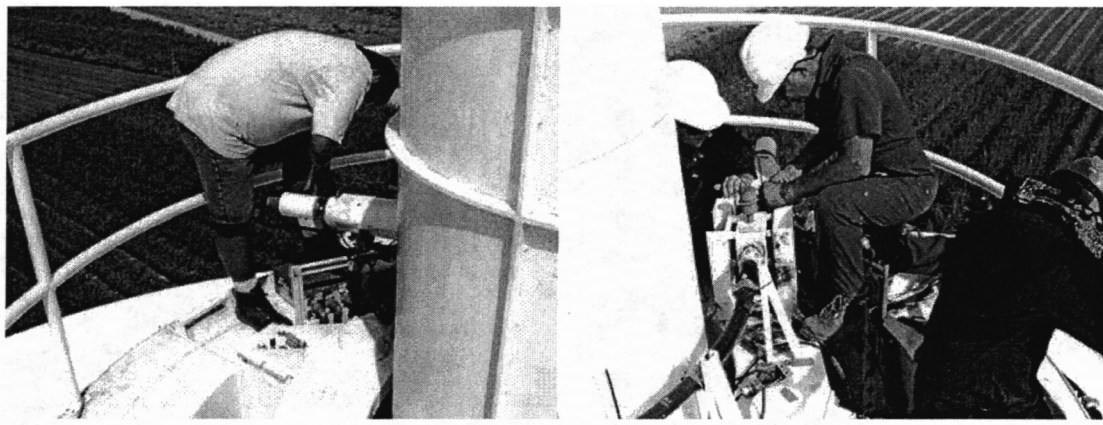
FRM was given a thorough inspection. A focus flex shaft was replaced and the new encoder coupling modification was installed.

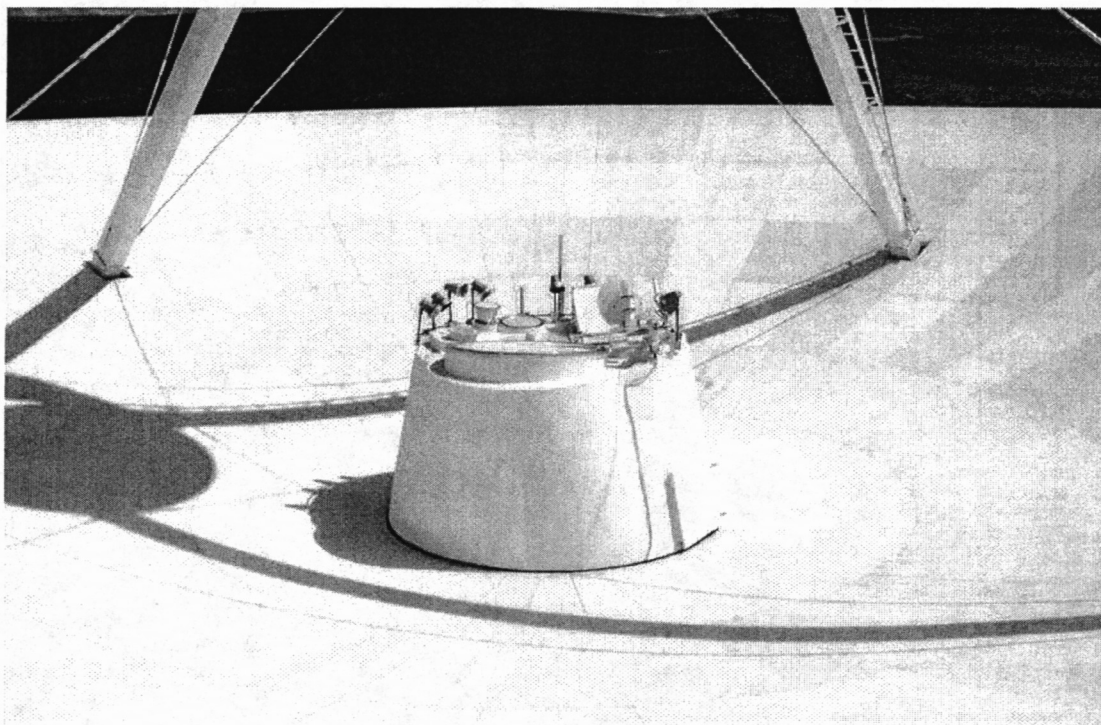
Feed cone was spot sealed and painted with elastomeric

Feed cone surface/insulation. Spot sealed and painted with elastomeric.

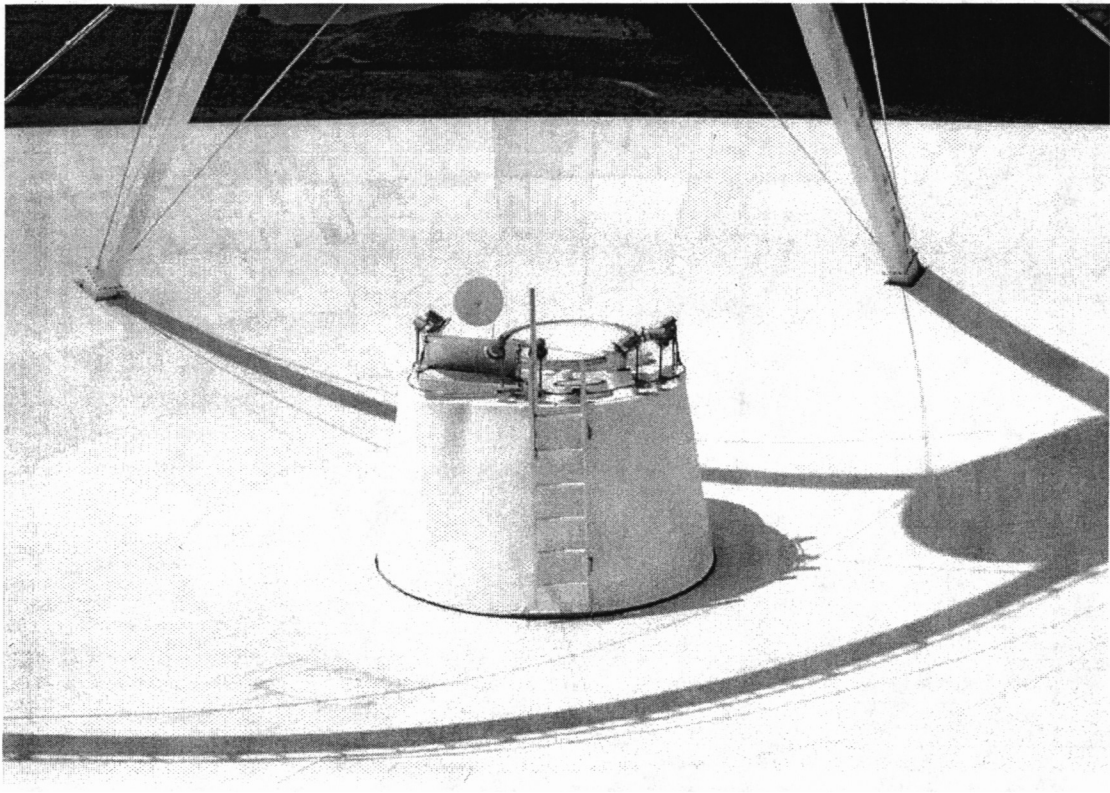
Dish panels are in good condition. Panels paint is in good condition. Quad legs paint and guy wires are in good condition.

Panel surfaces. Some discolored panels. Good condition other wise.

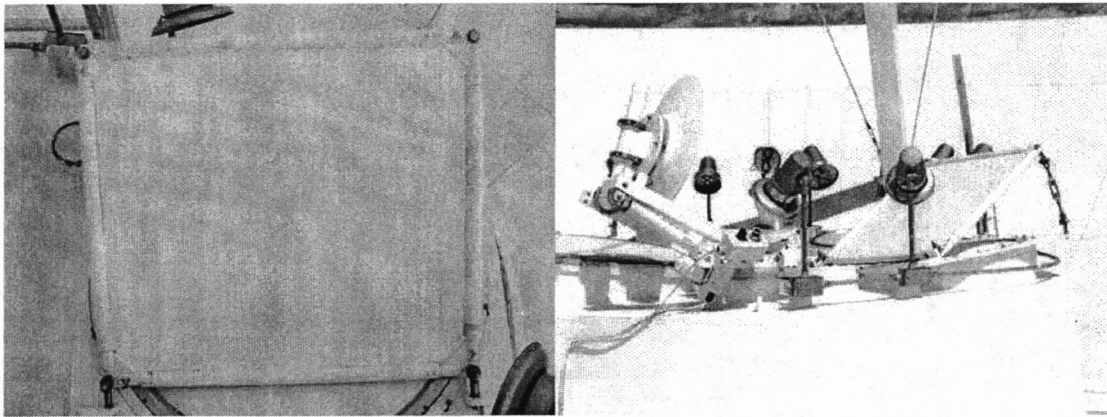
Dichroic reflector is good condition. Elipsoid reflector is in good condition.

Dichroic reflector cracking/delaminating. (NOP#6C3C) Panel in good shape, small frame crack.

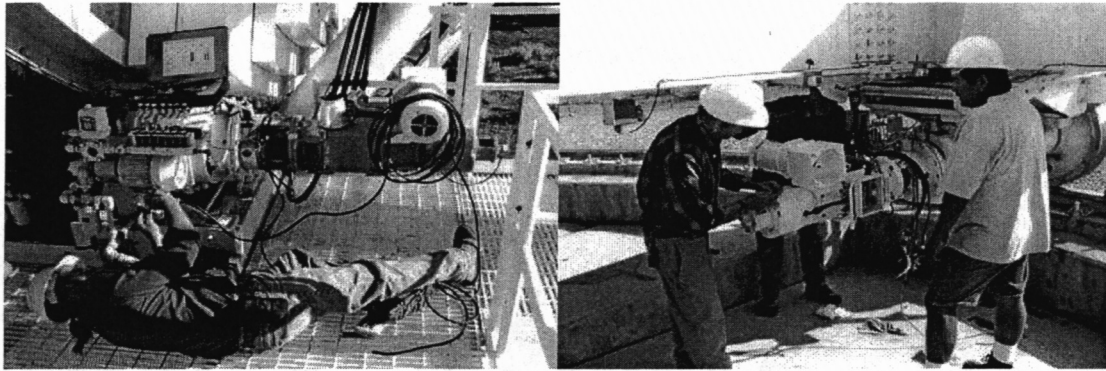
New digital tachs were installed on EL and AZ motors. All AZ and EL lube pump SJO power cables were replaced. Azimuth #2 motor was replaced. The ACU power supply and backplane upgrade were installed and tested.

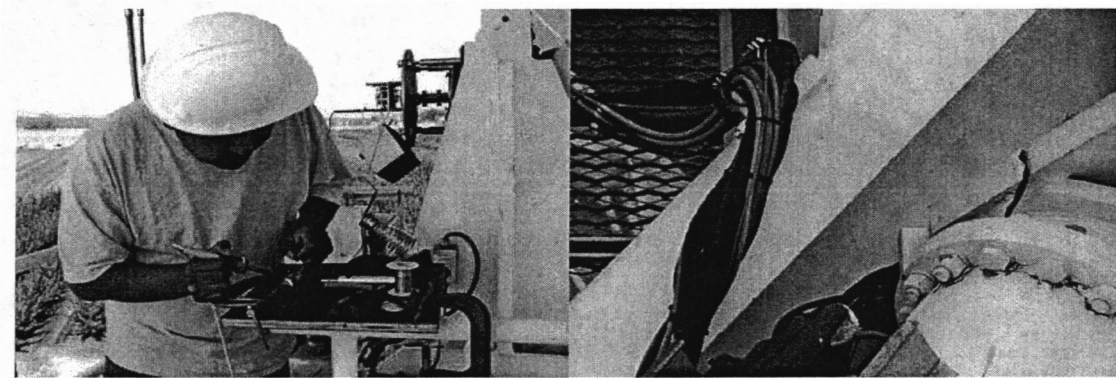
Elevation synchro data and power cable connector was repaired. The encoder side cable wrap strain relief and mounting bracket was repaired.

**Elevation synchro side blowing fuses——Nelson repaired/cut and resolderd cable conn.**  
**All drive motor lube pump power cables insulation deteriorating——Repaired all lube**  
**Pumps with new SJO power cable.**  
**Removed EL#1 RFI screen——screen was plugged.**  
**Ped room/antenna fire alarm batts dead——warehouse sending new ones.**  
**Adjusted 3 AZ idler contacts——(not touching rail).**

**Repaired encoder side elevation cable wrap. Welded unistrut and replaced cable strain relief.**

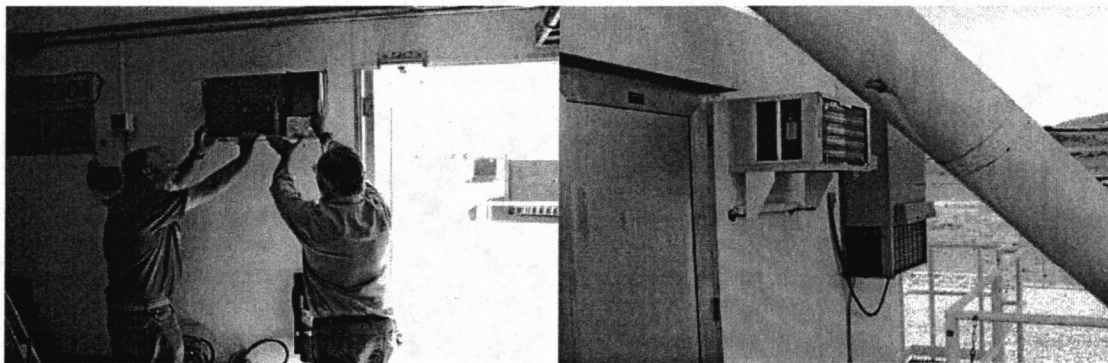
A Marvair backup air conditioner was installed in the Ped room.

ACU/FRM logic on UPS. FRM was not on UPS, FRM corrected.  
UPS operation/by-pass switch. Operates properly.  
Breakers labeled correctly. Labeled correctly.  
Dry air compressor. (run time <25%) 23%.  
Serv Air operation. Marginal cold air, Installed backup AC.

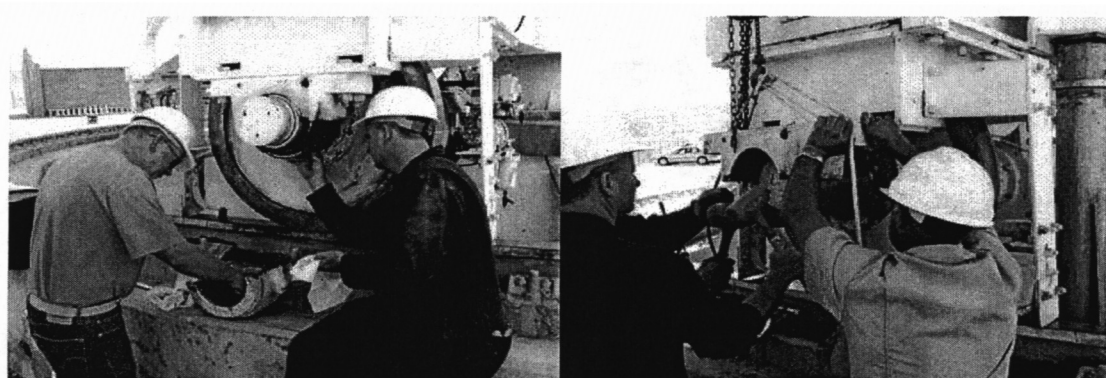
AZ bearings were inspected. AZ drive #1 outside bearing was replaced.

INNER BEARING	OUTER BEARING
D1	No metal found/rollers scratchy	REPLACED
D2	NEW WHEEL	NEW WHEEL
I1	No flakes/race a little scratchy	No flakes/good races
I2	Few brass flakes/smooth race	No flakes/race a little scratchy
All bearings were very well lubricated.

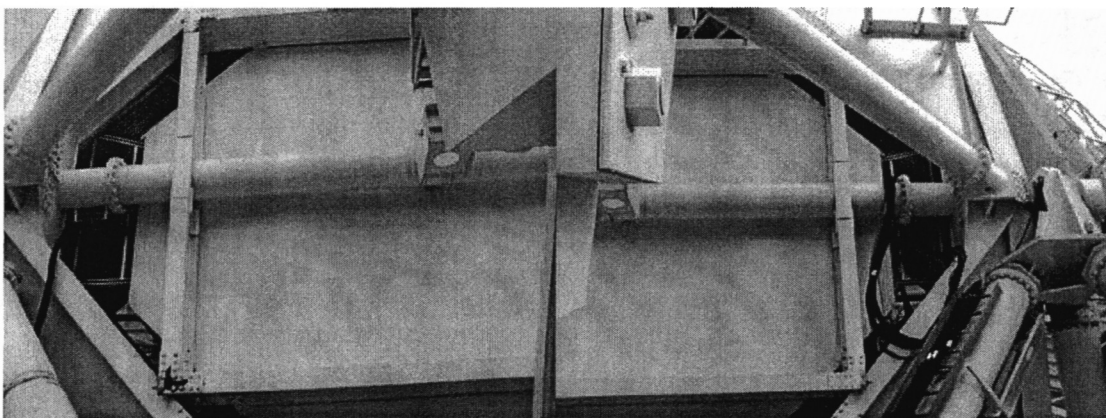
Elevation axle has no visible signs of cracks. Paint is good condition. Pintle bearing is well greased with no metal flakes.

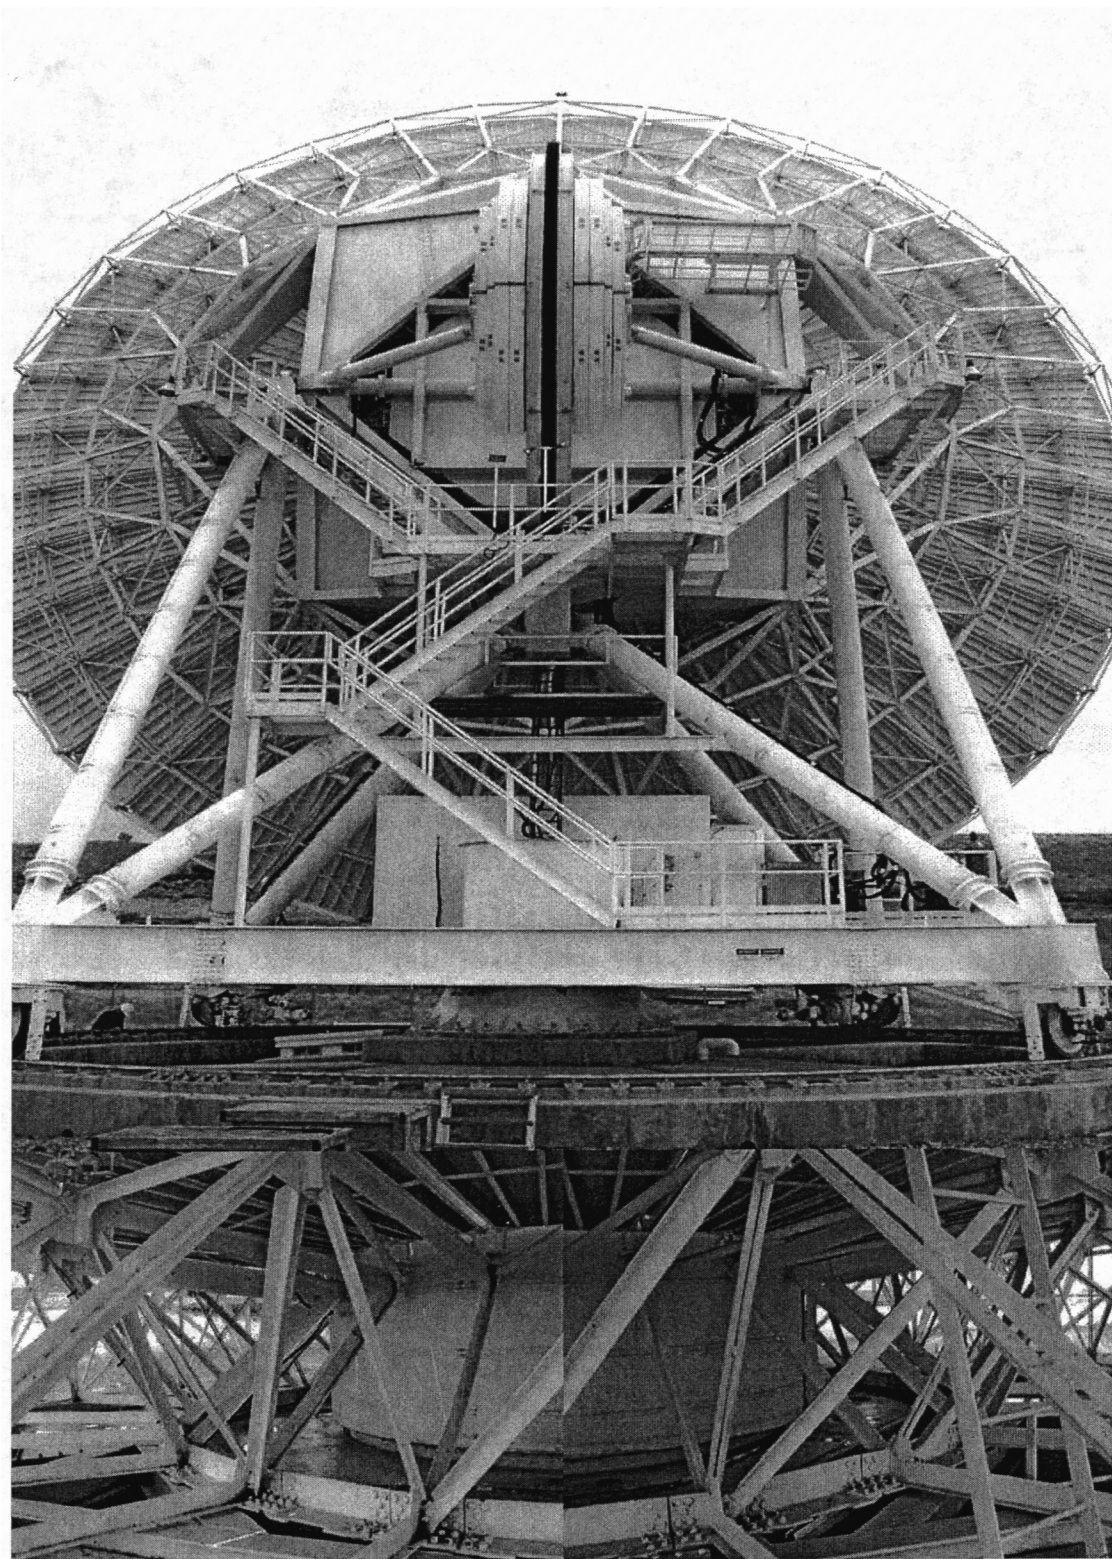
The antenna paint is in good condition.

Antenna paint condition. Fair to Good, Lots of bird nests and droppings.

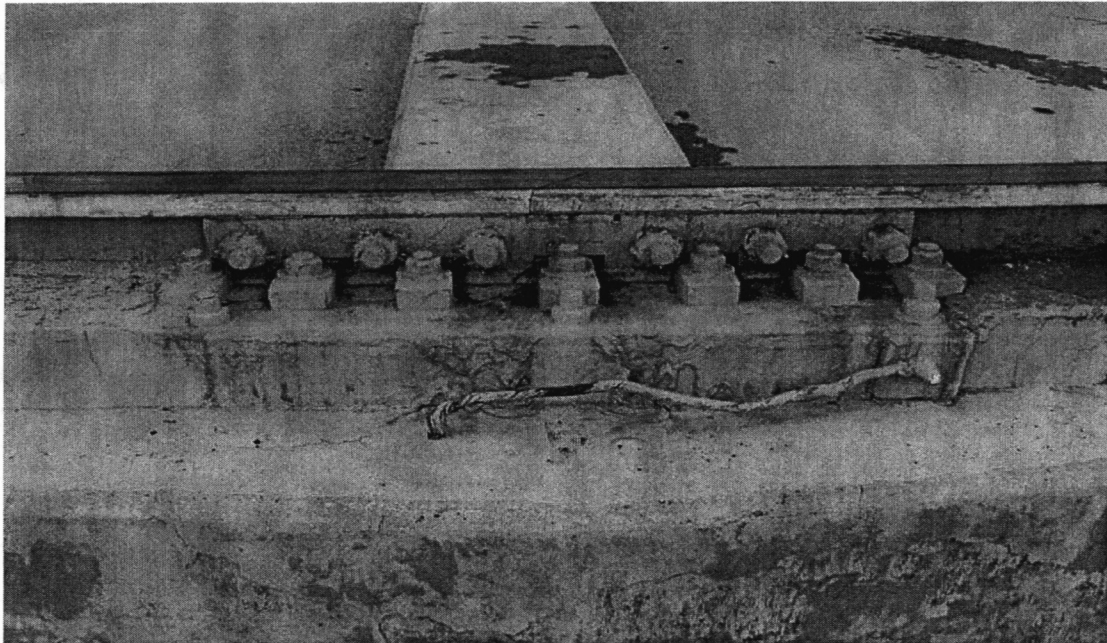
Vulchem is beginning to deteriorate from this rail splice and all others.

Antenna foundation/grout/vulchem. Deteriorating rapidly, needs to be removed.

Re-torque rail splice plates as needed. Done, most a little loose, all tightened.

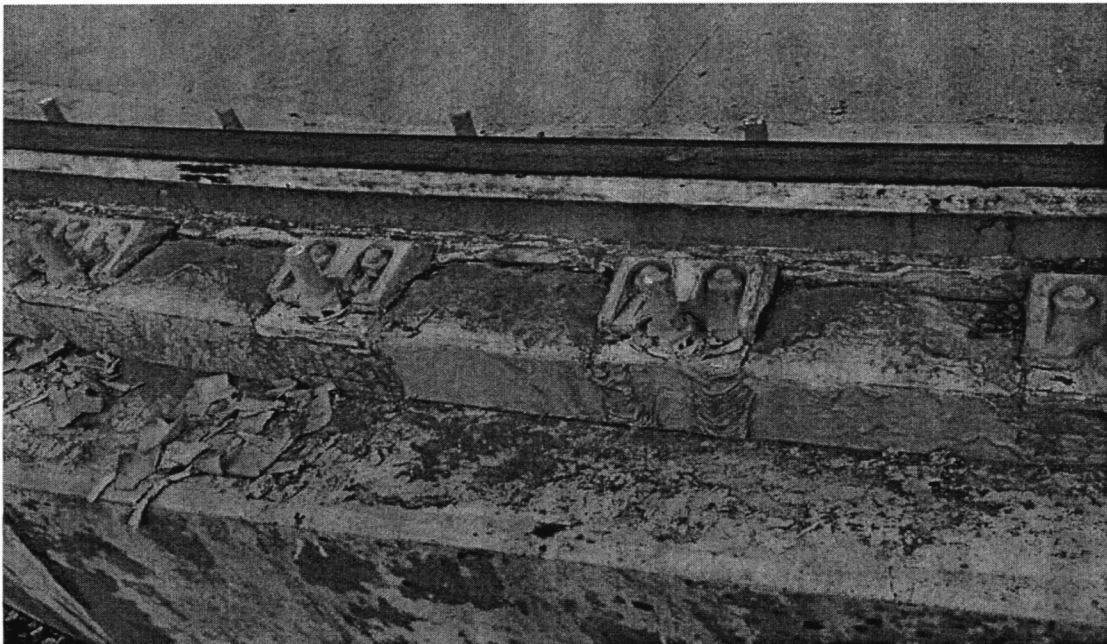
The rail is pulverizing the grout in many spots. Vulchem is deteriorating all over the rail. Site Techs began removing vulchem while the maintenance team was on site and will continue removing vulchem until it is all removed.

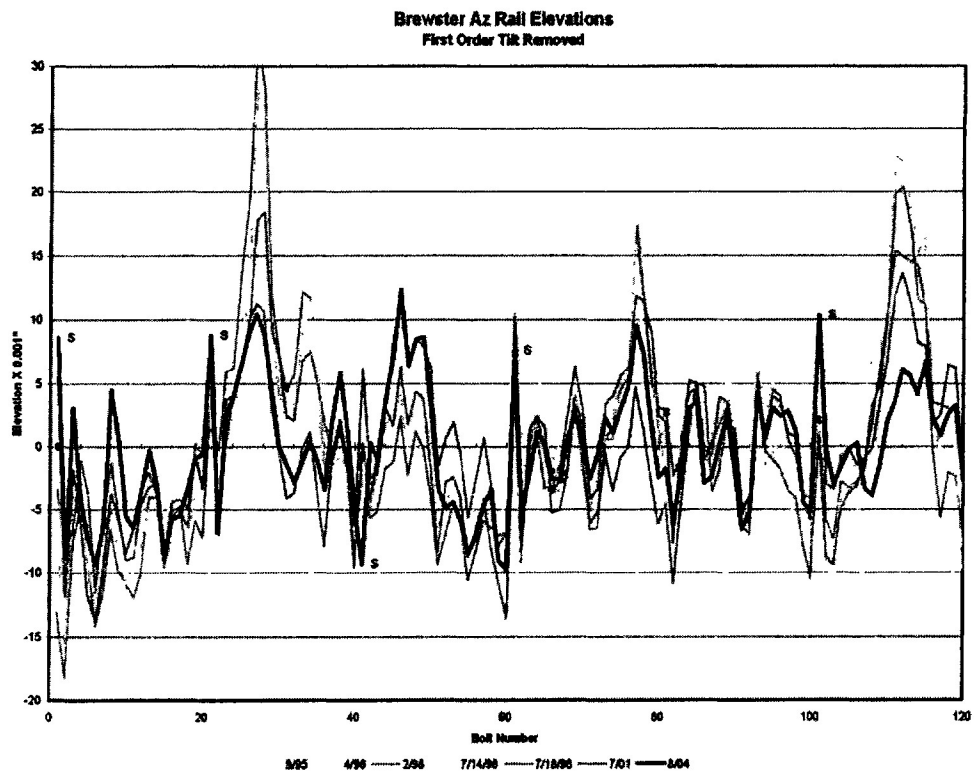
The Brewster rail is very flat with less than .025" change in elevation.
