**National Radio Astronomy Observatory
Socorro, New Mexico**

VLBA Antenna Memo #57

Owens Valley, CA. VLBA Maintenance Visit Sept. 23 thru Oct. 1 2004.

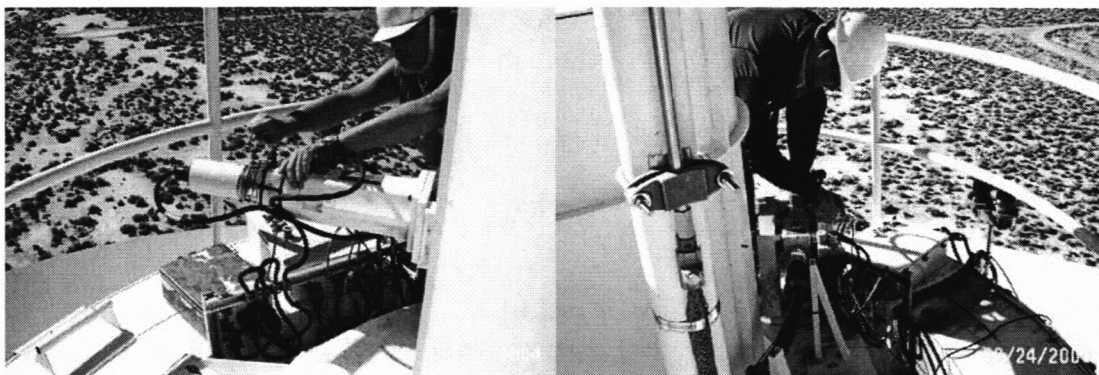
FRM was given a thorough inspection. A focus flex shaft was replaced and the new encoder coupling modification was installed.

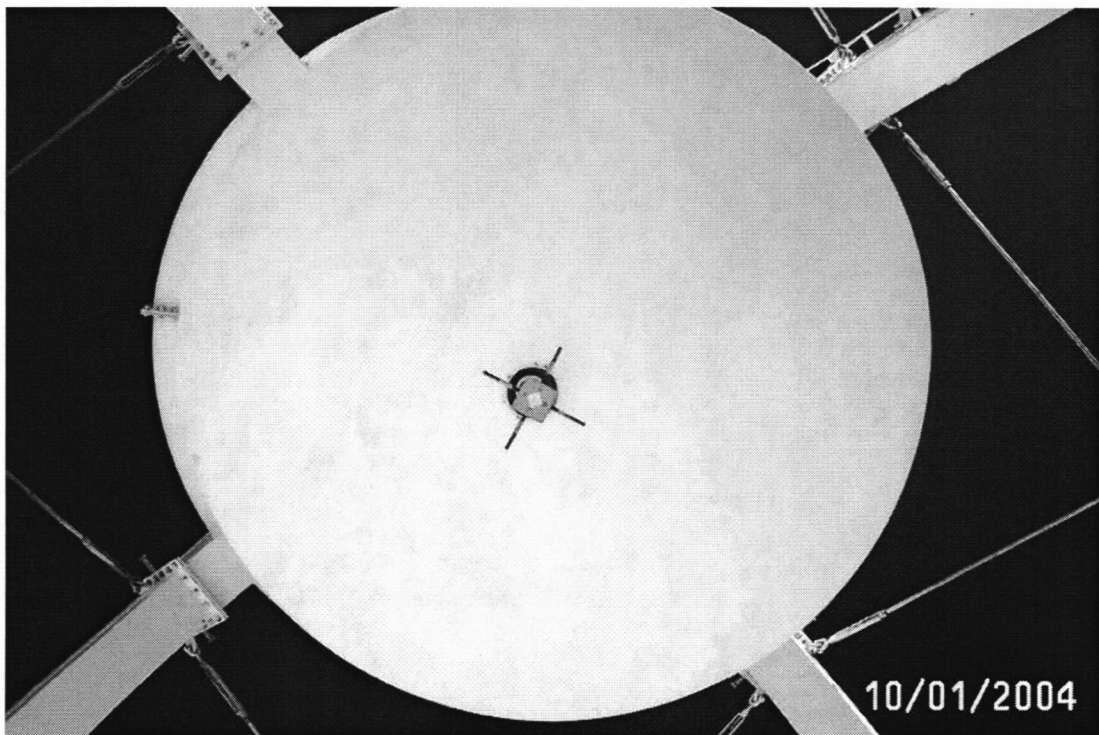
Subreflector is in good condition. Six 1 inch holes were drilled in the center of the reflector for extra drainage. The snow tarp was removed.

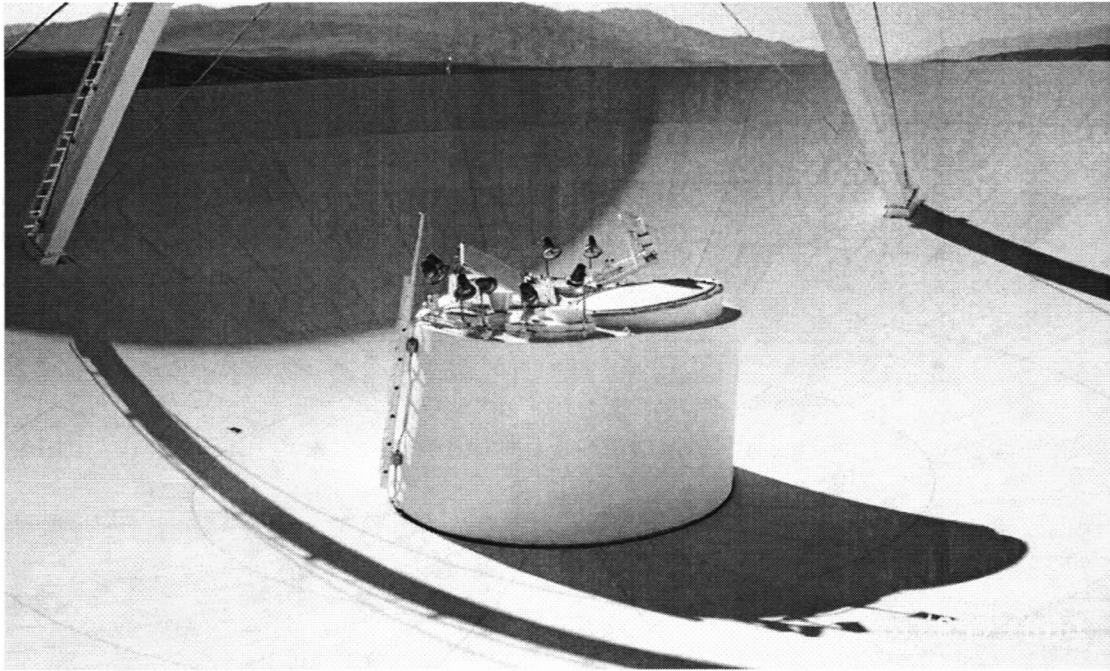
Feed cone was spot sealed and painted with elastomeric.

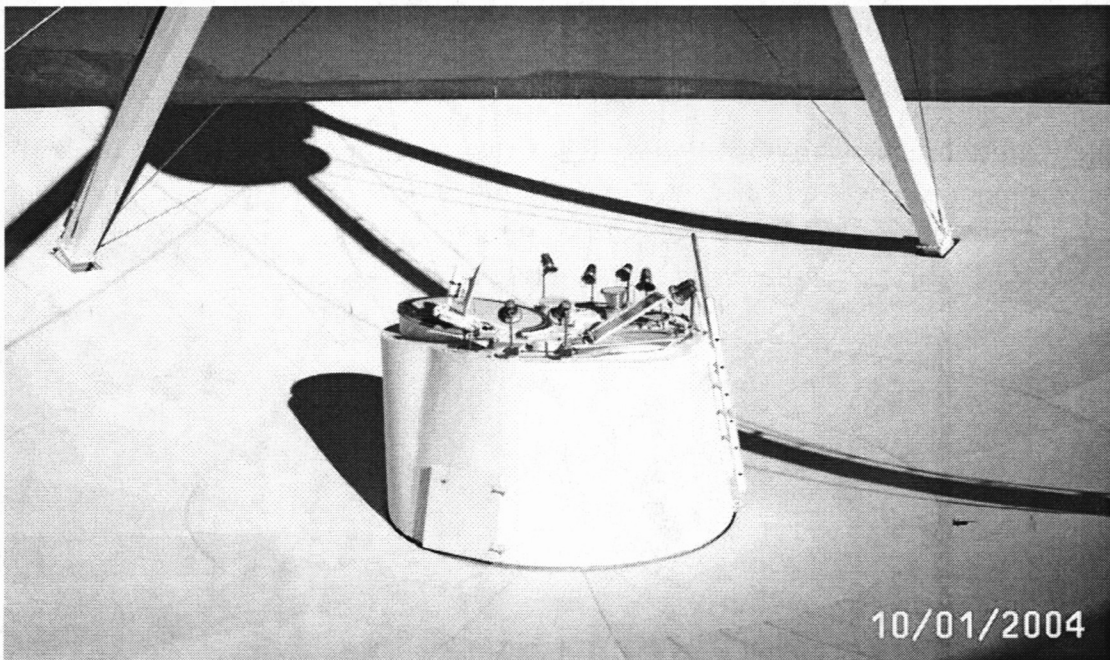
Dish panels, and the panels paint is in good condition. Quad leg paint is excellent. Guy wires are in good condition.

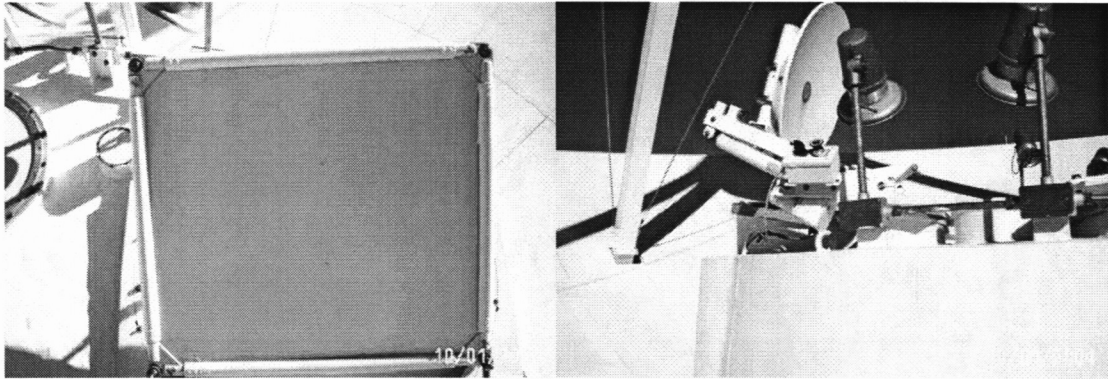
Dichroic reflector is good condition. Elipsoid reflector is in good condition.

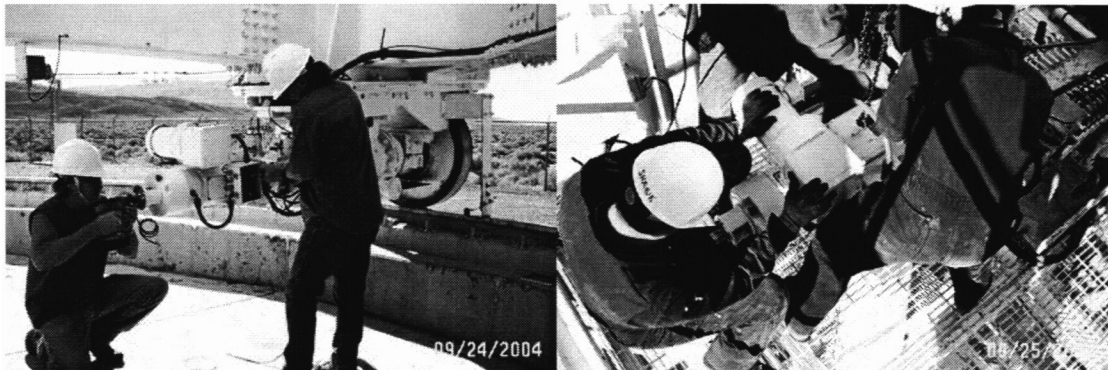
New digital tachs were installed on EL and AZ motors. Elevation #1 motor was replaced. The ACU power supply modification was previously installed by the site techs. The ACU backplane upgrade was installed and tested. An ACU +12 voltage regulator (U1) was replaced and tested.

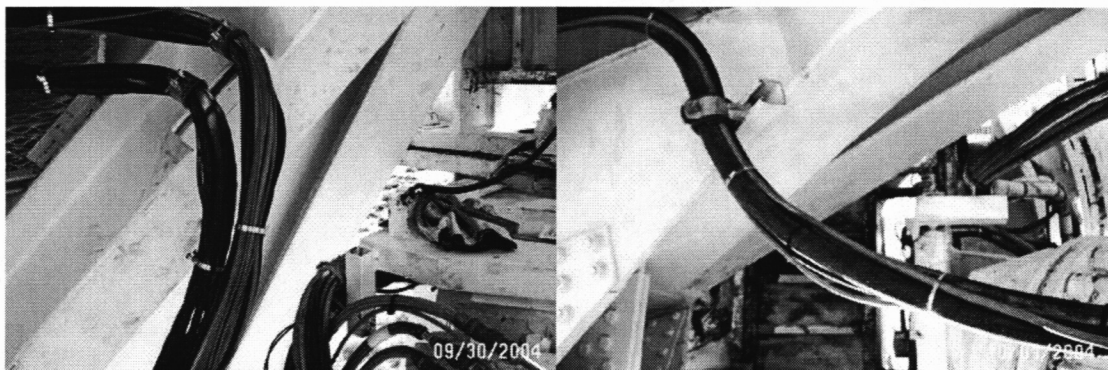
Both the encoder and synchro side elevation cable wraps were repaired by repositioning and replacing both sides strain relief brackets.

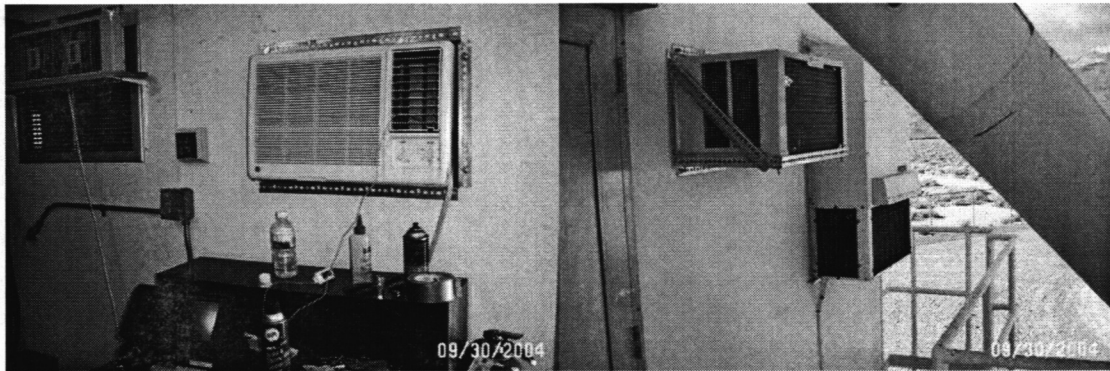
A backup AC was previously installed by the site techs in the ped room.

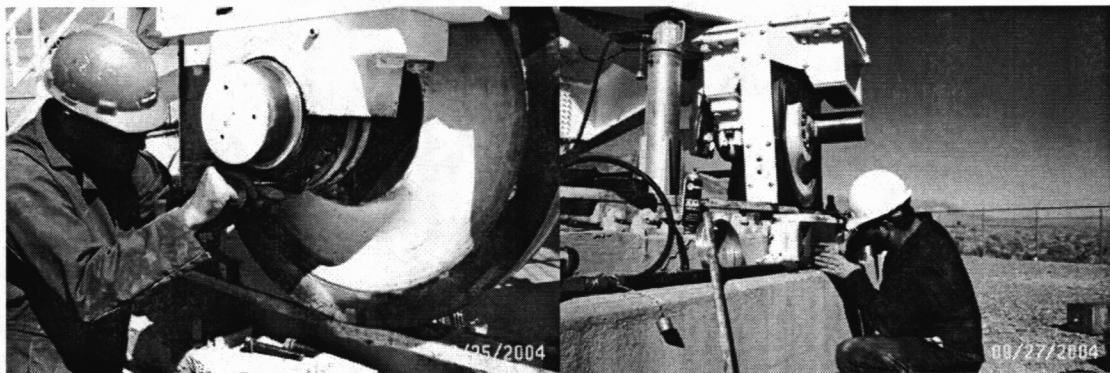
AZ bearings were inspected. AZ idler #1 outside bearing was replaced.

INNER BEARING	OUTER BEARING
D1	Metallic looking grease.	Same as inner bearing
D2	Needs to be replaced	Outer race severely grooved.
I1	OK	Replaced bearing.
I2	OK	OK
All bearings were very well lubricated. Azimuth D2 needs to be replaced.

1. Azimuth drive #2 Wheel/Bearing assembly needs to be replaced.
2. Elevation #2 motor needs replaced.

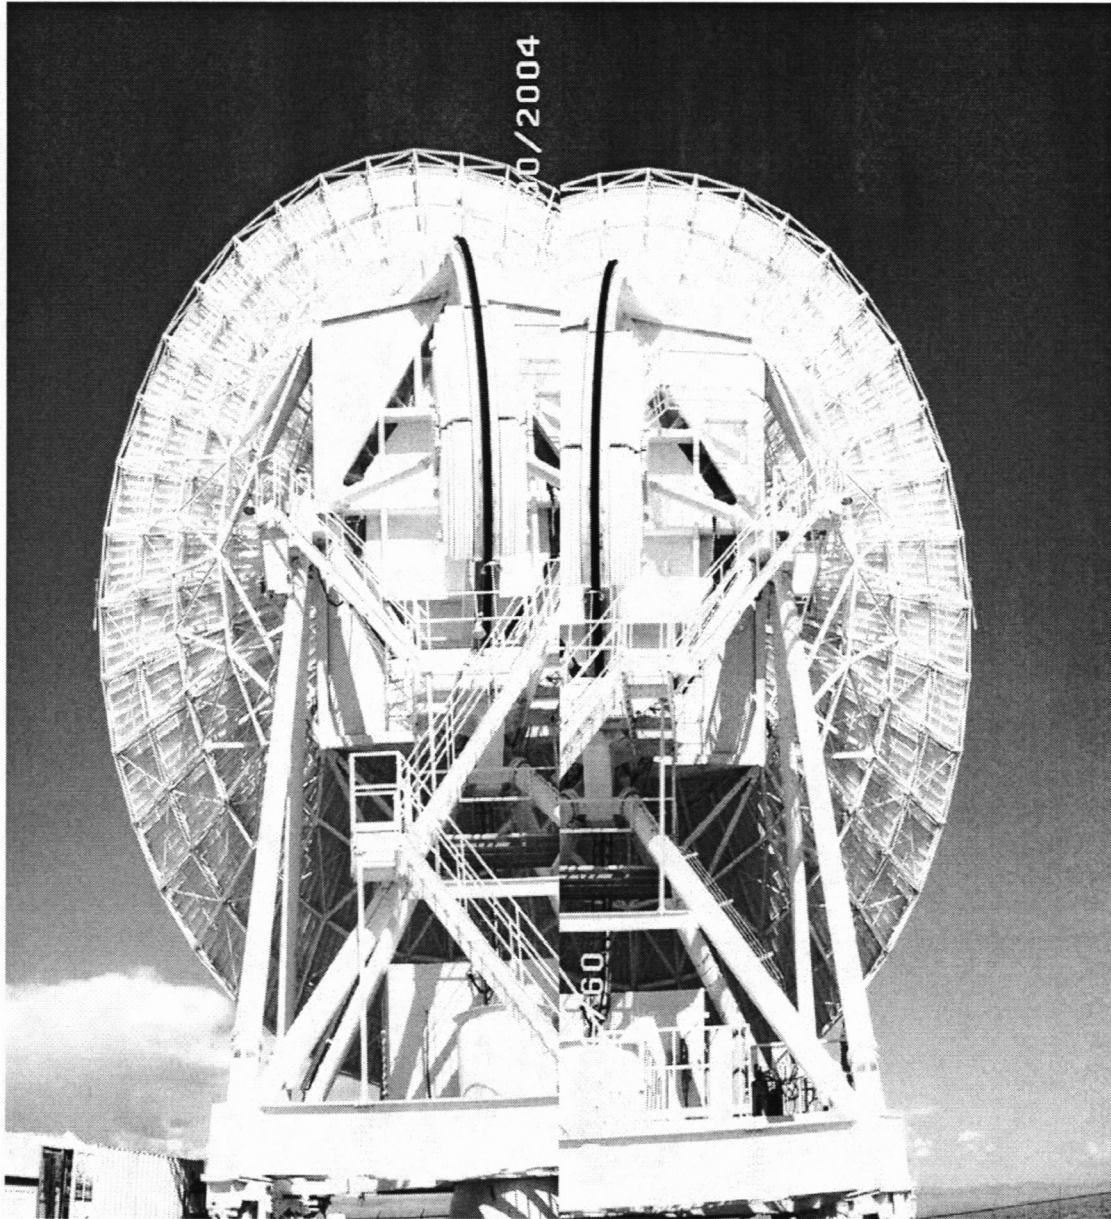
Backup structure paint is in excellent condition.

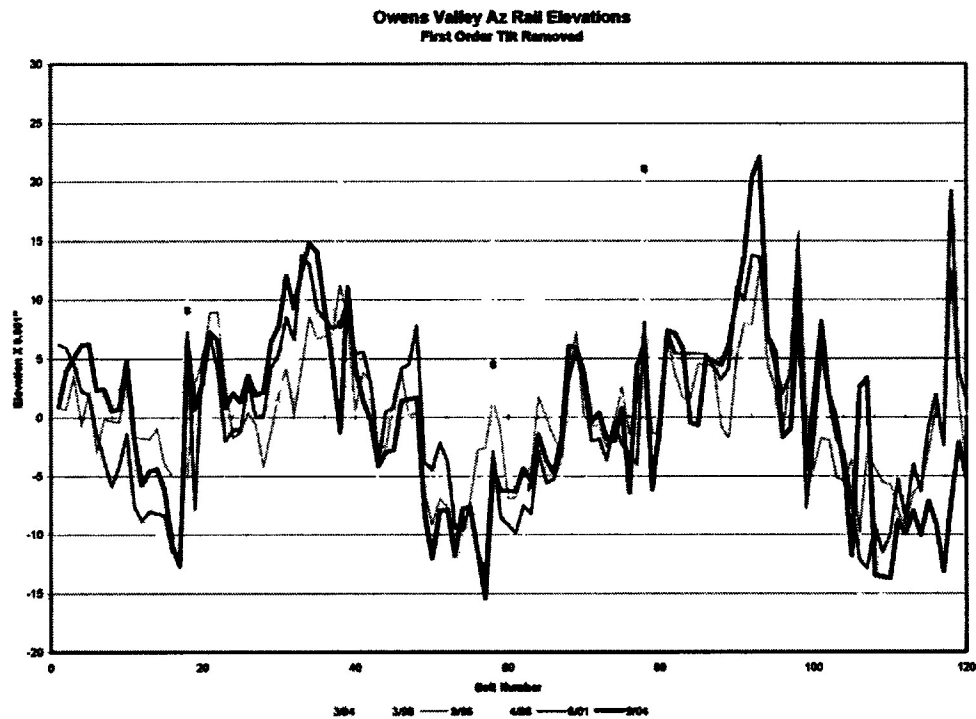
Owens Valley rail Elevations.

Vulchem is beginning to show signs of deterioration. Otherwise it is in fair to good condition all around the rail.
