**National Radio Astronomy Observatory  
Socorro, New Mexico**

**VLBA Antenna Memo #59**

~~VLBA~~ VI. VLBA Maintenance Visit April 4<sup>th</sup> thru April 22<sup>nd</sup> 2005.  
~~Saint Croix~~

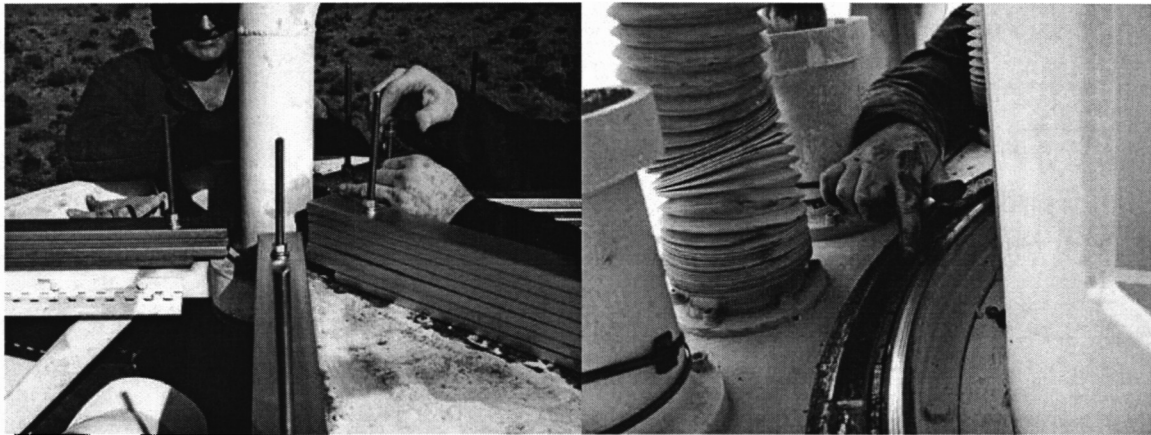
Sub reflector needed rebalancing. During the FRM inspection a broken INA bearing segment was found and repaired. The INA cap seal was replaced.

● LANCE AND REPAIR FRM TUBE. Done, replaced counter weights. Repaired SW INA---  
Bearing segment which had broken bolts. Replaced INA cap ring bearing seal.

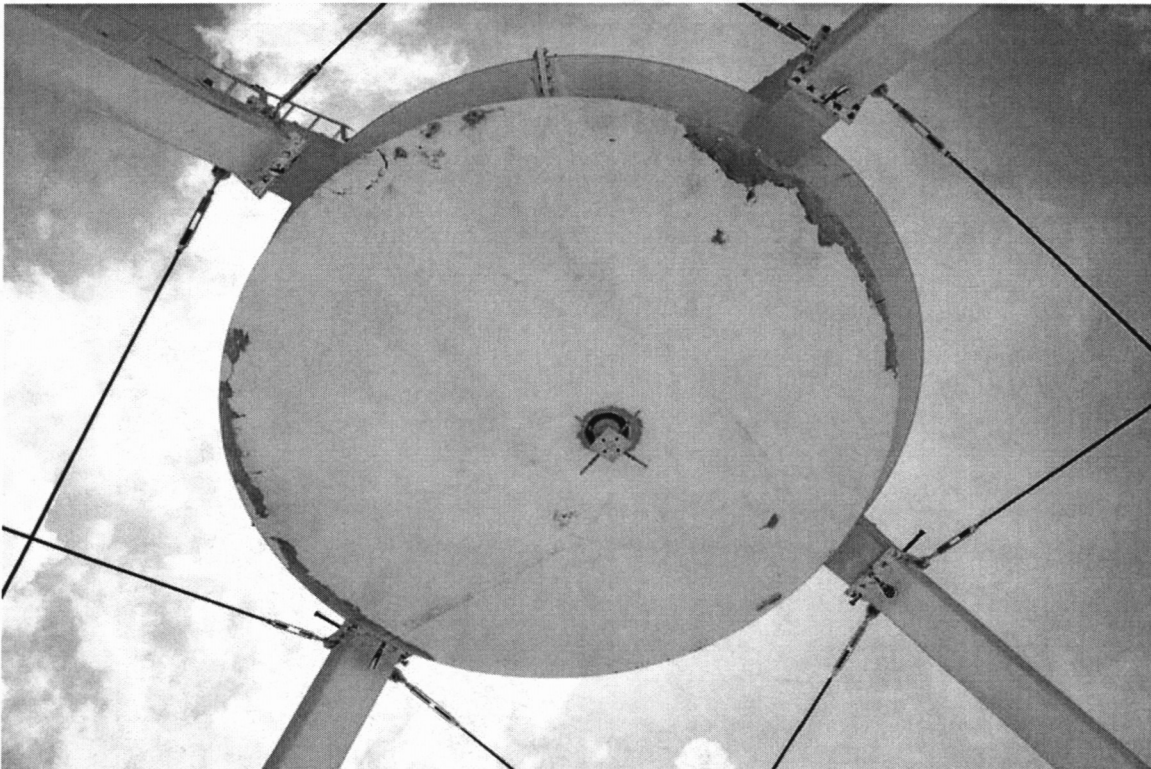
Sub reflector is in fair condition. The outside edges are soft, (spongy) and delaminating. Three 1 inch holes were drilled in the center of the reflector for extra drainage.

### SUBREFLECTOR INSPECTION: Delaminating—thin in spots (spongy).

Peeling paint/delaminating. Needs to be redone, reflector is soft in some places.

Drill 3-1 inch drain holes. Done.

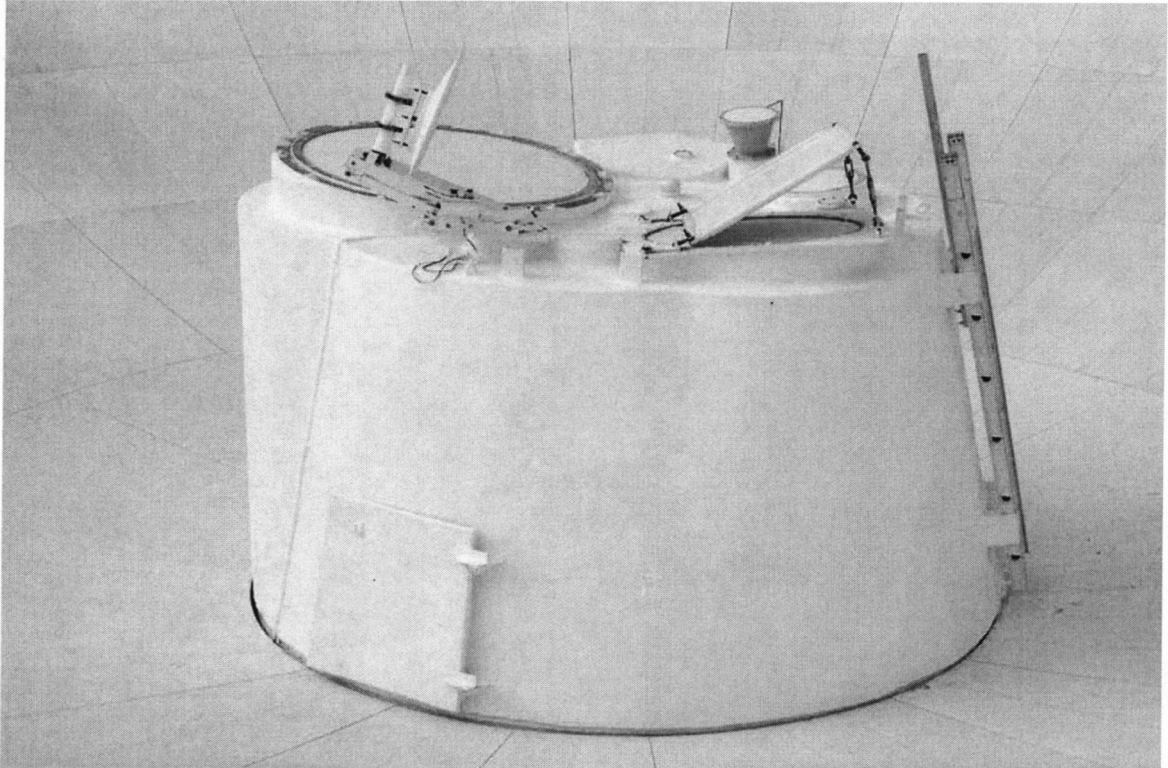
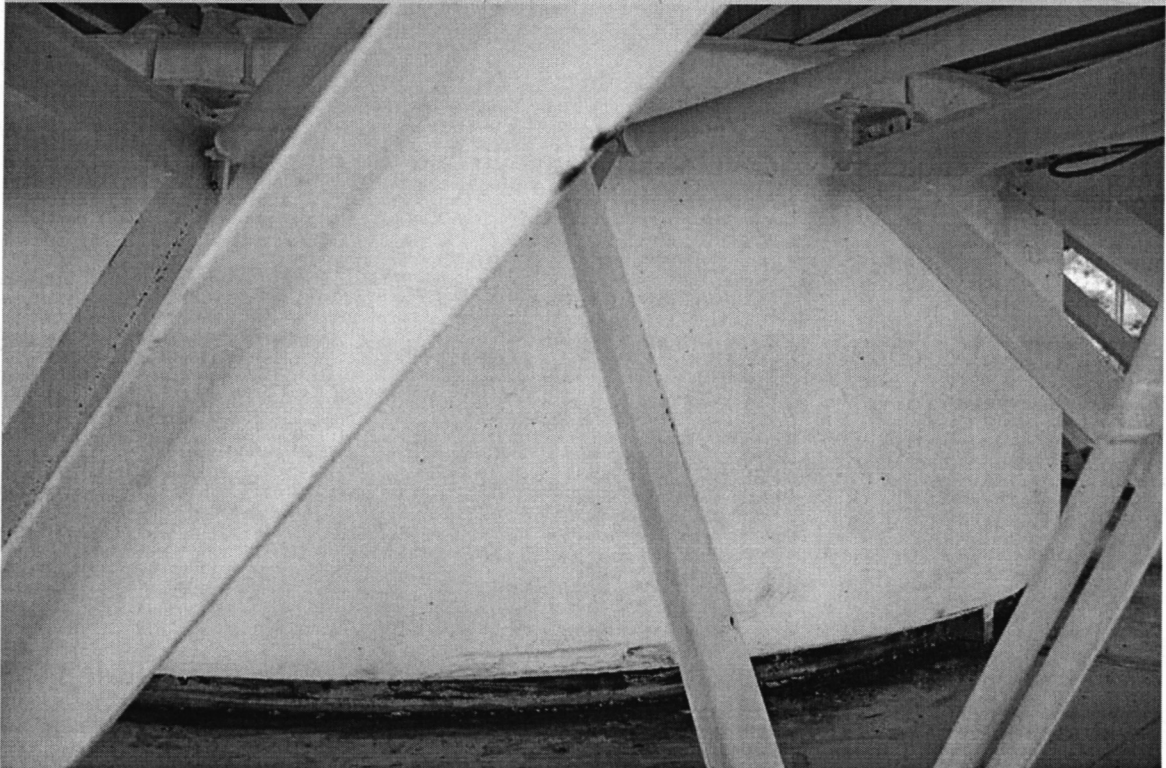
The feed cone was leaking into the vertex room. 5 gallons of elastomeric paint and 2 cases of caulk were used to seal it above and below the panels. The dish panel's paint is in good condition.

Seal and Paint. (Leak between FC & VTX). Done, gallons elastomeric & 2 cases of caulk.

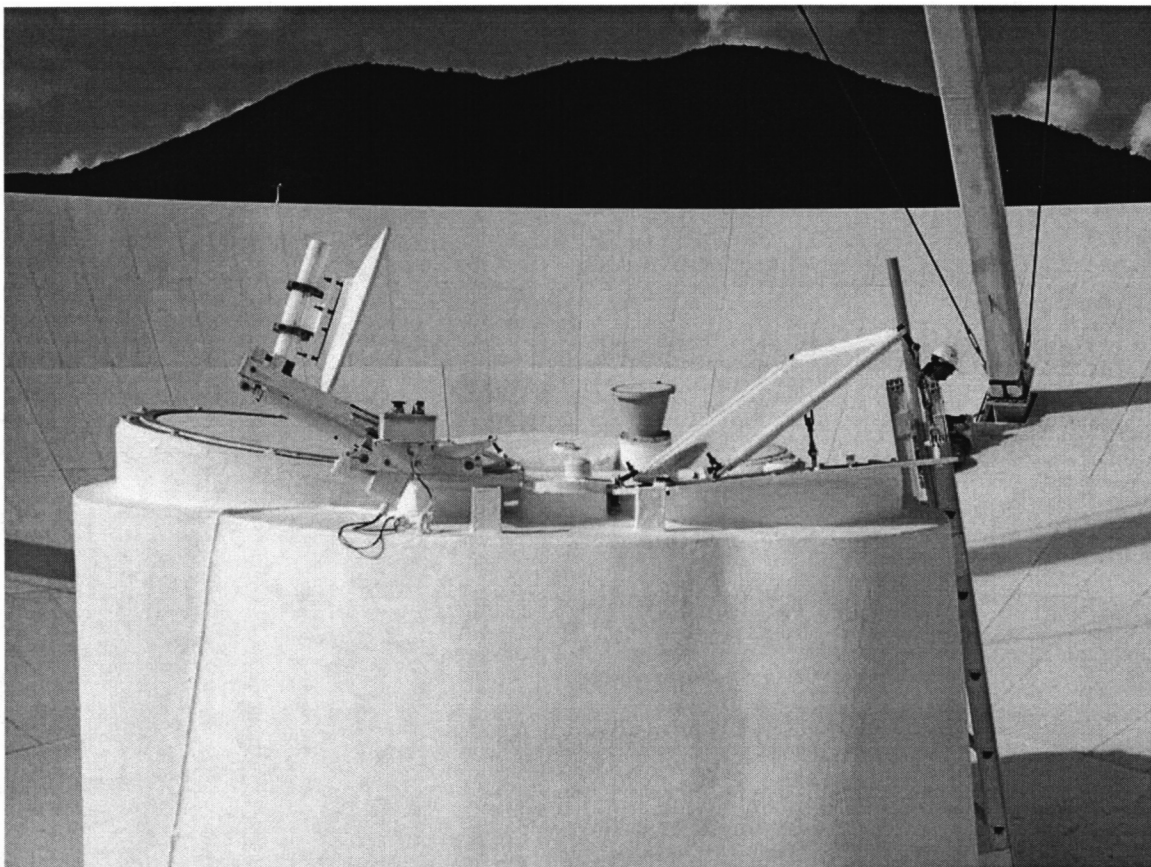
**The ellipsoid actuator was replaced. Ellipsoid and the dichroic reflectors were aligned and are in good condition.**

Ellipsoid dish/mount. Replaced ellipsoid actuator and realigned dish.

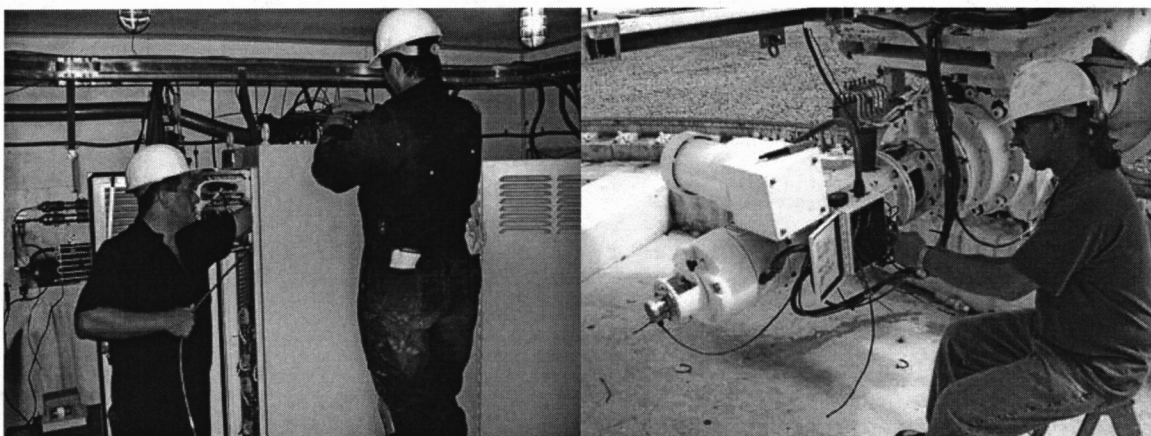
**New digital tachs were installed on EL and AZ motors. Azimuth #1 and Elevation #2 motors were replaced. The ACU backplane upgrade was installed and tested.**

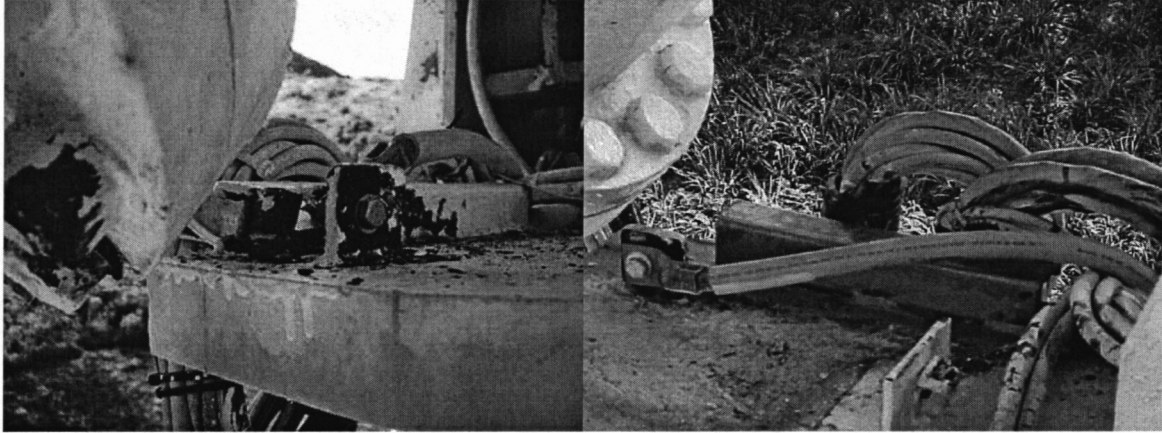
Both the encoder and synchro side elevation cable wraps were severely corroded. Stainless steel uni-strut was used to hold the new strain relief brackets in place.

Cable Wraps Brackets. Replaced uni-strut brackets on both sides.

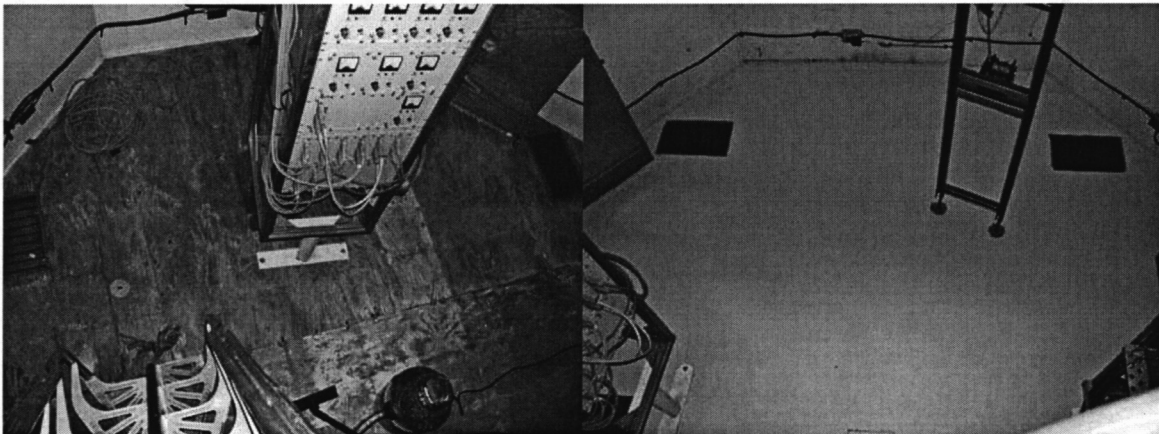
The feed cone leak had damaged part of the vertex room floor tiles. The floor was repaired and sealed, then covered with deck paint.

**Stripped VTX room floor—repaired, sealed and painted.**

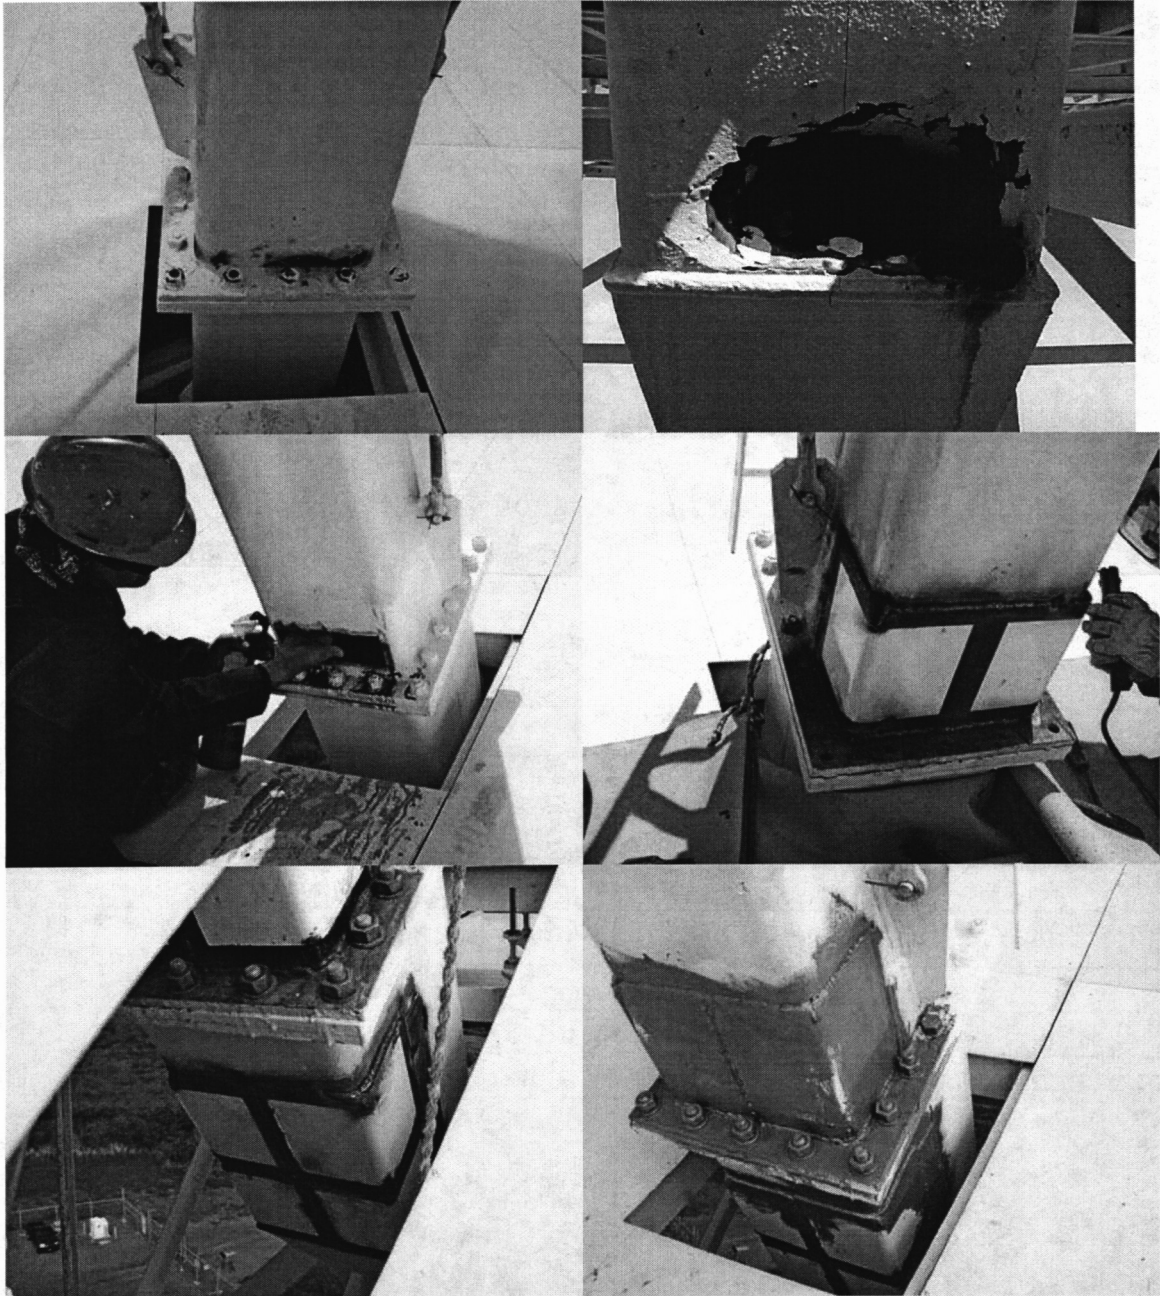
Rust holes were repaired in the ladder quad leg above and below the dish surface. All quad legs were inspected, patched and painted with rust bullet.

REPAIR CORROSION AFFECTED AREAS. All 4 patched—Ladder leg the worst. Clean out rust &  
Pant with rust bullet.

**Patched quad legs, Ladder leg above and below dish surface.**

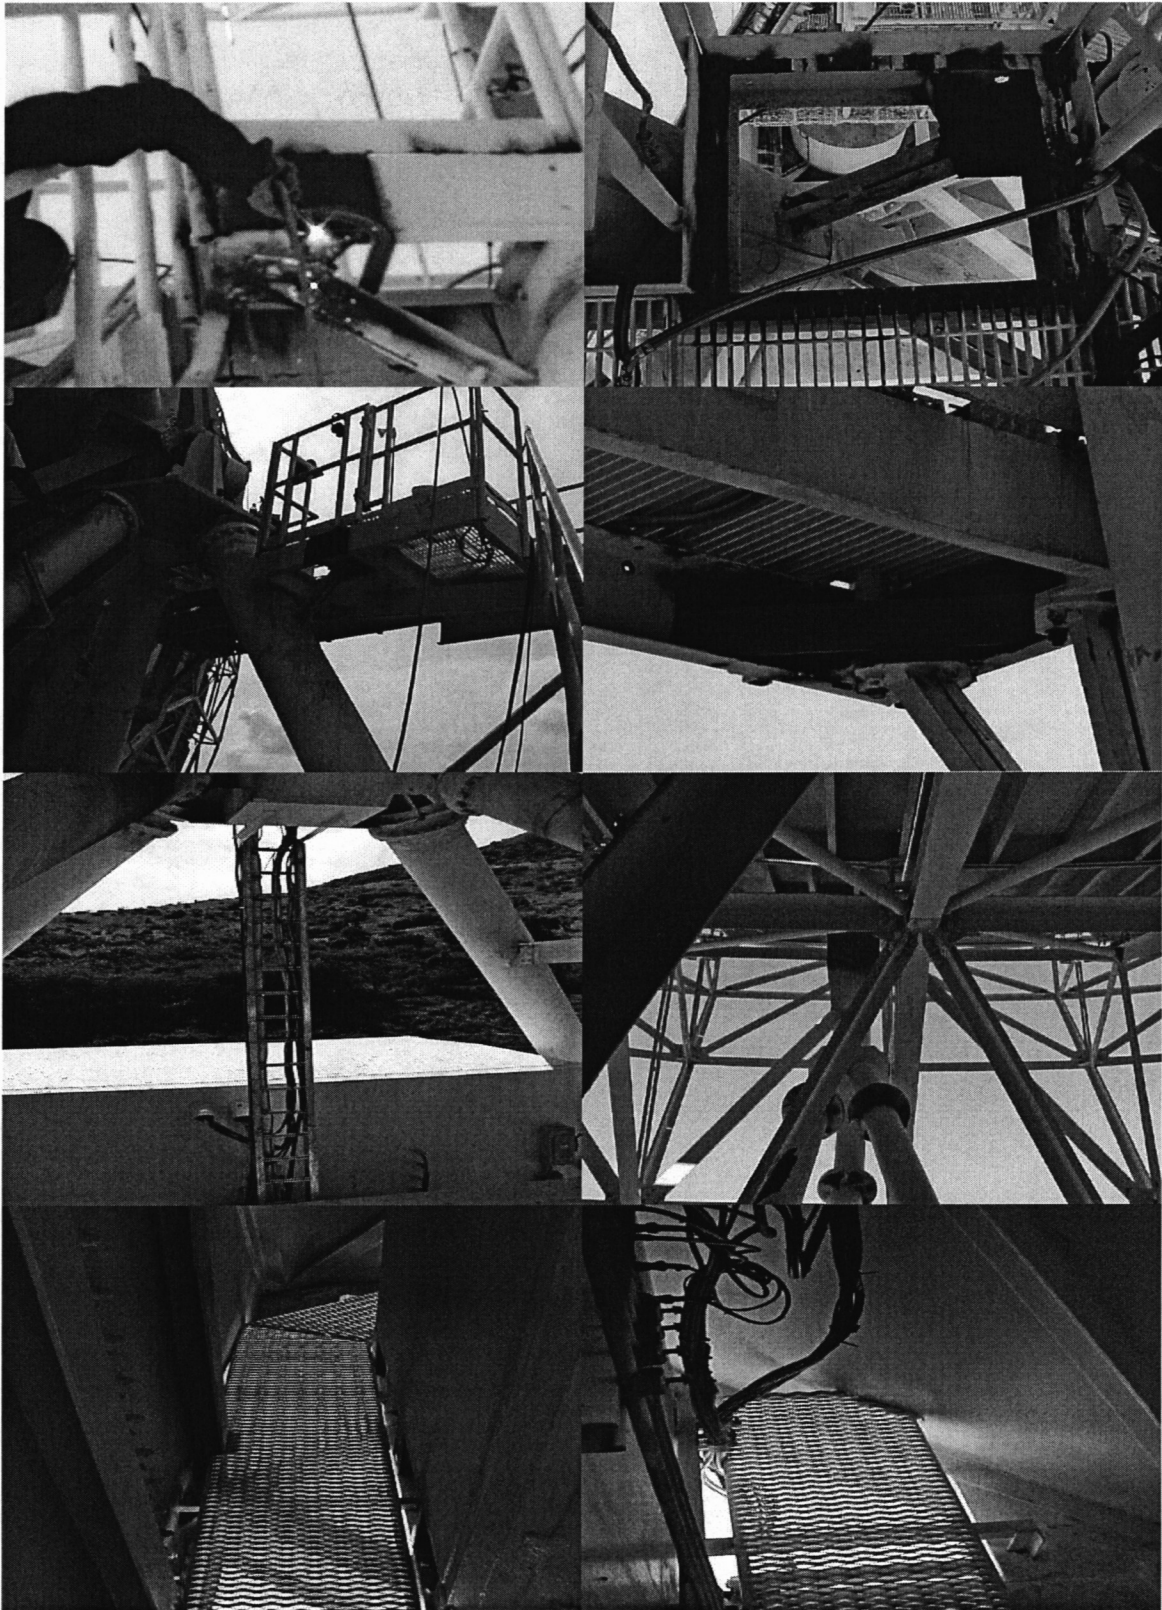
A tremendous amount corrosion repair was accomplished. Much more work is still needed.

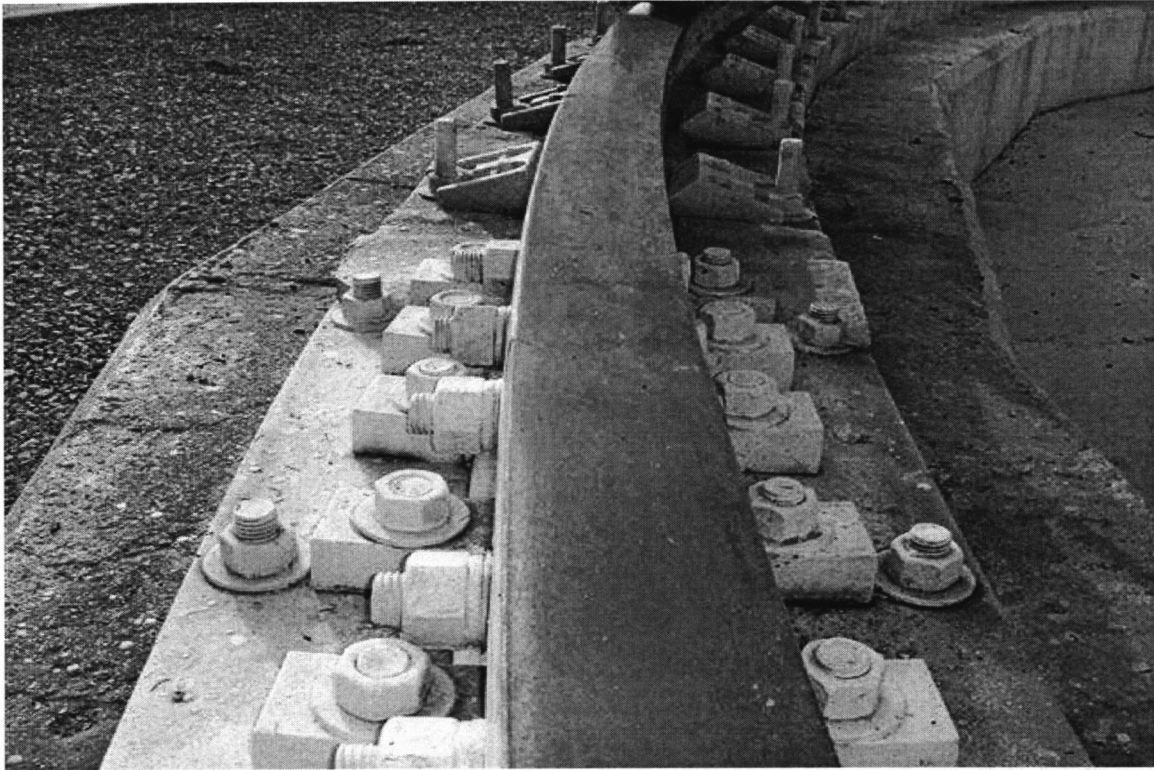
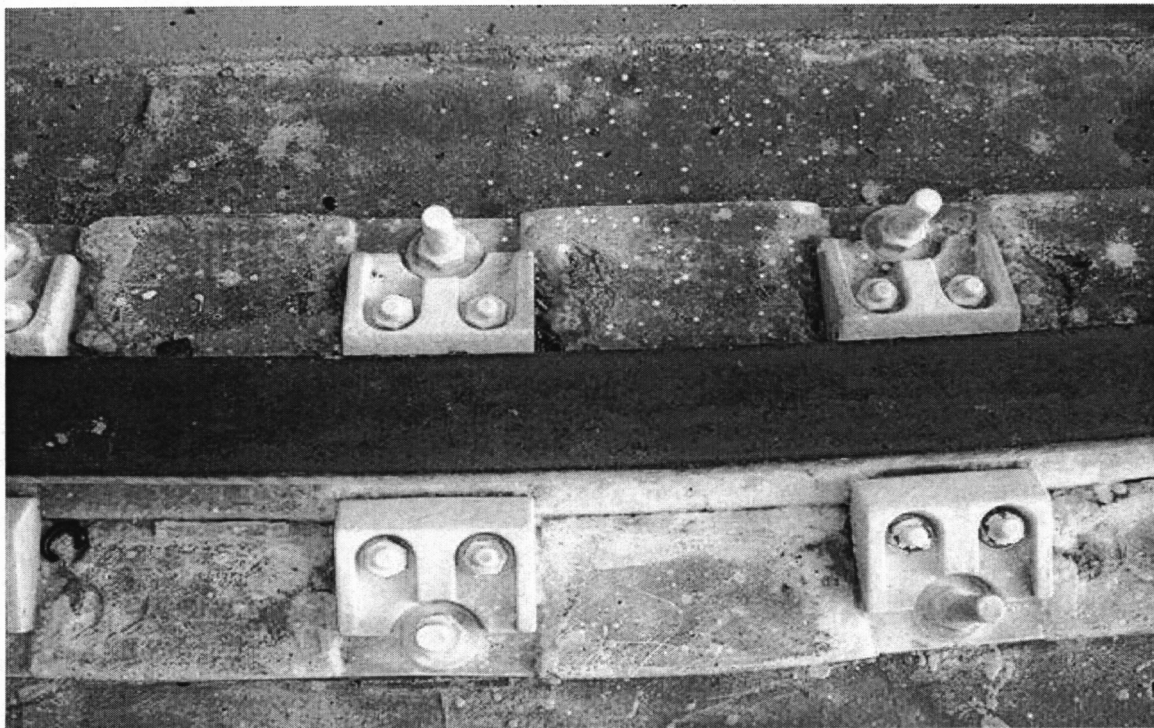
Site techs have done a great job removing vulchem and painting rail clips and splices. Overall the rail is in good condition.

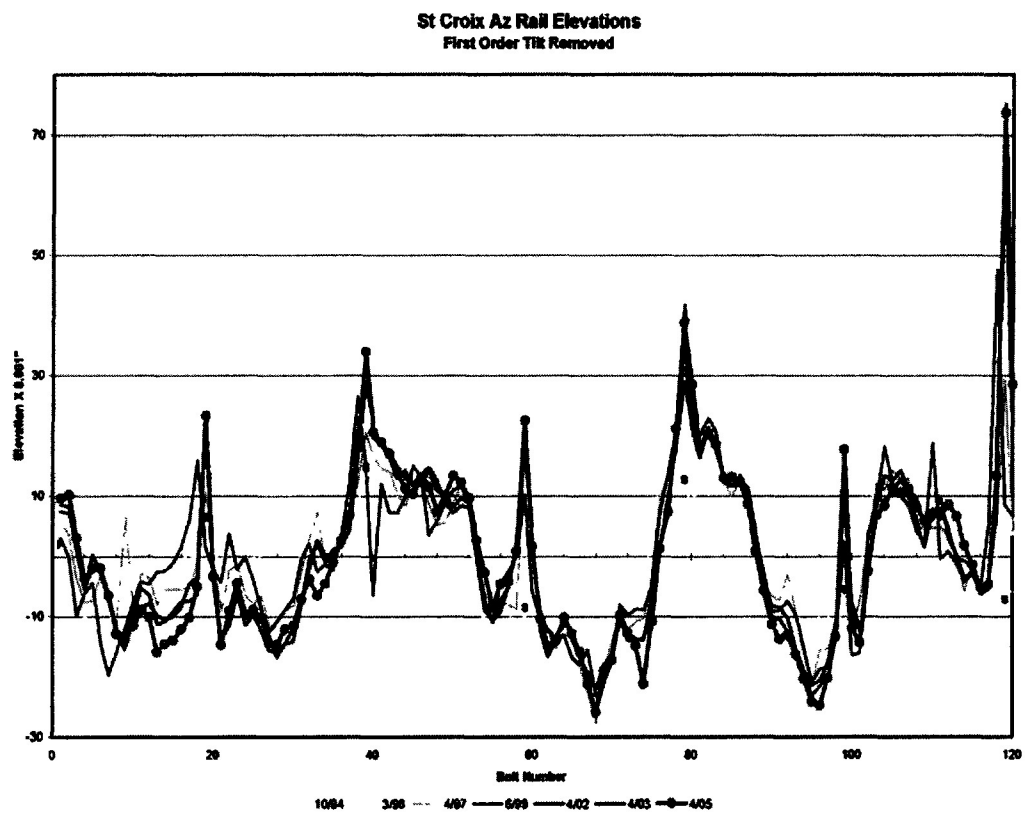
It appears the rail splice at bolt # 119 the failing.
