**National Radio Astronomy Observatory  
Socorro, New Mexico**

**VLBA Antenna Memo #60**

**Los Alamos, NM. VLBA Maintenance Visit July 28<sup>th</sup> – August 3<sup>rd</sup> 2005.**

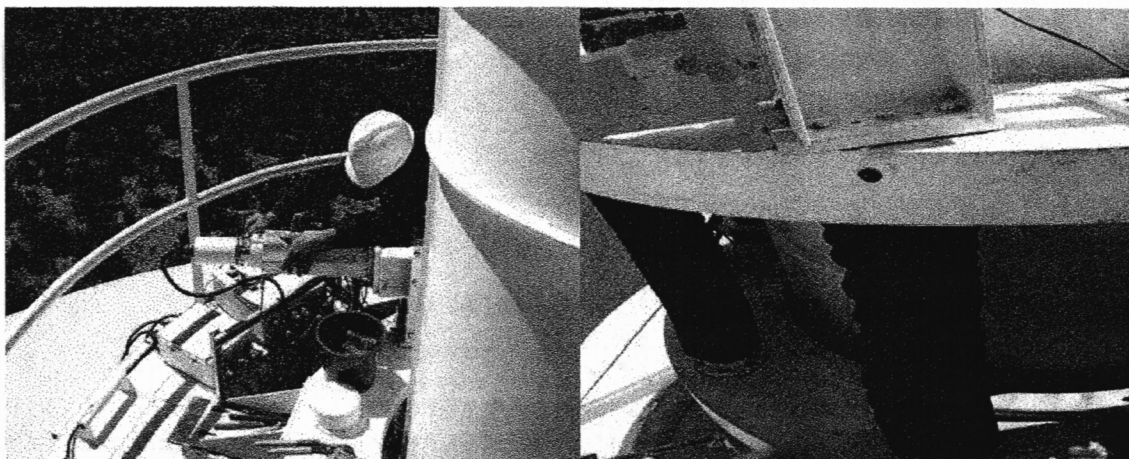
FRM was given a thorough inspection. A focus flex shaft was replaced and the new encoder coupling modification was installed. Both, 1<sup>st</sup> and 2<sup>nd</sup> screw bellows were replaced. Two bellows access holes were drilled in the mount.

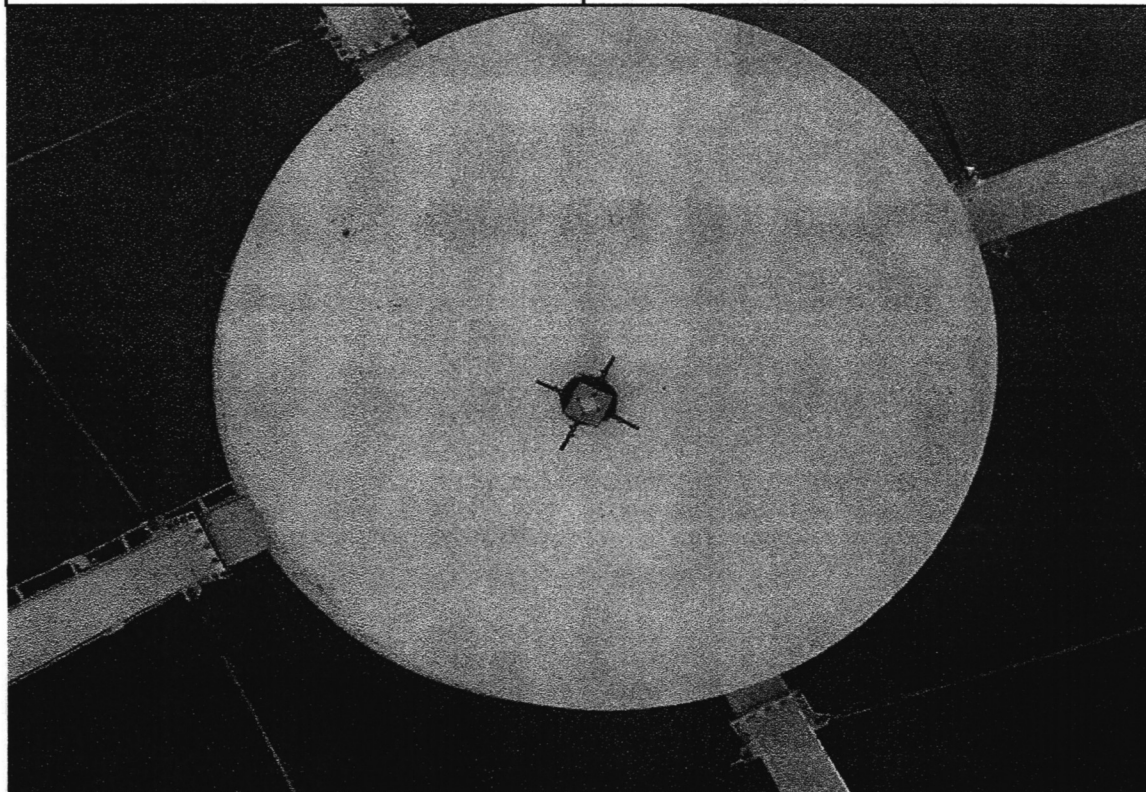
Sub reflector is in good condition. Three 1 inch holes were drilled in the center of the reflector for extra drainage. The snow tarp was removed.

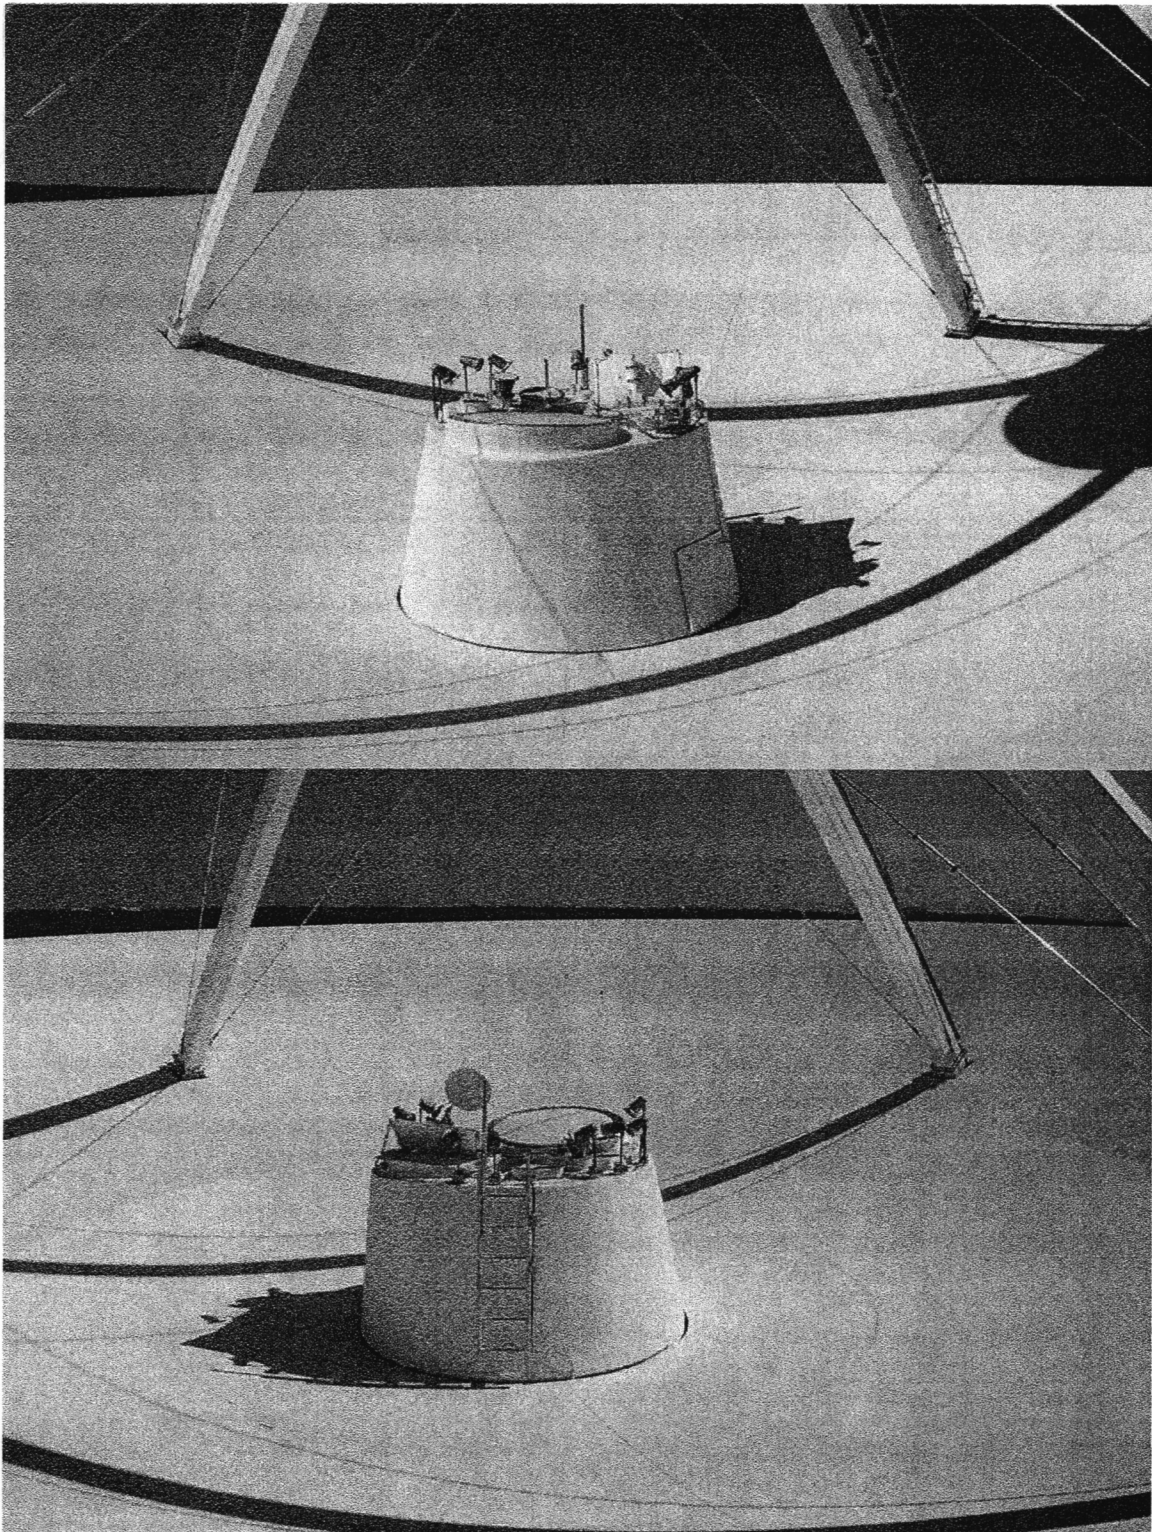
Dish panels, and the dish panels paint are in good condition. Guy wires are in good condition. Feed cone was spot sealed and painted with elastomeric.

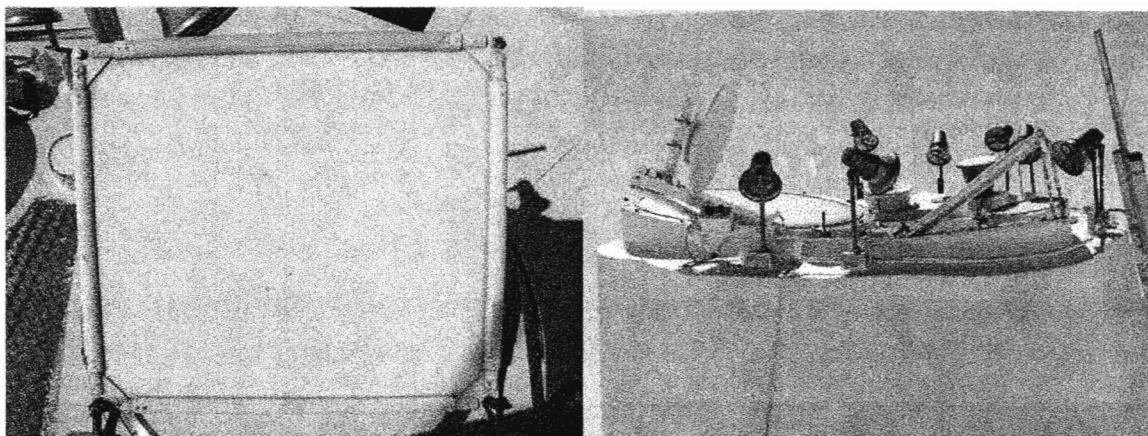
**Dichroic reflector is good condition. Elipsoid reflector is in good condition.**

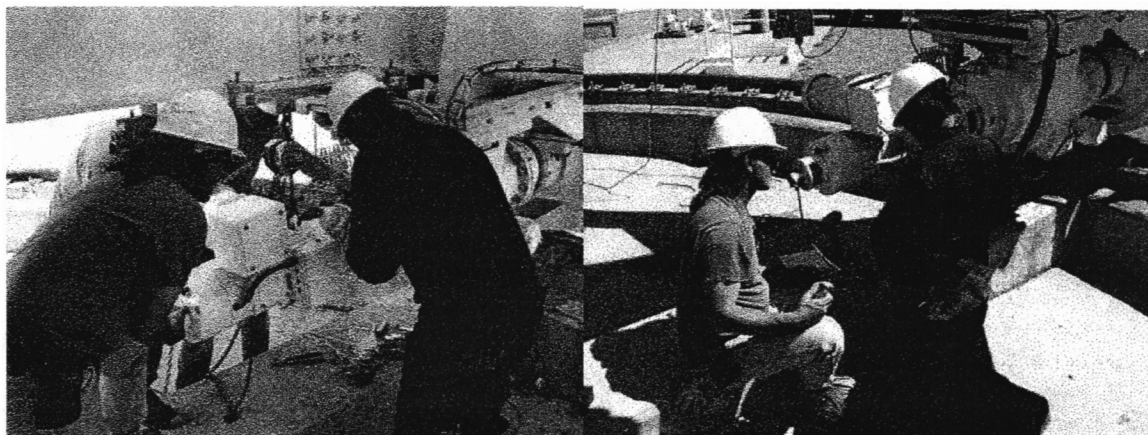
**Elevation #2 and azimuth #1 motors were replaced. Digital tachometers were installed and calibrated on the azimuth and elevation motors.**

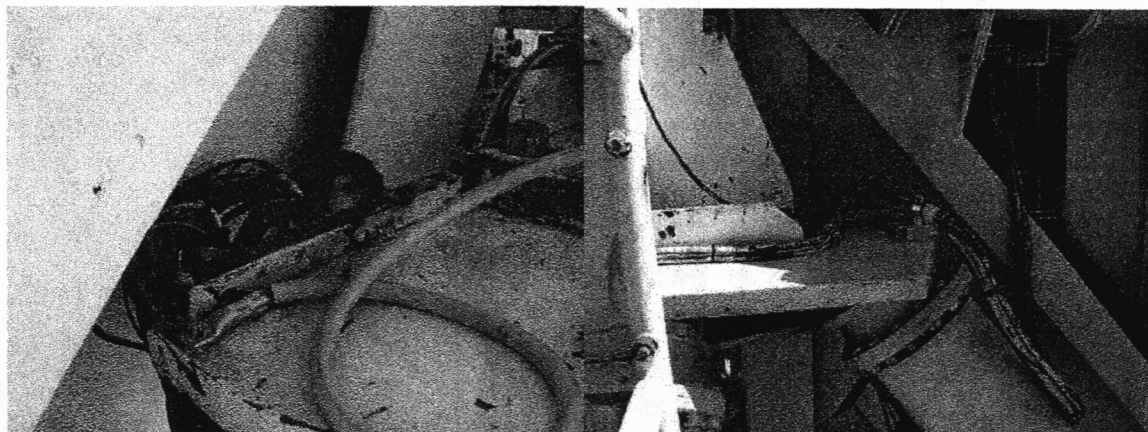
**Both the encoder and synchro side elevation cable wraps were repaired by repositioning and replacing strain relief brackets. Both sides elevation ground cables were replaced.**

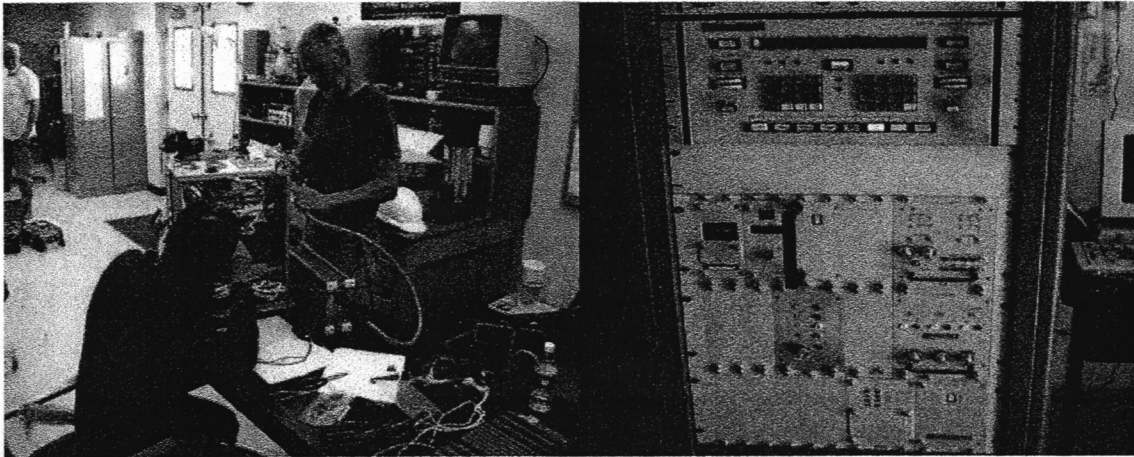
The ACU backplane upgrade was installed and tested. The ACU power supply modification had been previously installed by Paul Johnson.

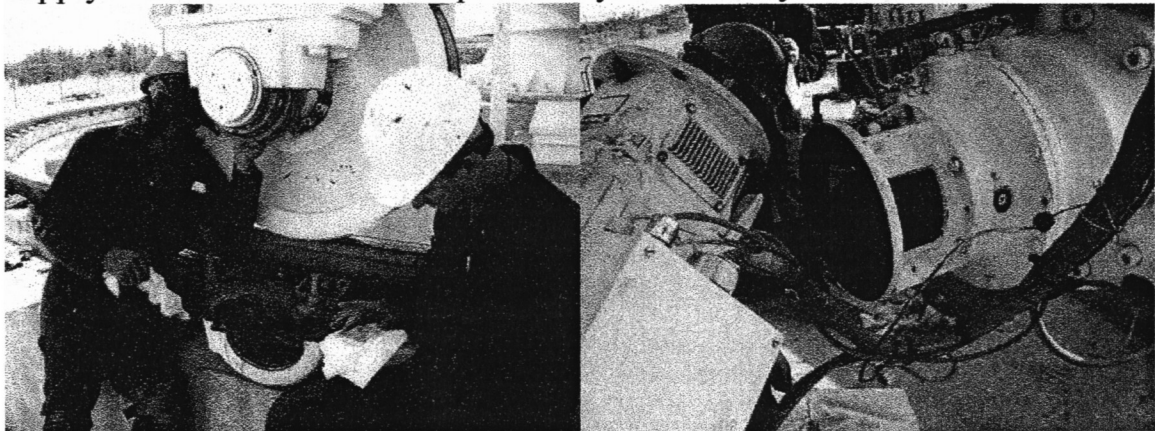
Azimuth wheel bearings were inspected. Azimuth #2 gear box seal was replaced with a double seal setup.

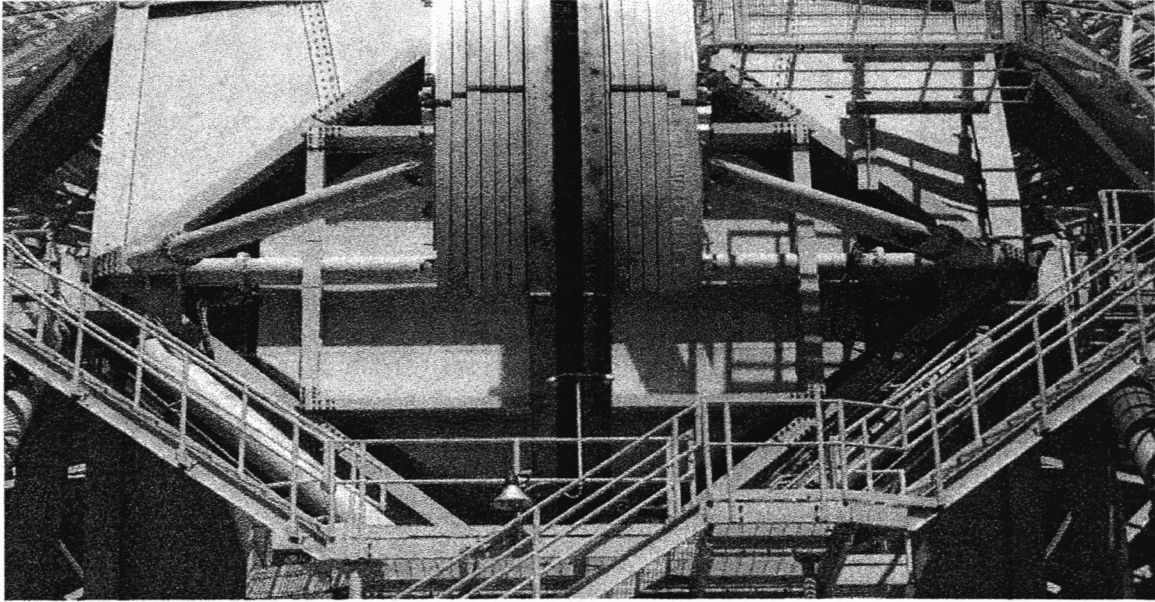
**Elevation axle has no visible signs of cracks. Paint is in good condition.**

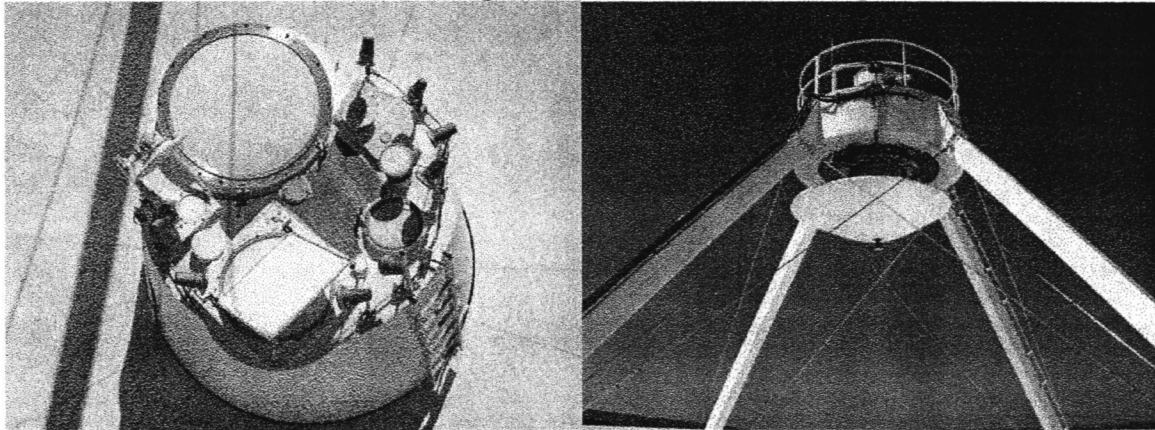
**Feed windows & heaters are in good condition. Apex paint is in good shape.**

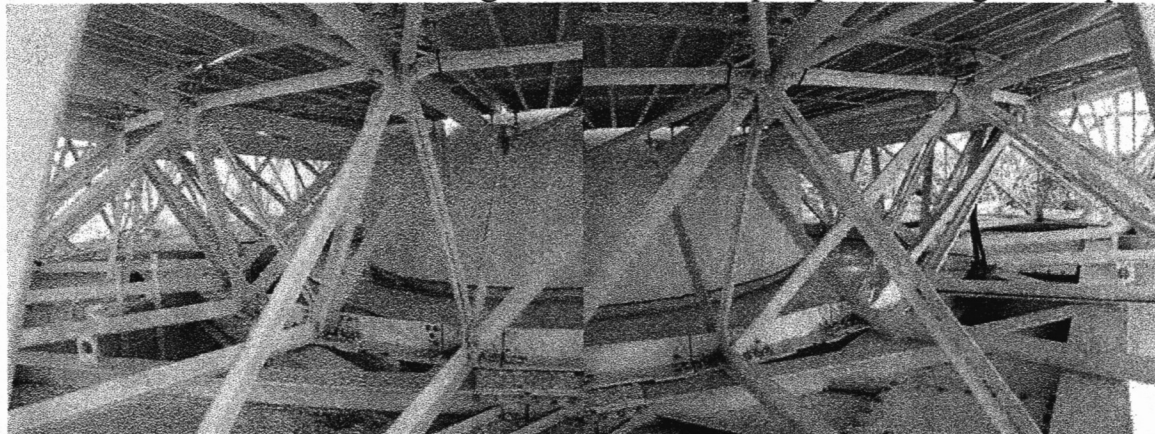
**Backup structure paint is in good condition.**

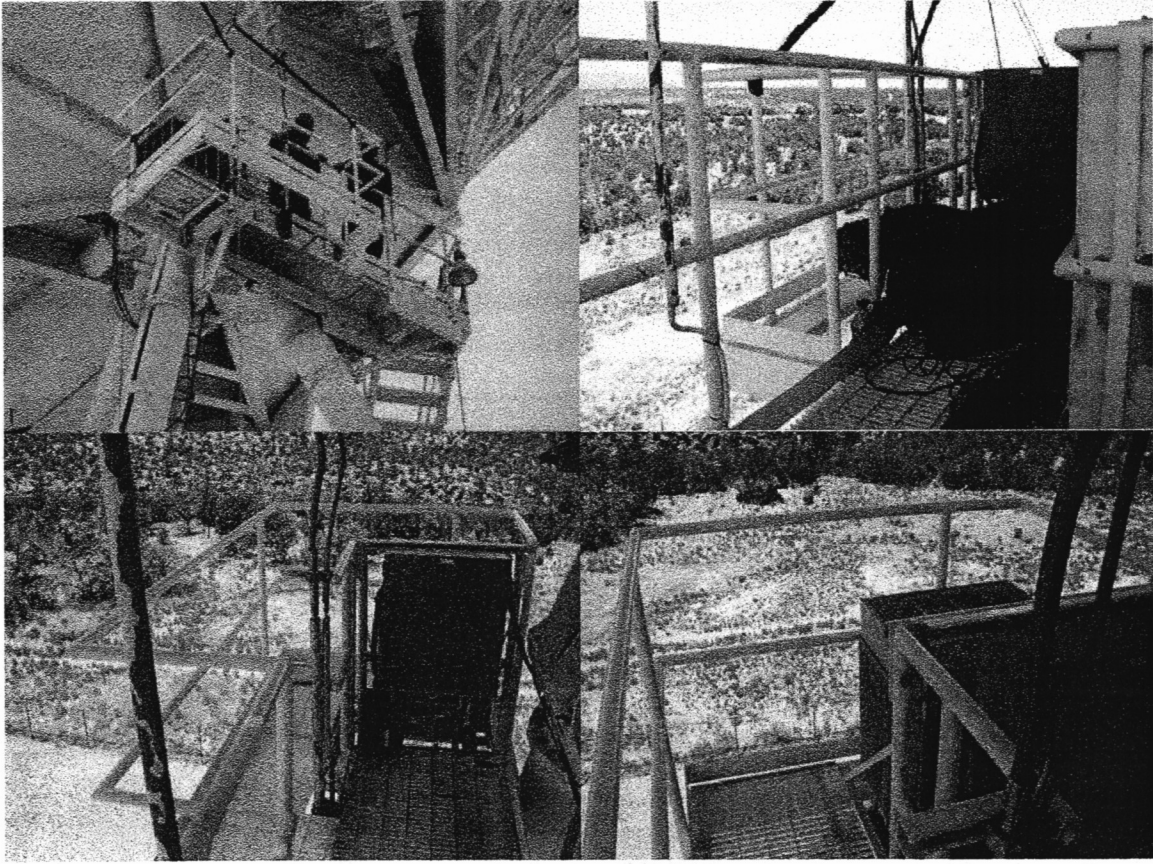
**A new HVAC platform extension was installed. Maintenance performed on the vertex room compressor/condenser can now be completed safely.**

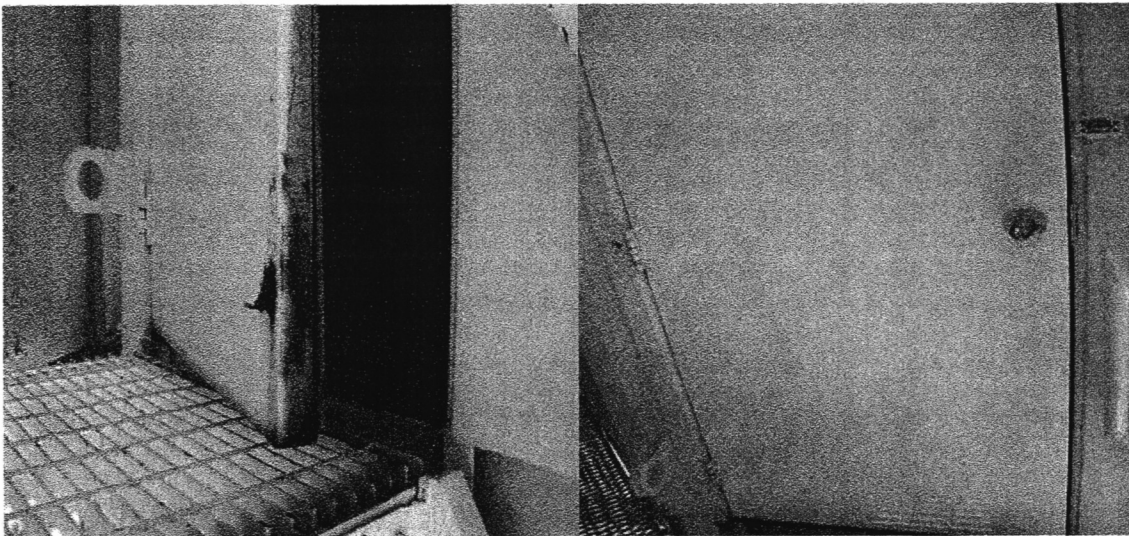
**The vertex room door was replaced.**

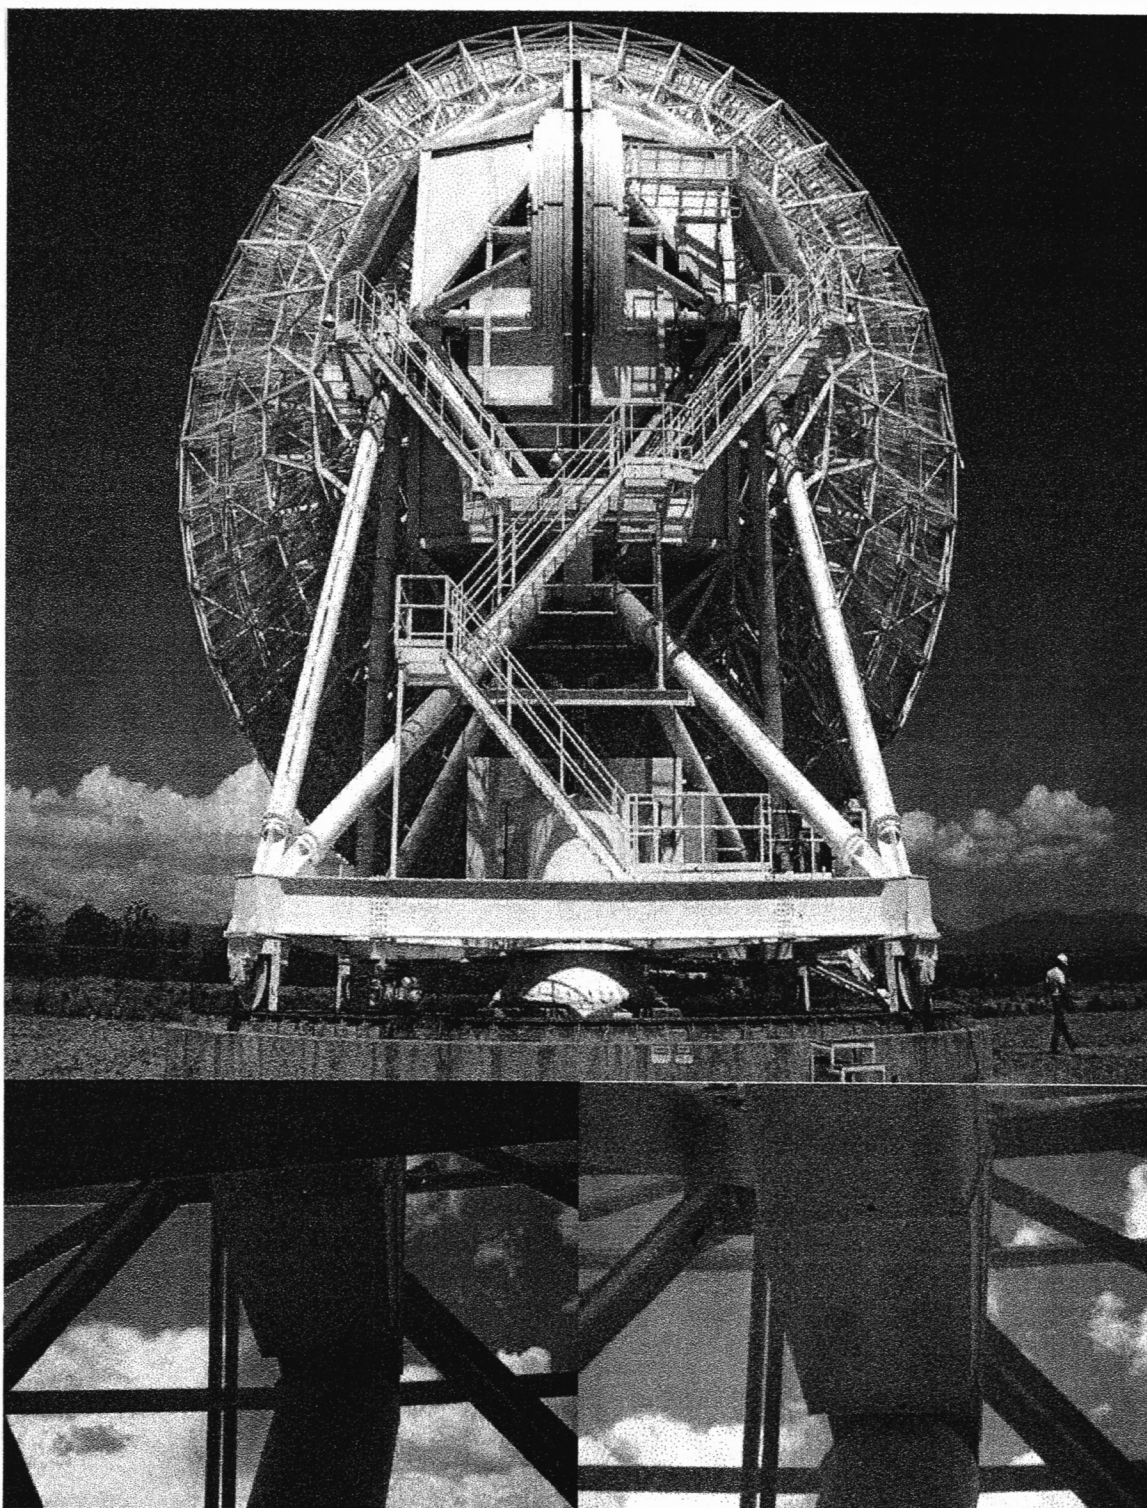
Overall the paint on the Los Alamos antenna is in good condition. Notice the drain holes drilled in the Quad Legs.

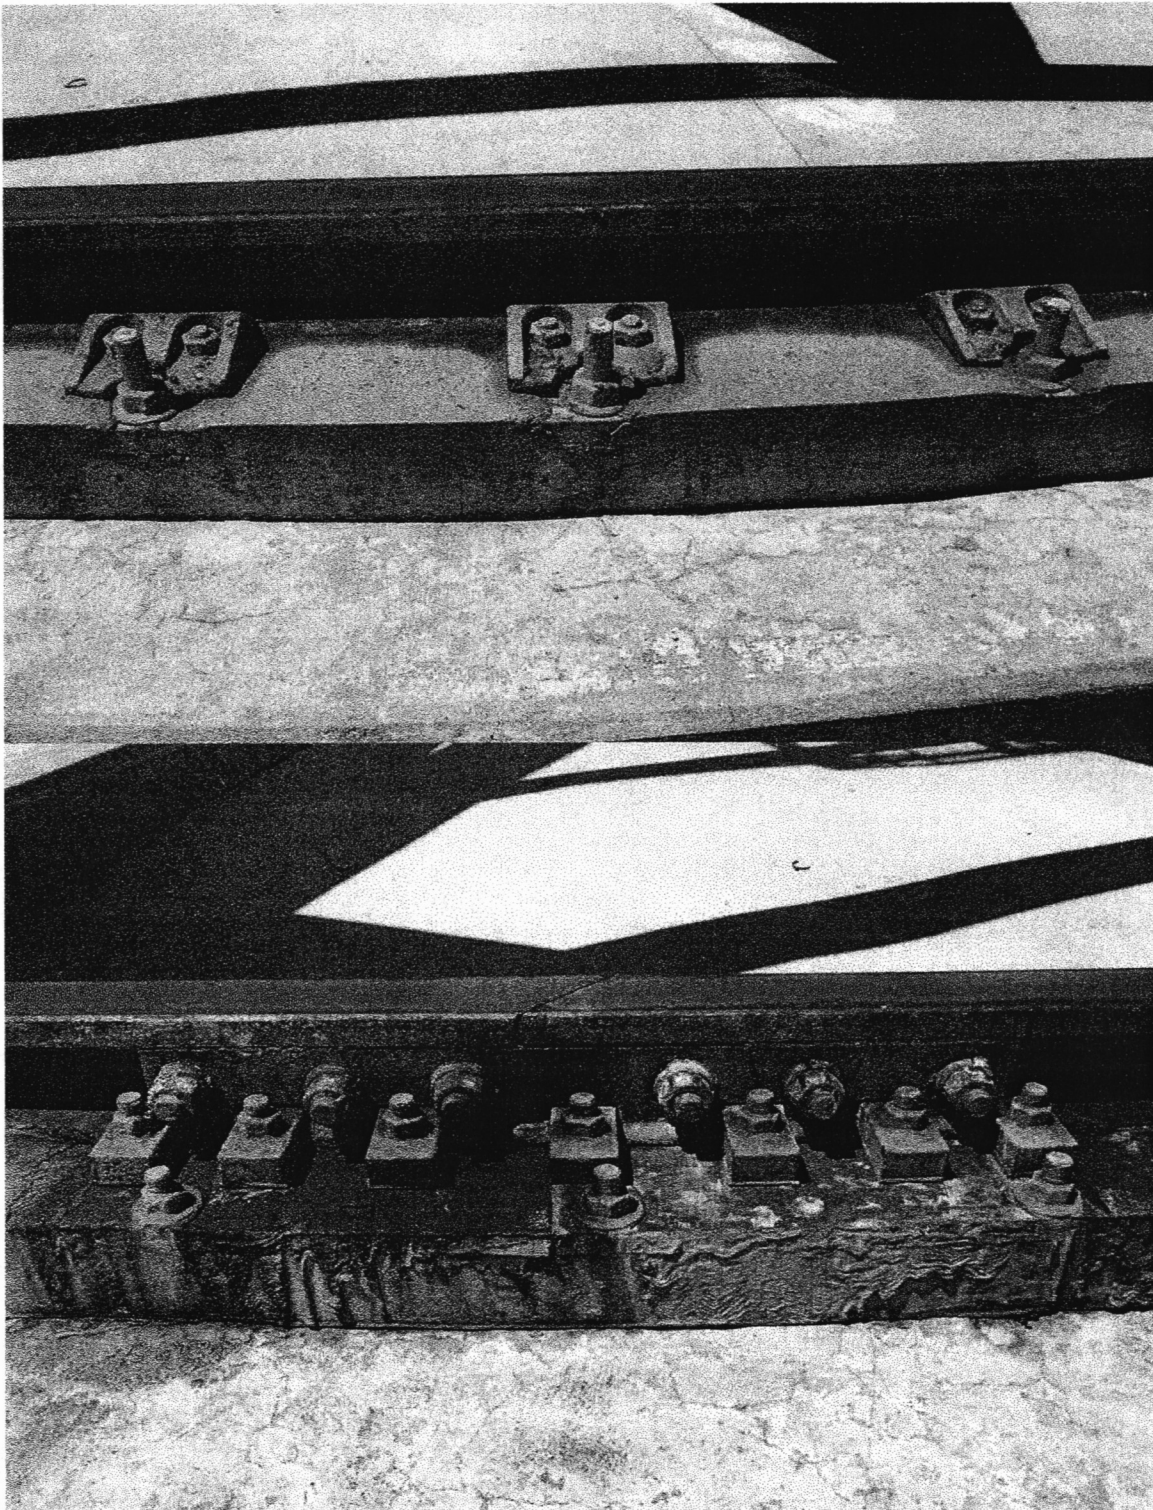
**Rail is in good condition. Site techs will remove remaining vulchem.**
