NATIONAL RADIO ASTRONOMY OBSERVATORY
Socorro, New Mexico

VLBA Antenna Memo Series No.68

St. Croix VLBA Antenna Painting and Surface Preparation Requirements

J. E. Thunborg
May 8, 2007

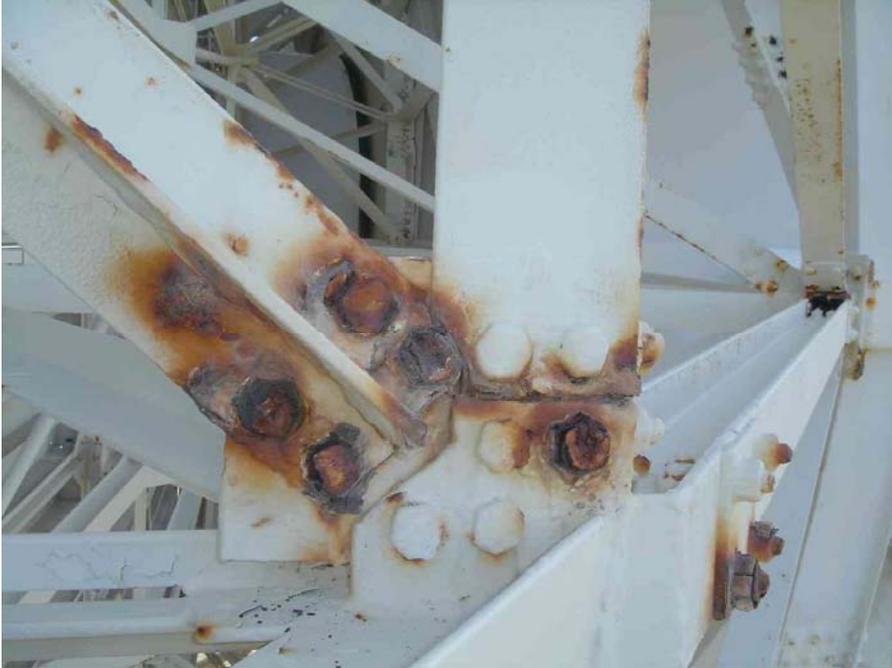
The picture below shows that corrosion is occurring on the edges of the structural members and at the bolted lap joint connections.

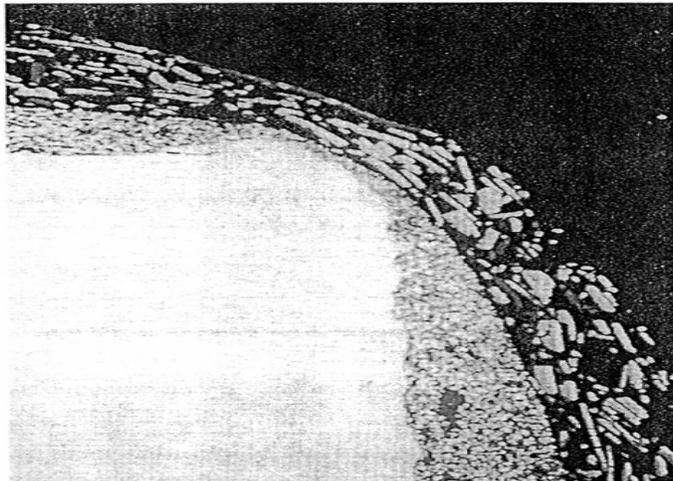
2.1 Edge Corrosion

The sharp edges of structural members are subject to corrosion for two reasons. The first is that the coating at the edges is prone to damage during shipping, assembly and maintenance of the structure. The second reason is that the coatings shrink and pull away from sharp edges during the curing process. The photograph below is a side view of a Micaceous Iron Oxide (MIO) filled epoxy product applied over a zinc primer. The photograph clearly shows both the zinc primer and the epoxy thickness narrowing over the sharp corner.

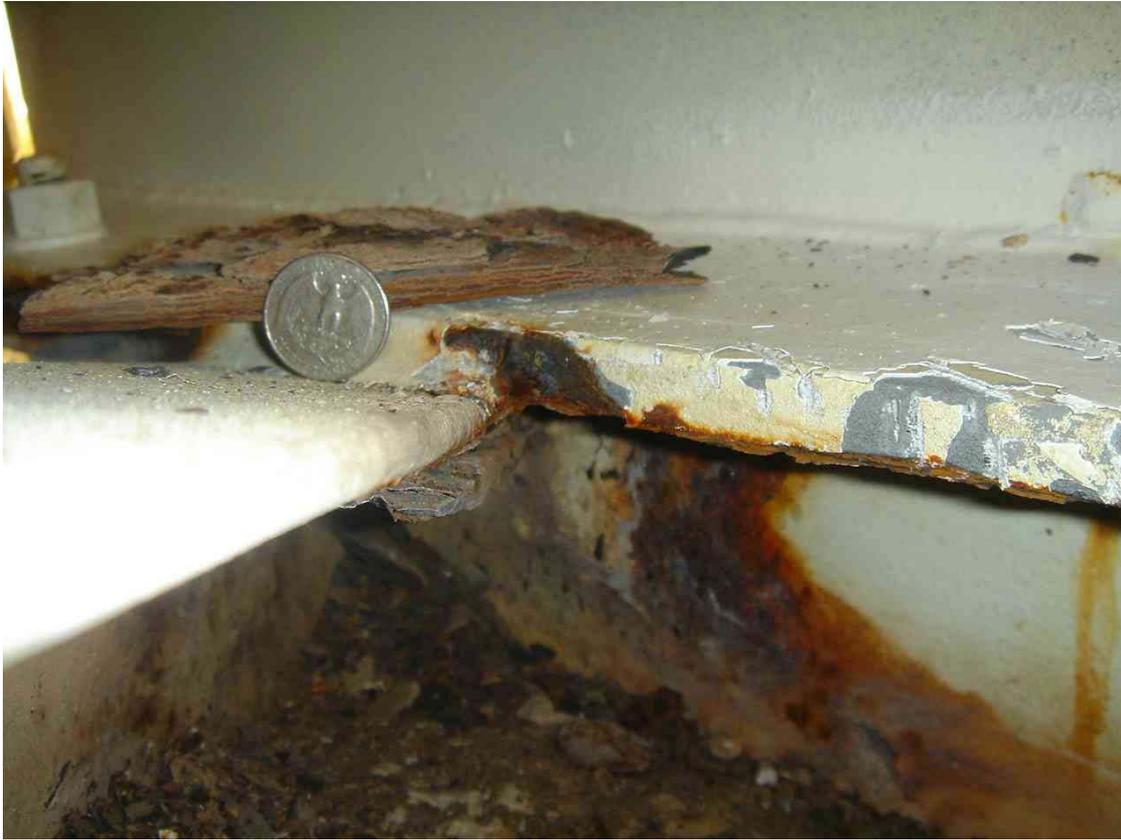
The picture below shows a flake of steel that was removed from the underside of a steel beam in the box section of the antenna.

The steel is beginning to swell and disintegrate and flakes off in layers. This form of corrosion is called exfoliation. Exfoliation is a form of layer corrosion which starts at the edge, proceeds within the body of the material in paths parallel to the rolling direction of the steel. The corrosion formed is greater in volume than the metal it replaced, and the layers of steel are forced apart.

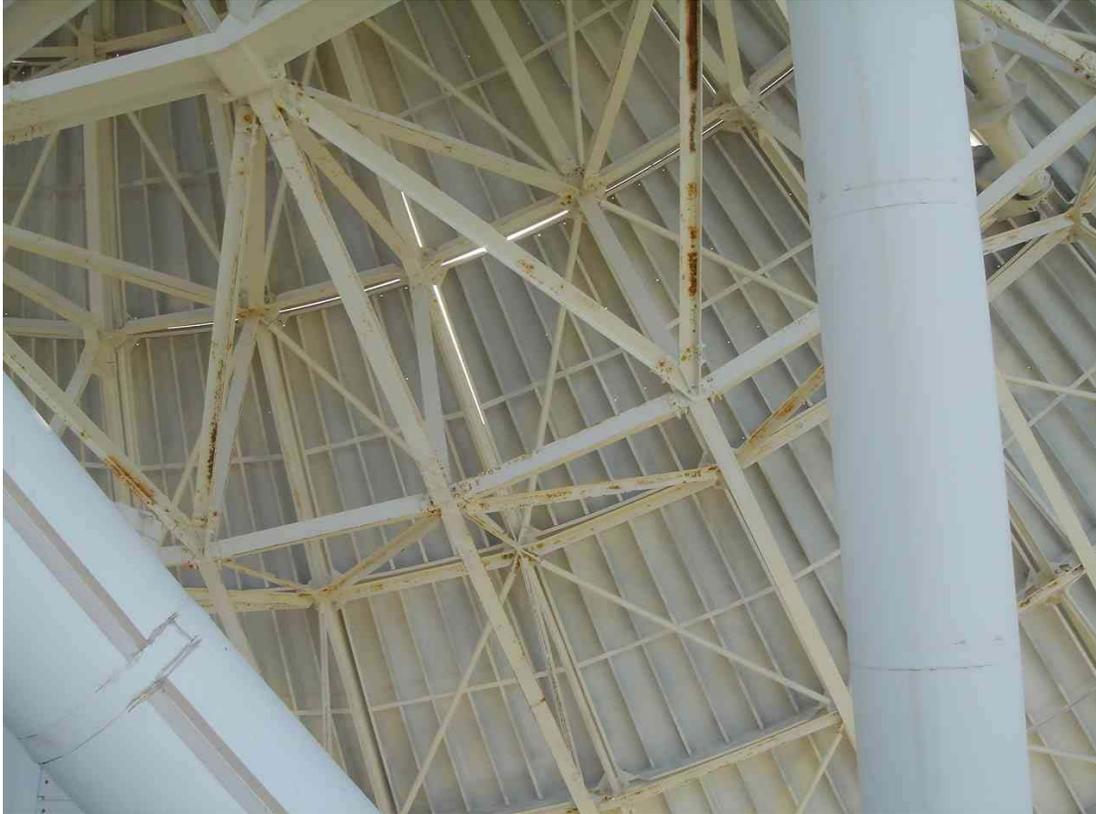
The next photograph shows rust beginning to bleed through the paint along the surfaces of some of the structural members. This indicates that the paint system may be approaching the end of its life. The coatings may have chalked to the point where there is insufficient thickness to adequately protect the steel. Some of this bleeding may also be due to osmotic blistering of the original paint system due to the presence of chlorides under the paint.

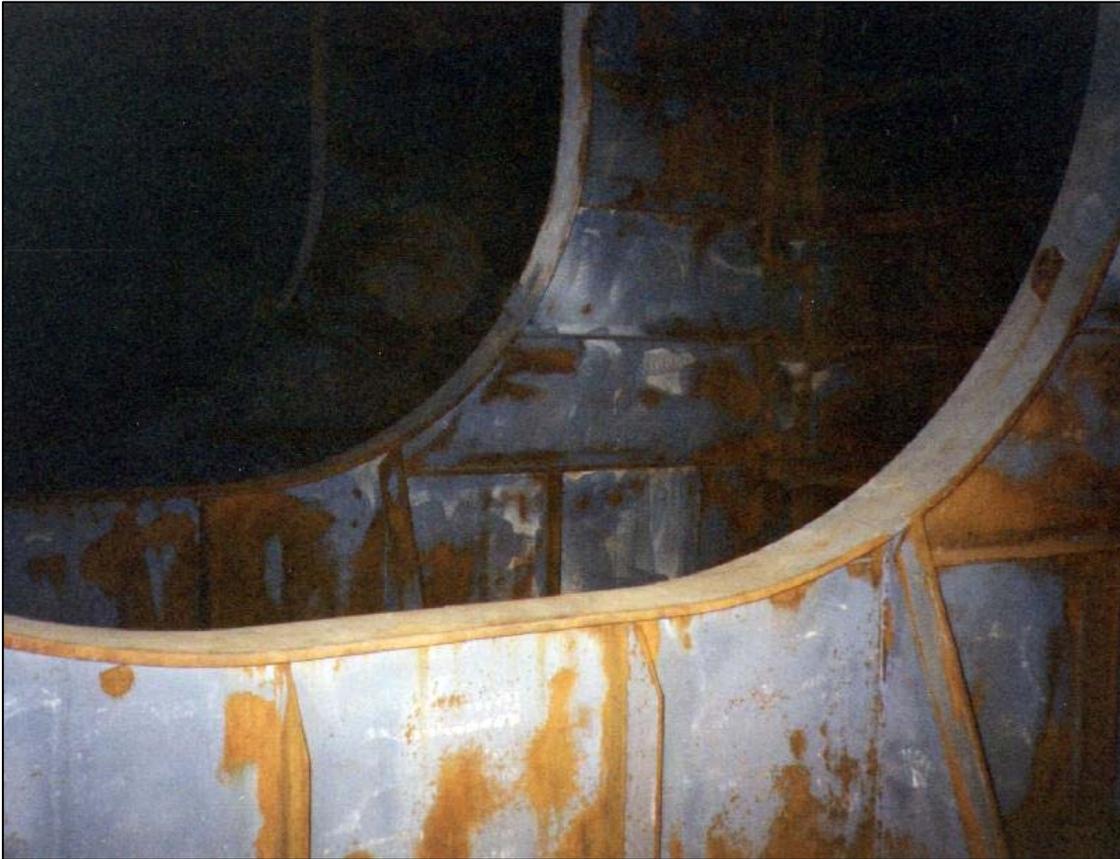
There may be another advantage to using UHP waterjetting. There is some evidence to suggest that UHP waterjetting may leave some of the original inorganic zinc primer intact. The photograph below shows a ship ballast tank which was cleaned by UHP waterjetting. This ballast tank was initially primed with an inorganic zinc primer. The inorganic zinc primer chemically bonded to the substrate so that it could not be removed by the waterjetting. The photograph also shows that the inorganic zinc primer was sacrificially consumed on the edges and where the original topcoat was compromised.

Because of these advantages, UHP waterjetting is the preferred method of surface preparation for the St. Croix antenna.
