NATIONAL RADIO ASTRONOMY OBSERVATORY
Socorro, New Mexico

VLBA Antenna Memo Series No.76

St. Croix VLBA Antenna Painting and Surface Preparation

J. E. Thunborg
March 31, 2009

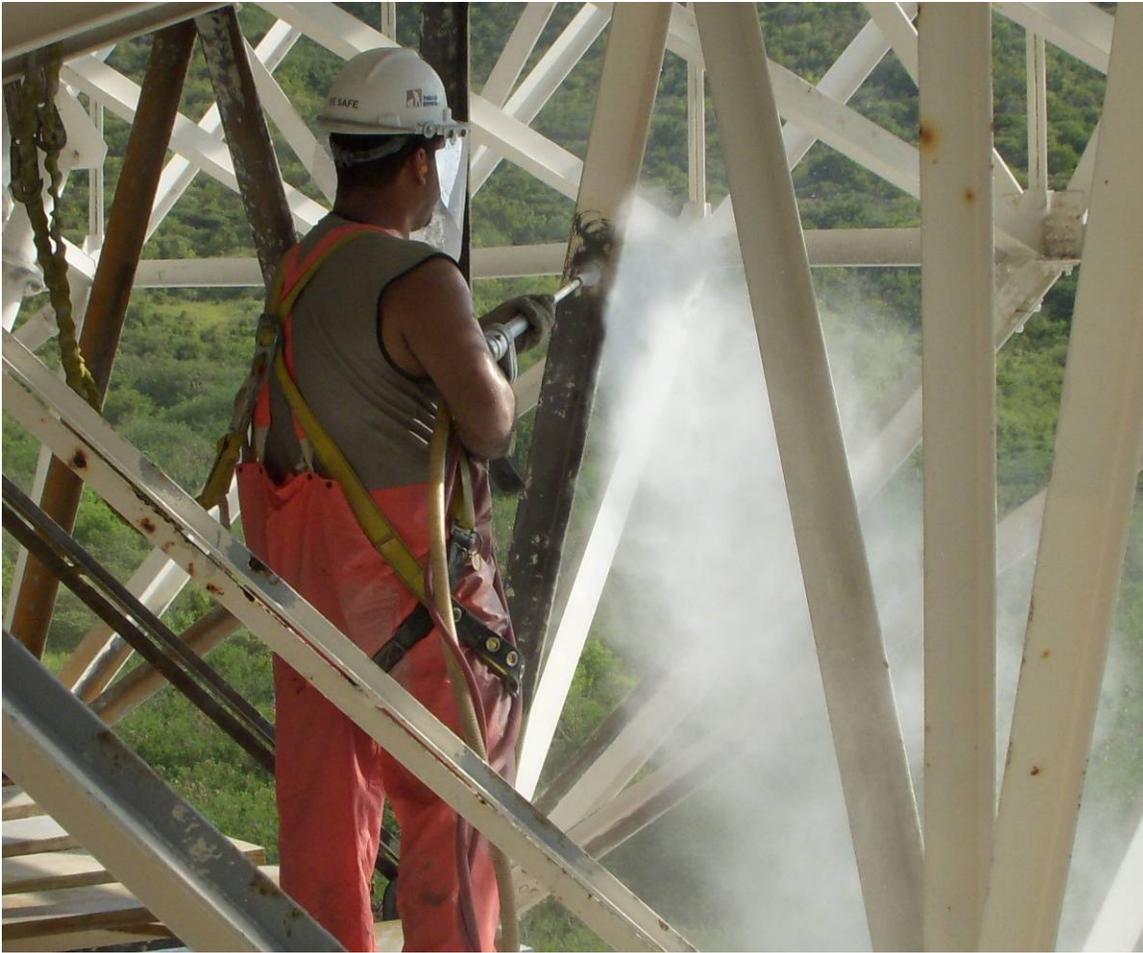
Figure 2, Ultra High Pressure (UHP) Waterjetting Structure at 42,000 PSI

Since coating performance, in general is proportional to the degree of surface preparation, we initially started out trying to achieve the more stringent WJ-2 level of surface preparation. It soon became evident that at this degree of surface preparation, we could not obtain production rates that would be consistent with our budget constraints. At this point, we relaxed the requirement to the manufacturer’s minimum surface prep requirements of SSPC-SP 12 WJ-3 on the bulk of the truss structure. We still required the SSPC-SP 12 WJ-2 on the severely rusted areas of the structure. One advantage of the WJ-3 surface prep was that it left more of the original organic zinc coating intact. This thin coating of organic zinc helped keep the flash rust to a minimum and will provide additional galvanic protection to the steel.

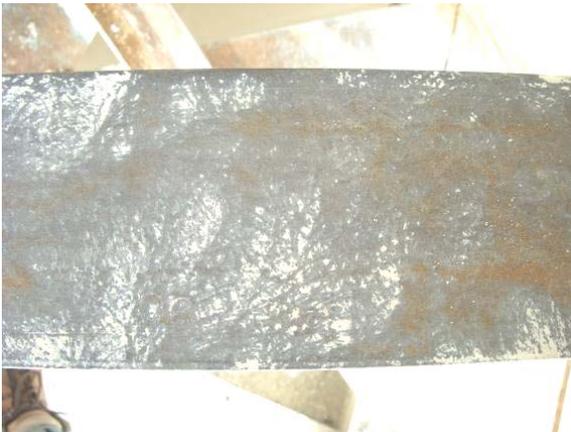
Figure 3, SSPC-SP 12 WJ-3 Surface Prep.

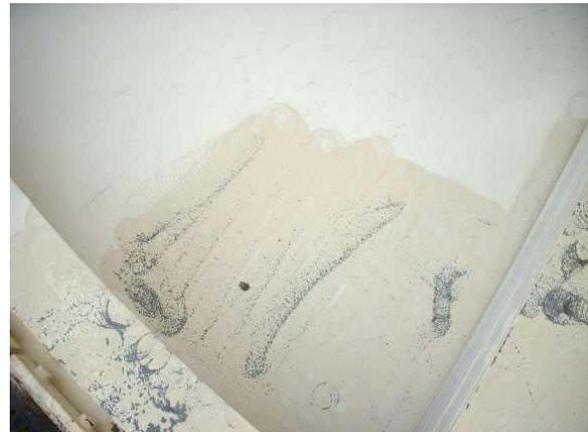
Figure 4, SSPC-SP 12 WJ-4 Surface Prep.

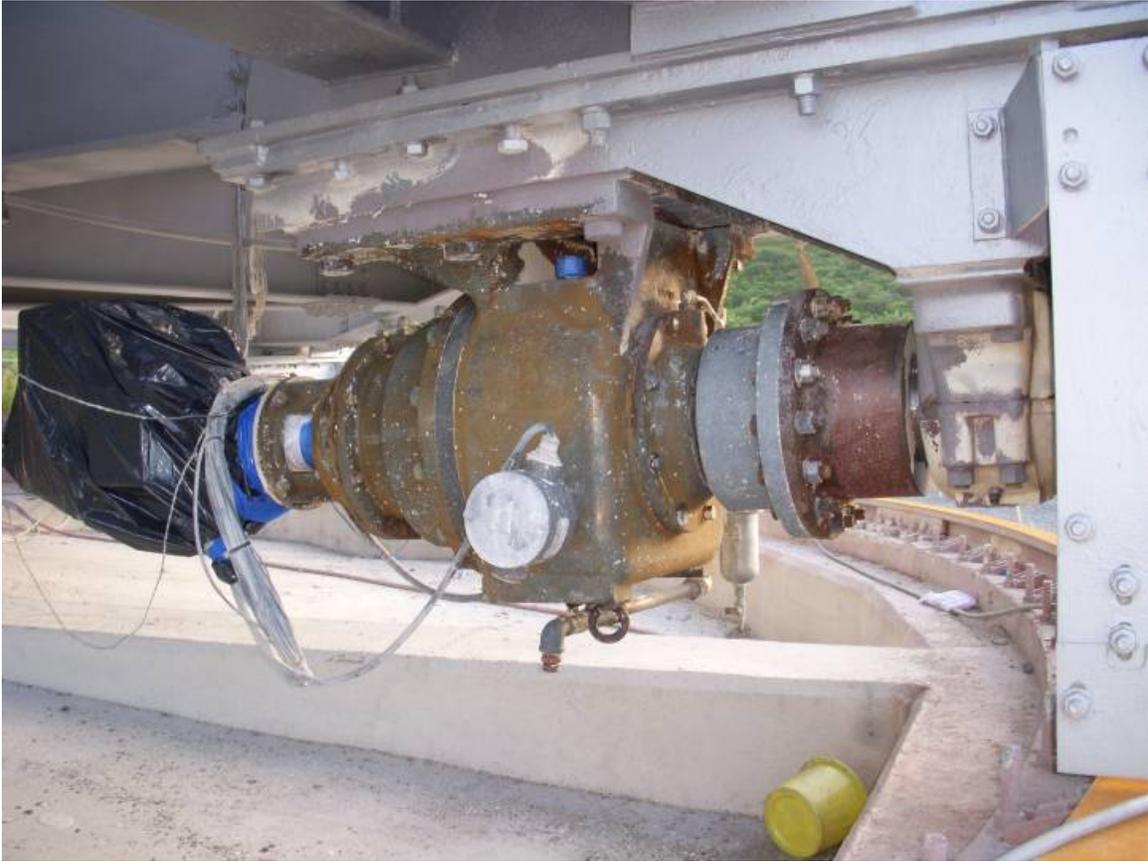
The gearboxes, pillow blocks and areas near sensitive equipment were power tool cleaned using needle scalers and then pressure washed before painting.

Figure 5, Power Tool Surface Prep on Azimuth Drive Gearbox.

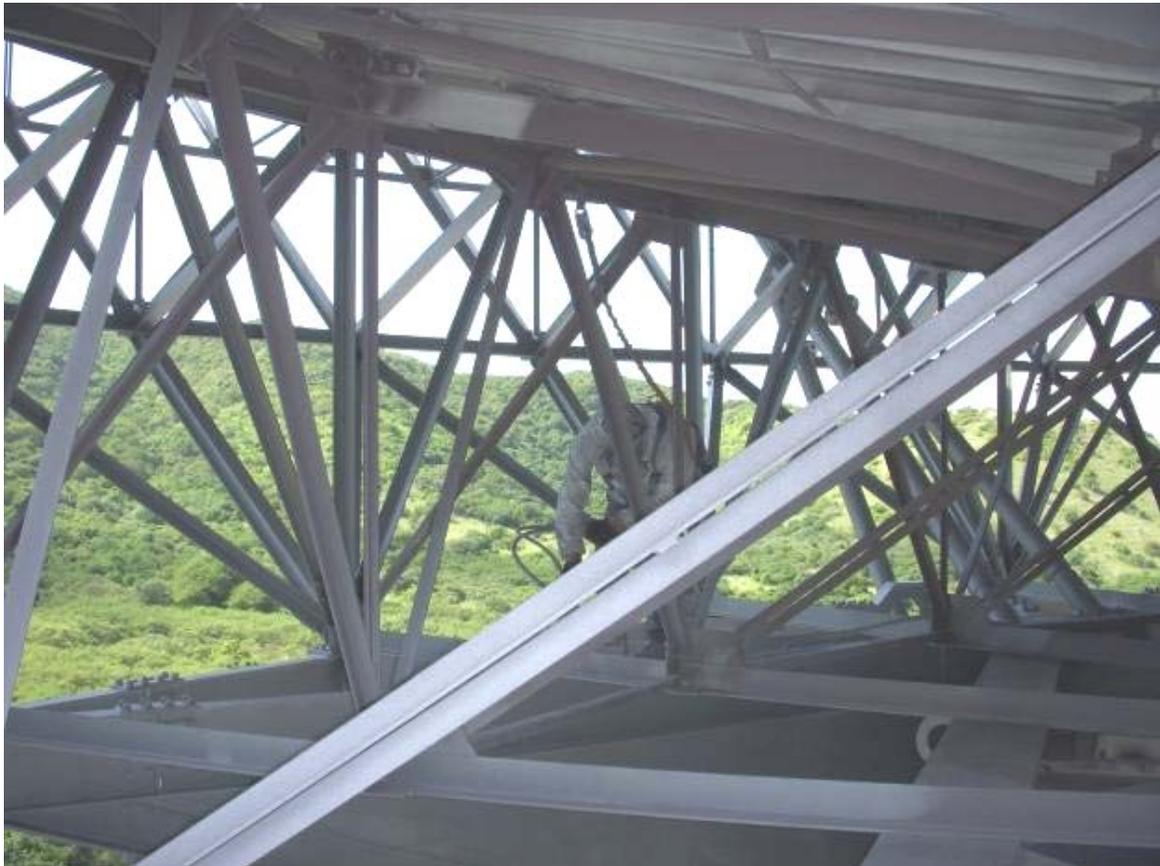
The primed backup structure was painted with Amerlock 400AL using conventional spray as described previously. The outer portion of the backup structure's dry film thickness was 7-12 mills which is in line with the manufacturers recommended thickness of 4-8 mils of Amerlock 400AL plus the 2-4 mils of the prime coat. A different painter painted the inside portion of the backup structure. The dry film thickness on the inside portion of the structure was 4 - 6 mills. This means that the intermediate coat thickness was about half of the desired thickness of 4-8 mills. Since we did not have enough time to add a second intermediate coat to this part of the structure, we did not topcoat this part of the structure until we could evaluate the thin coating. The inside portion of the backup structure was evaluated during a maintenance period approximately one year later. The paint was holding up well except for some rust staining at the bolted connections. The structure was then pressure washed and the rust stained areas were then stripe coated by brush with Amerlock 400AL.

Figure 8, Backup Structure Truss Epoxy Intermediate Coat.

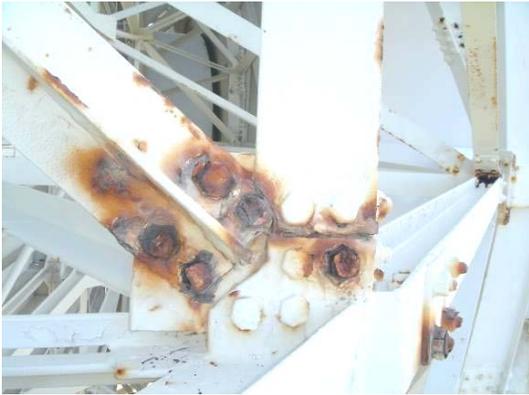
Figure 12, Before Painting - January 2006.

Figure 12 shows a photograph of a bolted connection on the backup structure truss before painting. Figure 13 shows the same connection approximately 1 ½ years after painting. As evinced in the photo, several of the severely corroded bolts were replaced. The rust staining in Figure 13 shows that there are several holidays in the paint where corrosion is beginning to take hold. These holidays are on the edges of the beams and places where it was hard to get paint coverage by spraying. There is very little rust staining along the beams and on the large flat surfaces.

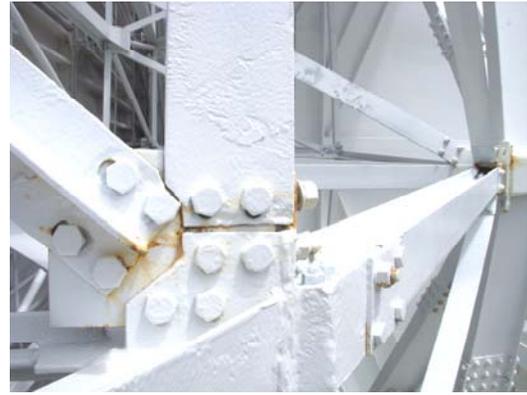
Figure 13, After Painting - March 2009.

The majority of the corrosion on the antenna is being inhibited by the new paint job. The paint adhesion is adequate and the paint system is performing well where it was applied properly. There are however, several holidays in the paint that will need to be addressed before the corrosion in these areas progresses to the point where additional surface prep will be required. These holidays should be encapsulated as soon possible with Amerlock 400 epoxy applied by brush. A small crew of NRAO or locally contracted painters should repair these holidays as soon as possible. After these holidays are repaired, only minimal paint system maintenance will be required for the next few years. The expected life of the paint job in the coastal environment, assuming the current holidays are repaired, is 10 – 12 years.
