National Radio Astronomy Observatory
Socorro, New Mexico
VLBA Antenna Memo #79

Mauna Kea, Hawaii, VLBA Maintenance Visit September 22- October 2, 2009. Team members consisted of Eric Carlowe, Ramon Gutierrez, Martin Lopez, Ken Lakies, Ray McFarlin and Phillip Sanchez. VLBA Site Technicians Bill Hancock and Tony Sylvester assisted in all areas of antenna maintenance throughout the visit.

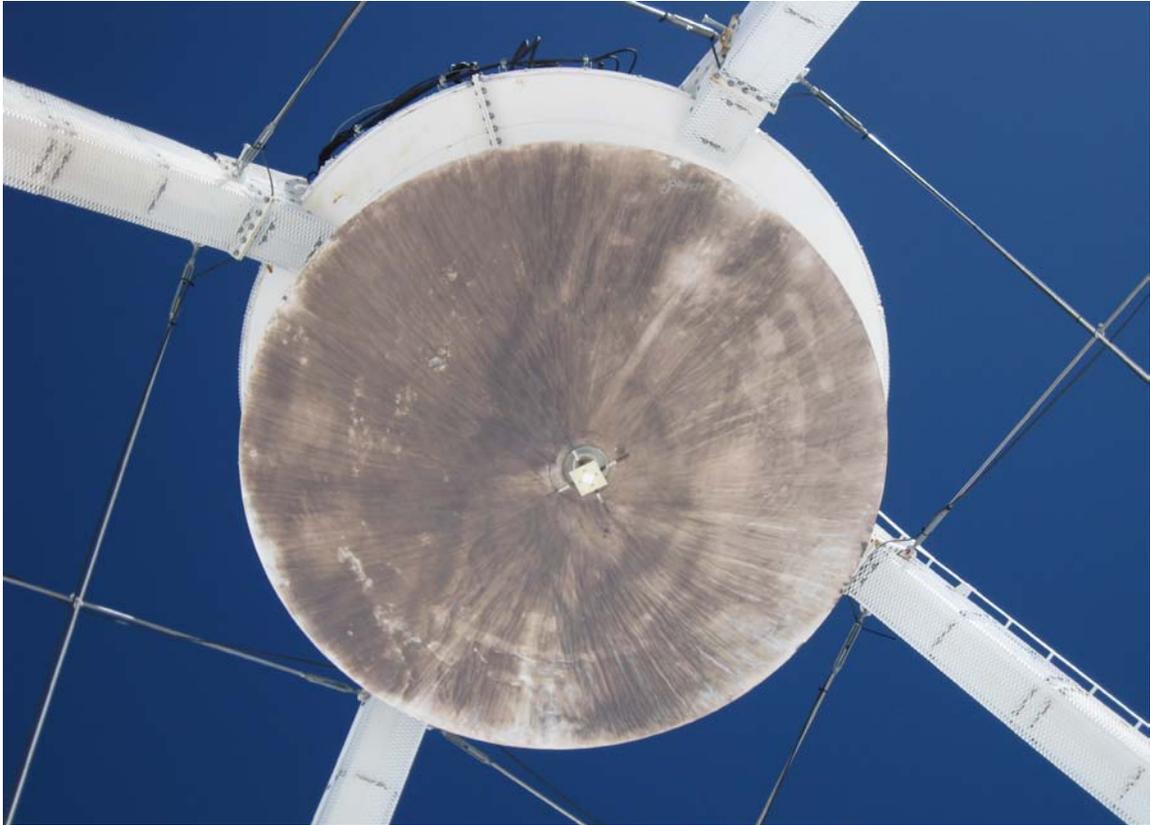
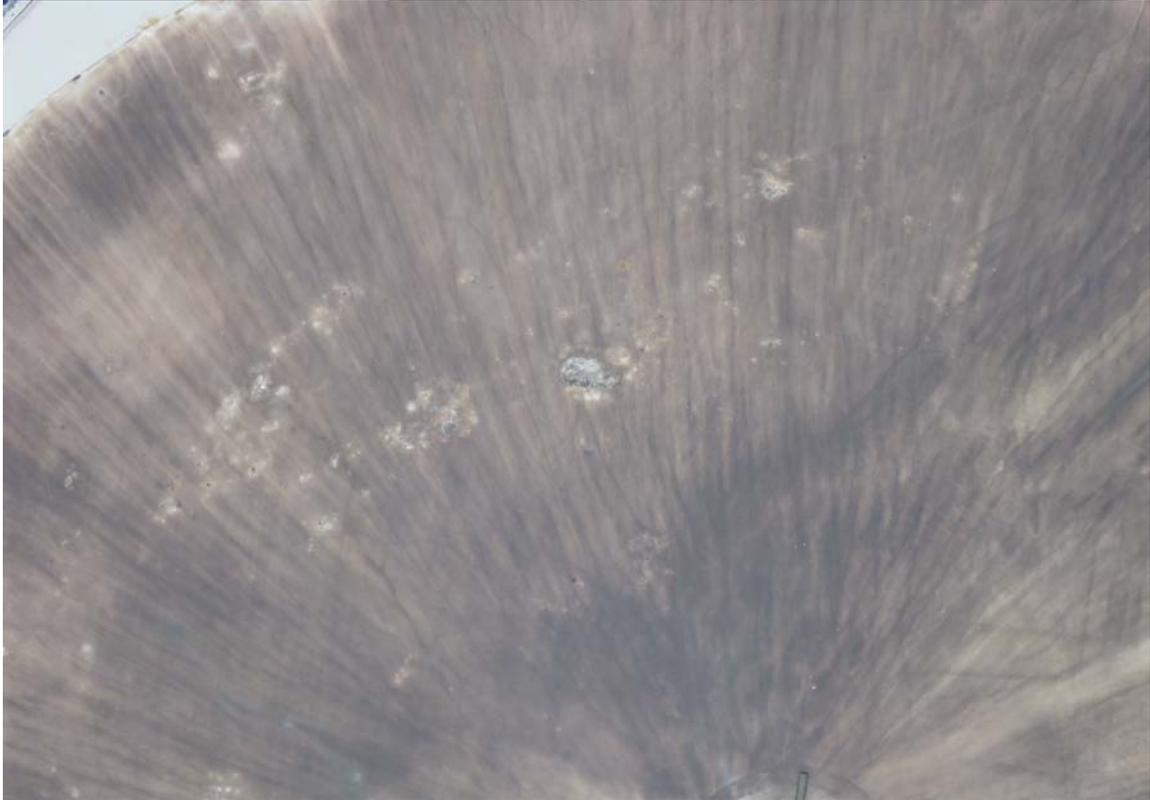
The Sub Reflector paint is beginning to flake off in spots.

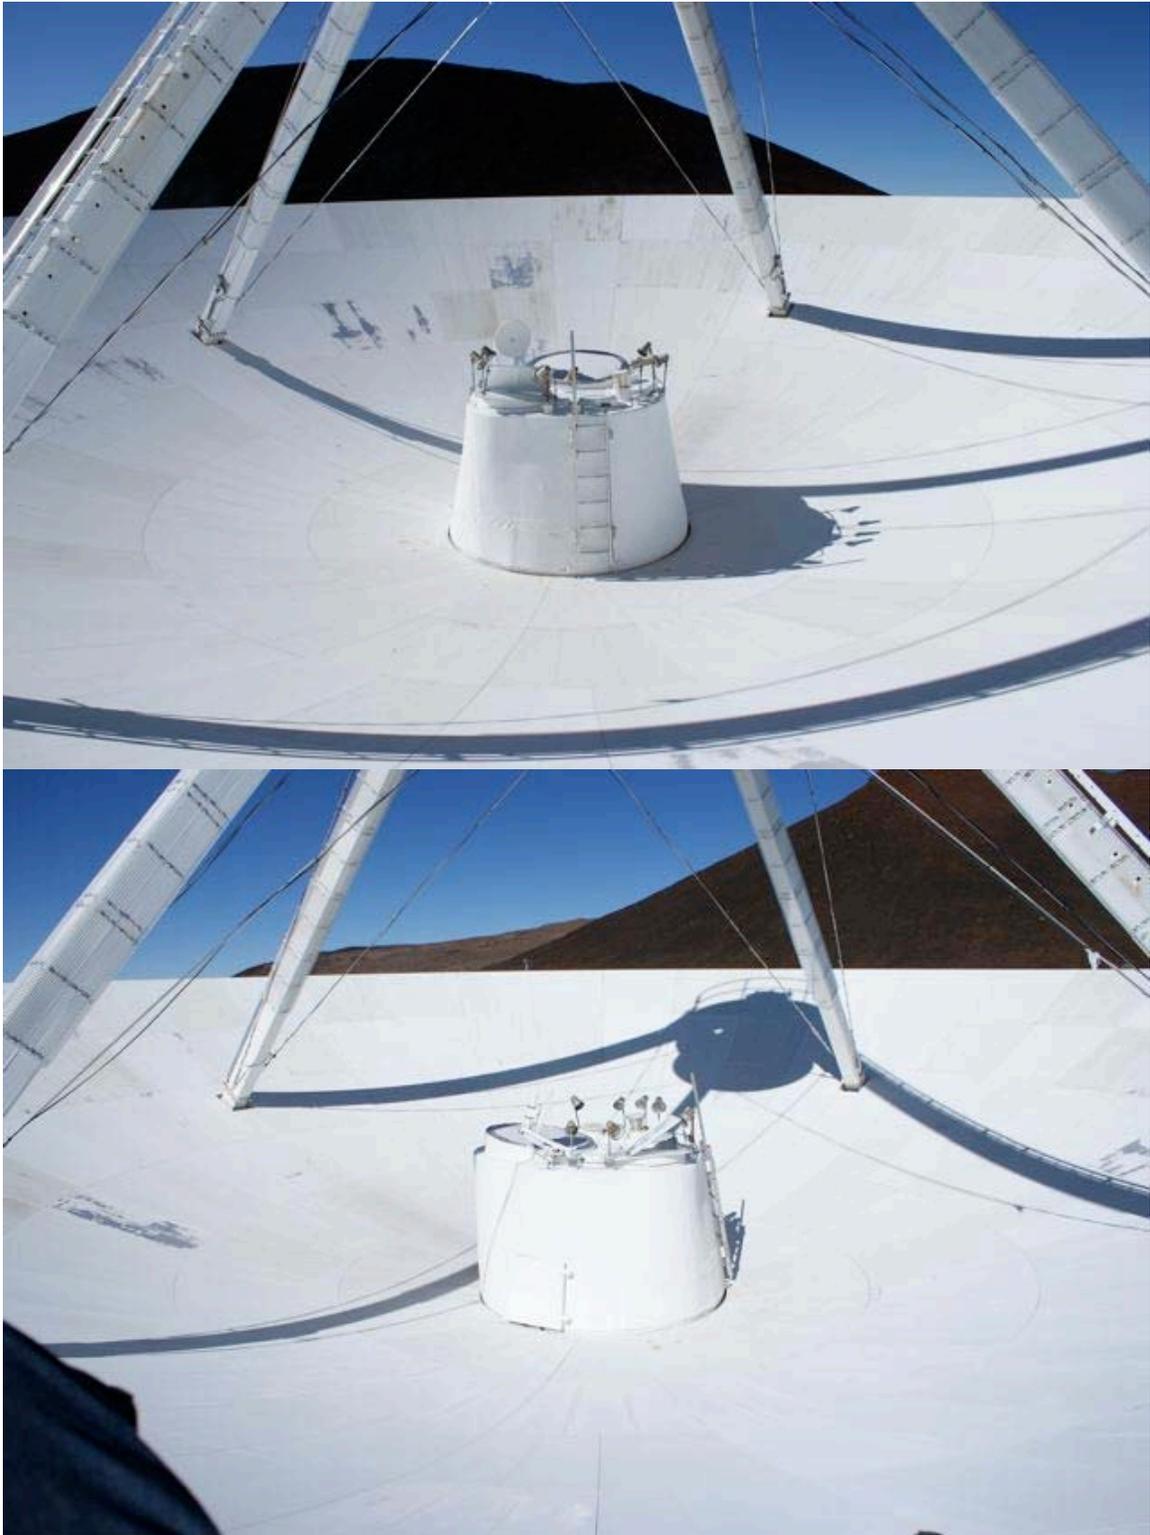
Dish panels are in good condition with only a few minor dents.

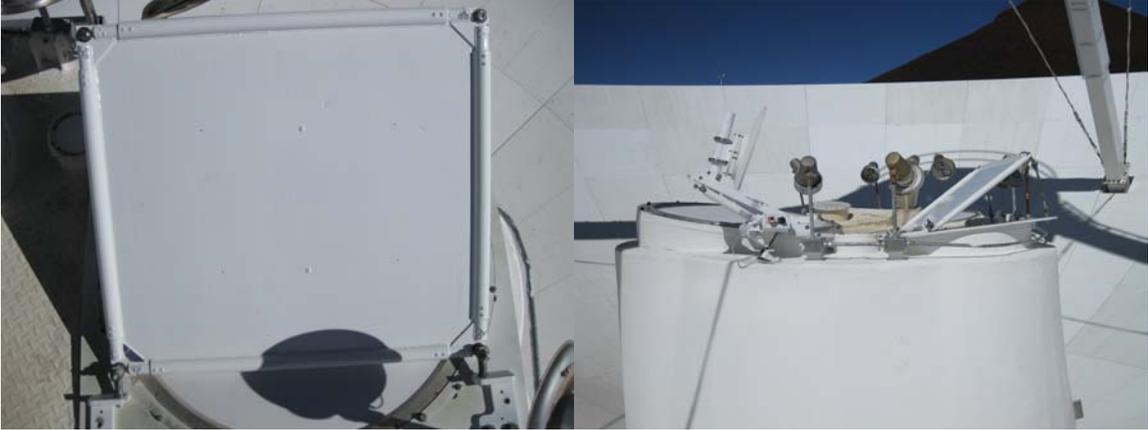
The Dichroic reflector is in good condition. The Ellipsoid reflector is in good condition. Ellipsoid actuator operates correctly.

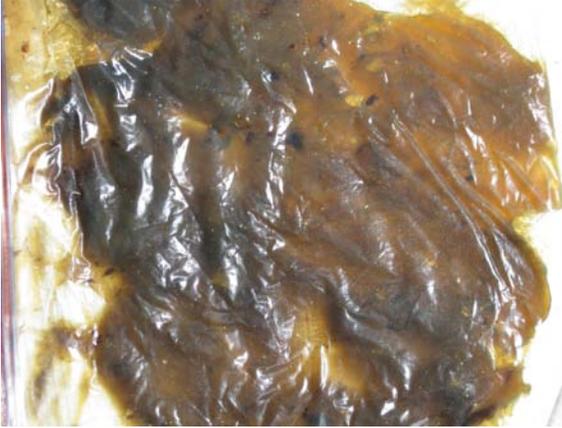
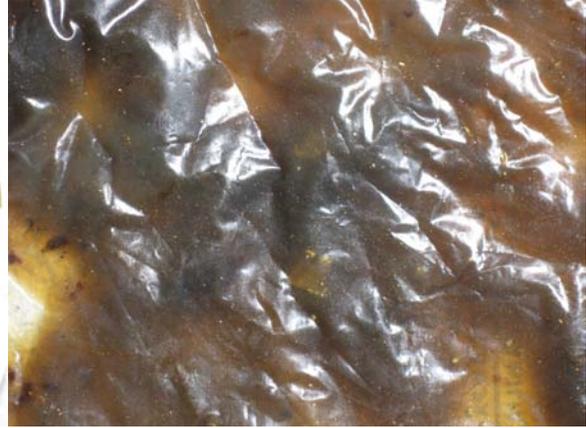
The grease from the Synchro side Elevation bearing has small brass and steel particles. This bearing will need to be replaced sometime in the future.

Encoder	Good grease with no metal flakes.
Synchro	Lots of brass and metal flakes.
All bearings are very well lubricated.

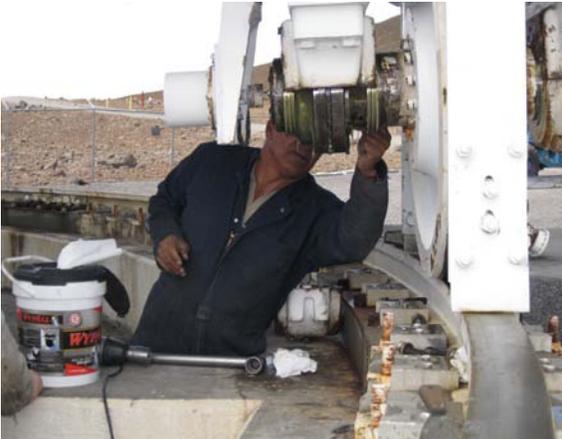
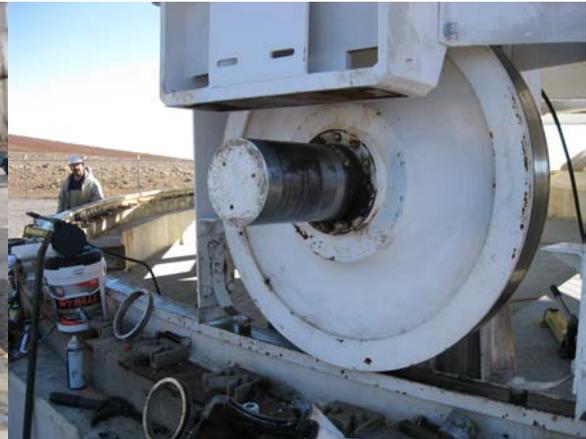
During the AZ grease inspection Idler wheel #2 outside bearing revealed a lot of metal and was replaced.

INNER BEARING	OUTER BEARING
D1	New Wheel.	New Wheel.
D2	New Wheel.	New Wheel.
I1	Good, no metal.	Few small metal flakes.
I2	Good, no metal.	Replaced.

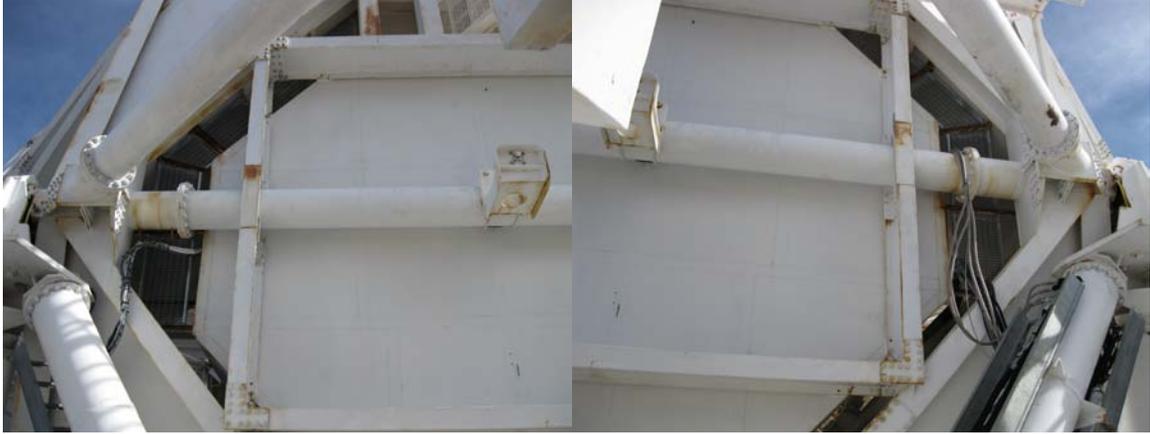
Elevation axle has no visible signs of cracks. Paint is in fair condition with surface rust.

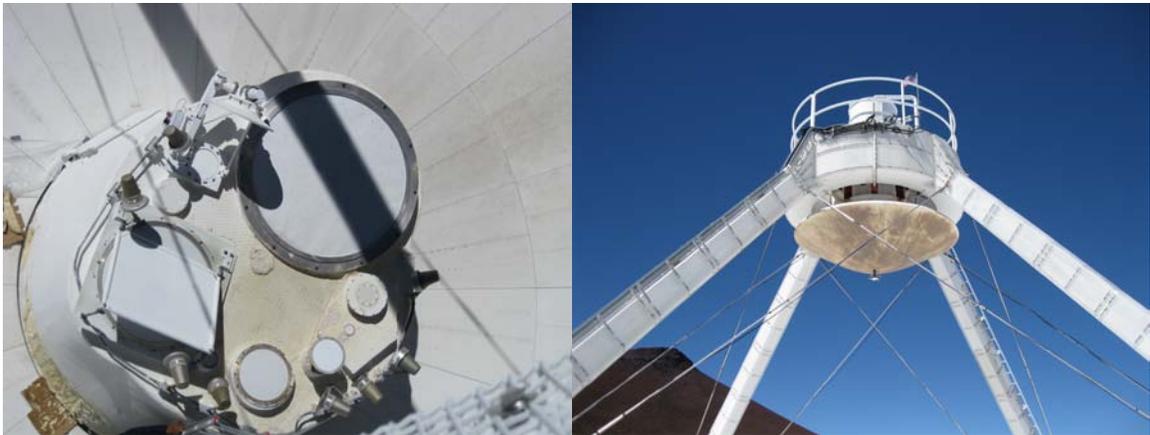
The feed heaters and FE windows are in good condition. Apex paint is in good condition.

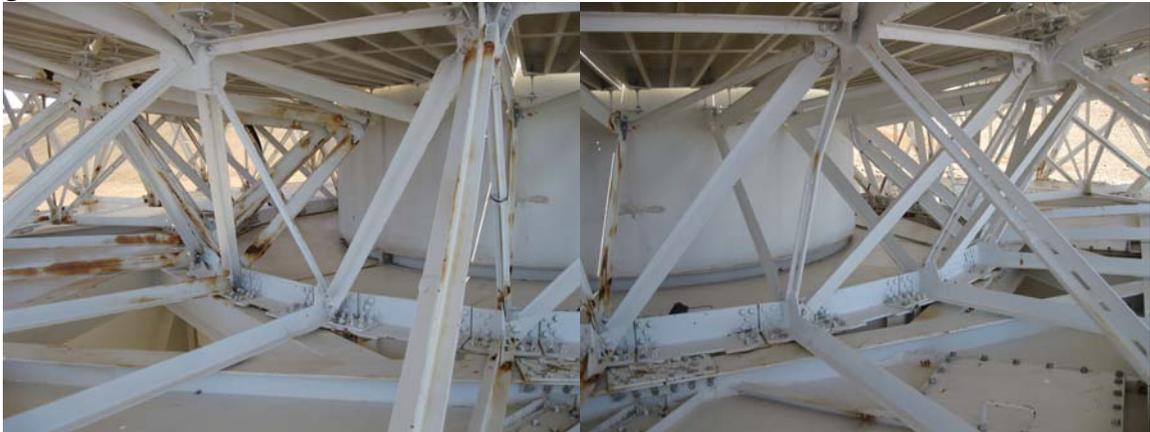
Antenna backup structure is in good condition. Paint is in fair condition with lots of surface rust.

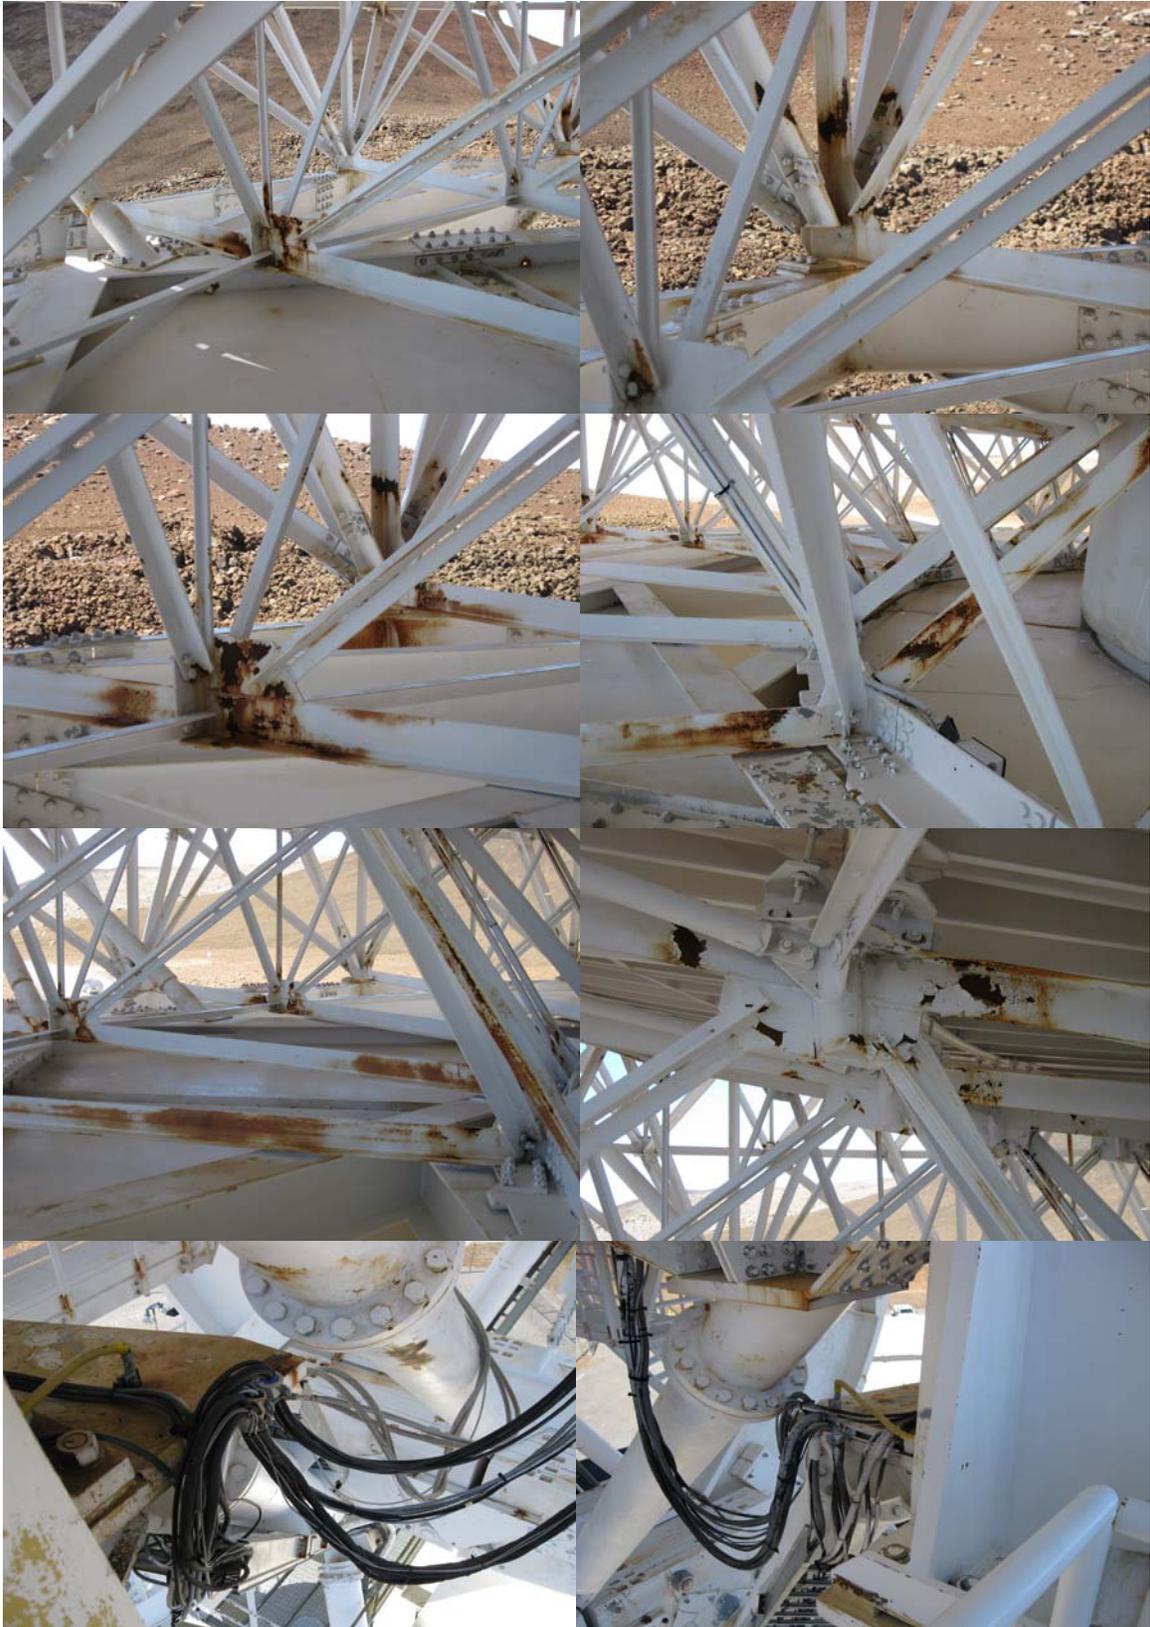
Surface rust is mainly found on the backup structure. Elevation axle cable wraps are in good condition. Page 7

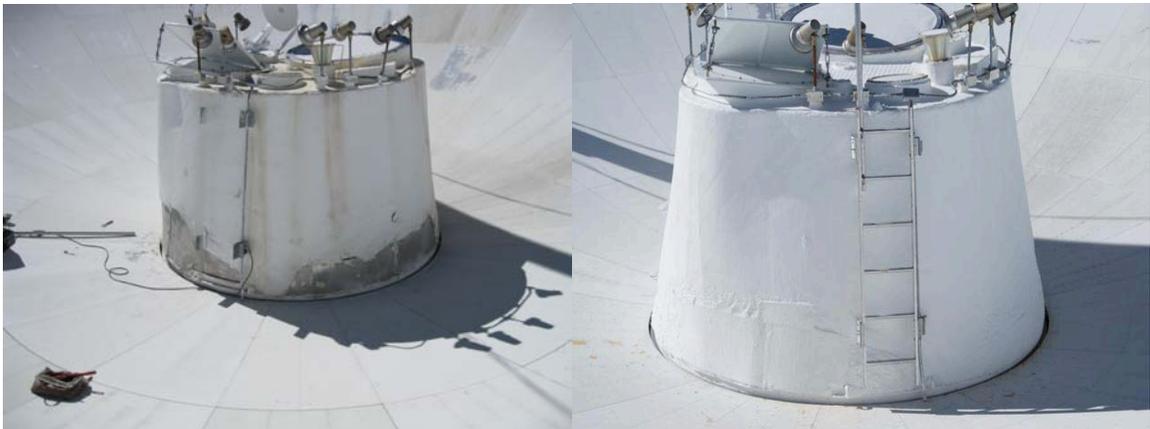
The feed cone insulation and ladder were damaged during the 2009 winter. This damage was repaired and the feed cone painted with elastomeric.

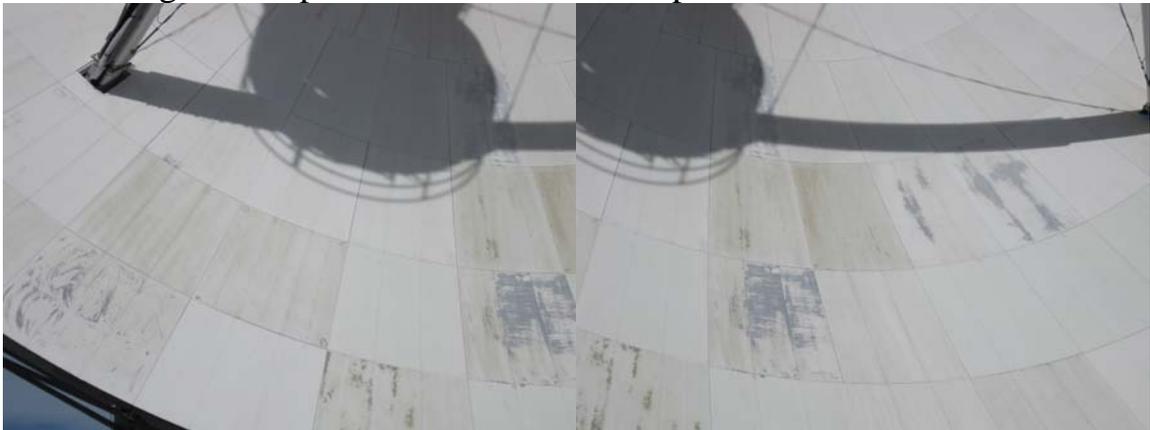
The paint is deteriorating on several dish panels.

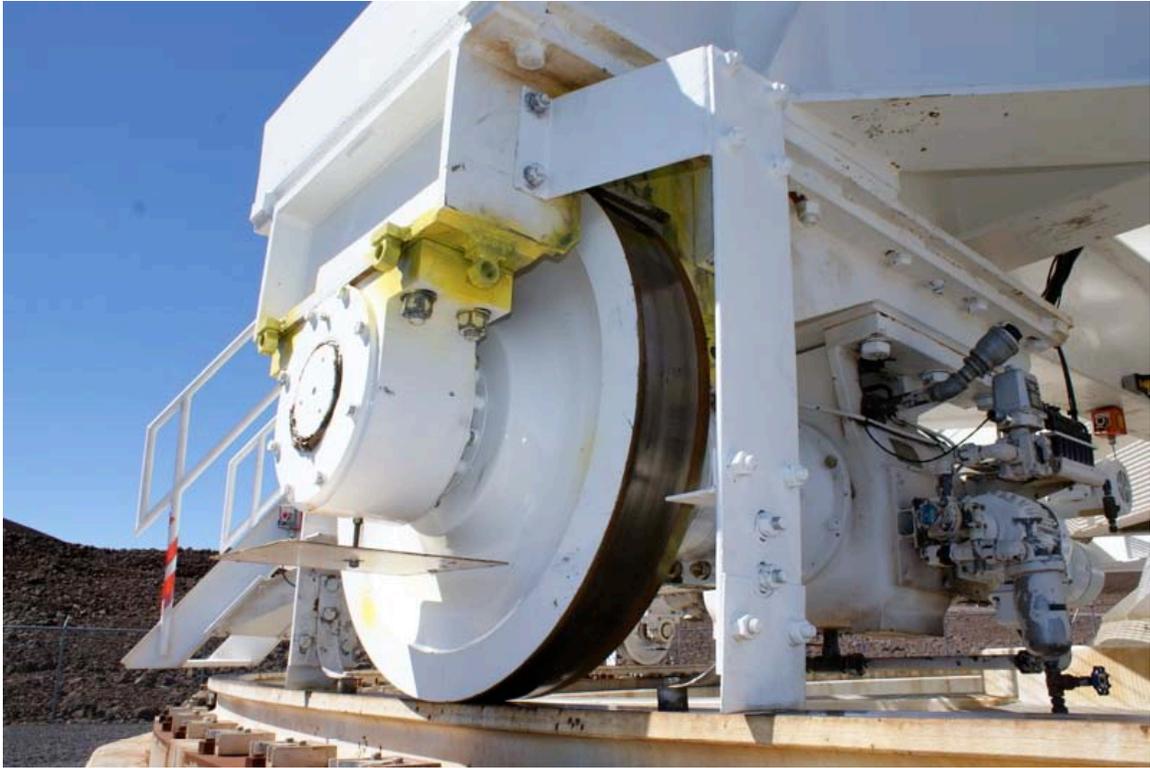
MEASURED	SPECIFIED
Conic Radius	300.185	300.00 +/- .25
Coupling Runout	.004	<.005
Vertical	93.445	93.440 +/- .023
Horizontal	.020	<.023

Azimuth #2 Drive Wheel assembly was replaced. The new drive wheel assembly rotated smoothly without any popping or grinding noises.

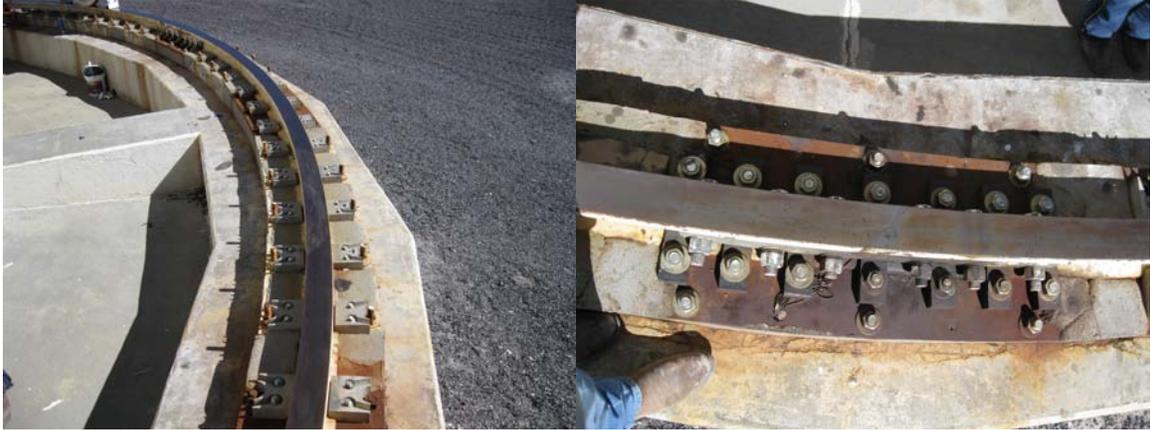
The Mauna Kea rail is in good condition.
