National Radio Astronomy Observatory
Socorro, New Mexico
VLBA Antenna Memo #84

North Liberty, Iowa VLBA Maintenance Visit April 12-18, 2011.
Team members consisted of Sam Abeyta, Eric Carlowe, Ramon Gutierrez,
Ken Lakies, Tommy Montoya and Ray McFarlin. VLBA Site Technicians
Mike Burgert and DJ Beard assisted in all areas of antenna maintenance.

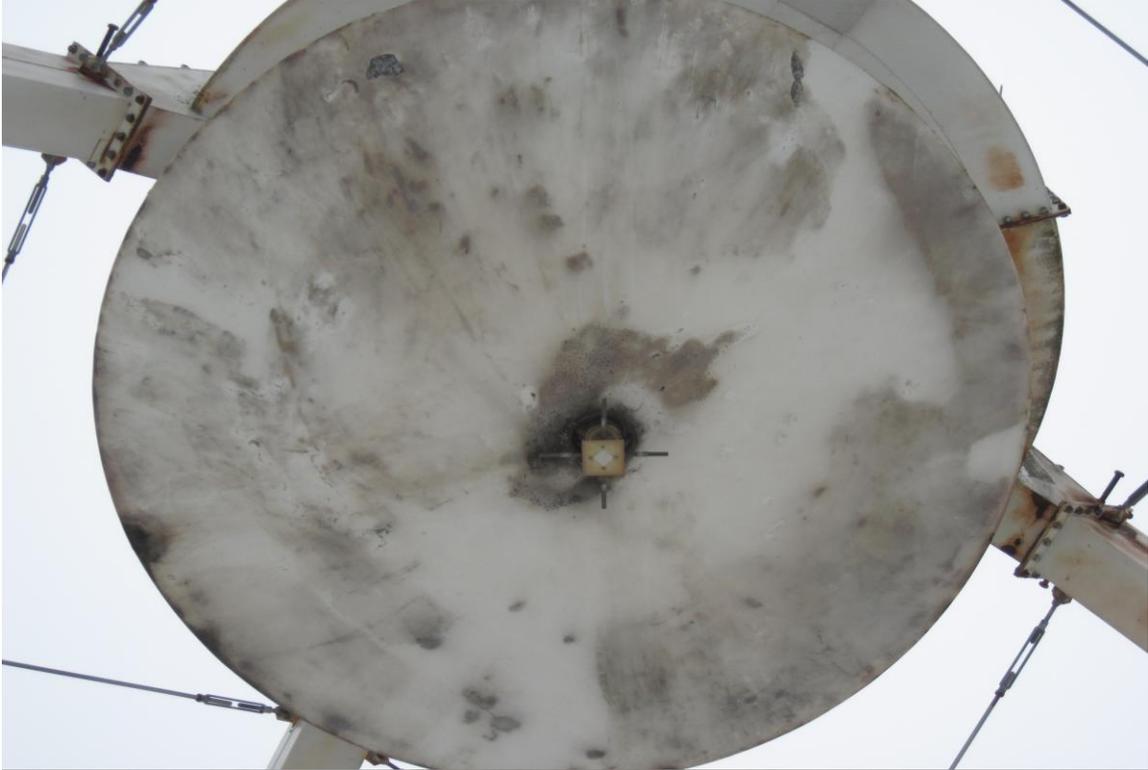
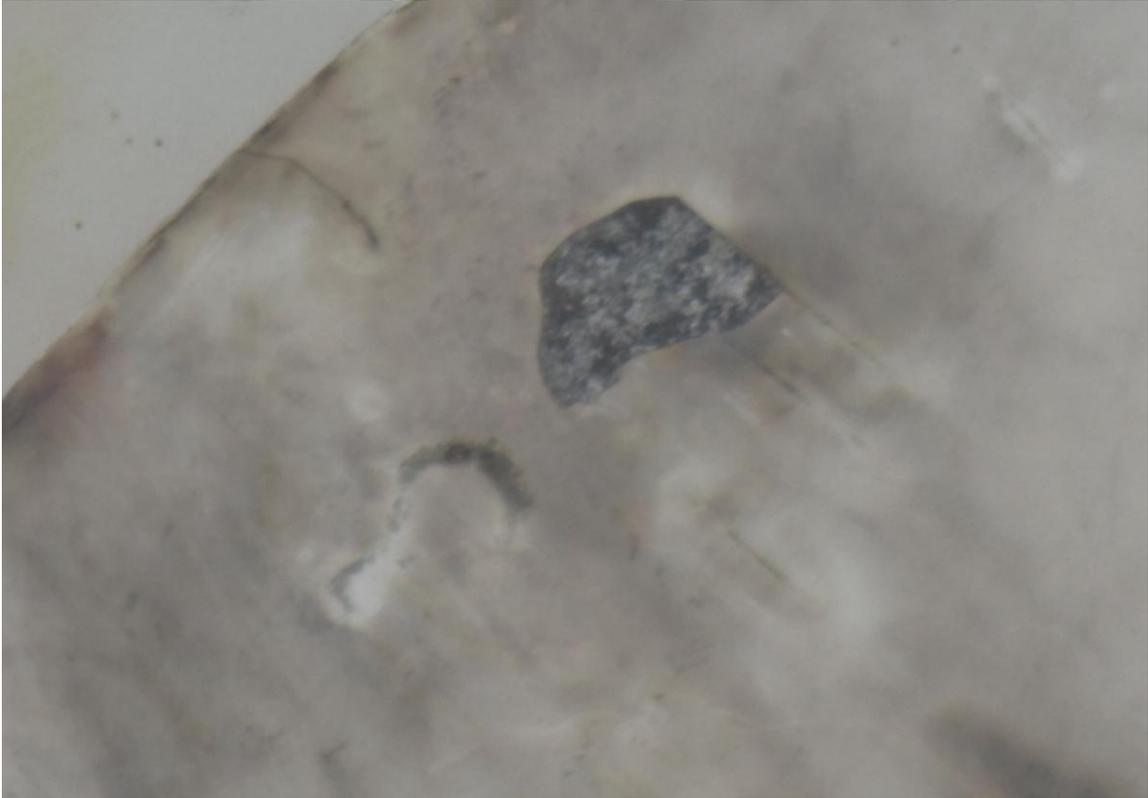
Sub reflector paint is beginning to flake off. FRM was given a thorough inspection. The focus flex was replaced. The FRM is well lubricated.

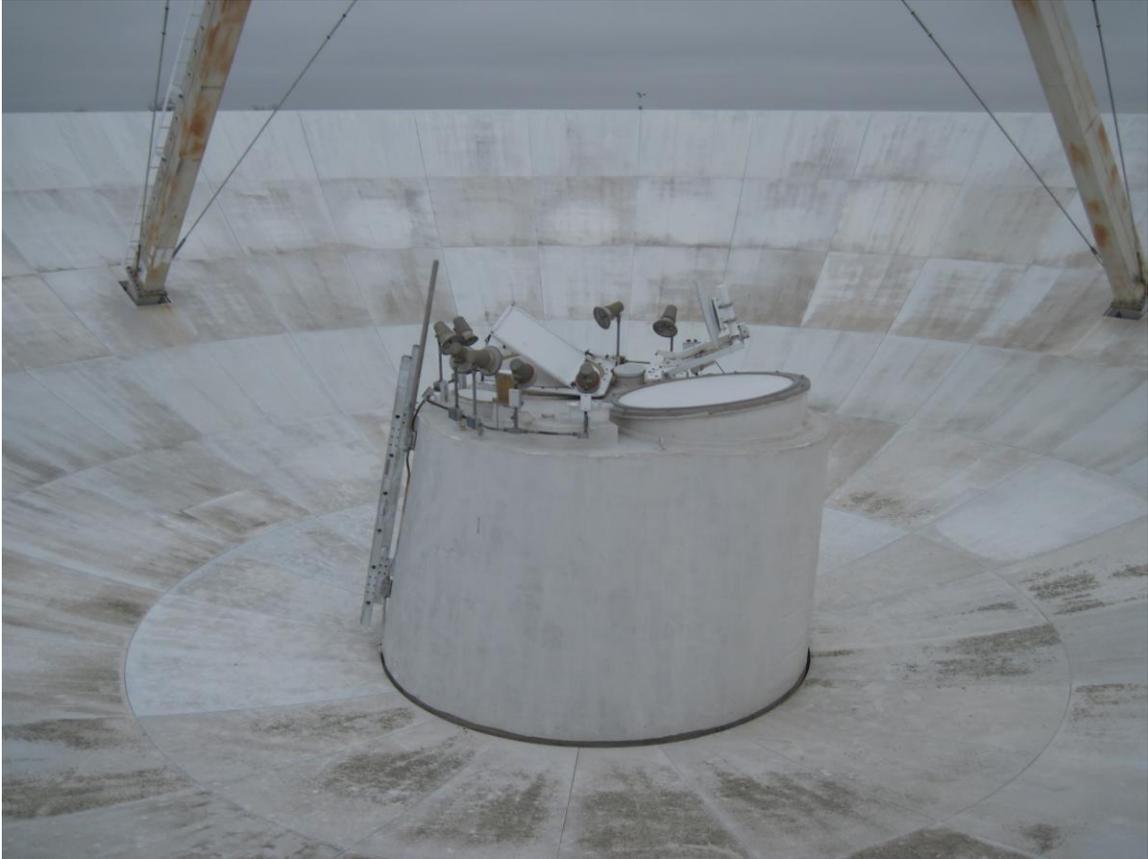
Dish panels are in good condition. The feed cone's elastomeric paint is holding up well. The feed cone was sealed and painted back in 9/2003.

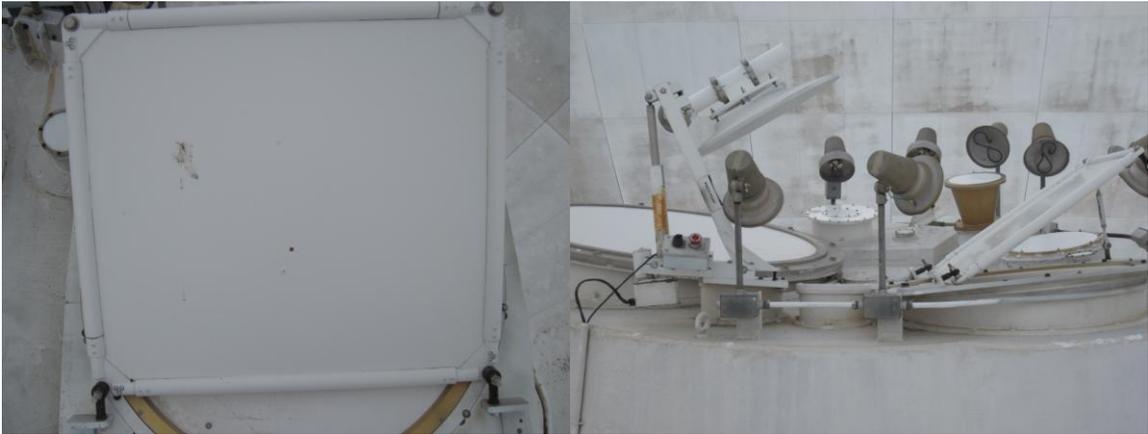
Dichroic reflector is in good condition. Ellipsoid reflector is in good condition. Dichroic reflector actuator operates correctly.

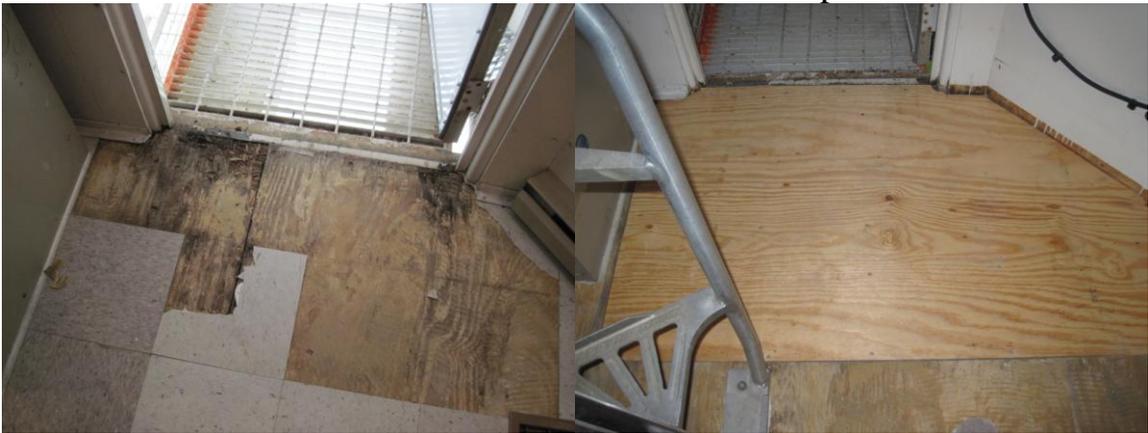
The Vertex room floor was severely rotted and had to be replaced.

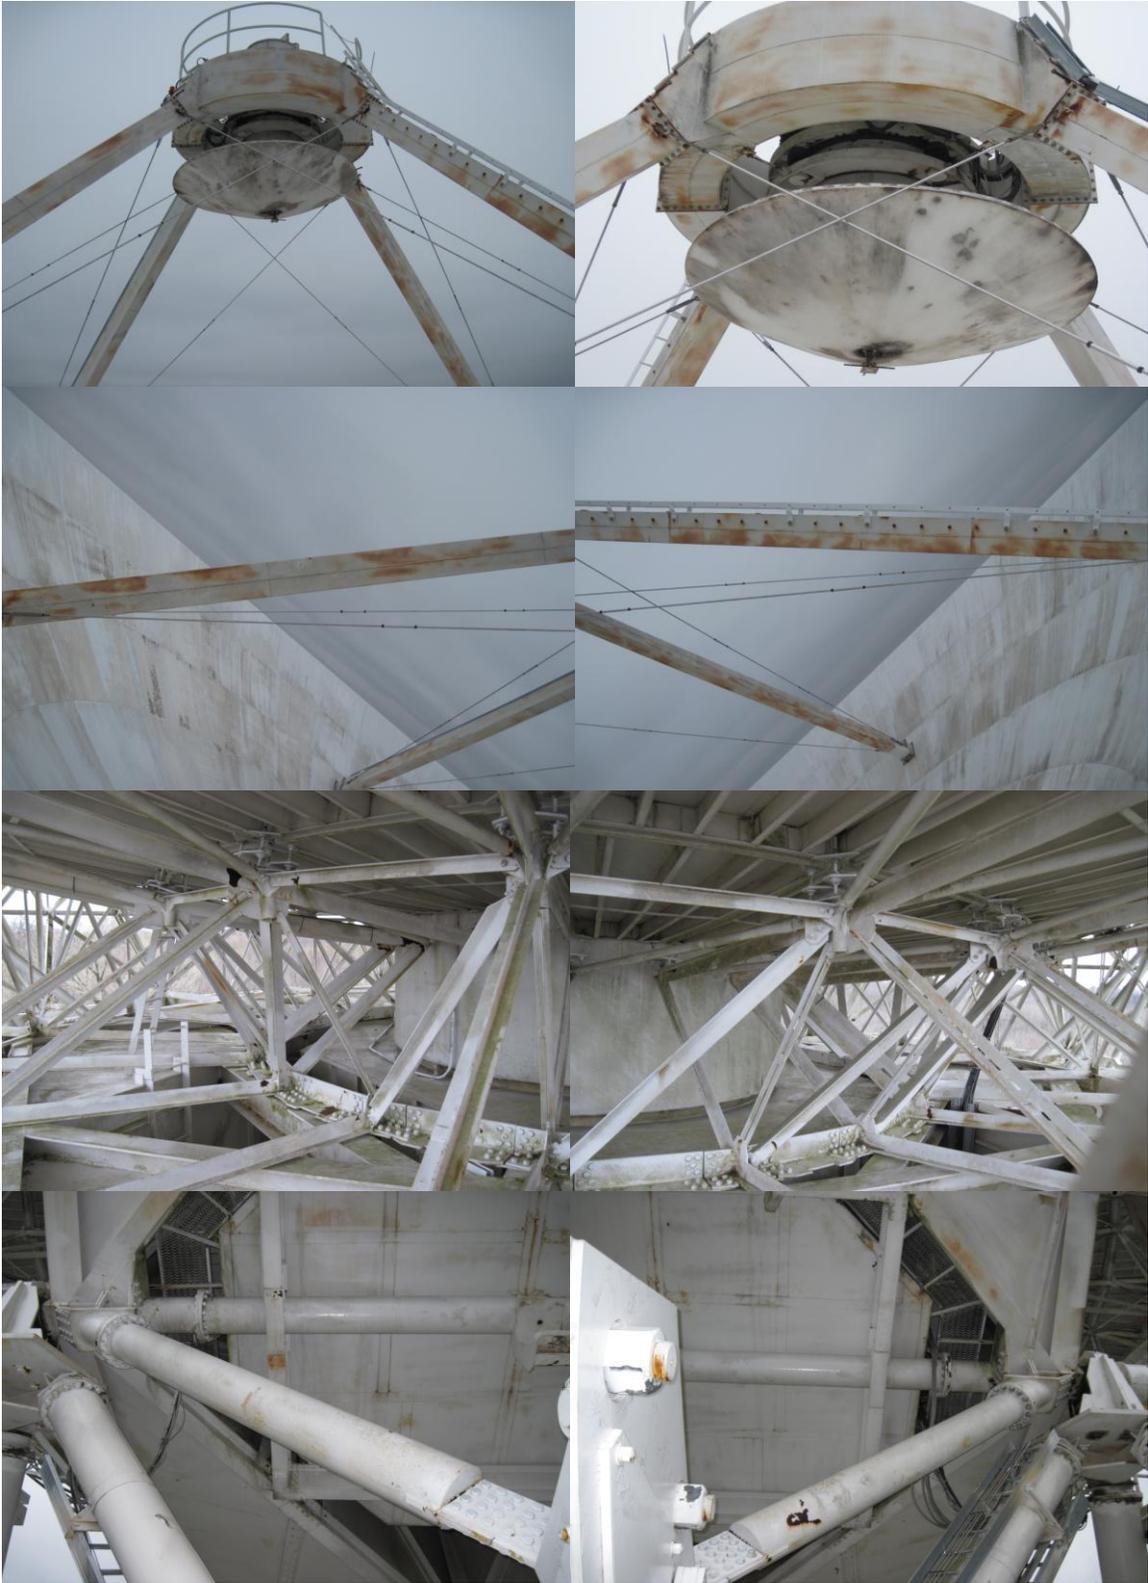
The Antenna needs some “spot painting” or a complete paint job. Paint is flaking off and surface rust is affecting most areas of the Antenna structure.

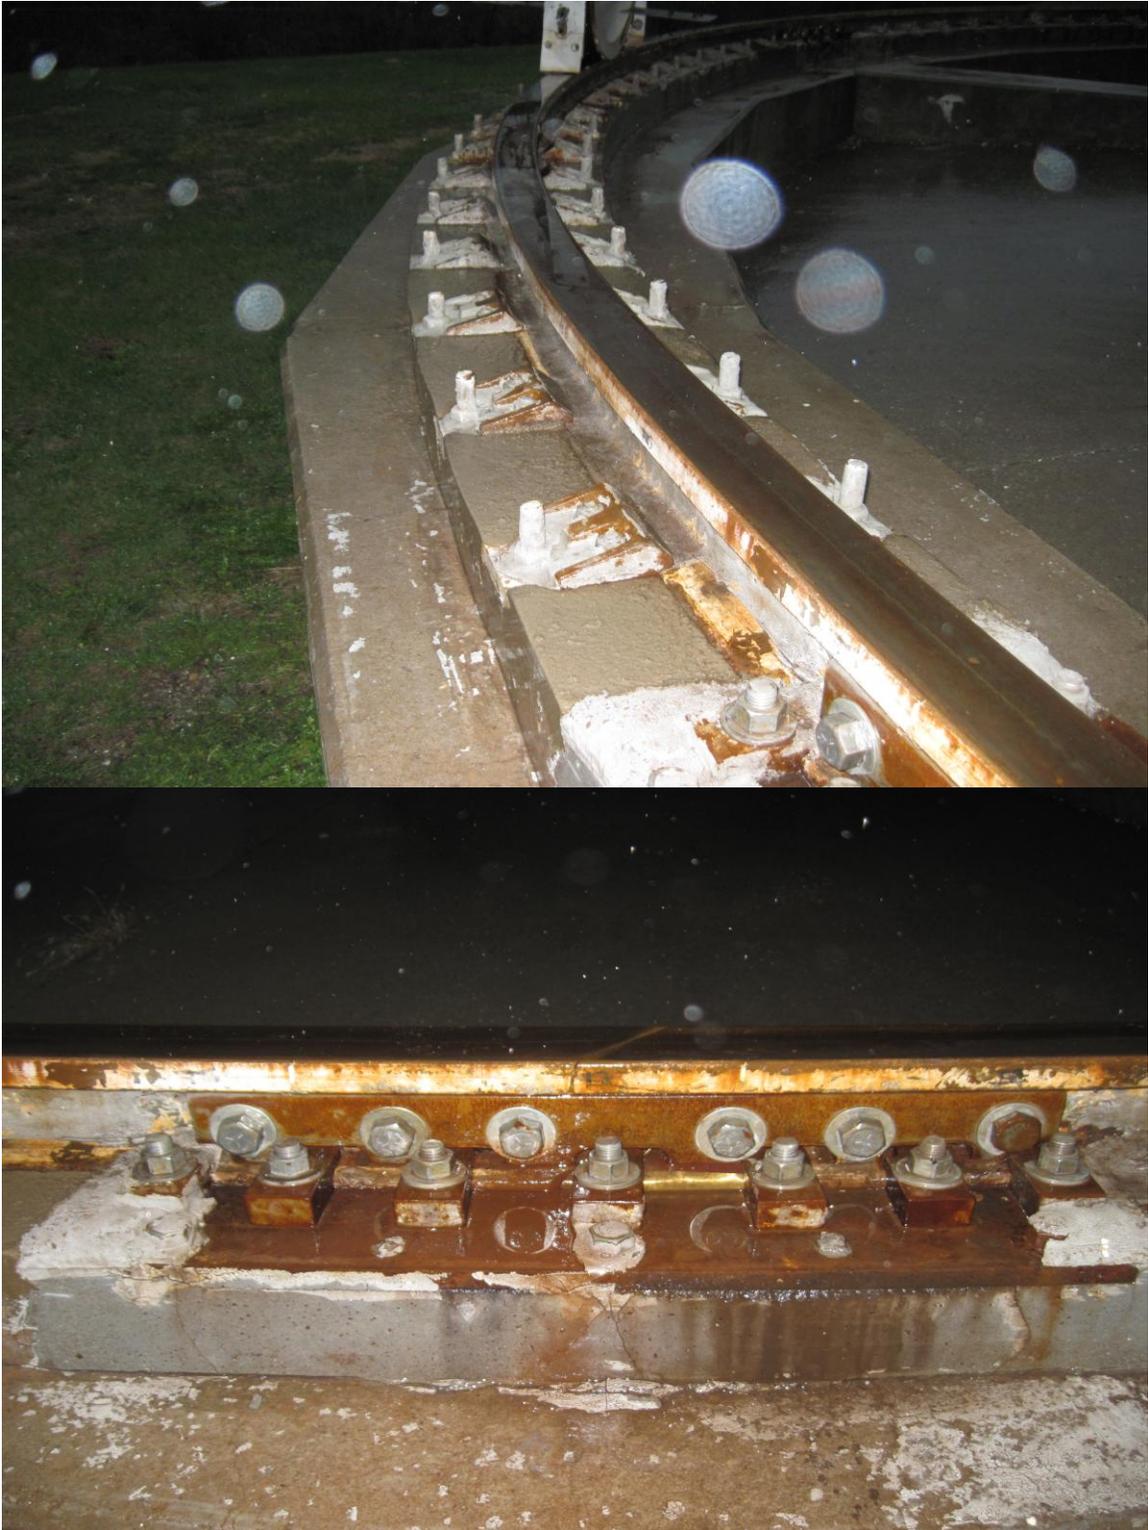
Bob Broilo completed a rail grout and splice bar repair on 7/10. Rail and grout is in great condition. Page 7
