National Radio Astronomy Observatory VLBA Antenna Memo Series – No. 88

TRIP REPORT – MAUNA KEA 31-MAY THRU 7-JUNE 2012
ELEVATION BEARING CHANGE

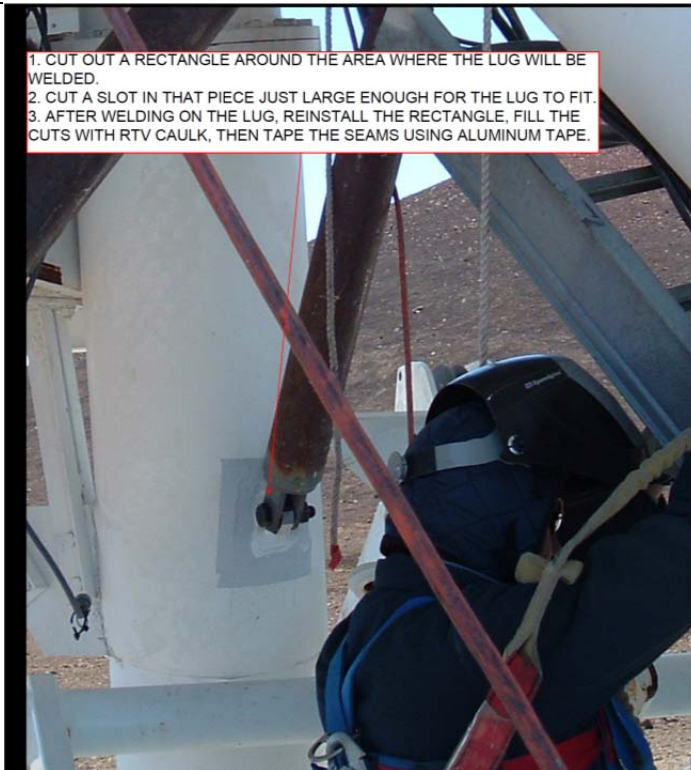
In order to make up for lost time, Tommy and Adrian came up with the idea of cutting out a small section of insulation from the location where the structural support lugs were to be welded on, then reinstalling that section after the lug was installed. See the figure below for details. This idea saved at least one full day at the end of the job by eliminating the need to reinstall large pieces of insulation. It should be noted that the patch job in these locations looks very uniform and professional.

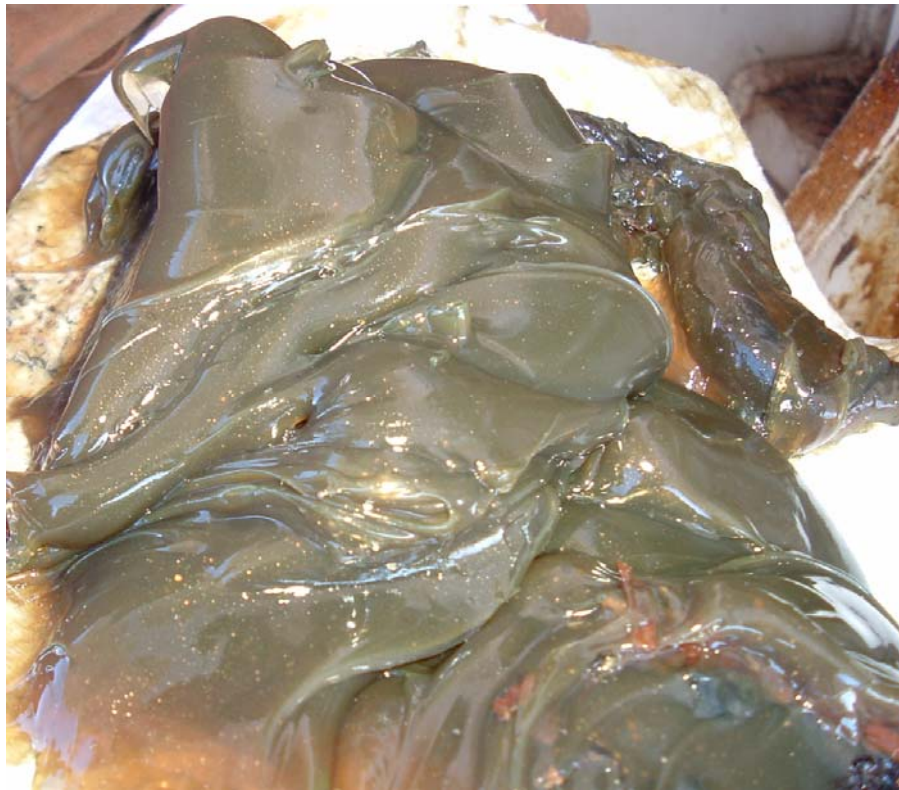
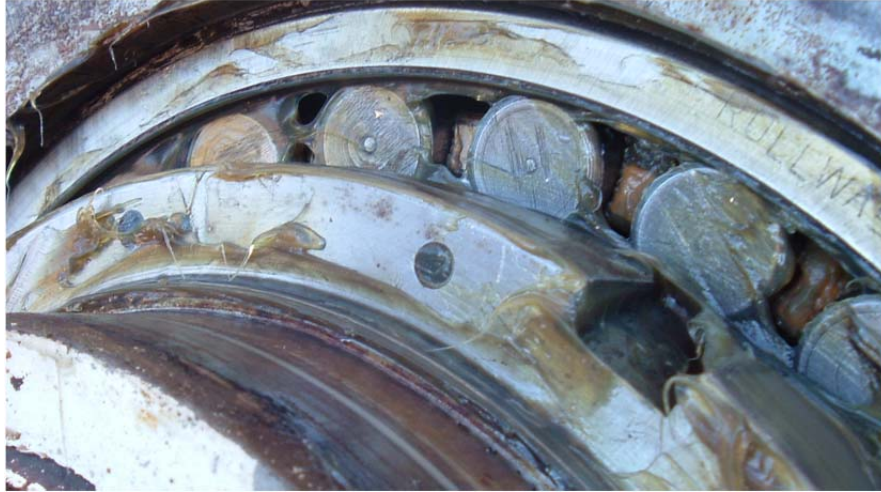
Some observations of the grease after the cover plates were removed from the bearing: Although heavy flushing with grease had slowed down the amount of new metal pieces seen coming out of the bearing, when the cover plates were removed from the bearing and the grease was examined, we found metal flakes in the grease like glitter (see the following figures). Heavy greasing probably cleaned out a small path in the bearing between the grease fitting and the particular place where grease usually came out, but the metal was still there in all other areas.

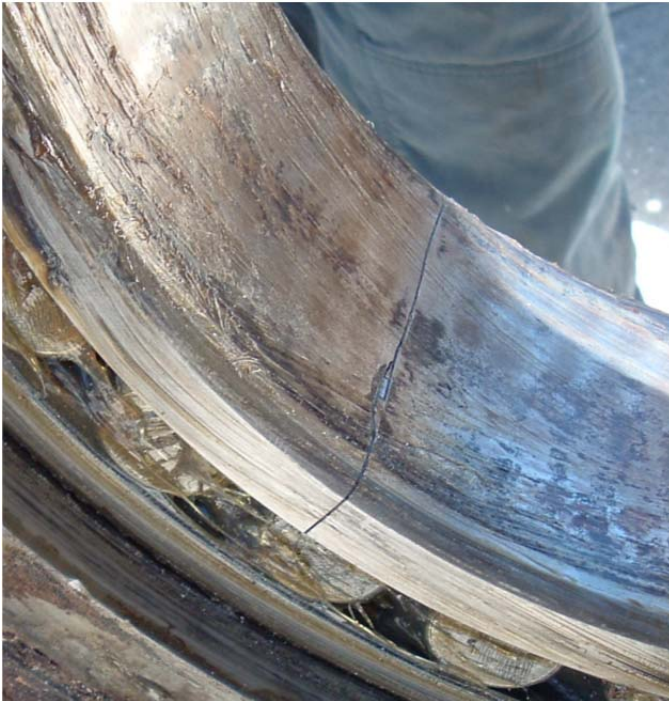
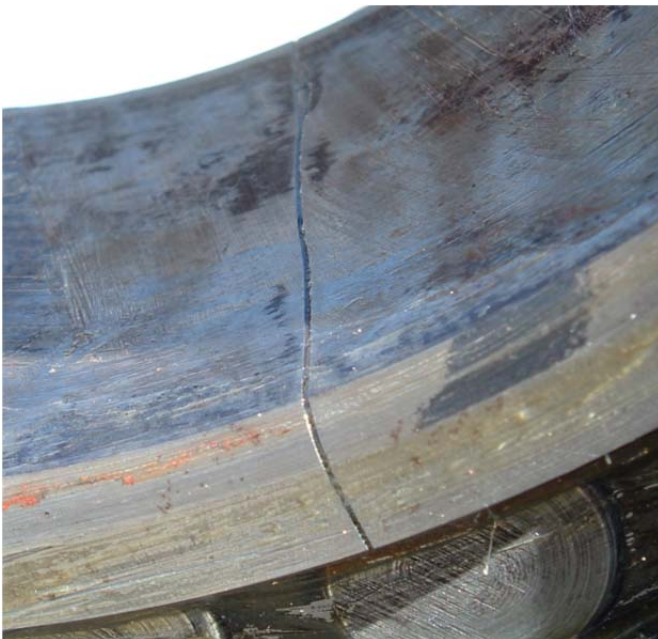
- Set up and remove the taper coupling from the axle.
Note that the taper coupling was already loose; no pressure was required to move it. We did not expect this; later, after determining that the inner race of the bearing was broken, it made sense that the taper coupling was loose.

The bearing will be inspected thoroughly when it arrives back at the VLA, but one failure mode was obvious; the inner race was cracked entirely through as shown in the following pictures:

The existing bearing was a Rollway 23056MBKW33C3. The old bearing slid out easily, and the new bearing slid in easily with no press force required.

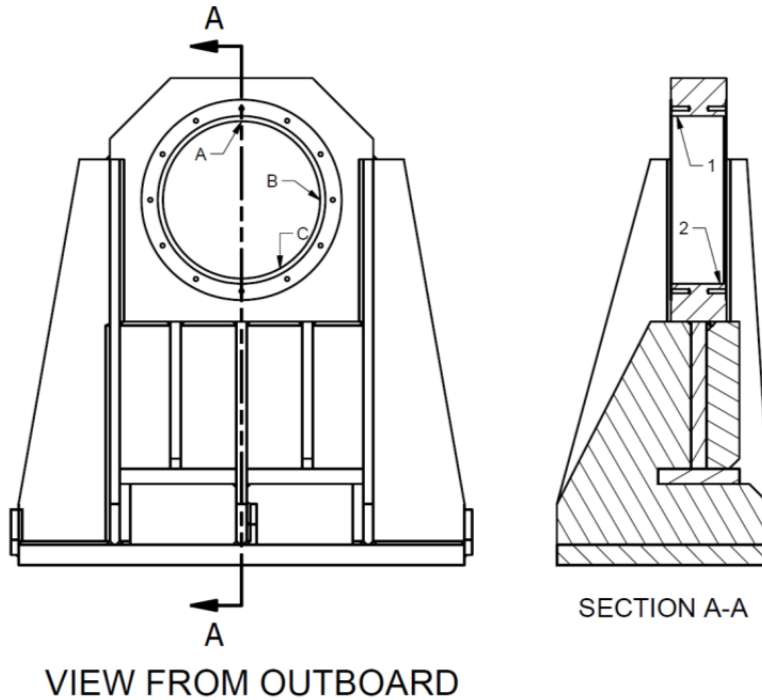
The nominal ID of the PB bore from the VLBA drawings is $16.5354 +.002/-.000$ inches. The PB ID measurements are shown in the following figure and table:

<u>Location</u>	<u>Measurement</u>
A1	16.5315
A2	16.5305
B1	16.5395
B2	16.5389
C2	16.5332

Allowable ID Range: 16.5354 – 16.5374 (= .002)

Measured ID Average: 16.5347 → .0007 undersized

Measured ID Range: .009 → Exceeds allowable tolerance range of .002 by .007 inches

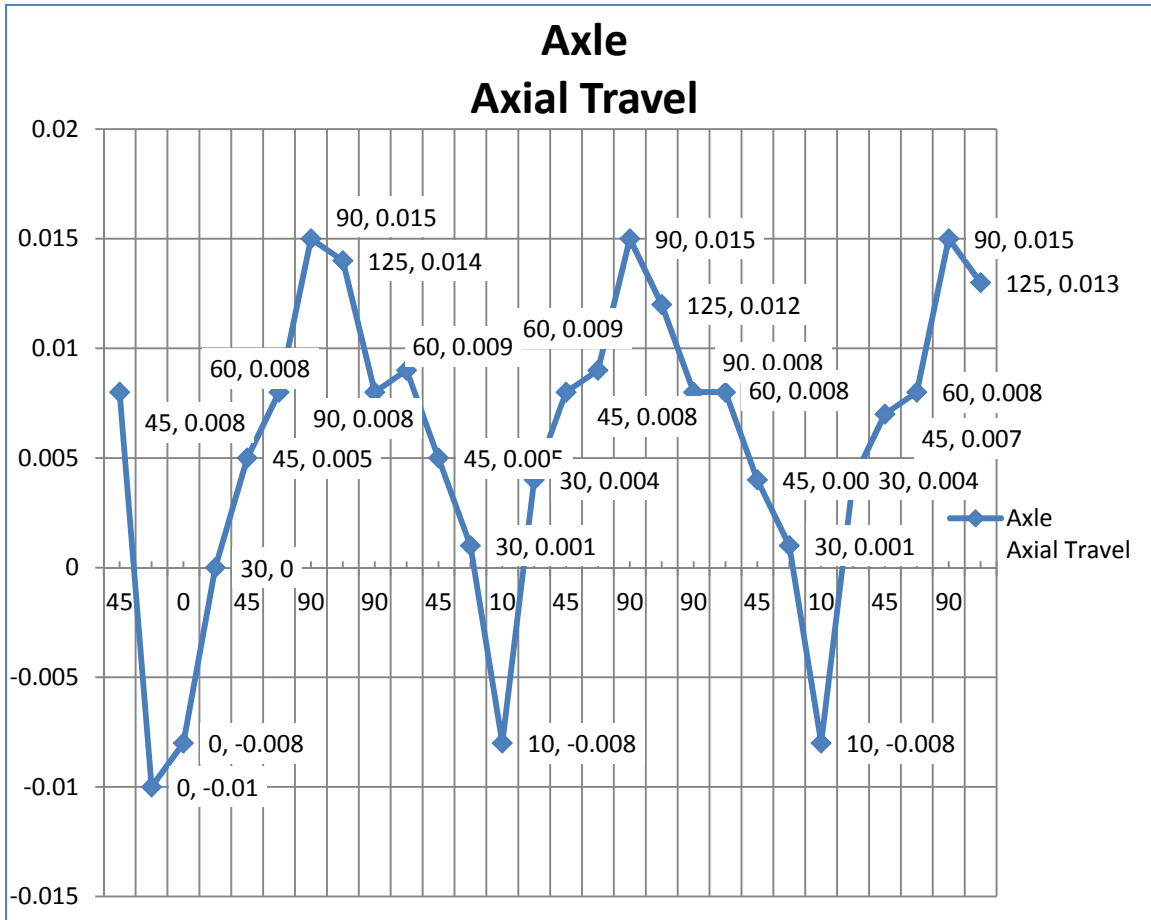
This morning we ran the elevation axis while watching a dial indicator that was configured to read axial motion between the pillow block and the axle. The following graph shows the results. Note that the axle is running smoothly with no sounds evident

The graph shows that there is a maximum of .007" of hysteresis occurring at 90 degrees, but that the repeatability when moving the axis in the same direction seems to be better with a maximum difference of about .004" at 30 degrees travelling up.
