NATIONAL RADIO ASTRONOMY OBSERVATORY
Socorro, New Mexico

VLBA Antenna Memo Series No.92

2016 - St Croix Mechanical Repair Trip Report

J. E. Thunborg
September 9, 2016

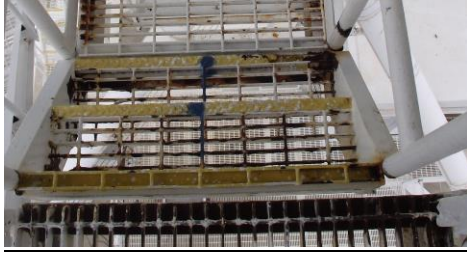
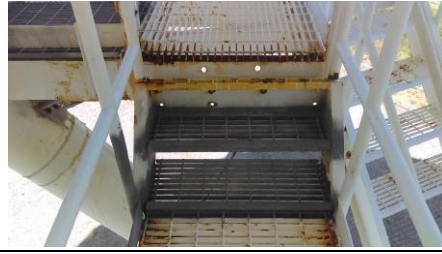
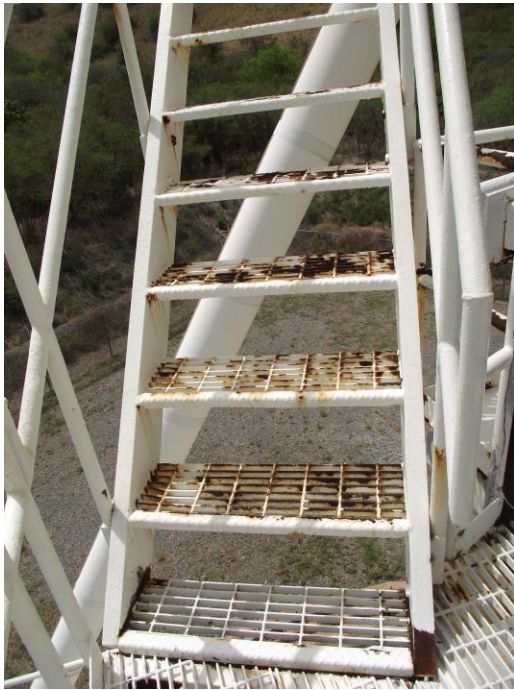
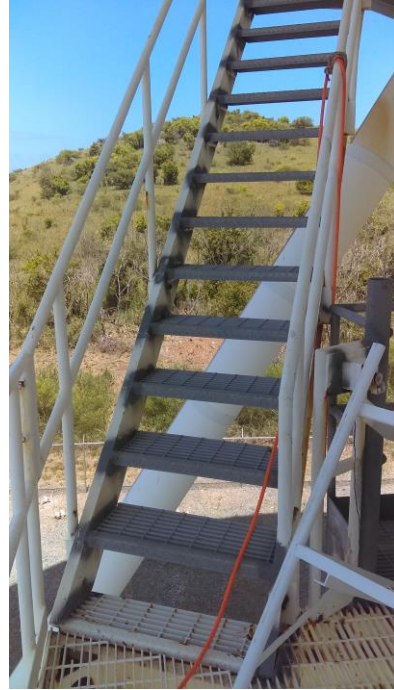
1. Tang How Brothers replaced 17 stair treads with noses and replaced an additional 13 stair noses.

Before and after photos of step replacement.

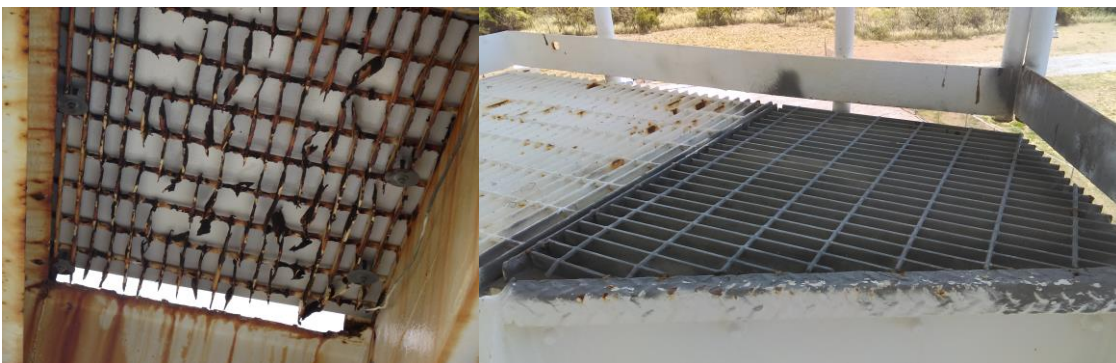
2. Tang How Brothers replaced several sections of severely corroded bar grating.

Before and after photos of replaced grating.

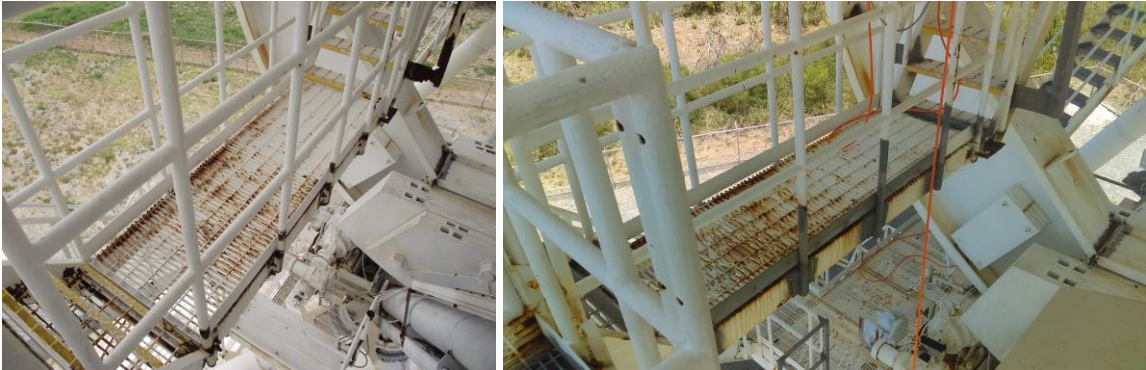
3. The swinging platform handrail pipes and stair supports were severely corroded. These were all replaced or repaired by Tang How Brothers.

Repair of stair supports and handrail sections.

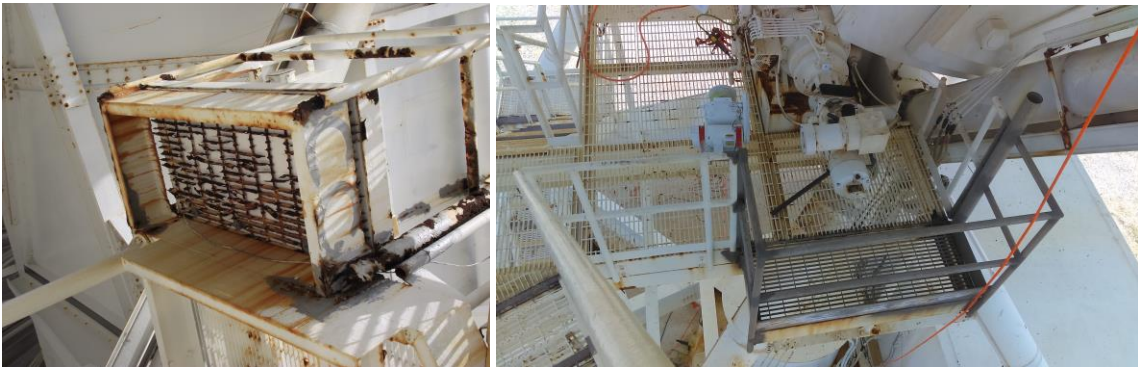
4. Tang How Brothers replaced the handrails and grating on the elevation platform extensions on both sides of the antenna.

Before and after photos of elevation platform extensions.

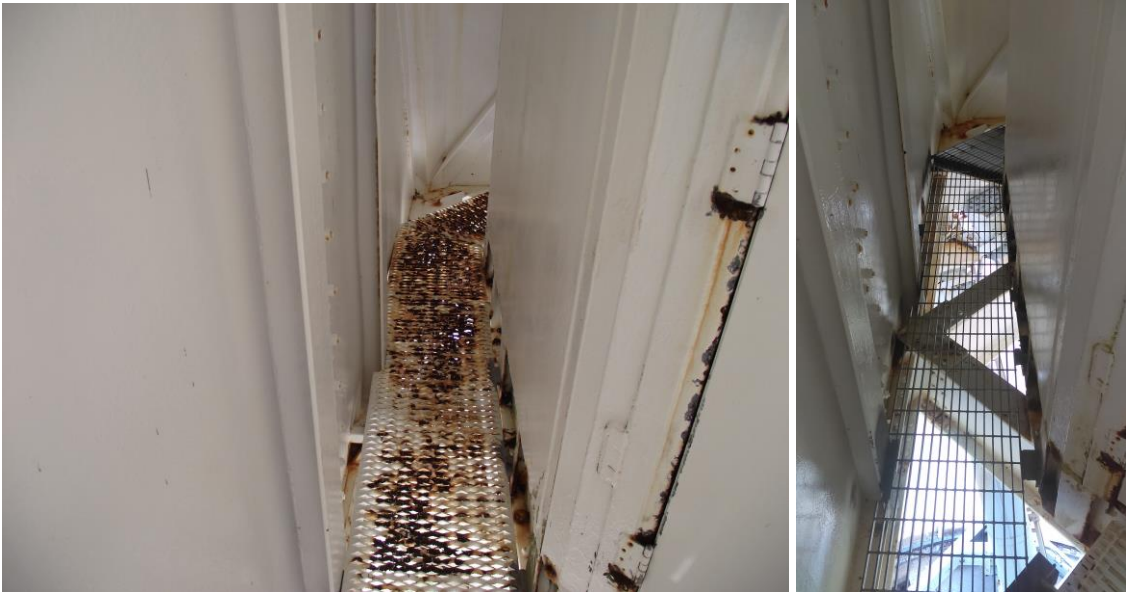
5. Tang How Brothers replaced the lightweight grating around vertex house.

Before and after photos of vertex house grating.

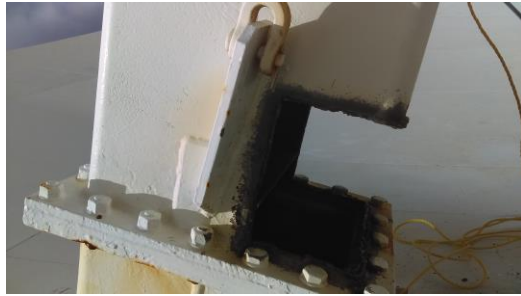
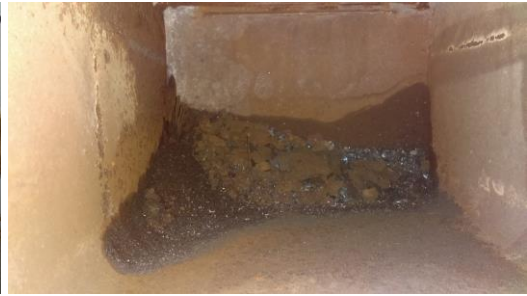
The extent of the corrosion on the quad legs could not be defined until large holes were cut out so they could be inspected from the inside. After cutting these holes it was evident that most of the corrosion was associated with debris that accumulates in the corners and on the quad leg flanges. This debris traps moisture which greatly accelerates the corrosion. Holes were cut in all of the quad legs and the debris was vacuumed out.

Quad leg with corroded section removed. Accumulated debris inside Quad leg.

On a tiger team visit in April 2005, the corroded quad legs were repaired by welding steel panels over the corroded areas. This repair did not address the problem with the pockets of trapped debris. Another problem with this type of repair was that moisture was able to get in between the quad leg and patch causing accelerated corrosion of the patch. During the recently completed visit, we completely removed the corroded sections and then welded in thicker galvanized steel pieces. This type of repair takes more time but should result in a longer lasting patch. The new patches were fabricated with drain holes at the bottoms to keep water and debris from accumulating.

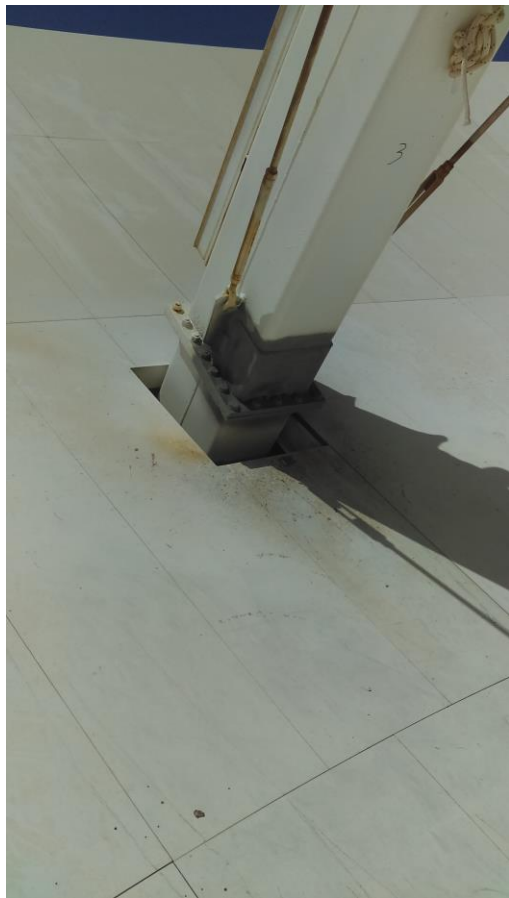
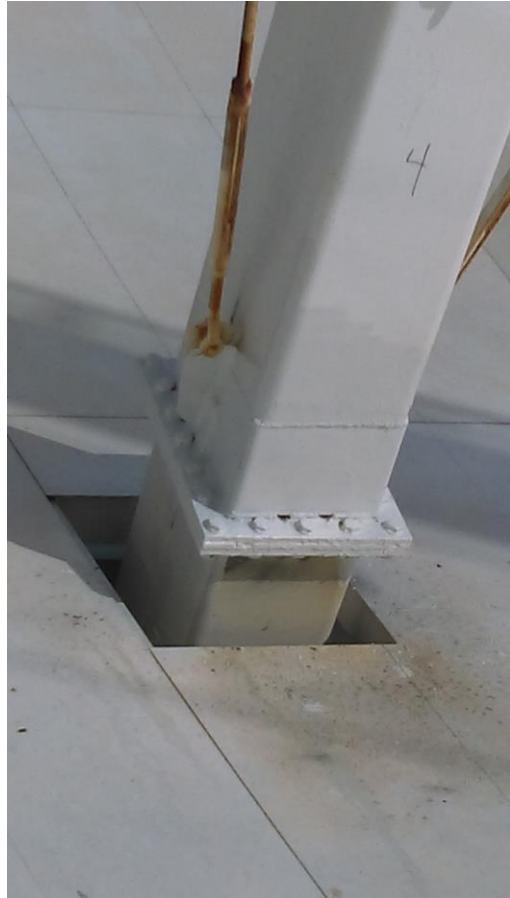
Repaired quad leg with primer and then with epoxy topcoat.

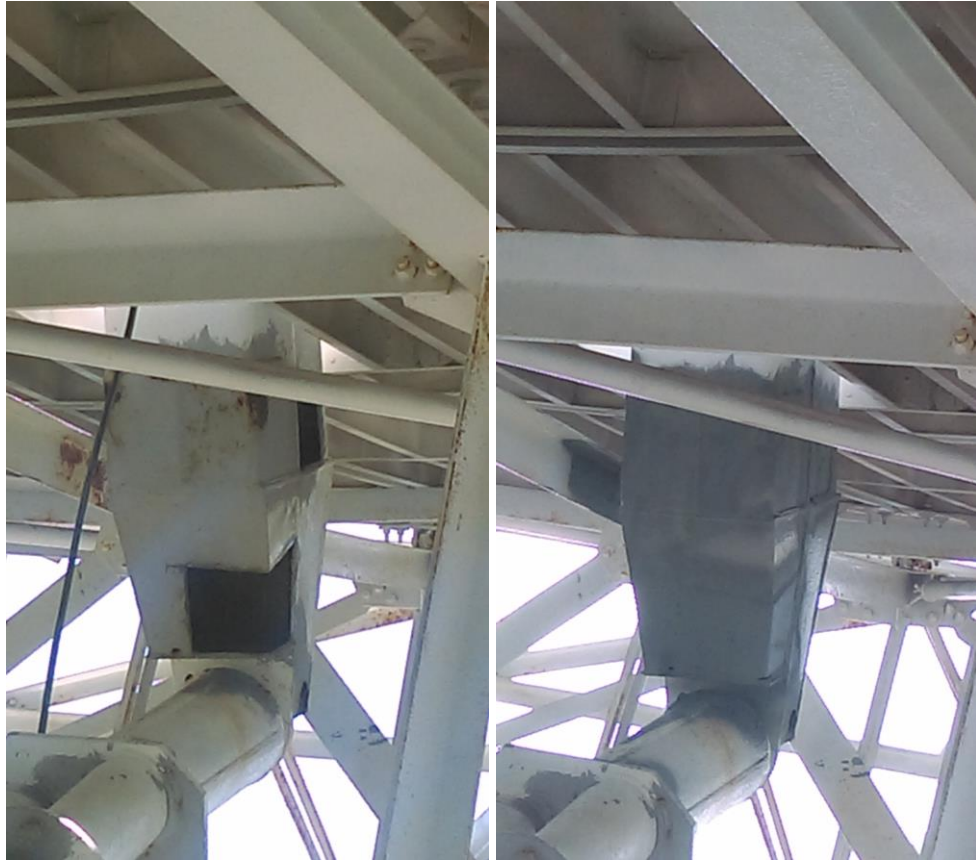
Smaller quad leg patches below the dish.

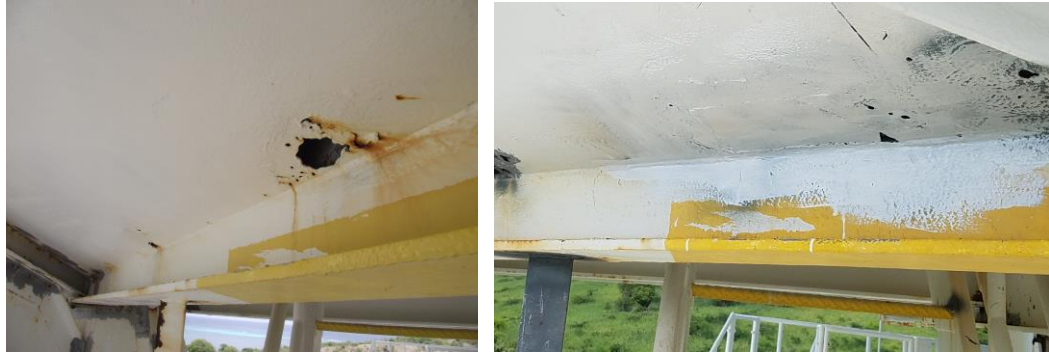
The tank sections of the antennas have holes corroded through them in all the corners where water gets trapped. We did not have sufficient time on location to repair all of the holes in the tank sections but we did repair a few of these corroded sections by cutting out and replacing pieces of steel. These patches will be evaluated over the next few years to determine how they hold up to the corrosive environment. The corroded holes on the tank sections are not yet large enough to pose a risk to the structure. What we call the tank sections of the antenna are actually sections of the structure containing shear panels used to minimize the deflection of the dish when it is tipped. The shear panels will still perform well in spite of the holes caused by corrosion. However, the holes should be repainted regularly so that they do not continue to grow.

Repaired corroded hole in tank section.

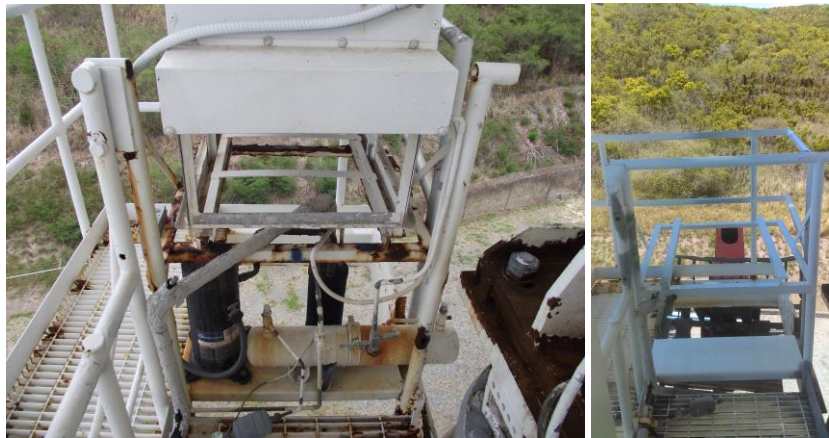
The HVAC condenser platform was replaced by NRAO personnel instead of a contractor because of the need for a certified HVAC technician to evacuate the Freon before the condenser could be removed. The corroded condenser platform was removed and replaced with a new one.

Replaced HVAC platform.
