NATIONAL RADIO ASTRONOMY OBSERVATORY

VLBA Antenna Memo Series No.94

**St. Croix VLBA Antenna Structural Repair, Surface Preparation and Re-Coating**

R. J. Taylor October 2020

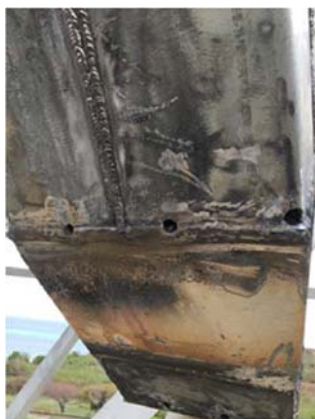
*Figure 3: Repaired Quad Leg with Weep Holes*

On a previous maintenance visit (Thunborg, St. Croix VLBA Antenna Painting and Surface Preparation Requirements, 2007), NRAO staff cut away the lower section of the tube and welded ¼” galvanized steel plate in its place. During this maintenance visit, Tang How Brothers performed similar repairs on quad leg “A”. However the thickness of the replacement plate was not recorded. Weep holes were added to allow water to drain from the interior cavity of the quad leg.

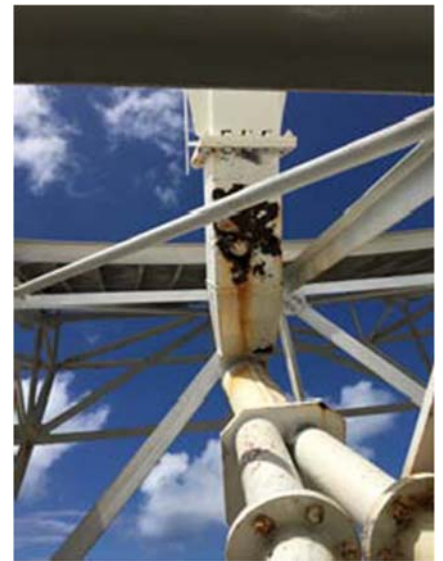
The quad legs are the hollow square tubes that support the subreflector and Focus Rotation Mount (FRM) assembly. The quad legs are made of 12 gauge (0.109”) sheet steel that are welded to ½ steel plates at the lower connections. Debris from inside the steel tube collects at the connection between the steel plate and the tube and promotes corrosion.

*Figure 2: Quad Leg Connection to Support Structure*

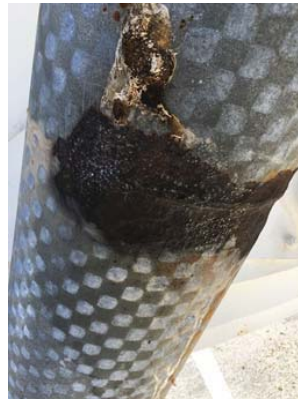
The cable trays and their support brackets suffered corrosion to the point of failure. The corrosion at the support tube, Figure 4, was initiated because the cable tray was welded onto the support tube which compromised the galvanized coating. Repair work involved cleaning the corrosion, welding a steel cap over the corroded area and welding the new bracket onto the cap. Figure 5 shows the welded cap and the new aluminum cable tray.

Figure 4: Typical Corrosion at Bracket Connection

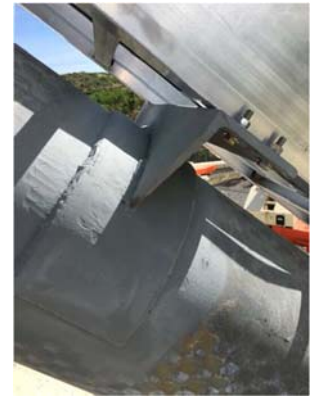
Figure 5: Completed Cable Tray Connection Repair with Cable Tray Installed

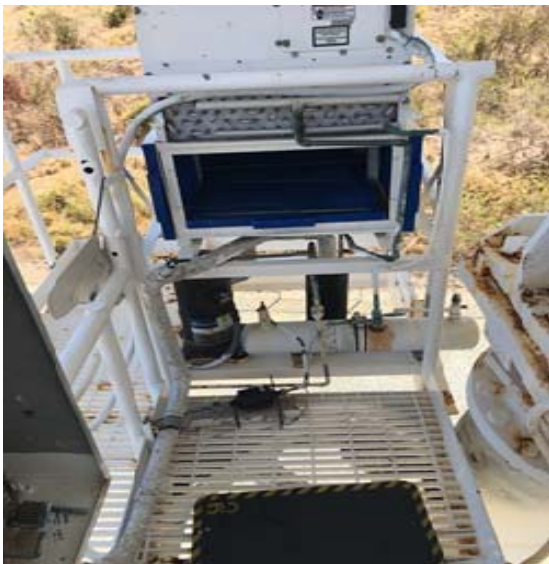
Figure 6: Condenser Platform Pre-Replacement

The condenser platform and its points of connection to the antenna was in a highly corroded state. Engineering Services determined that its replacement was preferable to attempting repairs to the platform. Tang How Brothers fabricated and installed a replacement.

Concurrent with the fabrication work, the existing platform was removed and new connection points were installed.

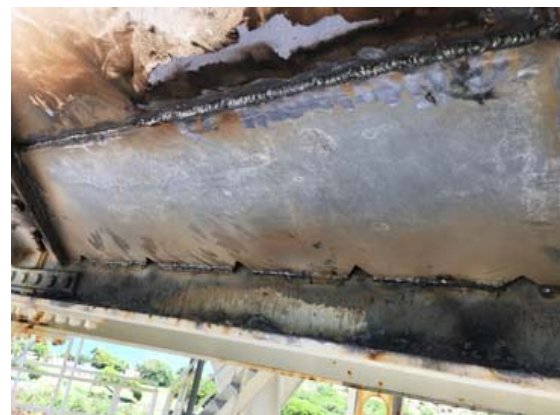
The shear panels at the vertex room level (also referred to as tank sections) of the antennas have holes corroded through them in all the corners where water gets trapped. Repairs to these panels were begun during the 2016 maintenance visit (Thunborg, St. Croix VLBA Antenna Painting and Surface Preparation Requirements, 2007).

Figure 7: Shear Plate with Weep Holes

Tang How Brothers continued this repair effort. Corroded sections of the shear panels were cut away and patched and covered by  $\frac{1}{4}$  inch thick galvanized steel patches, which were welded in place. Weep holes are cut out at the lower

portions of the patches to eliminate water being trapped in the corners of the structure.

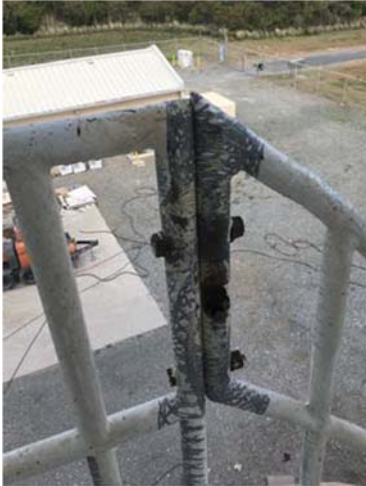
Figure 9: Typical Hand Rail Corrosion

Items 5 and 6 of Table 1: Structural Repair Tasks remain incomplete. Item 5 may become a safety hazard if left unchecked. However, Engineering Services has deemed that the hand rails do not pose a safety hazard at this time. Item 5 will be added is planned as a task for the next tiger team visit to the St. Croix facility. Engineering Services considers item 6 to be beneficial to the longevity of the structure. The weep holes will be added as supplemental task for future visits, to be completed as time allows.

As mentioned paragraph 4.5 above, Engineering Services recommends that remaining structural damage be addressed during future tiger team visits. Additional time will be allotted to upcoming tiger team visits to facilitate these additional tasks. There is no need to schedule a dedicated visit to complete repairs. In the meantime, site techs will be tasked with maintaining the coating systems to limit corrosion as future damage occurs.

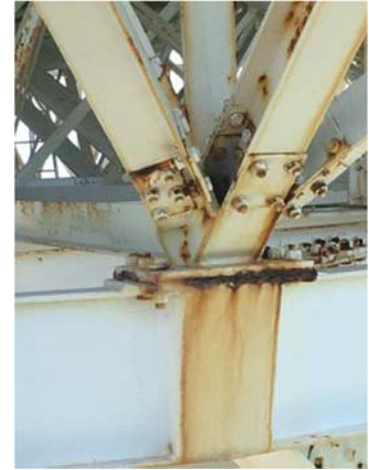
Figure 8: Structural Connection that Ponds Water

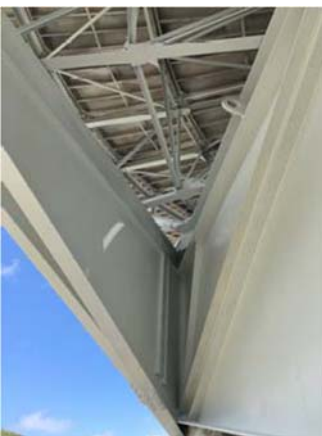
Figure 10: Antenna Support Structure with Top Coat

The first step in the process was to use a UHP jetting process that employs 40,000 psi water jets to strip corroded areas down to bare metal and to remove the old top coat from some areas of the antenna. Most of the antenna area was simply washed as the existing coating was in condition that allowed the new coating to be applied directly.

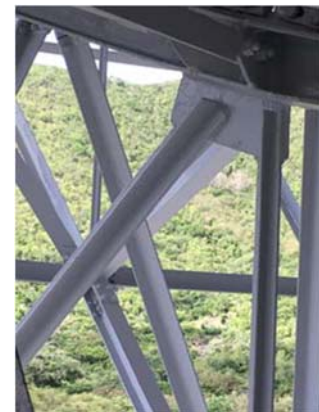
Figure 11: Antenna Support Structure with Top Coat

The stripe coat serves as an additional layer of protection in these high risk areas. The stripe coat was followed by a prime coat and top coat, covering the antenna structure in its entirety.
