National Radio Astronomy Observatory
Socorro, NM

VLBA Antenna Memo Series #27

Fort Davis Maintenance Visit
August 14th through 19th, 2000
Trip Report

Jim Ruff
8/22/00

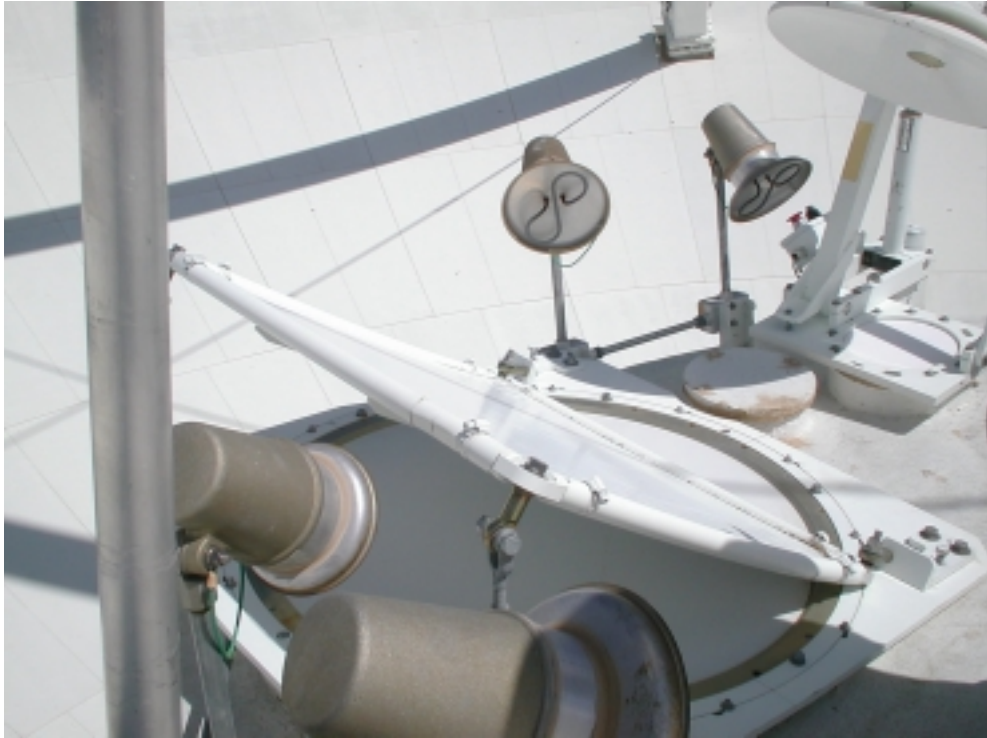
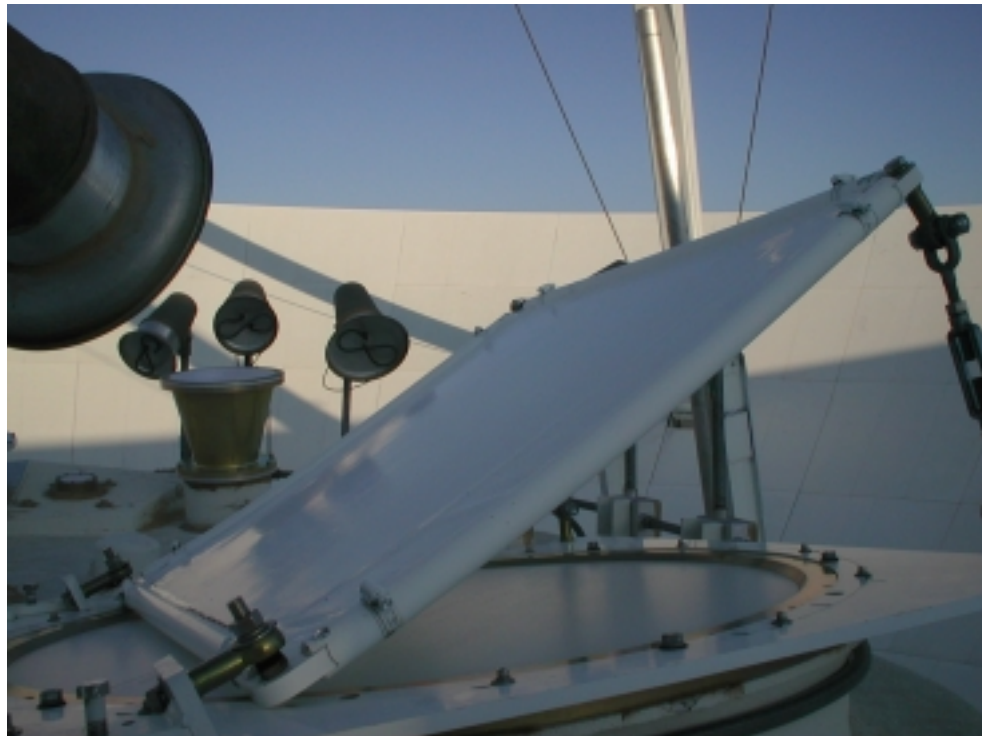
The dichroic panel is delaminated in the corners and sagging. It appears a feed heater partially melted the top tube. (Figures 1 & 2). This dichroic should be replaced when a new plate becomes available.

Figure 1: Dichroic Reflector

Figure 2: Dichroic Reflector

- FRM 2-year PM done
- FRM INA bearing check done
- Install apex guardrail done
- Subreflector
- Check for peeling, delamination Done
- Check spider bolts, backside,etc Done
- Check Donut Bolts Done
- Feeds & Dichroic
- Inspect feeds,mounts,htrs,etc done
- Repair dichroic reflector, check panel panel 40% delaminated. Top tube damaged.

- V. The Dichroic needs to be replaced; Jim Ruff is aware of the wear problem.
- VI. The upper room of the Vertex room, inside the feed cone, hatch has some styrofoam insulation on the door sill that is loose and should be repaired or replaced; the Site Techs are aware of the problem. Some large feedcone bolts have some old evidence of corrosion, snd the Site Techs assure me that they have been aware of it and they are monitoring it; there has been no change since they arrived at the site. There is no other evidence of leakage at this time.

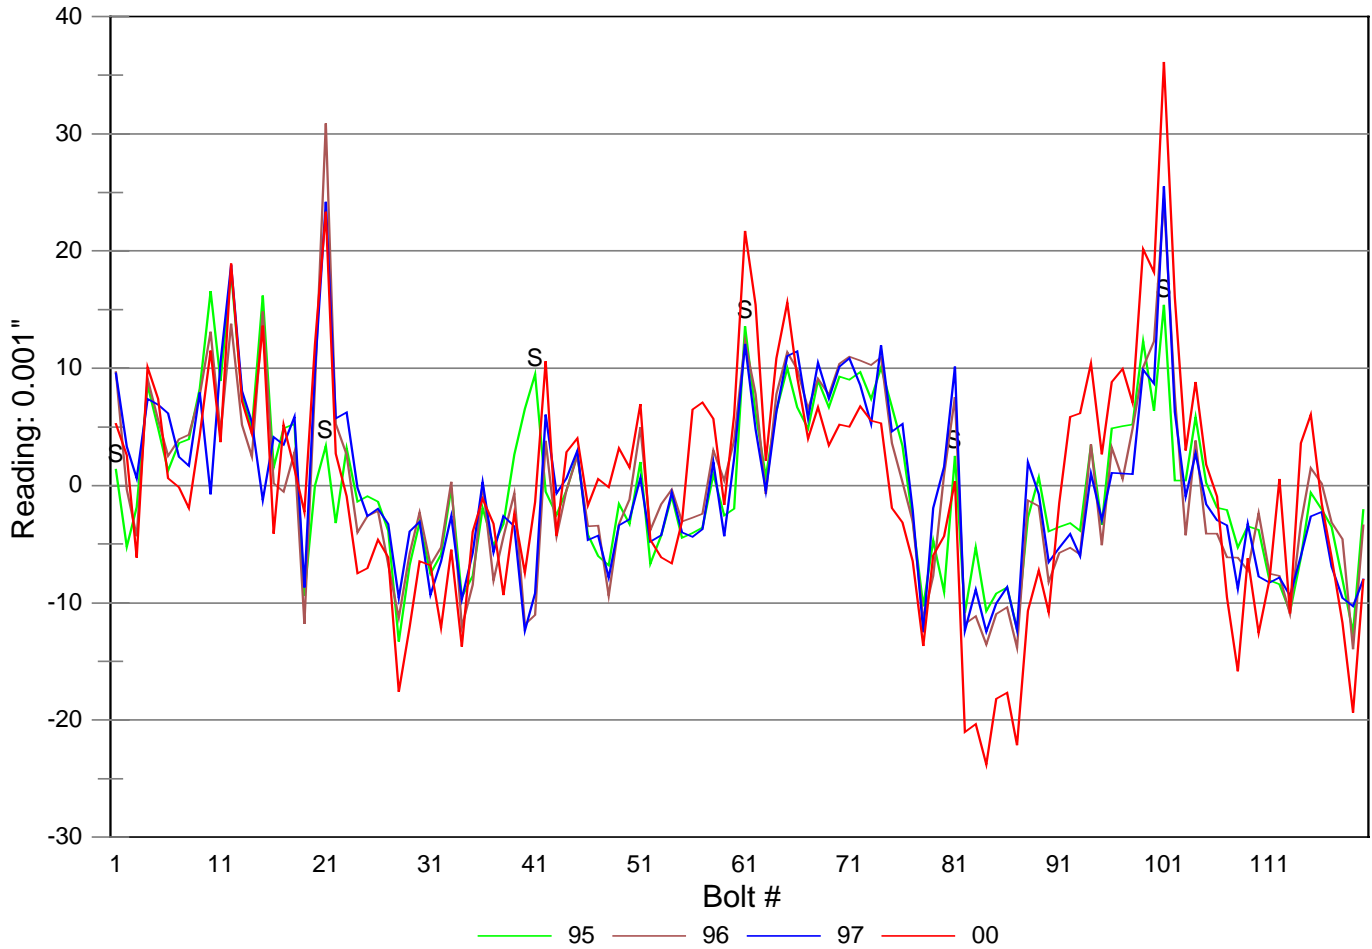
FD Azimuth Rail Elevations

The azimuth rail and grout were in good condition. Elevation readings appear to be stable. The course focus on the Wild level was not working properly and may have caused some error in the readings.

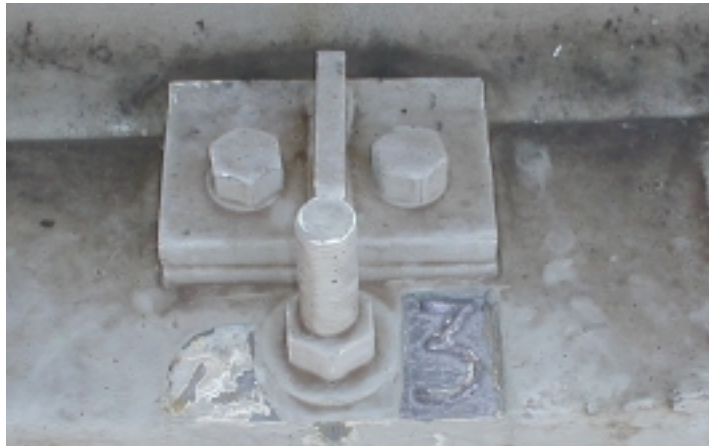
An original RSi bolt ID was located. It is a numeral 3 welded on the rail support plate.

Figure 3: Az Bolt ID

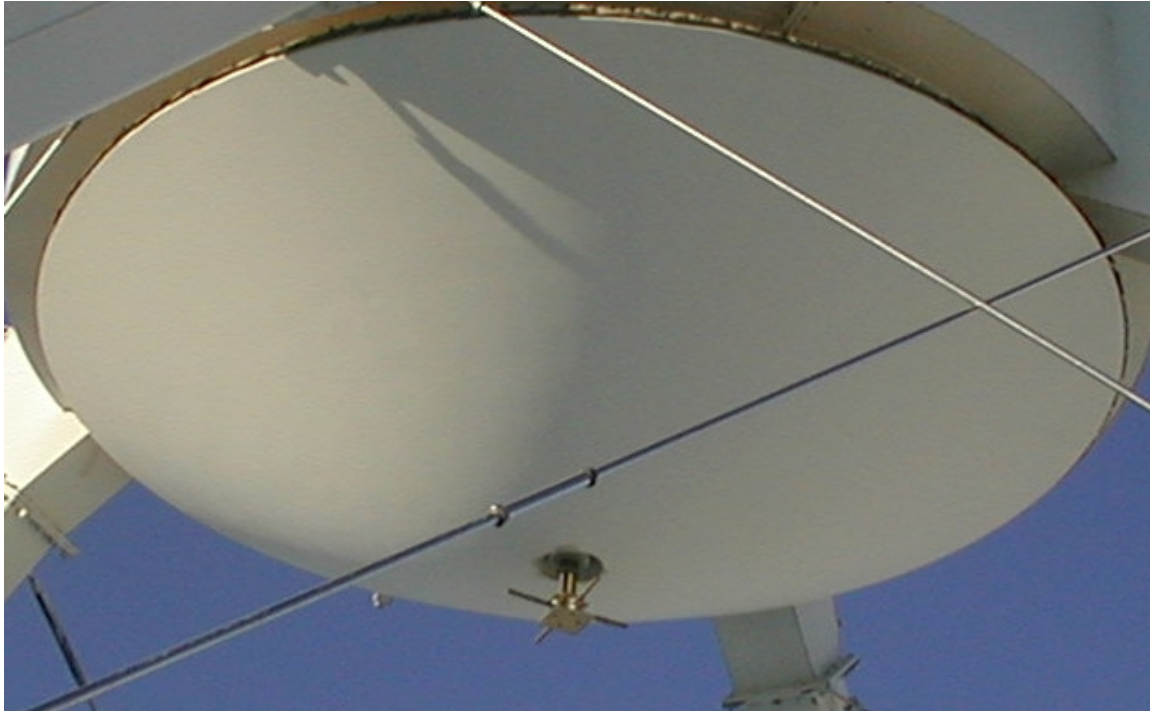
The subreflector appears to be in excellent condition.

Figure 4: FD Subreflector

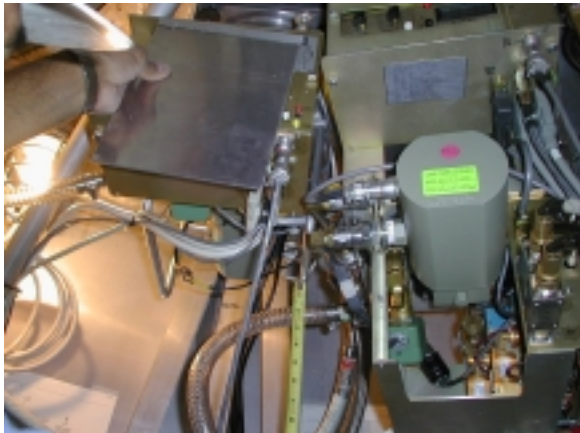
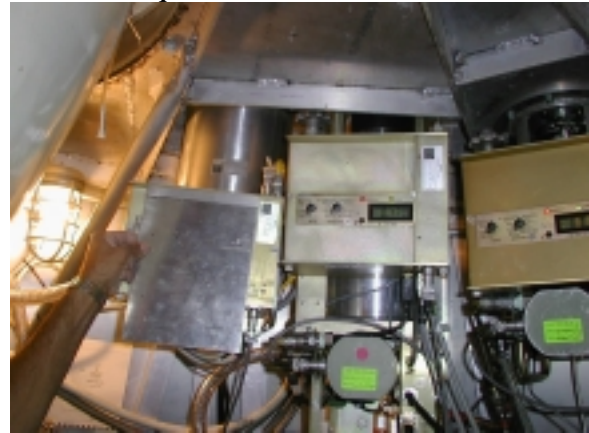
The 3mm receiver was checked for clearance. Clearance is adequate.

Figure 5: 3 mm receiver

Figure 6: 3 mm receiver

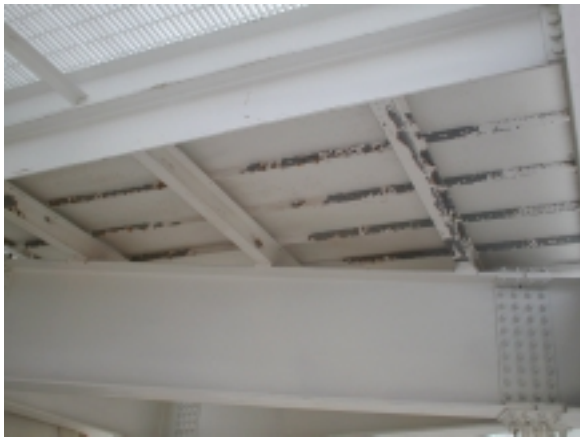
About 50% of the paint under the pedestal room was flaking off the galvanized structure. We scraped most of the loose paint off. I recommend that the site techs borrow a water blaster from the VLA and use it to remove the rest of the paint from this area. (Figure 7)

Figure 7: Ped room underside, before scraping

- VIII. The Antenna paint is in remarkable condition considering it has never been painted, however the lower underside of the structure seems to have accelerated its coating detereioration, and paint is flaking off at a seemingly greater rate. Jim Ruff is aware of this.

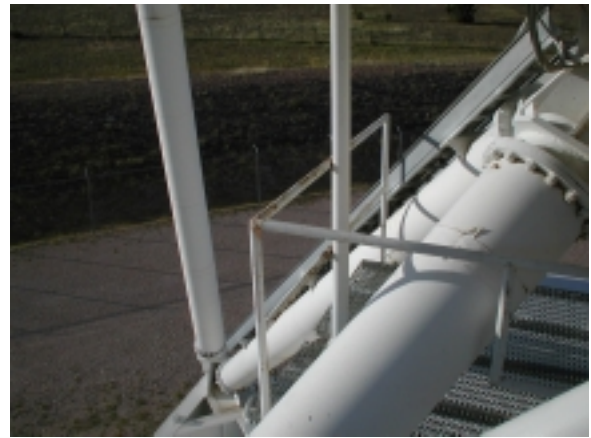
Figure 10: Mid-level handrail before painting

The mid-level handrail was repainted. (Figure 10)

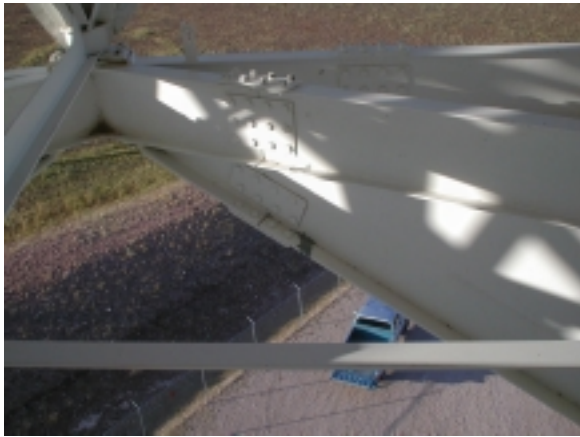
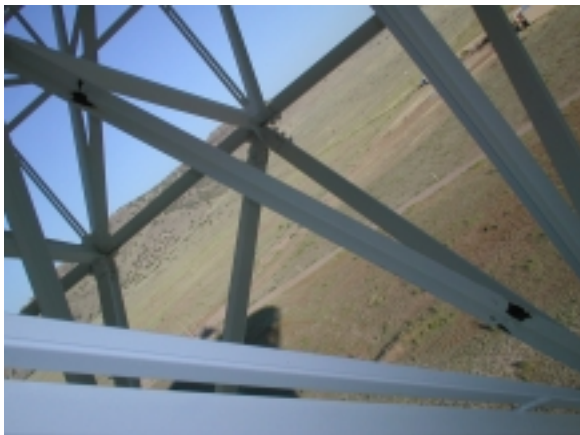
The paint on this antenna is in excellent condition. There is very little rust, and most failures are flaking of paint from galvanized metal. (Figures 8 & 9)

Figure 8: Paint failure

Figure 9: Paint failure

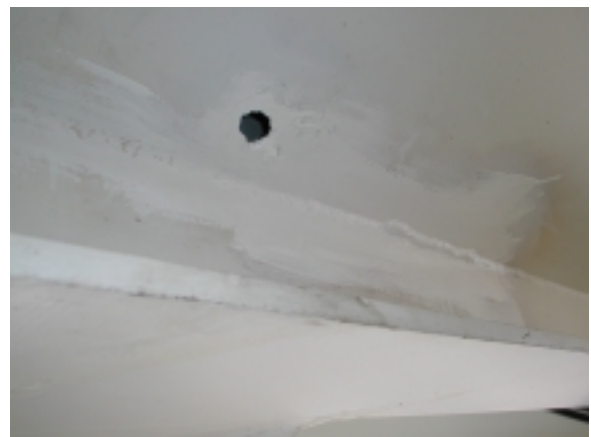
A structural crack was found over the EI encoder-side bearing and re-welded. (Figure 11)

Figure 11: Repaired weld over El bearing

Structural		
Install EL hard stops	Done	
Check ant structural bolts	Done	
Inspect ant structural welds	Done	Re-welded a crack above RH el bearing.
