**National Radio Astronomy Observatory**  
Socorro, NM

VLBA Antenna Memo Series #32

**Los Alamos Maintenance Visit**  
April 17<sup>th</sup> through 23<sup>rd</sup>, 2001  
Trip Report

Jim Ruff  
5/1/01

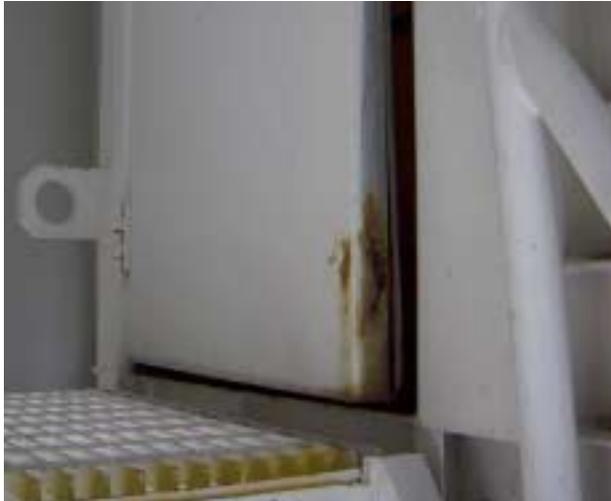
**Figure 1: Vertex house door**

The vertex house door is rusting. (Figure 1) This door should be replaced during the next tiger team visit.

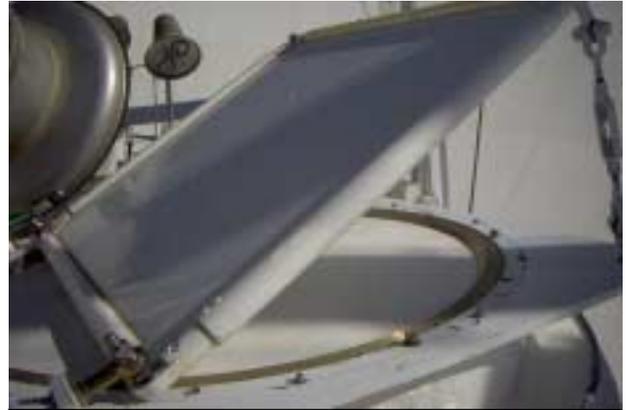
**Figure 2 : Dichroic Panel**

The dichroic panel is in good condition. (Figure 2)

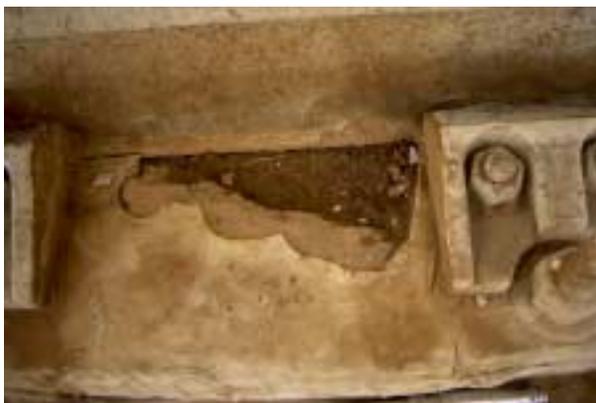
**Figure 3: Bad grout**

The azimuth rail grout is bad in several places. The areas that were previously patched with epoxy grout appear to be holding up well. More patching is called for. (Figures 3 through 6)

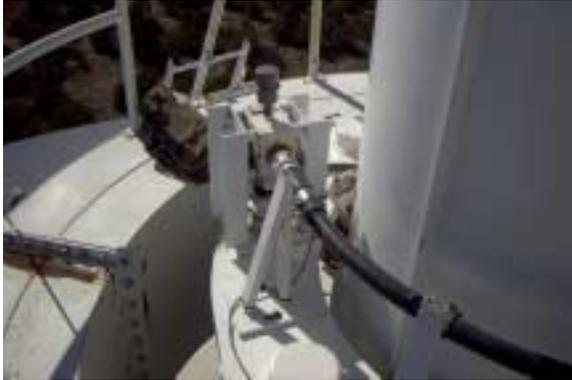
**Figure 7: Apex**

The paint on this antenna is in excellent condition. (Figures 7 through 10) We did some touch up painting around the mid-level handrails, pedestal structure, and the elevation bearing that was changed last January.

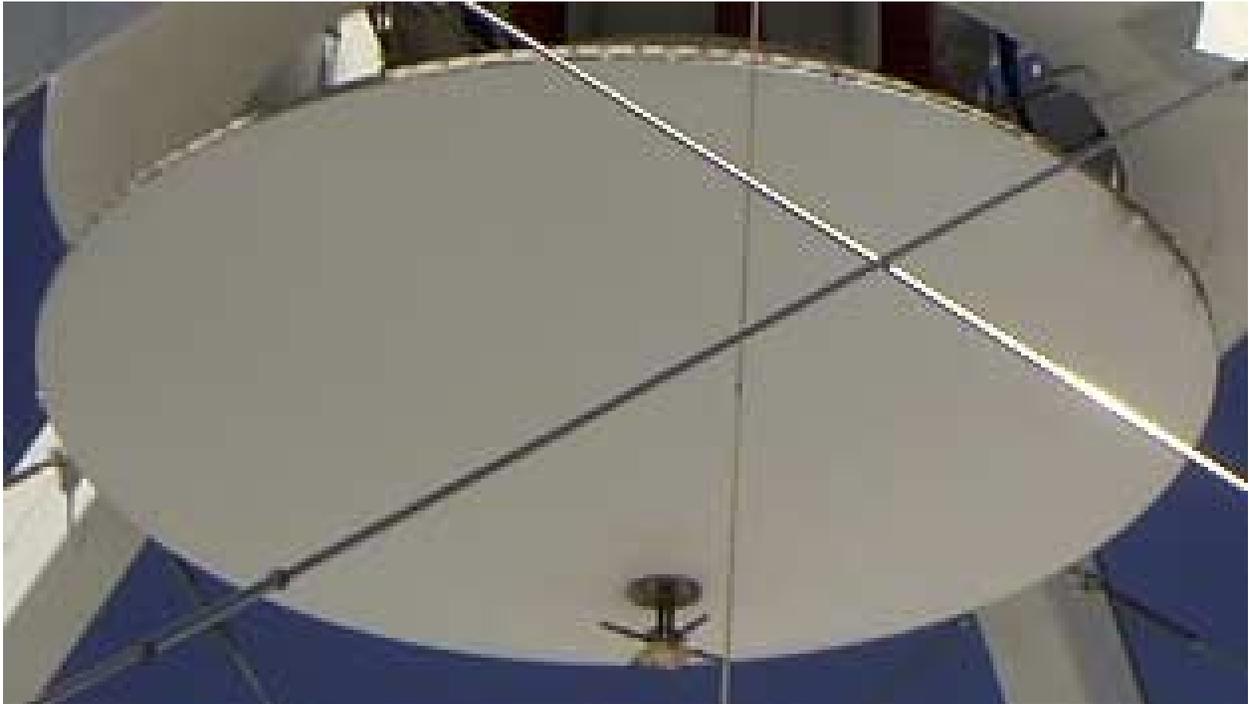
**Figure 11: Subreflector**

The subreflector is showing some small dark spots, but otherwise looks OK. (Figure 11)

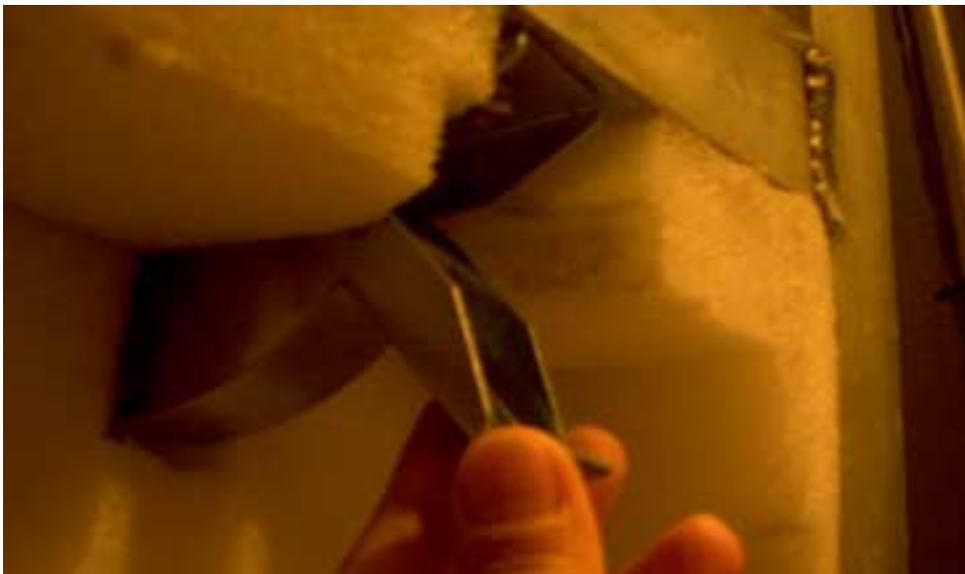
**Figure 12: New vertex room latch**

A modified Southco #9770-220-11 latch was tried out for the vertex room hatch. It worked well, so more have been ordered and we will begin replacing broken rubber latches with these. (Figure 12)
