VLBA Antenna Memo Series #41

Hancock Maintenance Visit
June 3rd through 10th, 2002

Jim Ruff
6/25/02

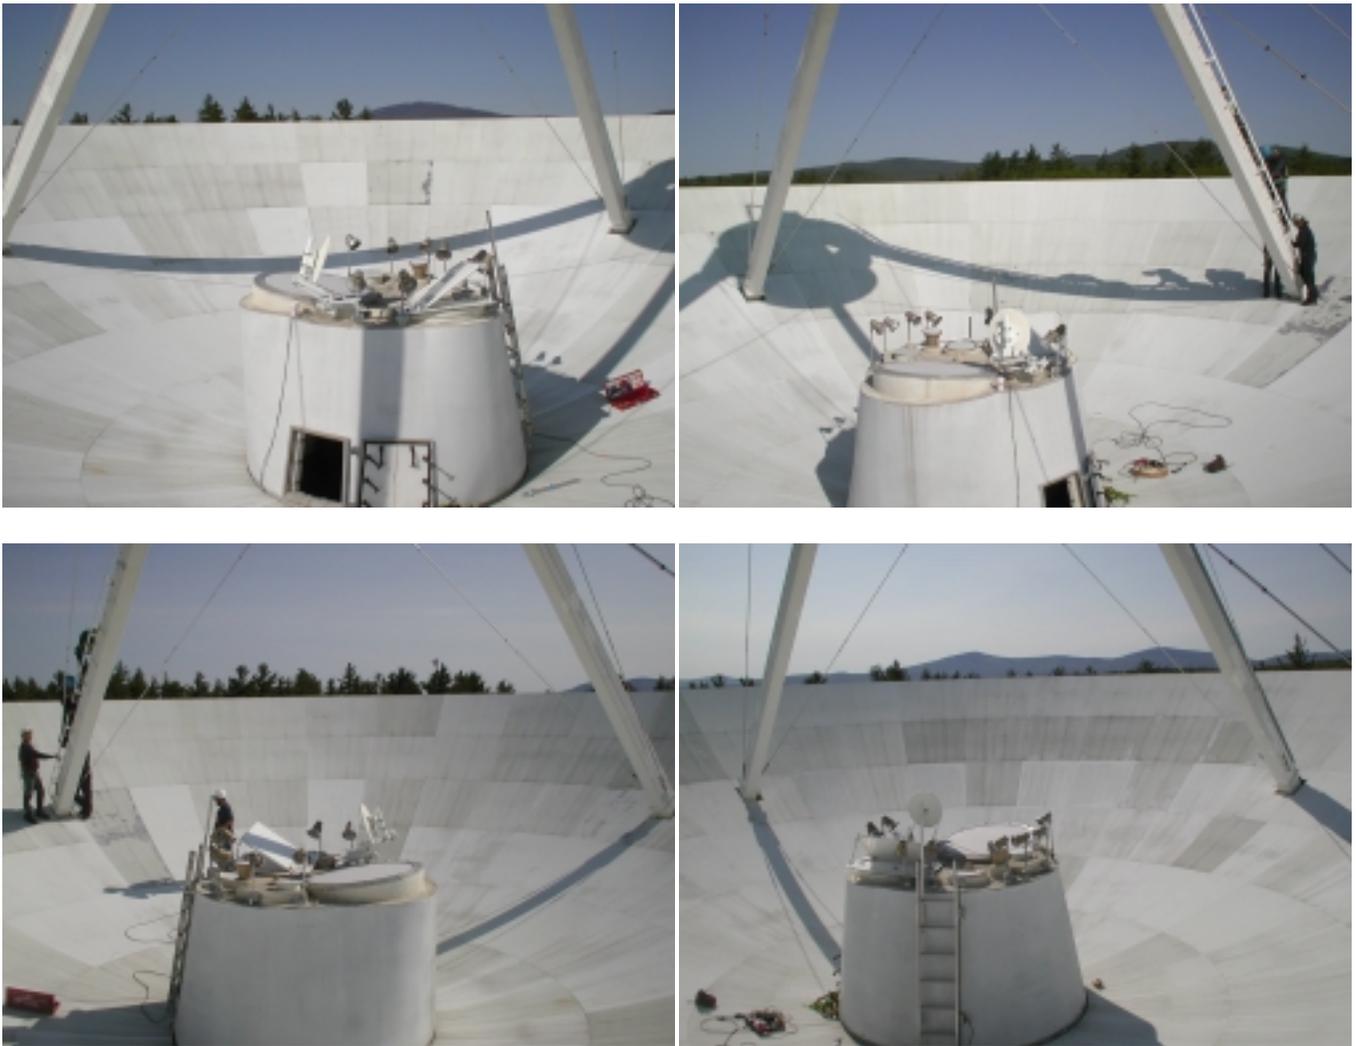
Antenna Surface Panels

Many of the panels on this antenna are losing their paint. The paint on these panels comes off down to bare metal with a shoe swipe. The panel next to the ladder had large bare spots due to extra traffic. The bare spots are slippery, so we swapped this panel with one from a less-traveled location. The next four photos show each quadrant of the dish. (These photos were taken before we swapped panels.)

16. Jim Ruff, Ramon Gutierrez, Mark Alfero, and Bob McGoldrick transposed two panels in the dish for safety reasons; the panel to the right of the quadraped leg with the ladder was replaced by the fifth panel in the same row while it was put in the latter's position. The aforementioned panel was missing much paint and it was slick.

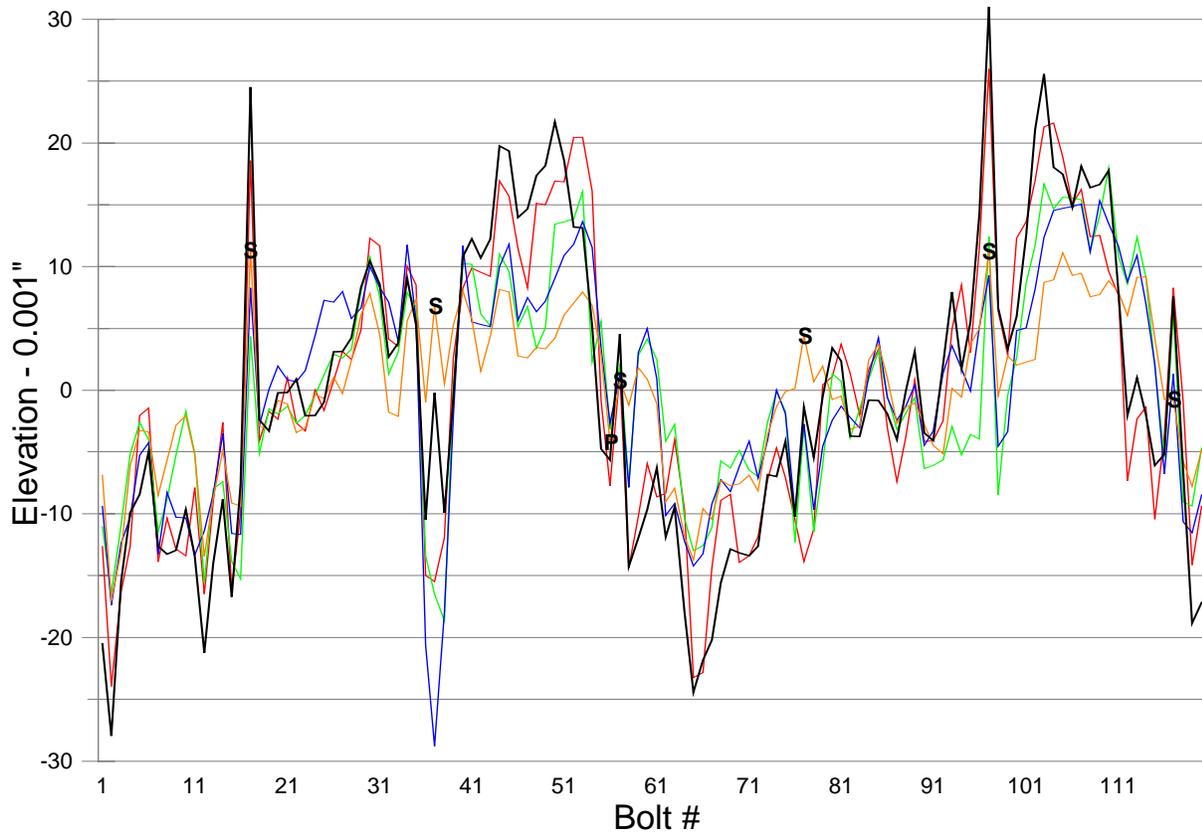
Hancock Az Rail Elevations

The azimuth rail grout and Vulkem are in fairly good condition. We removed Vulkem and inspected the epoxy grout at all splices. The grout looked fine.

The first order tilt amplitude is 0.018"

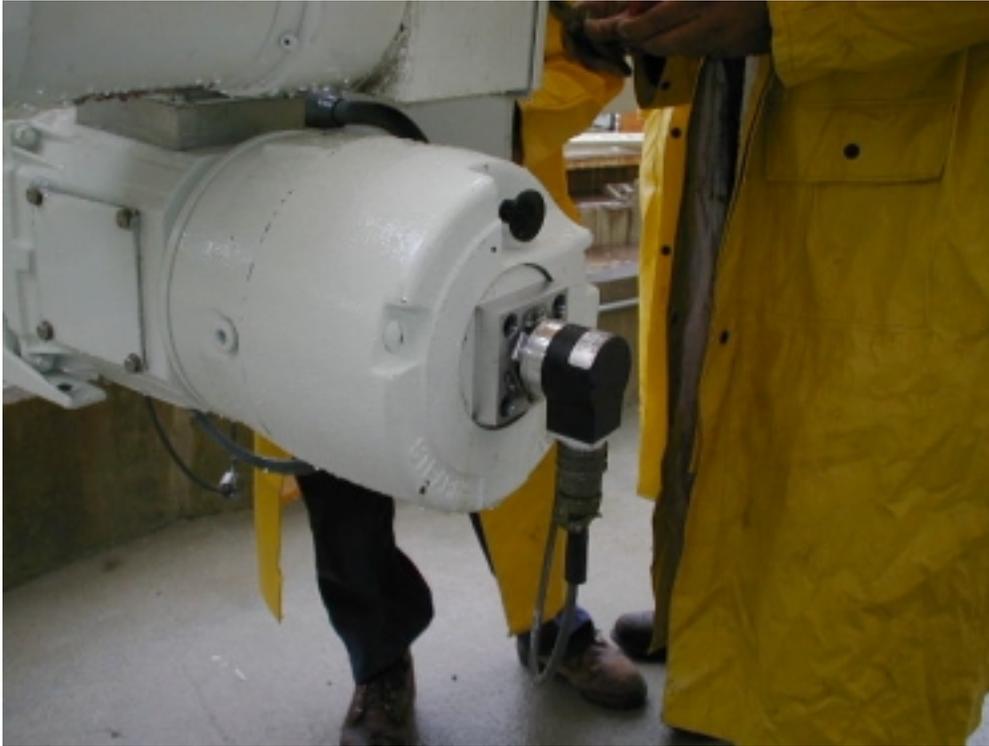
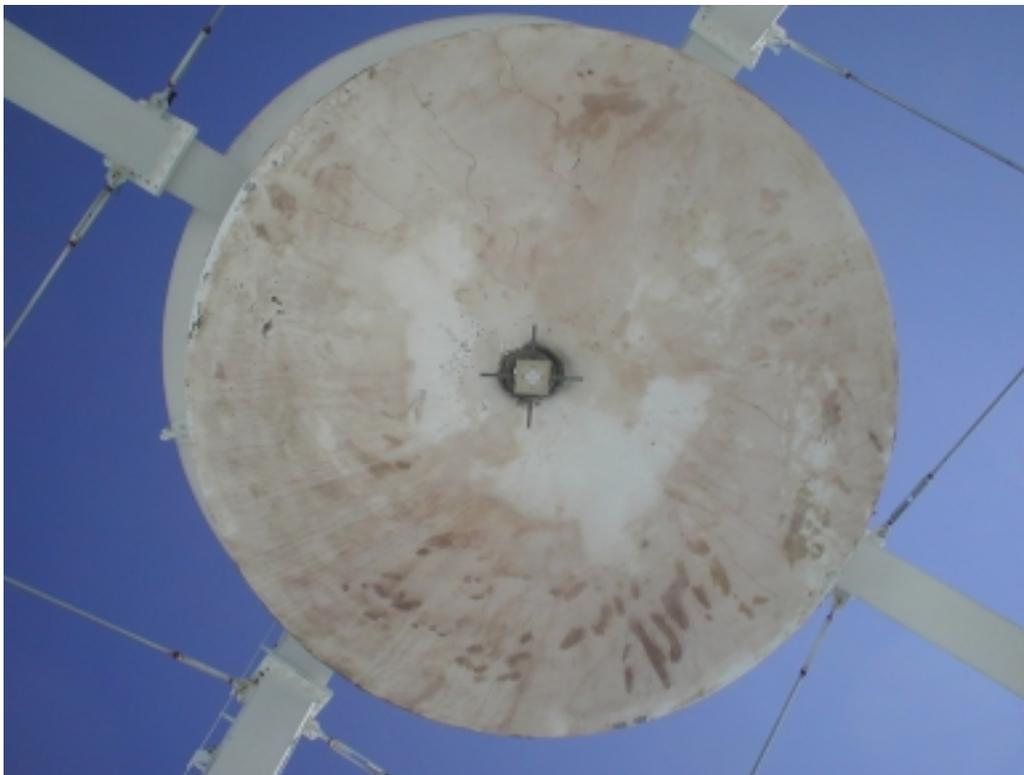
The subreflector is stained.

The paint is fairly good, but there are many areas where rust appears to be bleeding through. There are also some large areas where newer paint is peeling off of older paint.
