NATIONAL RADIO ASTRONOMY OBSERVATORY
Socorro, New Mexico

VLBA Antenna Memo Series No. 48

St. Croix Elevation Bearing Replacement - Trip Report

J. E. Thunborg
September 10, 2003

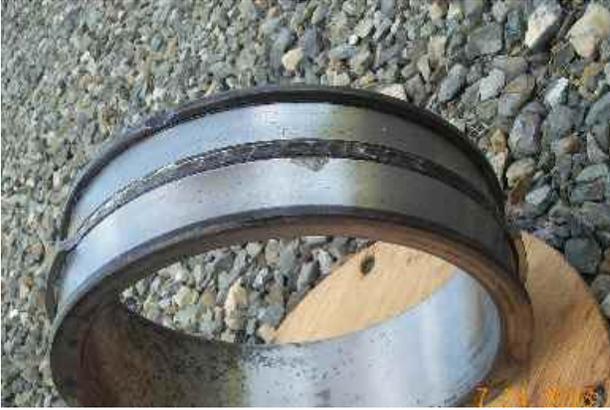
The original bearing's inner ring center guide flange was fractured. According to engineers at Torrington Bearing, this kind of fracture is due to excessive thrust load on the bearing.

One possible reason for the excessive thrust load is the way the bearing was initially installed. The slots on the bearing pillow block and the slots on the elevation platform both go in the same direction. This allows for misalignment

perpendicular to the axle. However it does not allow for misalignment along the axle. This means that great care must be used to position the bearing correctly on the axle to prevent thrust loads that could develop between the axle and the elevation bearing pillow block. During disassembly we found that the original bearing was positioned such that these thrust loads were present.

The thrust loads induced during assembly would have been alleviated if the slots on the pillow block went in a direction perpendicular to the slots in the elevation platform. A careful check of the AUI VLBA drawings showed that both the platform and the bearing pillow block were fabricated according to the drawings but the slots shown on the drawings were specified in the same direction. Since all of the VLBA antennas were built using these drawings, it is reasonable to believe that they all have the same problem. This is probably why the Las Alamos elevation bearing failed.

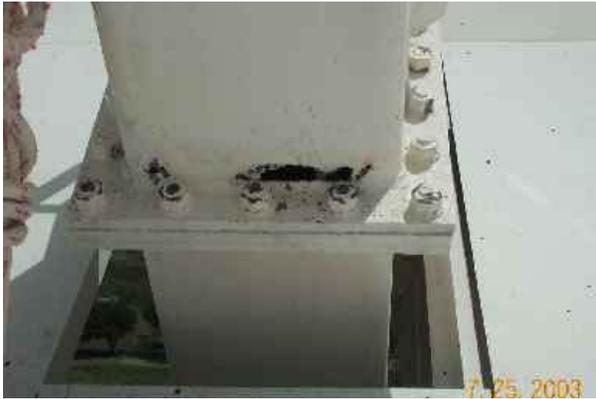
This picture shows a hole that has corroded all the way through the quad leg of the antenna. The steel on this side of the quad leg has completely failed due to this corrosion. The reason that the corrosion is so bad on this part of the quad leg is that water runs down the inside of the quad leg and pools on an internal lip in the quad leg. This quad leg should be repaired during the next maintenance visit.

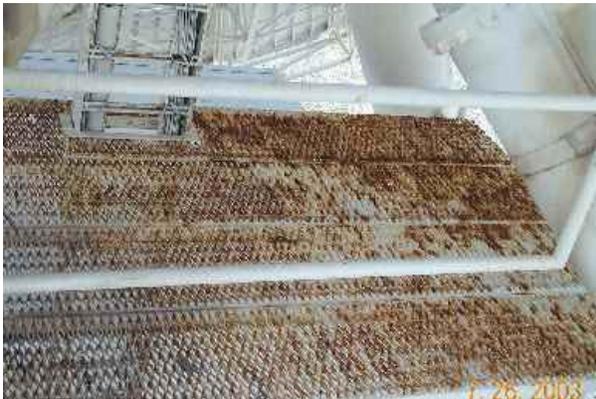
The walkway grating under the elevation platform has corroded to the point where it needs to be replaced during the next maintenance visit. The metal has corroded away so much that I was able to easily knock holes in the grating with a small hammer. The cable tray should also be replaced during the maintenance trip.

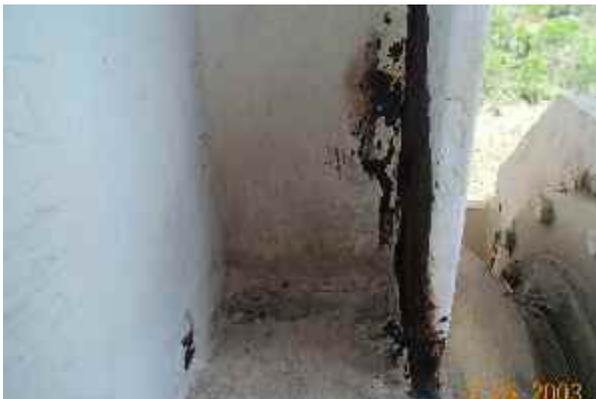
The major structural elements of the antenna were not severely corroded except for one of the beams that connect the dish to the elevation axle. Approximately 20% of the flange thickness has corroded away. This beam is in a pocket on the up side of the antenna where water collects. It will be very hard to drill a drain hole in this pocket. Therefore, the site techs should “Chem Prime” and paint these areas carefully.
