National Radio Astronomy Observatory
Socorro, New Mexico

VLBA Antenna Memo #55

Fort Davis, Texas VLBA Maintenance Visit June 10th thru 18th 2004.

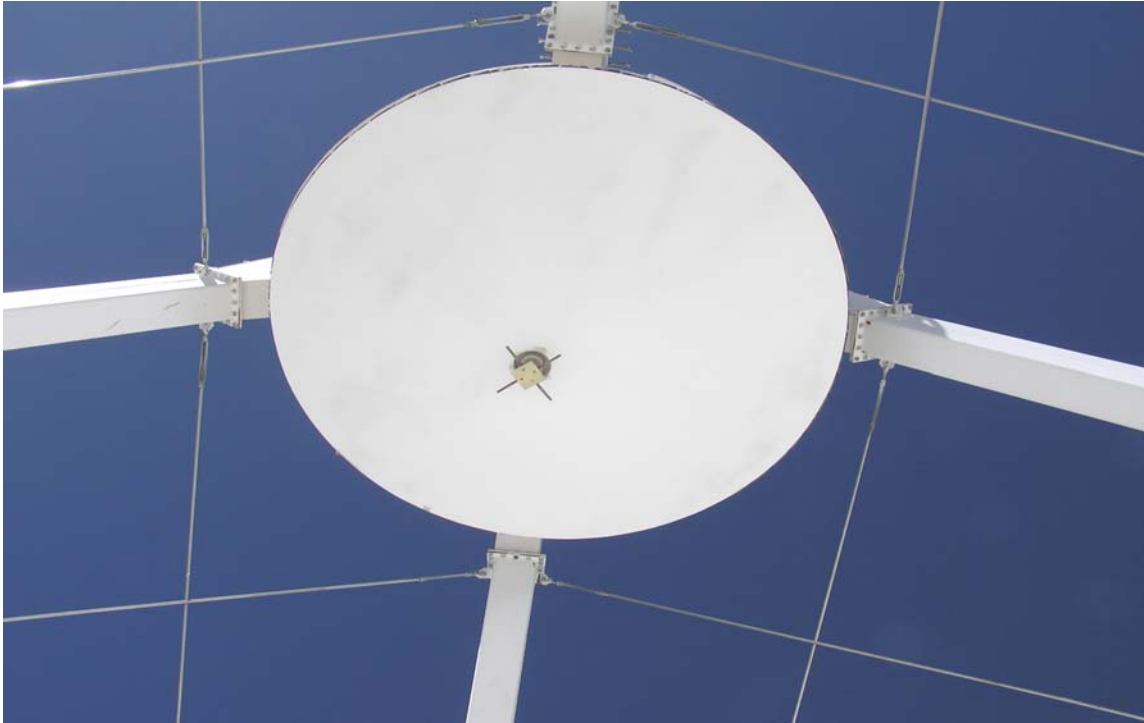
Subreflector is in good condition. A new ladder and fall arrest were installed. Site Techs were trained on using the new fall arrest.

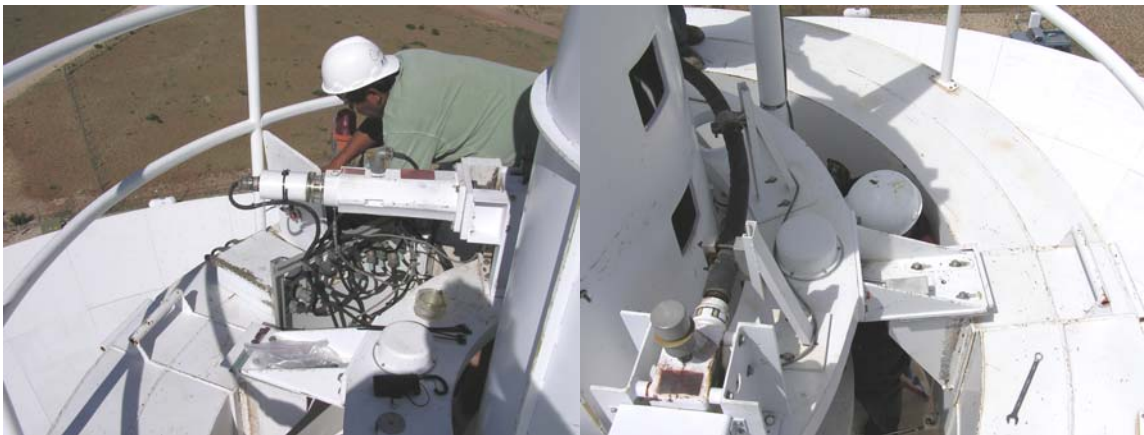
FRM was given a thorough inspection. A focus flex shaft was replaced and the new encoder coupling modification was installed. Focus motion analysis faults were occurring. The problem was found to an unbalanced focus motor amp and water inside the encoder. This was corrected.

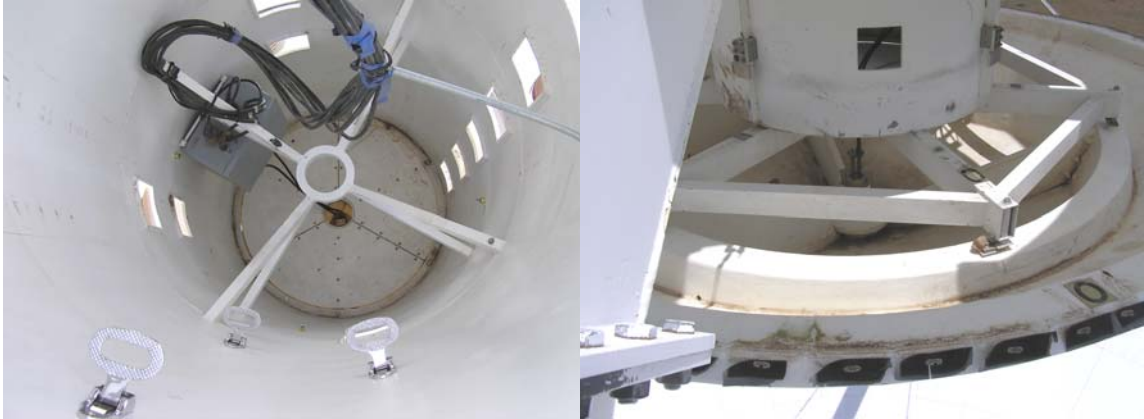
Flip steps were installed for easier access in and out of the FRM tube. 90/50 FE cables and connectors are in good condition. Subreflector drain holes were cleared. Dipole is in good condition.

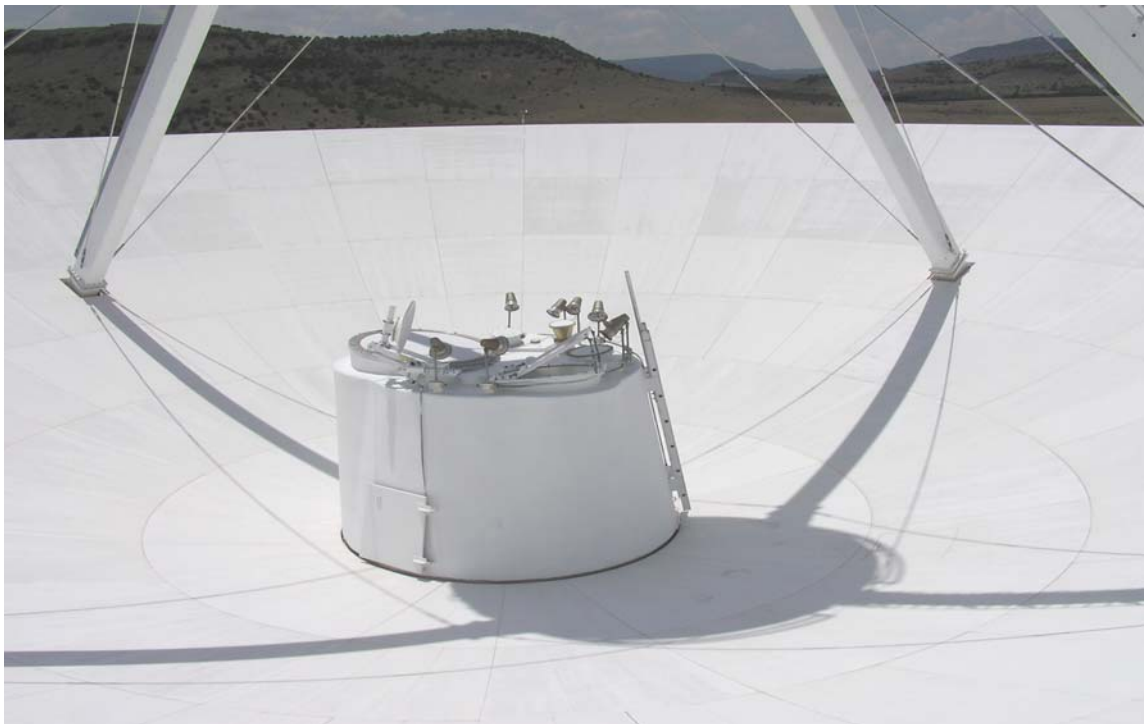
Feed cone was spot sealed and painted with elastomeric

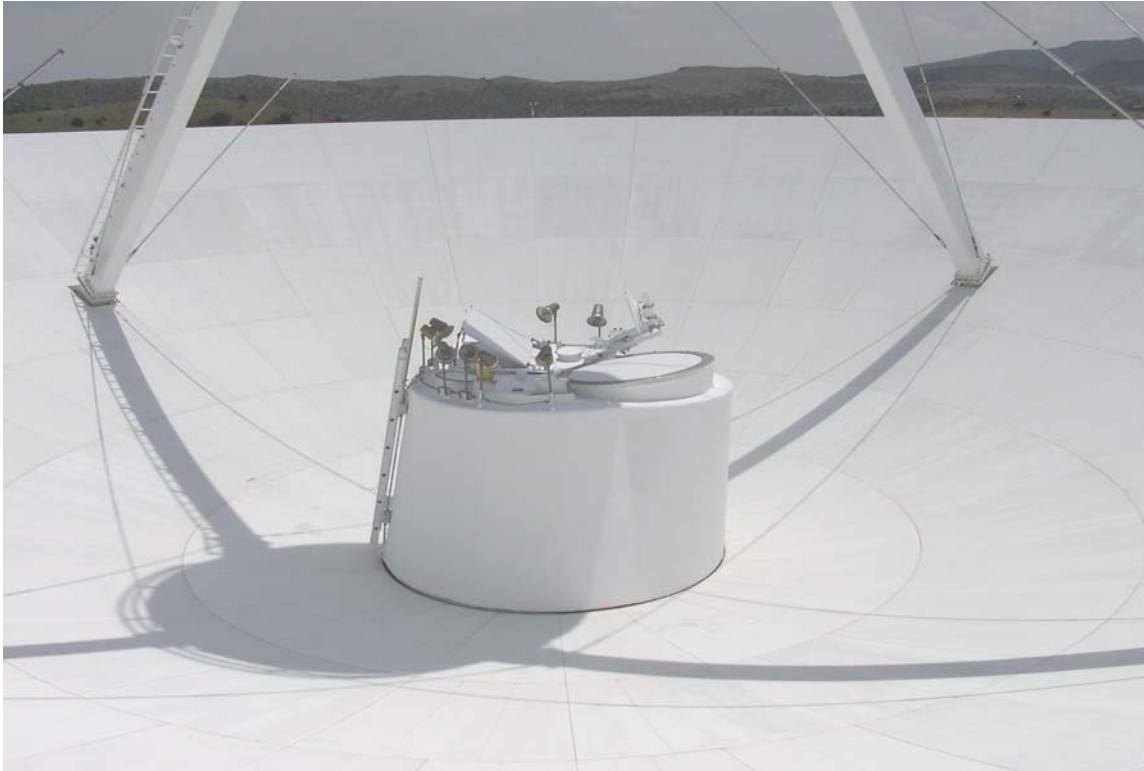
Dichroic reflector was replaced and aligned. Dish panels are in good condition. Panels paint is in good condition. Quad legs paint and guy wires are in good condition.

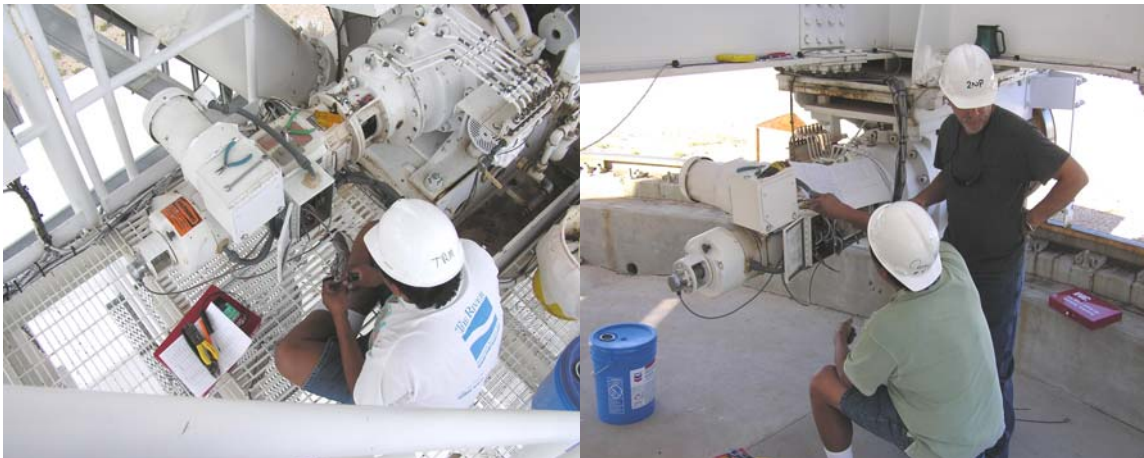
New digital tachs were installed on Elevation and Azimuth motors. Elevation # 2 motor and Azimuth motor #1 were replaced.

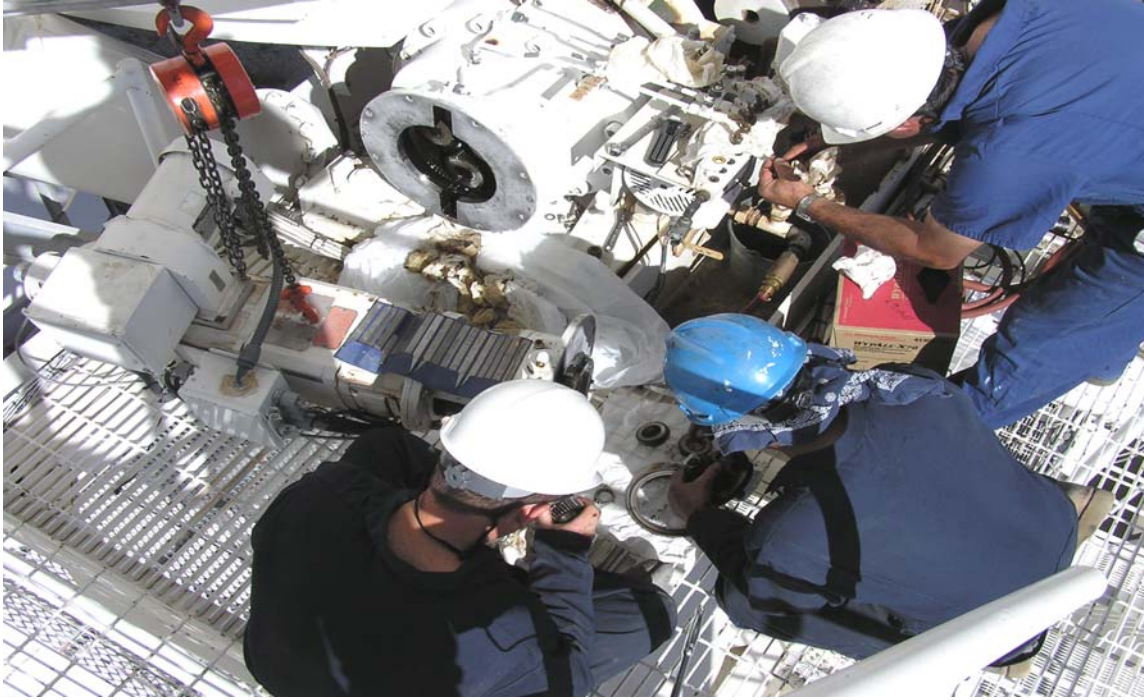
Elevation #1 gearbox, 1st and 2nd stage gear inspection.

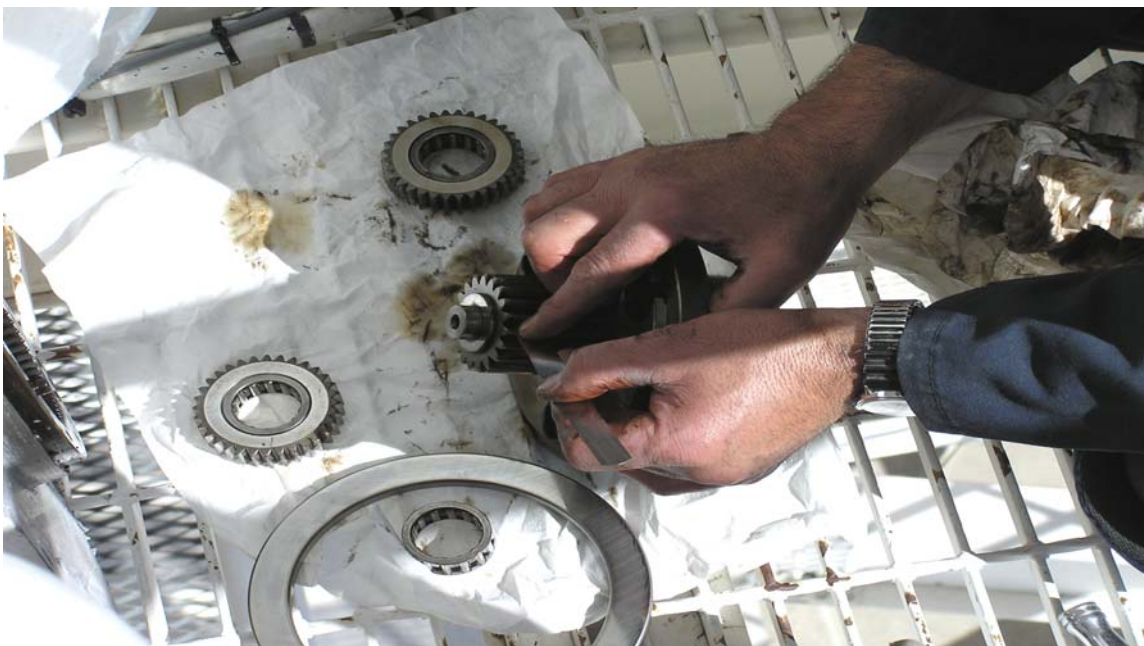
Steve measures $\sim .003''$ of wear with a feeler gauge. Elevation #1 gearbox is in good condition. Both elevation gearboxes oil was changed. Fish eyes and flow gauges were cleaned. Elevation #2 was not opened for inspection.

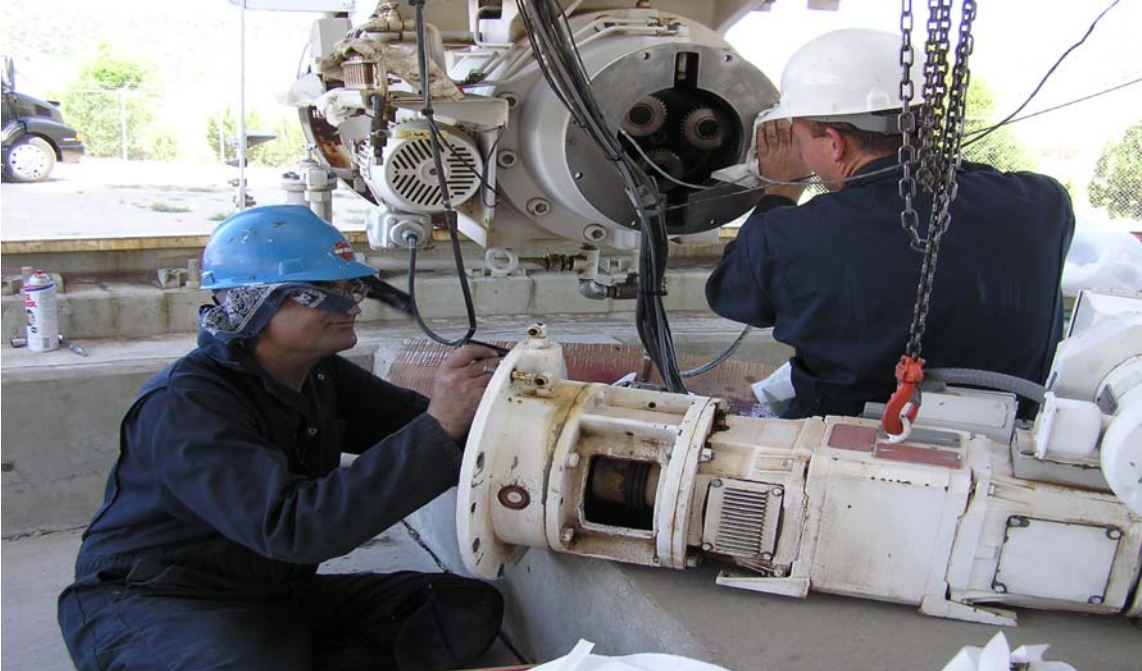
Azimuth #2 gearbox, 1st and 2nd stage gear inspection.

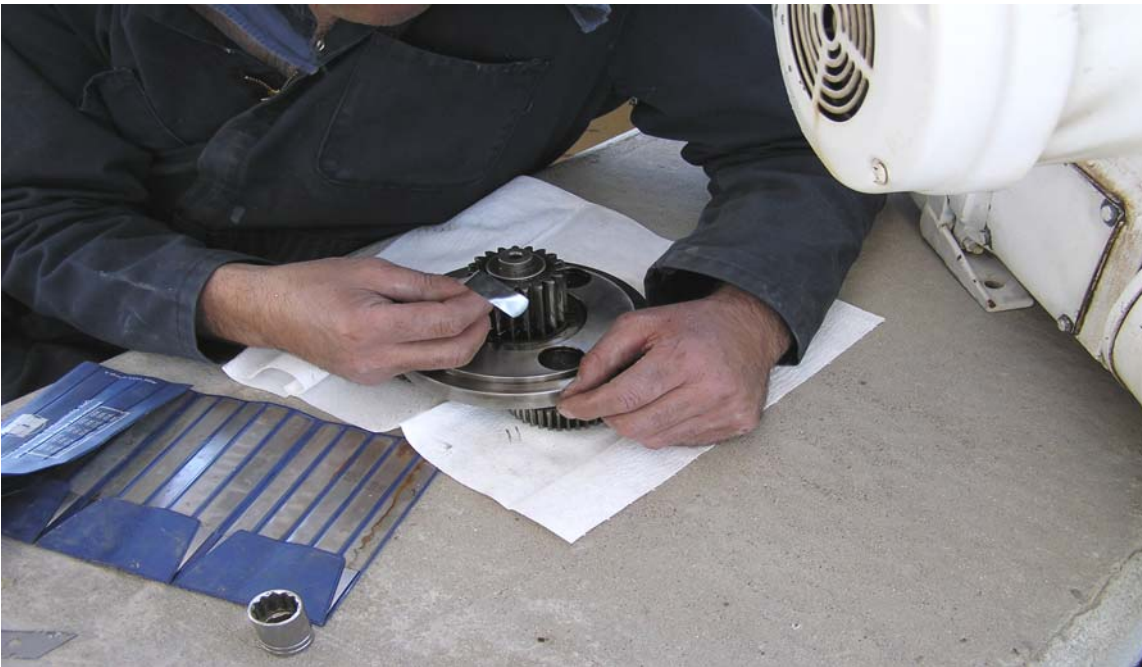
Steve measures $\sim .002''$ of wear with a feeler gauge. Azimuth #2 gearbox is in good condition. Both azimuth gearboxes oil was changed. Fish eyes and flow gauges were cleaned. Azimuth #1 was not opened for inspection.

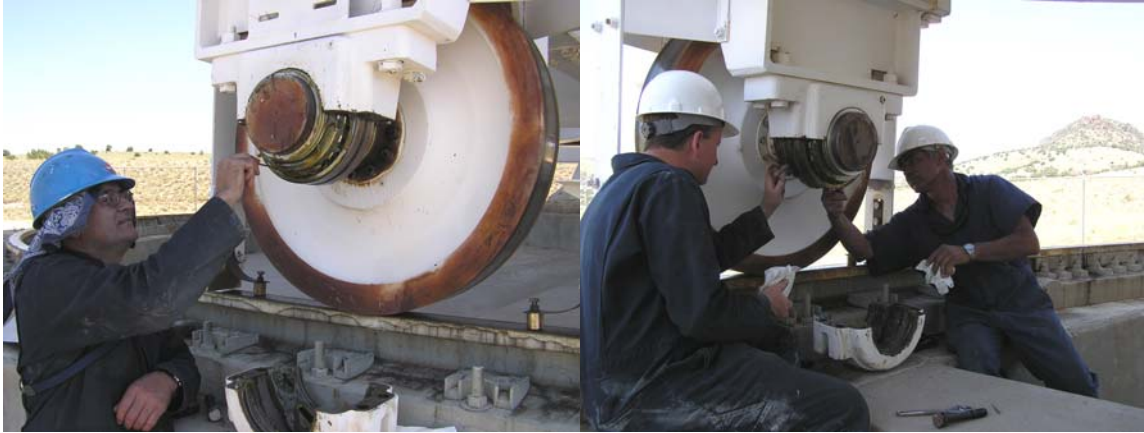
Azimuth bearings were inspected. No azimuth bearings needed replaced.

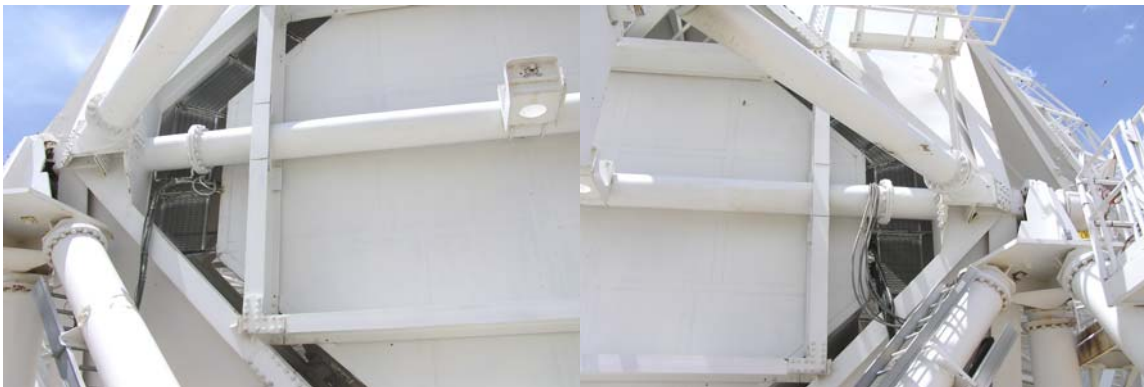
Elevation axle has no visible signs of cracks. Paint is good condition. Pintle bearing is well greased with no metal flakes.

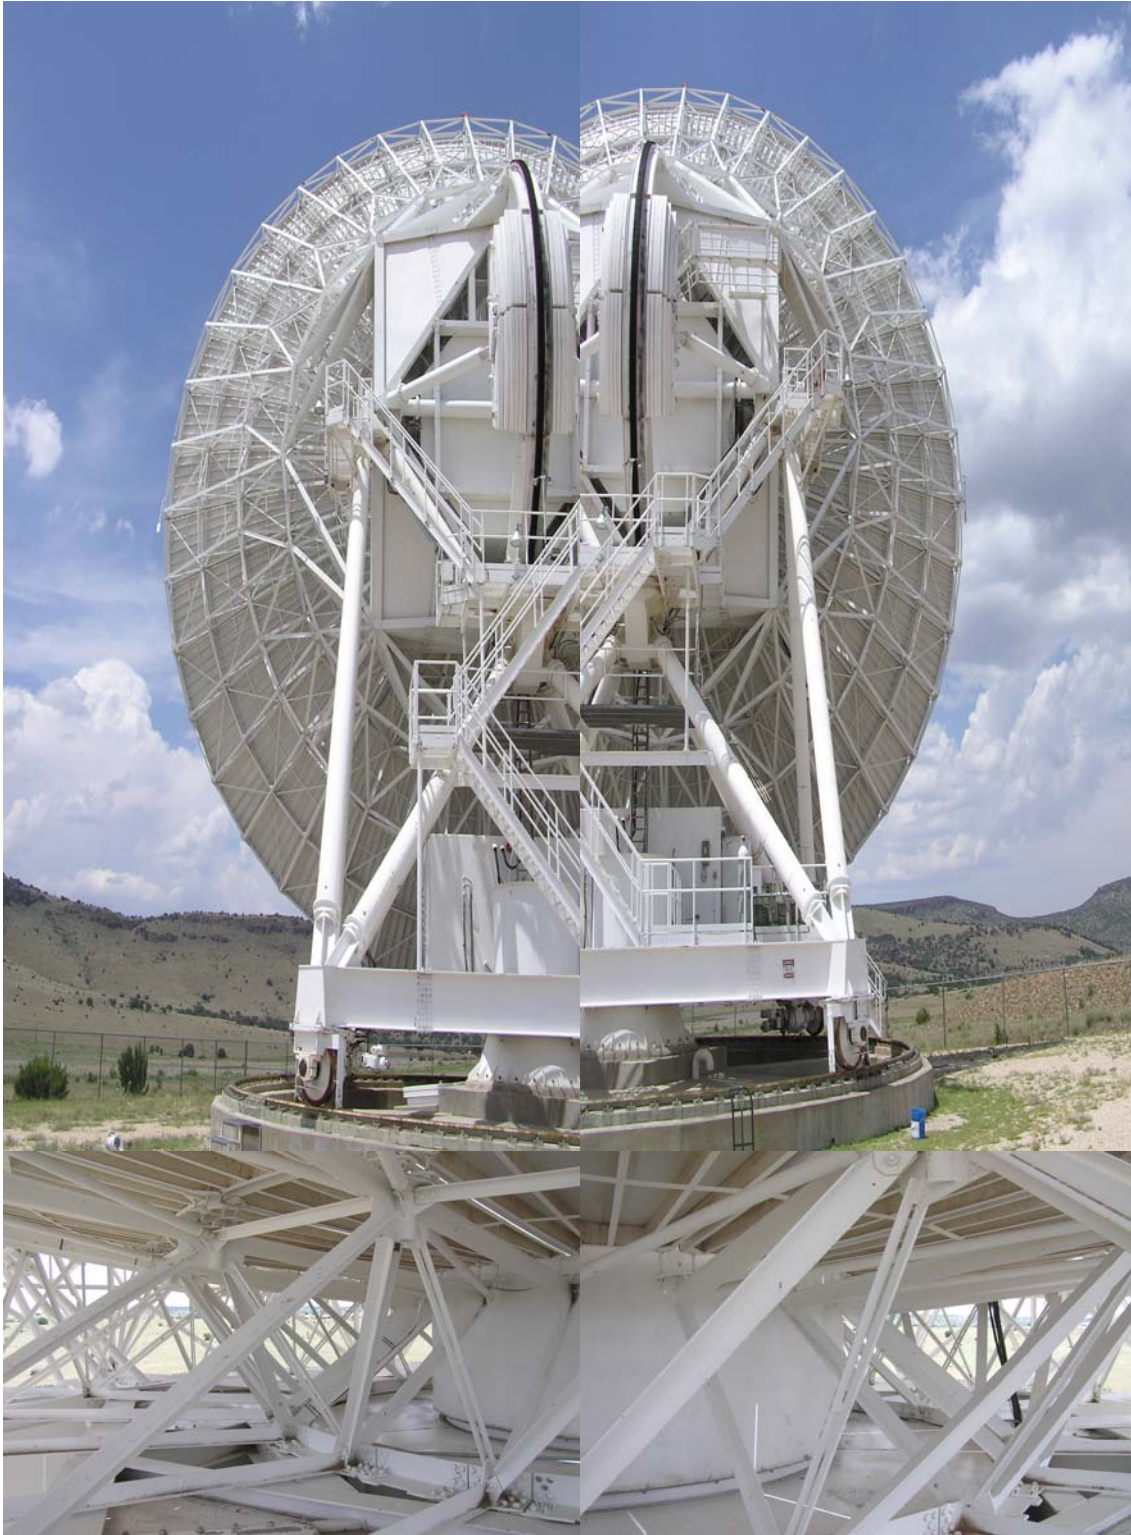
The antenna paint is in great condition.

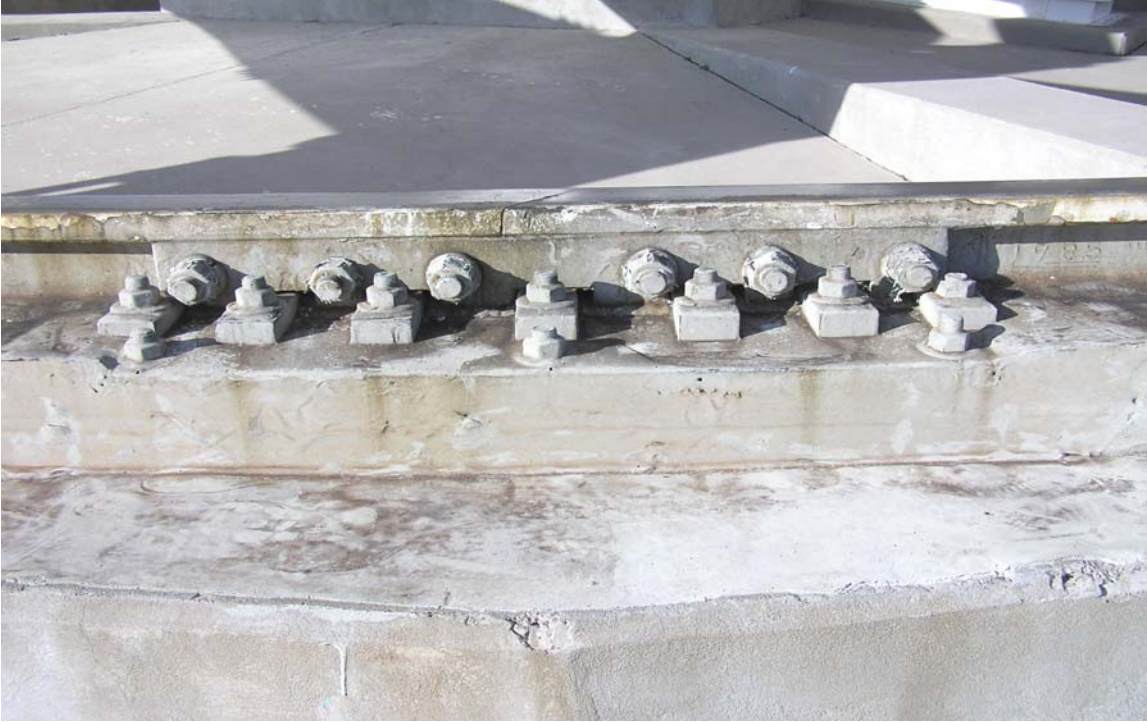
Vulchem is beginning to deteriorate from this rail splice and all others.

1. INSTALL PED ROOM BACK UP AC.
2. INSTALL PED ROOM 6KVA LIEBERT UPS.
3. INSTALL NEW ACU BACKPLANE.
4. REMOVE VULCHEM FROM RAIL.

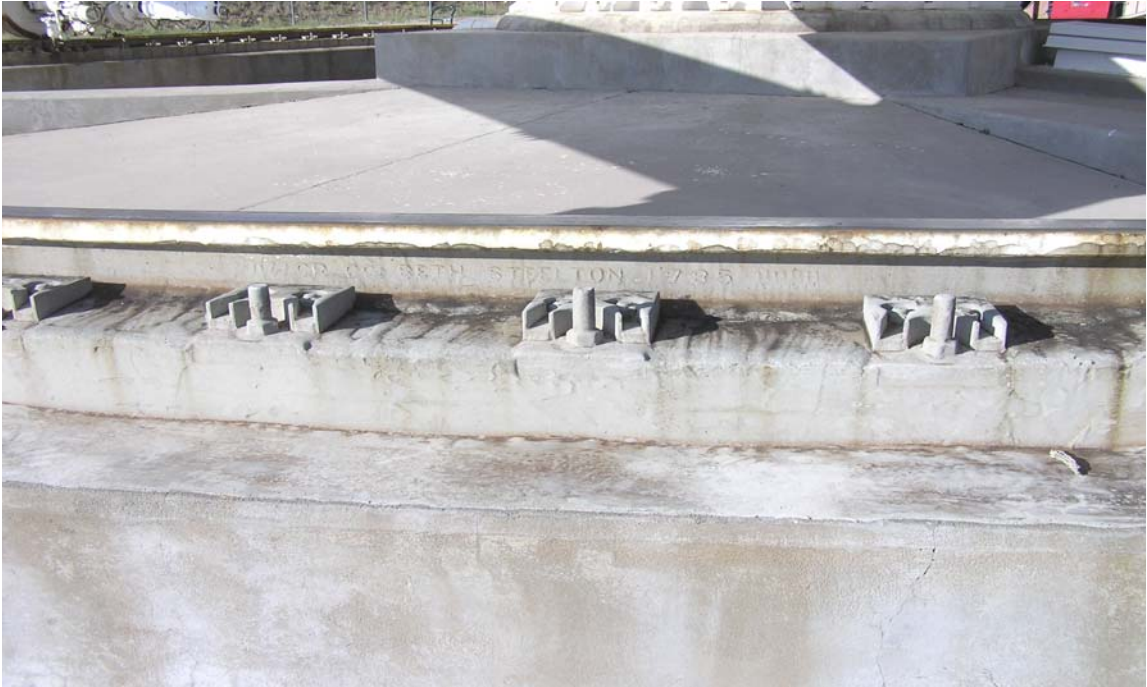
Vulchem is deteriorating off rail clips and will have to be removed.
