VLBA Antenna Memo Series No.62

St. Croix Corrosion Report

J. E. Thunborg
March 3, 2006

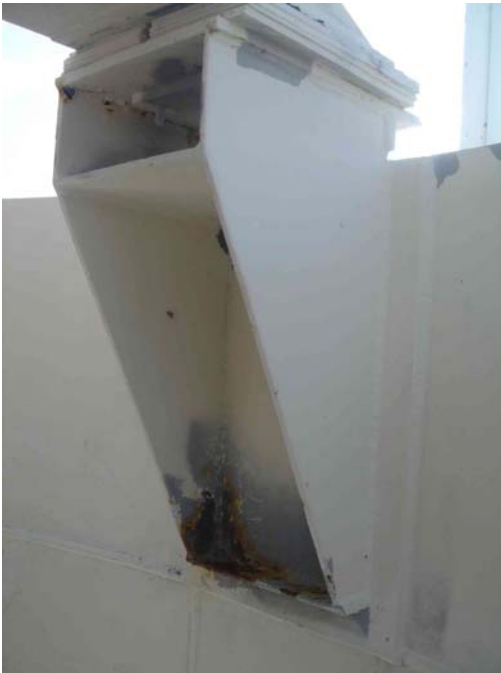
The picture below shows corrosion developing on the lower part of the

structural brackets used to connect the FRM to the quad legs. This appears to be galvanic corrosion.

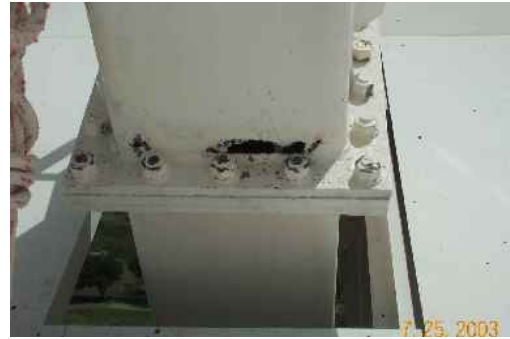
Quad Leg - The next picture shows the quad leg corrosion damage before it was repaired during the April 2005 maintenance visit. The corrosion was localized at the bottom of the quad leg because debris accumulated on the lip inside the leg. This allowed crevice corrosion to consume the leg from the inside. To prevent this type of corrosion from reoccurring, access doors would need to be installed on the quad legs so that their insides could periodically be cleaned.

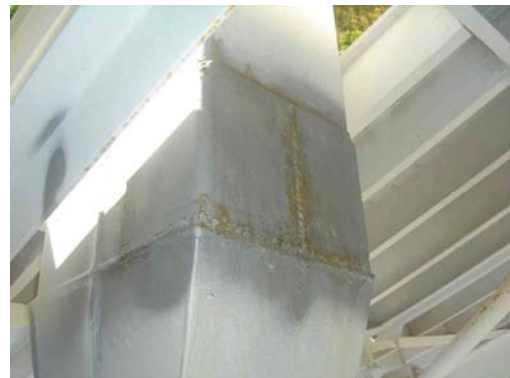
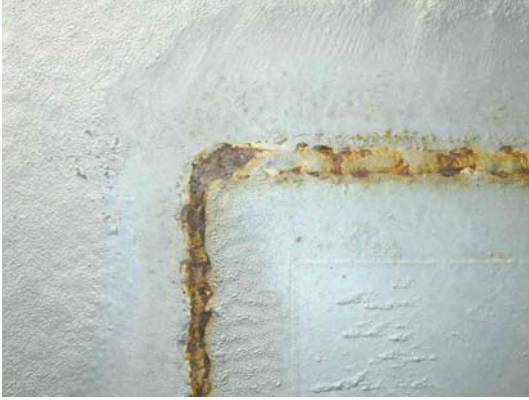
As you can see from the following picture, the corroded steel was removed and steel plates were welded over the damaged area during the 2005 maintenance visit.

In less than one-year, rust is appearing at the weld on the quad leg patch. This illustrates how the weld material is anodic to the surrounding steel. The silver paint is a product called Rust Bullet that was supposed to eliminate all rust. As you can see, this product is beginning to fail with less than one-year of service. The patches have effectively repaired the damage. However, the paint system on the patches must be repaired or the welded area will rapidly corrode.

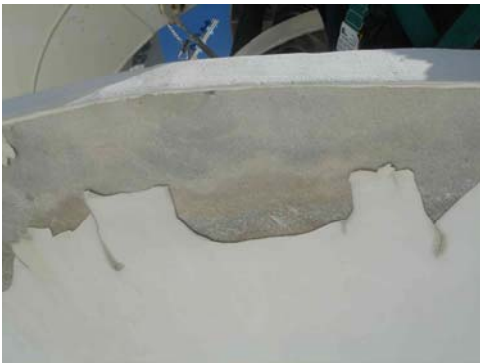
Subreflector – Both the reflective silver paint and the white overcoat paint on the outer eight inches of the subreflector has peeled off. The carbon fiber substrate is now exposed. The paint will continue to peel until the antenna is unusable. The subreflector that was removed from the Brewster Antenna should be repaired and swapped with this one as soon as possible.

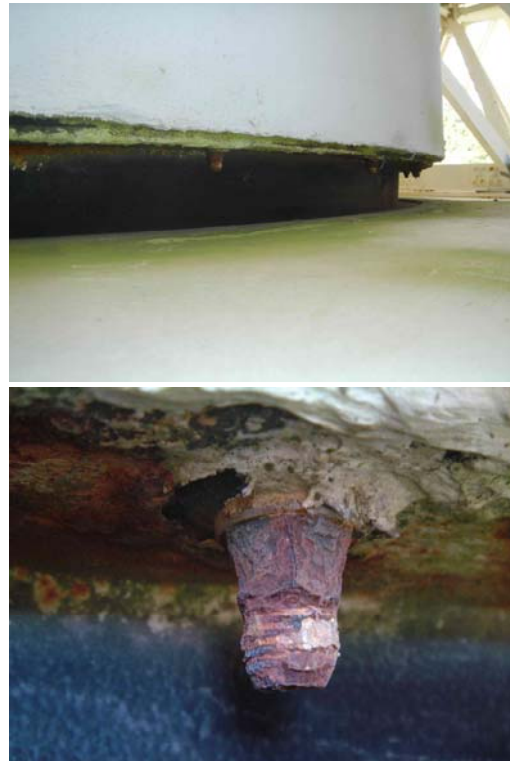
Vertex Room - The bolts and nuts that attach the vertex room feed house, as shown below, to the structure have severely corroded and need to be replaced with stainless steel.

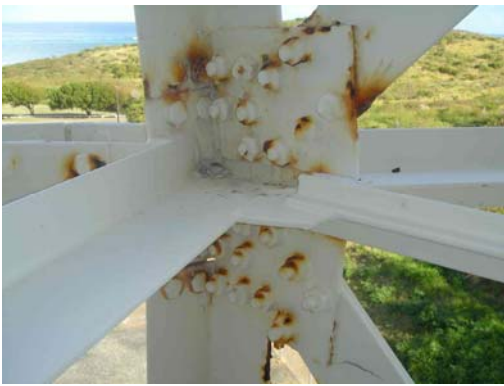
The first picture shows the corrosion on an average bolted connection. This is how the majority of the bolted connections look. It is evident in this picture that the paint system has failed and crevice corrosion is beginning to consume a majority of the bolts.

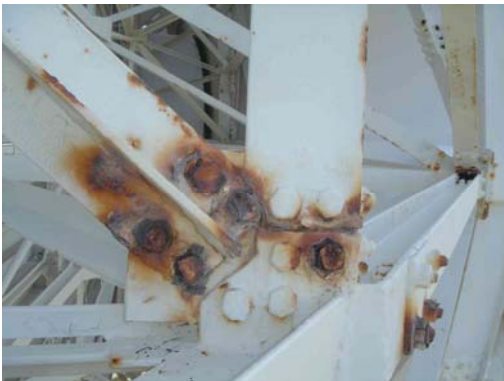
The next picture shows one of the more seriously corroded bolted connections. On this connection, most of the bolt heads have corroded to the point where they will need to be replaced. I estimate that approximately 10% of the backup structure bolts have corroded such that they will need to be replaced.

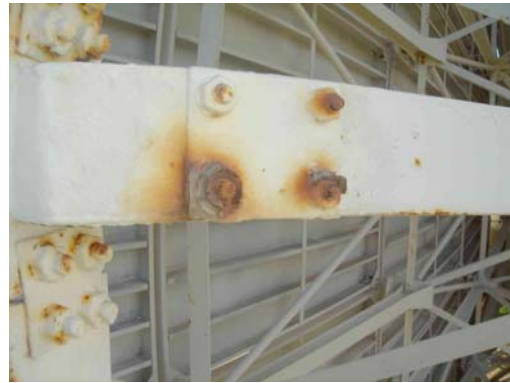
From my experience with the St. Croix Antenna, the next picture illustrates the time scale on which the corrosion occurs. The upper left hand nut is beginning to show a slight discoloration as the paint system is compromised. The remaining nuts going clockwise show how the corrosion progresses in one year intervals. The third-year after the paint is compromised, the nut rapidly begins to fail. Bolts which have corroded similar to the second bolt in this series need to be replaced. This is because once crevice corrosion begins, it will continue its attack even if it is painted over.

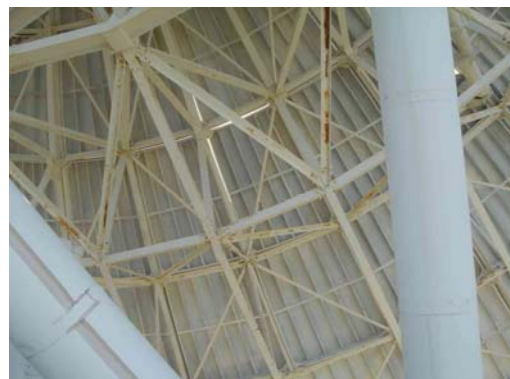
Trusses – The truss members have lost minimal steel due to galvanic corrosion.

The corrosion on the truss members does not seem to be rapidly progressing even though the paint system has failed as evinced by the above picture.

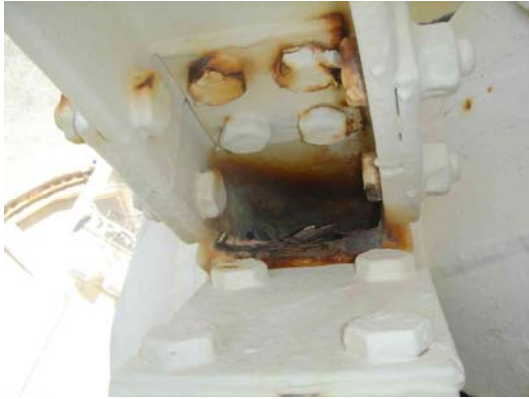
Another place on the trusses that will require attention is the joint underneath the intersection between the third and fourth row of panels where the trusses trap water and debris. These boxes need to be modified so that the water traps are eliminated.

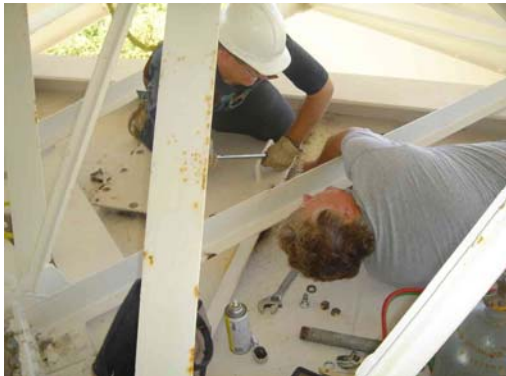
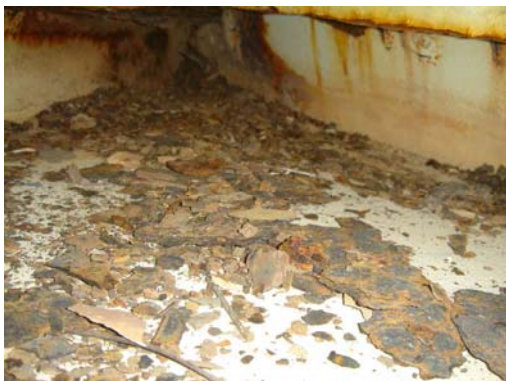
Tanks – The access doors on the large enclosed box sections of the backup structure were opened up and inspected from the inside.

These box sections had severe rust in pockets where water collects. All of the box sections on the antenna will need to be opened, cleaned and painted. Holes should be drilled in the structure to allow water to drain. These drain holes need to have clean edges and then must be properly covered with paint. The drain hole shown below was cut with a torch. Corrosion has severely attacked the hole demonstrating the need for clean painted holes.

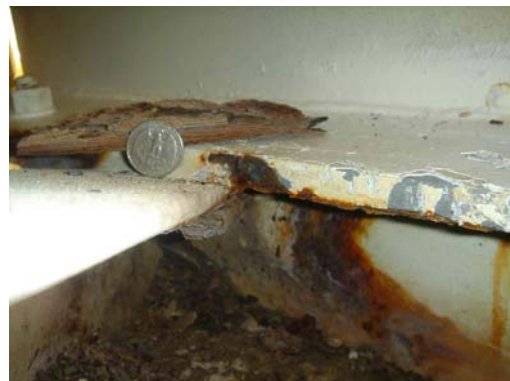
The I-beam inside the antenna “tank”, as shown in the next picture is severely corroded. The top of the flange of the I-beam will need to be reinforced to restore the I-beam to its original strength. There are a few other places on the structure that will also require reinforcement.

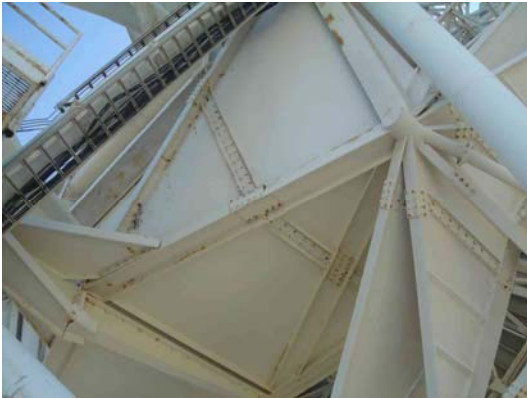
Star Structure – The paint needs to be restored on several of the star structure bolts. Places where water collects have corroded excessively and will also need to be restored.

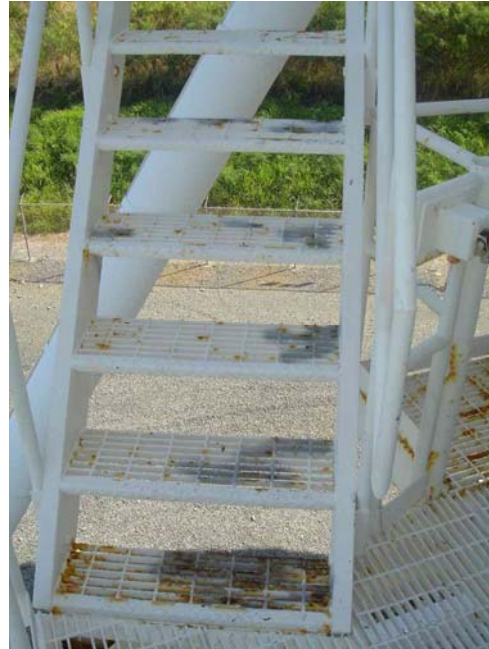
Catwalks and Stairs – Repairs done on the catwalks and stairs have mostly alleviated the corrosion problems. However the paint system on these areas needs to be improved to impede further corrosion.

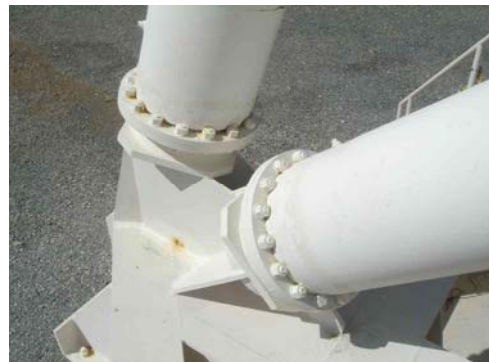
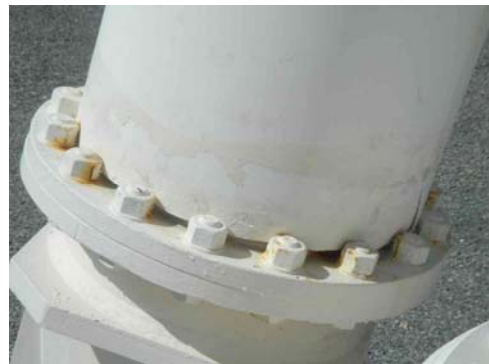
Large Tubes - The large structural tubes supporting the antenna show only minimal corrosion at the flanges where they are bolted together.

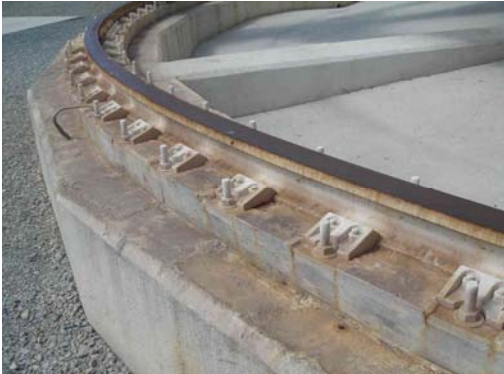
Rail – When the rail began to show accelerated corrosion, the site technicians initiated an extensive corrosion control program. The rail was treated with Chemprime for several days and then repainted. Their efforts have mostly eliminated the corrosion problems on the rail.

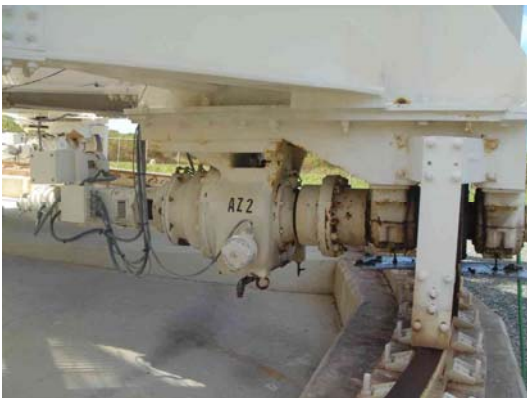
Drive Systems – The corrosion on the drive motors and gearboxes is mostly superficial. This area will require repainting.

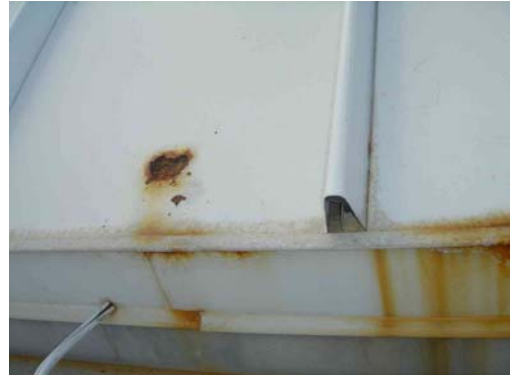
Roof – The roof of the control building has corroded through in a couple of

places. When the roof fails, a local contractor should be used for replacement.

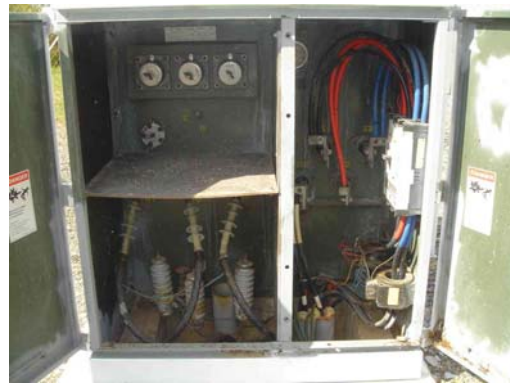
Power Transformer – The utility transformer door has corroded through. A patch should be installed over the corroded hole to keep vermin out of the transformer.
